# Building and Pest Report

## 13 Cowrie Street, Lennox Head

# Inspection Report

**13 Cowrie St, Lennox Head, NSW, 2478**

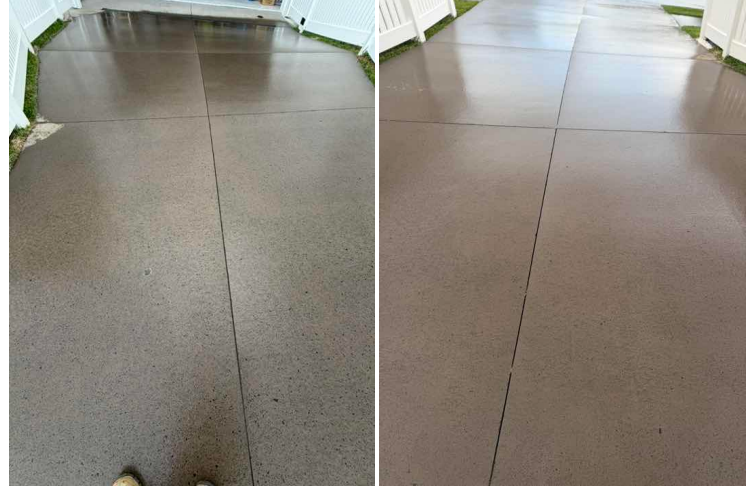
#### Driveway Condition

On visual inspection, the general condition of the driveway is serviceable.

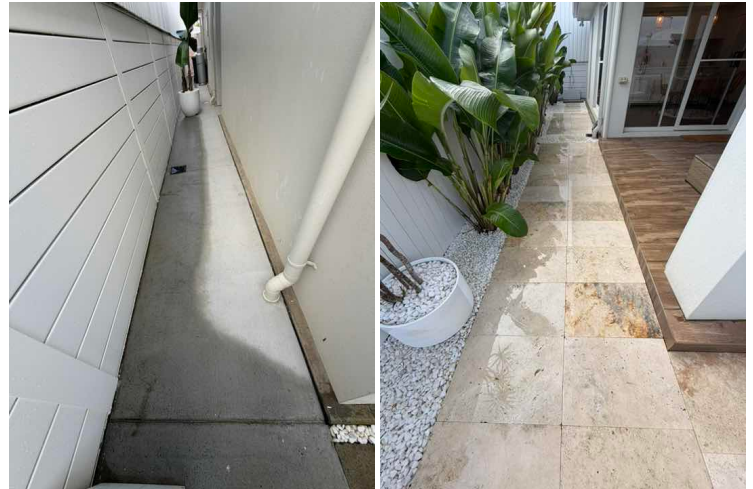
#### Pathways Condition

The paths around the home are in a serviceable condition for the age of this dwelling with no major defects visible.

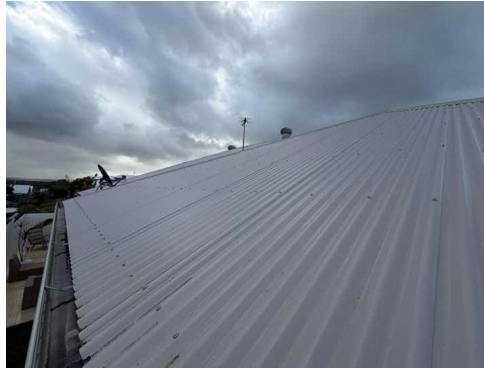
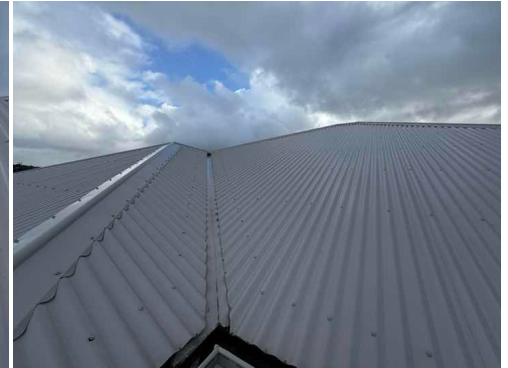
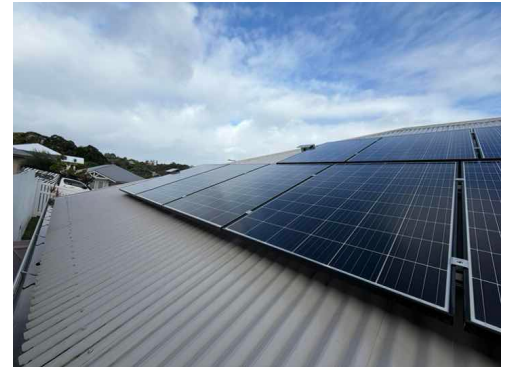
#### Overall Condition

Of the visible areas, the general condition of the roof is in serviceable condition for the age.

Note: In the absence of rainfall there is no guarantee that the roof won't leak.

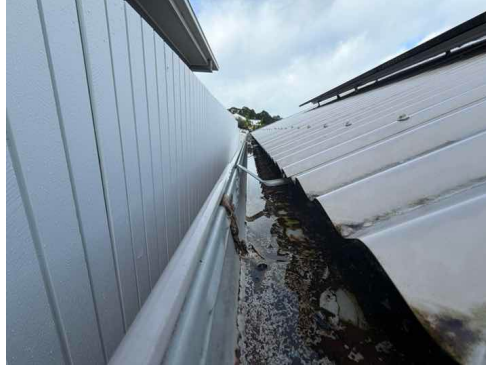
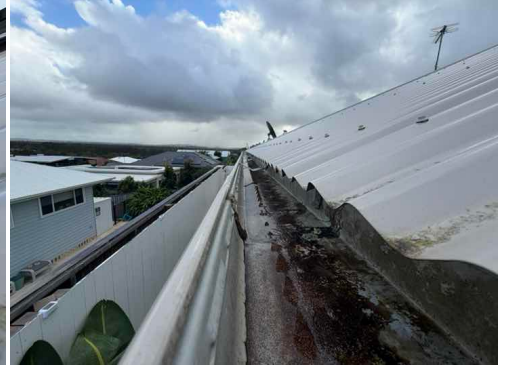
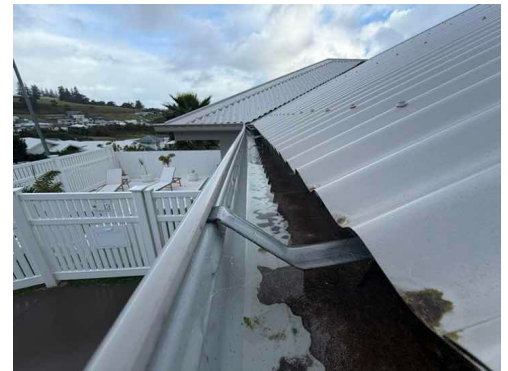
### **Gutter Findings**

All visible and accessible of the physical nature of the guttering system appears to be in a serviceable condition with no apparent defects at the time of inspection. In the absence of prolonged rain fall efficiency of the guttering can not be assessed and you may find that further investigation or repairs maybe required. Note: Periodic maintenance checks should be carried out for rust penetrations and leaks.

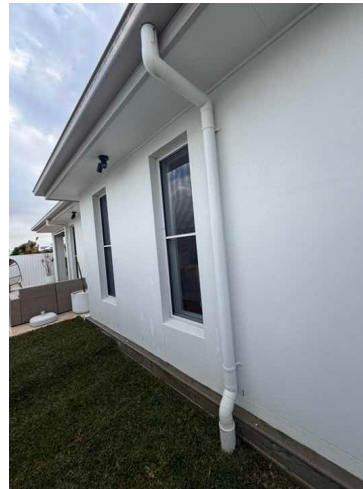
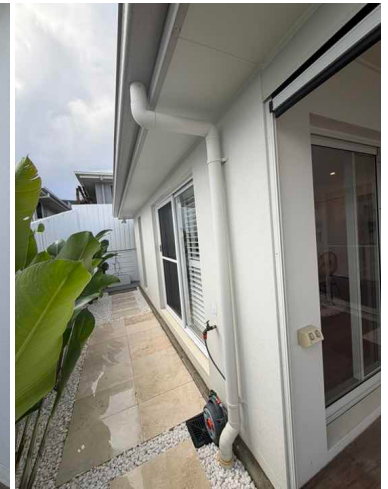
### **Downpipe Findings**

On visual inspection no apparent defects were noted to the down pipes and are considered serviceable, however no comment can be made with regard to blockages or connections to stormwater or functionality in the absence of rain. Note: Periodic maintenance checks should be carried out for rust penetrations and leaks.

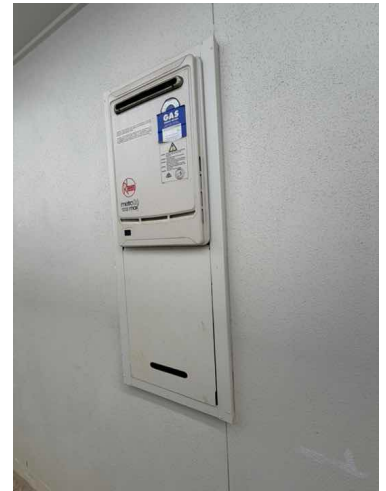
#### System Make

The make of the hot water unit is rheem.

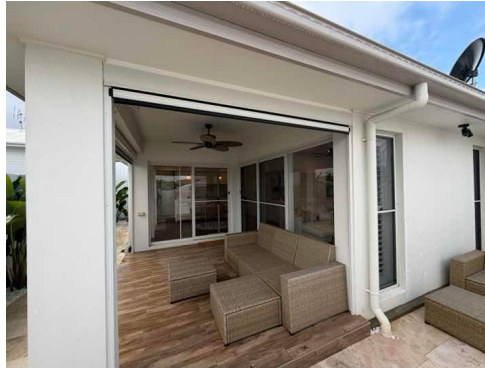
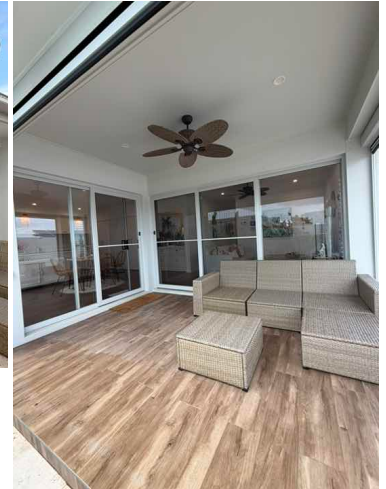
#### Overall Condition

Visible sections of the Alfresco area are serviceable or in reasonable or condition for the age of this dwelling.

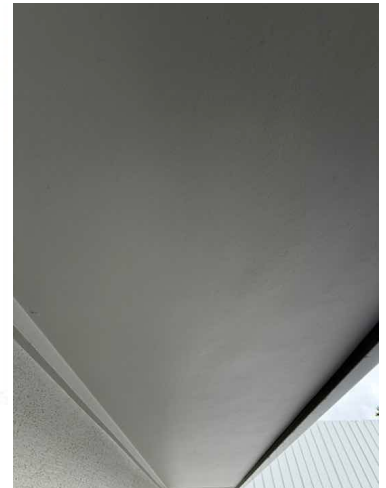
#### Eave Condition

The soffit lining (eaves) are in a serviceable condition with no notable defects.

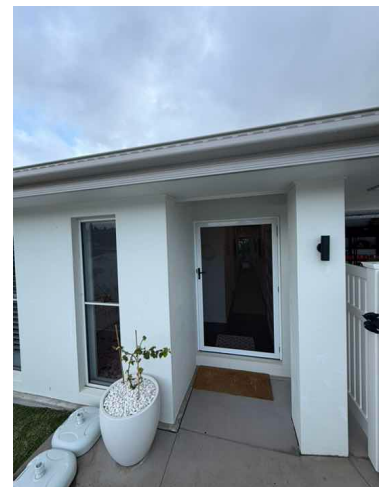
### Entry Porch Area

The entry porch serviceable or in reasonable or condition for the age of this dwelling.

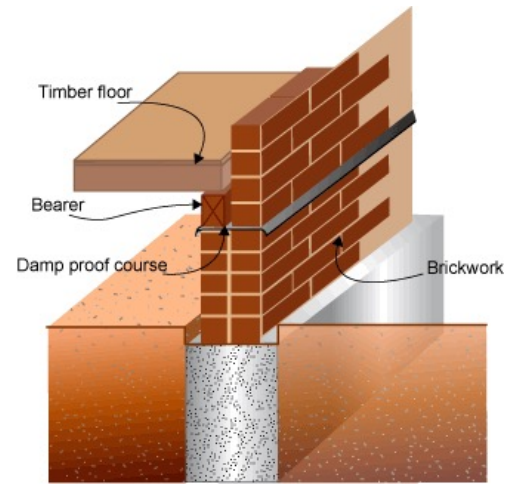
### **Damp Proof Course**

A damp proof course (DPC) was noted.

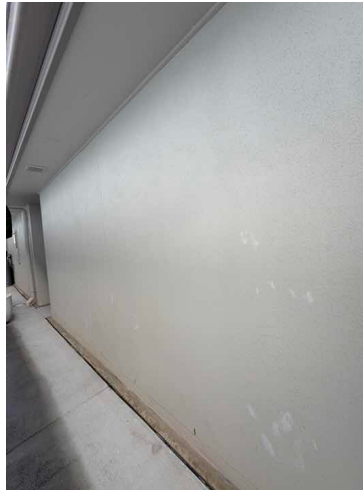
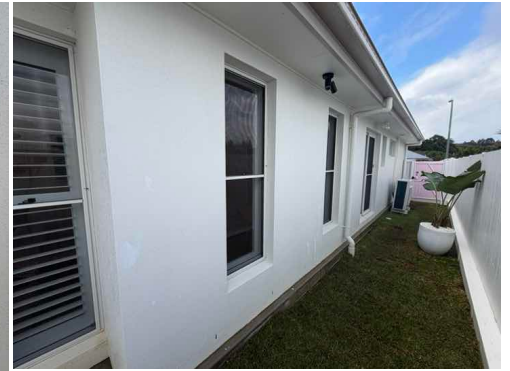
### **Condition**

On visual inspection, the general condition of the exterior walls is serviceable for the age.

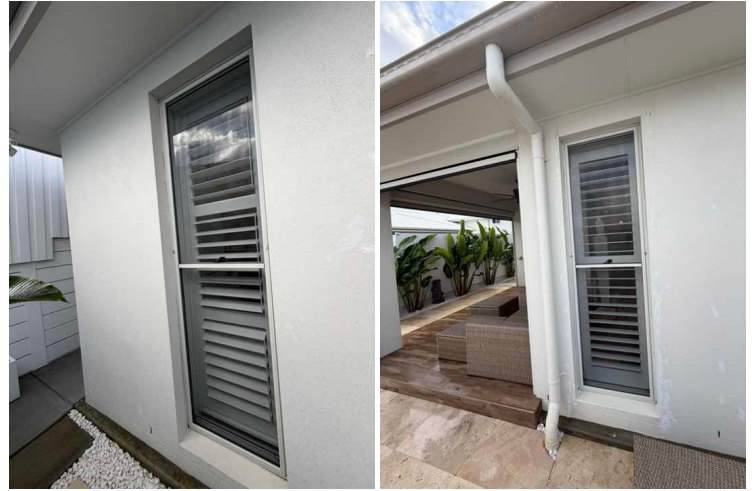
## Overall Condition

On visual inspection, the general condition of the windows is serviceable for the age.

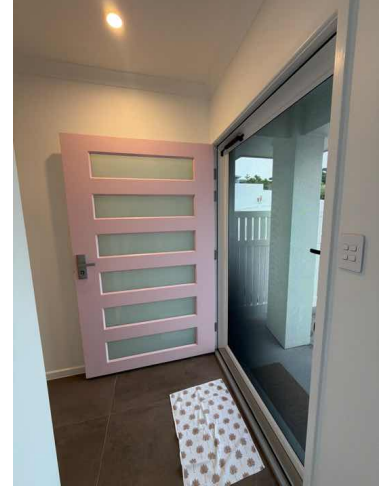
#### **Front Entry Doors**

The doors are in serviceable condition with no notable defects observed.

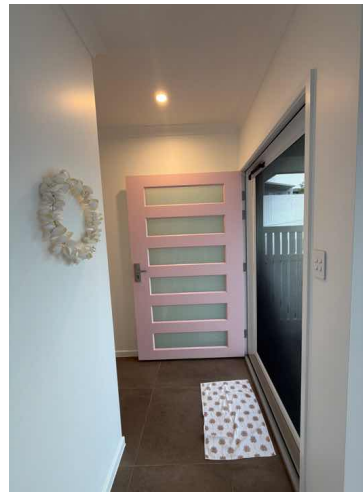
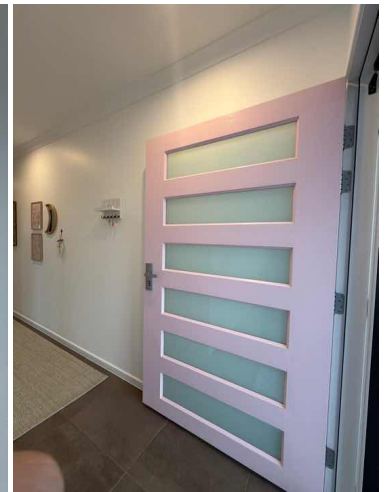
#### **Overall Condition**

From the visible and accessible areas, this area appears to be in a serviceable condition for the age of the property with no notable structural defects sighted.

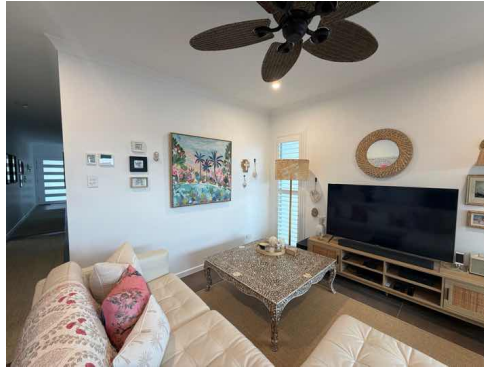
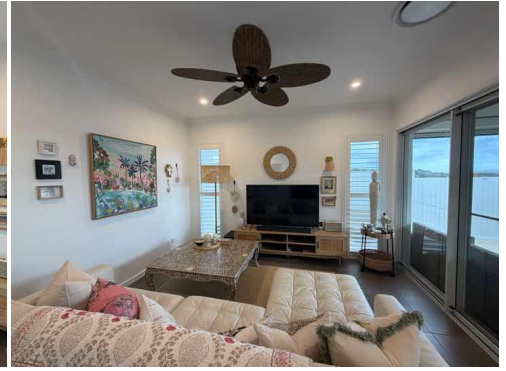
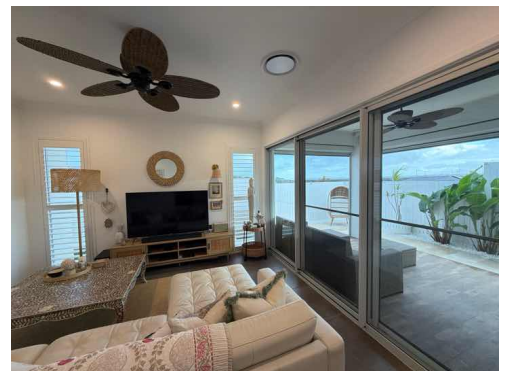
## Living Room

From the visible and accessible areas, this room appears to be in a serviceable condition for the age of the property with no notable structural defects sighted.

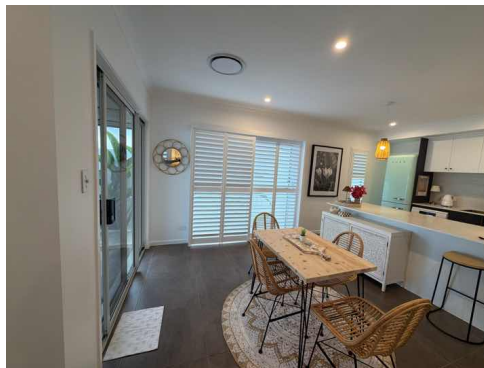
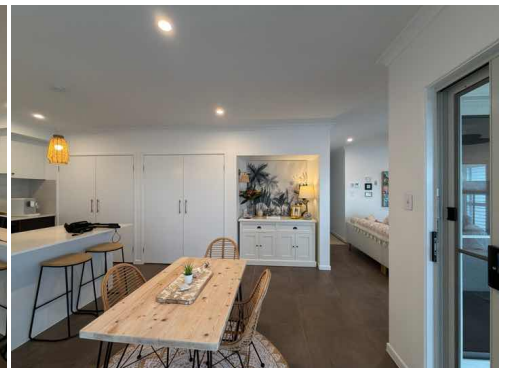
## Dining Room

From the visible and accessible areas, this room appears to be in a serviceable condition for the age of the property with no notable structural defects sighted.

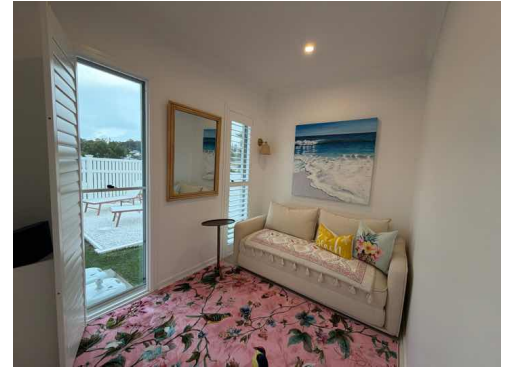
## Sunroom

From the visible and accessible areas, this room appears to be in a serviceable condition for the age of the property with no notable structural defects sighted.

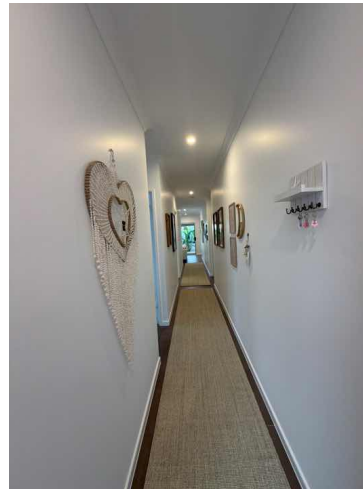
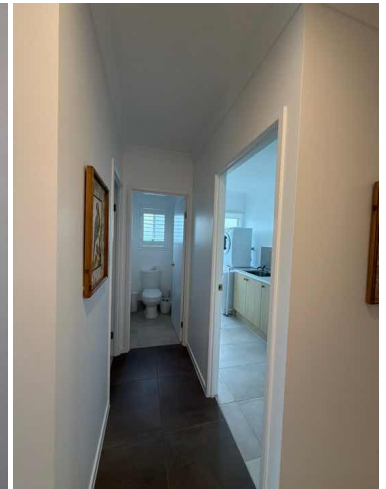
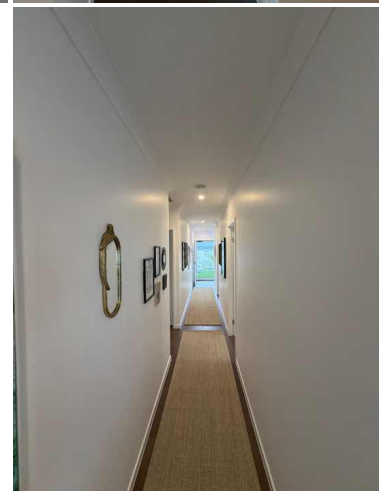
## Hallway/s

From the visible and accessible areas, the hallway/ appears to be in a serviceable condition for the age of the property with no notable structural defects sighted.

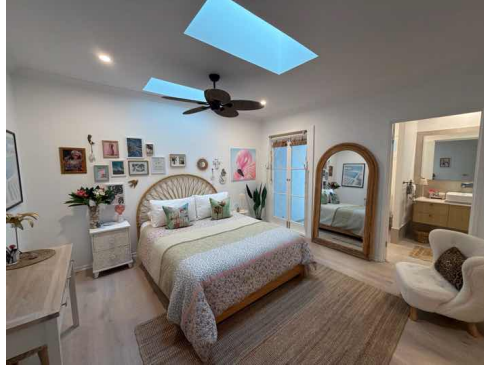
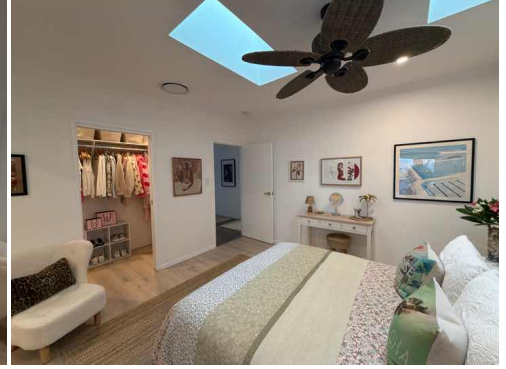
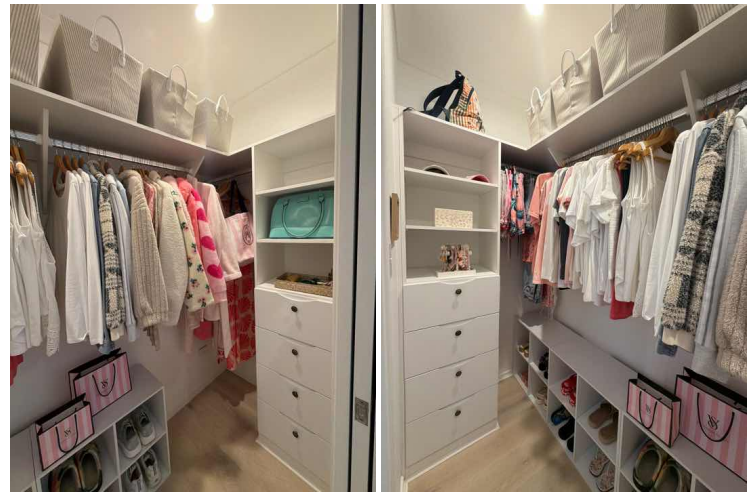
## **Bedroom 1**

From the visible and accessible areas, this bedroom appears to be in a serviceable condition for the age of the property with no notable structural defects sighted.

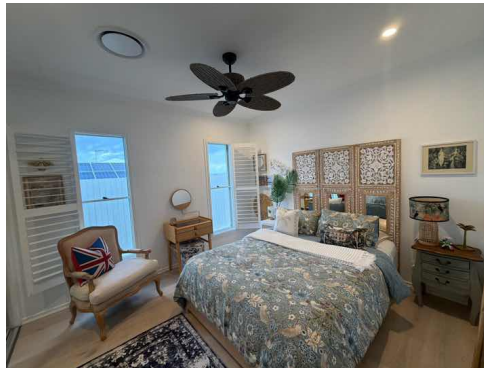
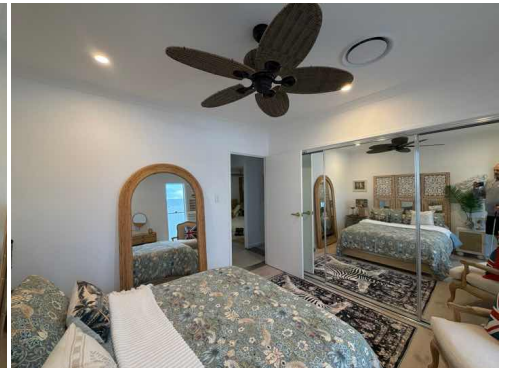
## **Bedroom 2**

From the visible and accessible areas, this bedroom appears to be in a serviceable condition for the age of the property with no notable structural defects sighted.

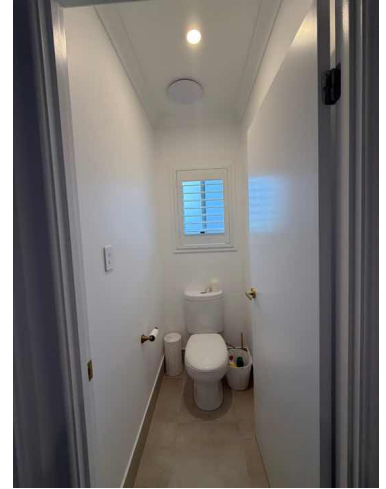
Of the visible areas, the general condition of this bathroom is serviceable or in reasonable condition for age of dwelling.

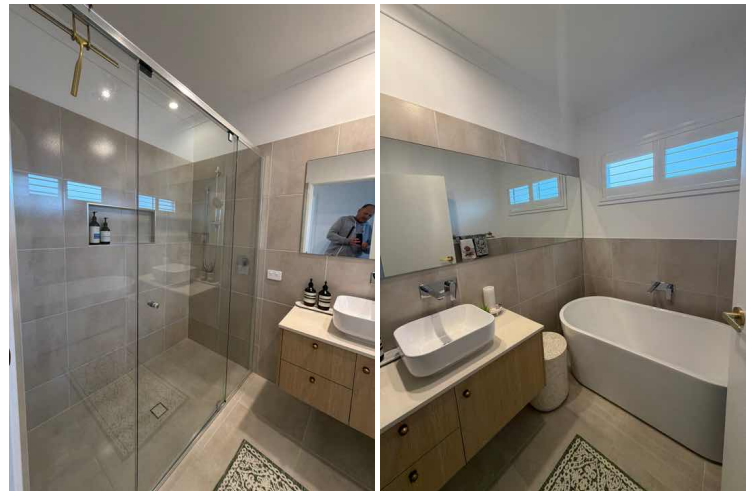
Of the visible areas, the general condition of this bathroom is serviceable or in reasonable condition for age of dwelling.

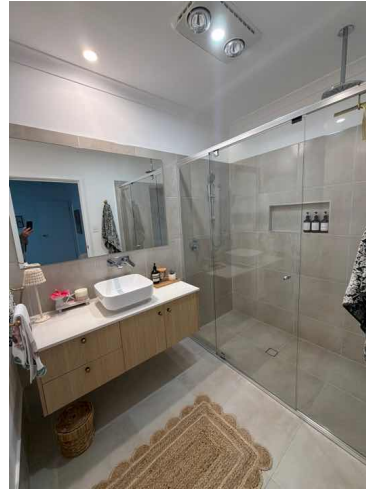
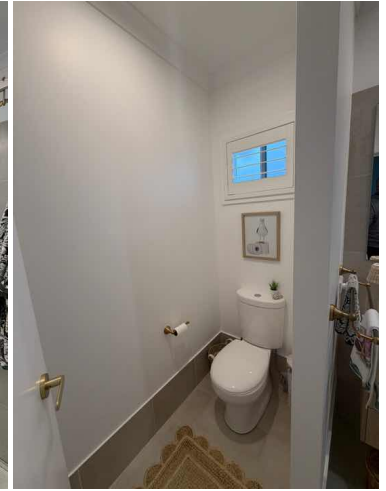
Of the visible areas, the general condition of this bathroom is serviceable or in reasonable condition for age of dwelling.

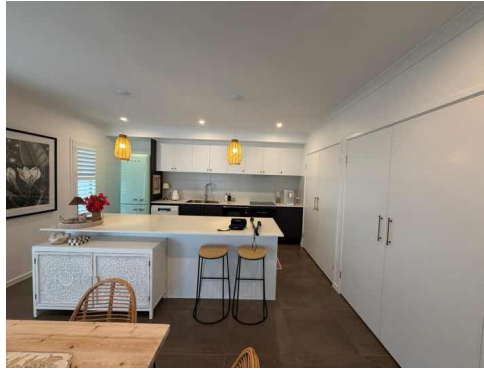
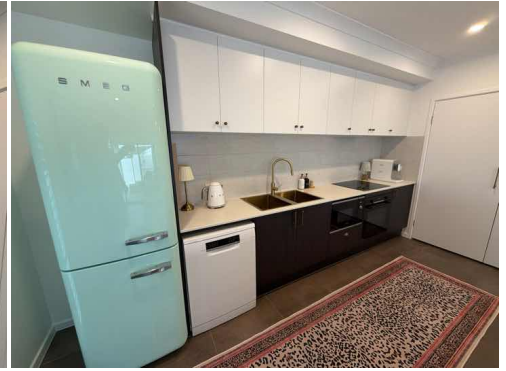
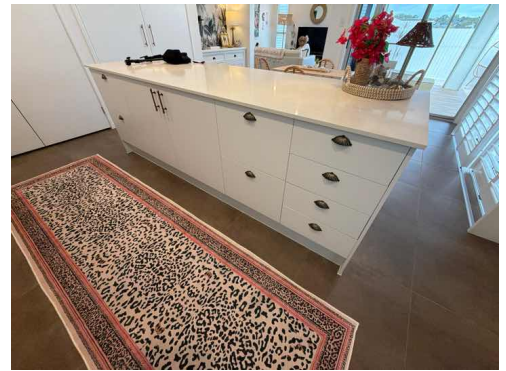
Of the visible areas, the general condition of the kitchen and pantry is serviceable or in reasonable condition for age of dwelling.

These components appear to be in a serviceable condition

Adjustment to cabinet doors required, in some instance hinges may need to be replaced.

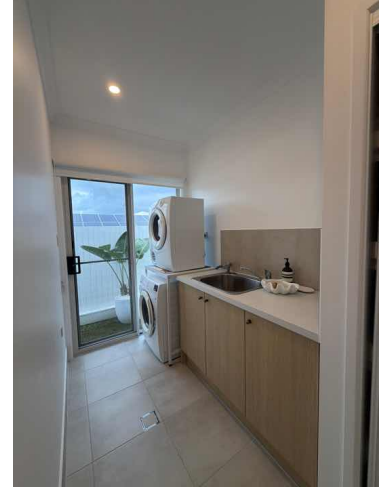
Of the visible areas, the general condition of the laundry is serviceable or in reasonable condition for age of dwelling.
