# Building and Pest Report

## 19 Amber Drive, Lennox Head

# Inspection Report

**19 Amber Drive, Lennox Head, NSW, 2478**

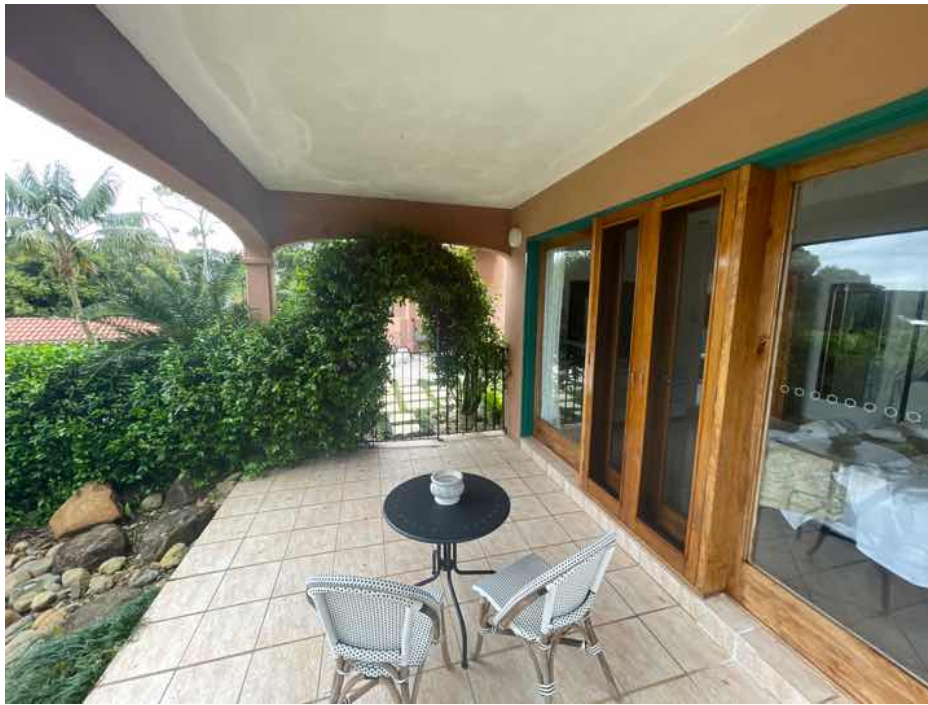
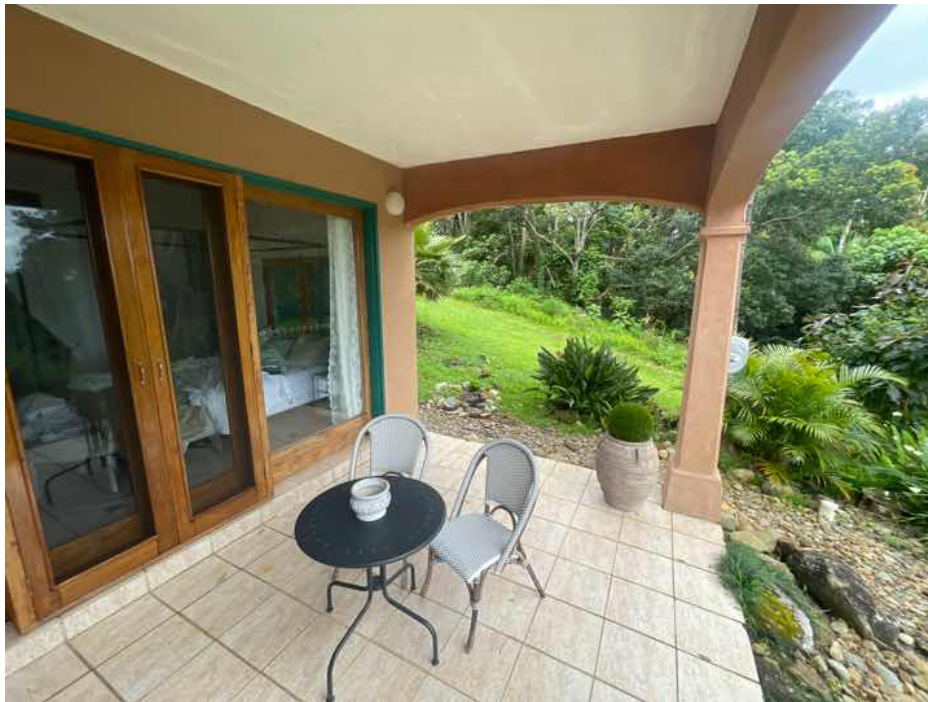
Tile cracking observed. A qualified tiler should be engaged for advice and recommendations. This may cause leaking and water penetration.

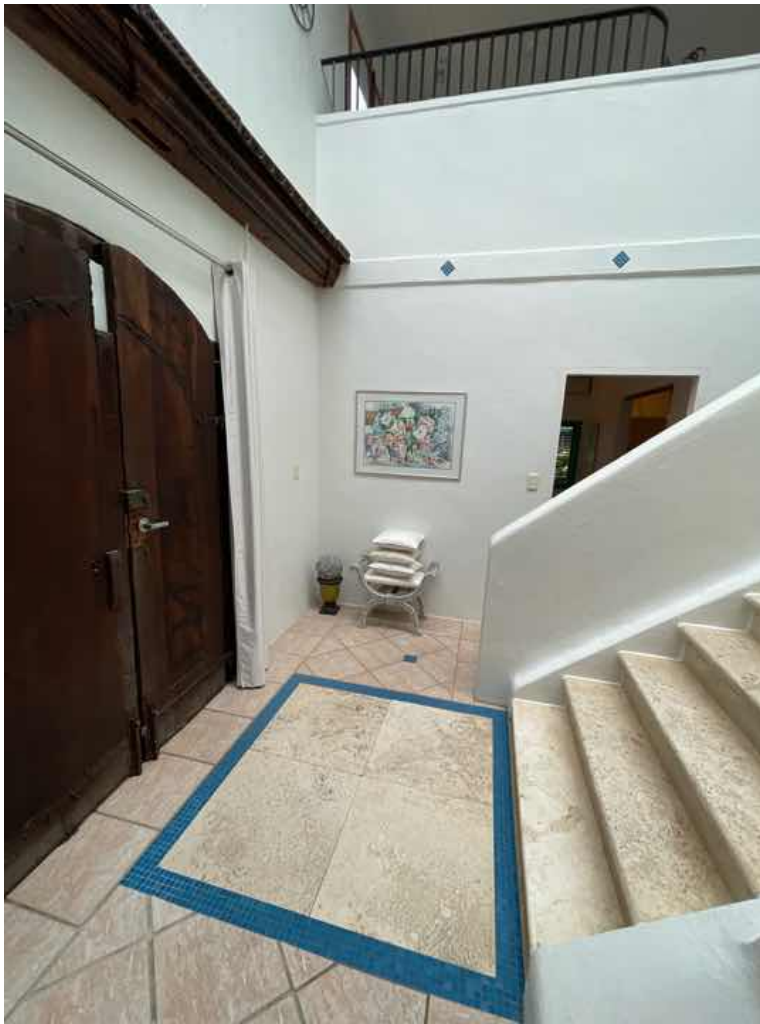
### **Walls**

Settlement Cracks Noted. These are typical and generally patch and paint will suffice, however we recommend you monitor these cracks and if they become wider or longer, you will need to contact a structural engineers to assess.

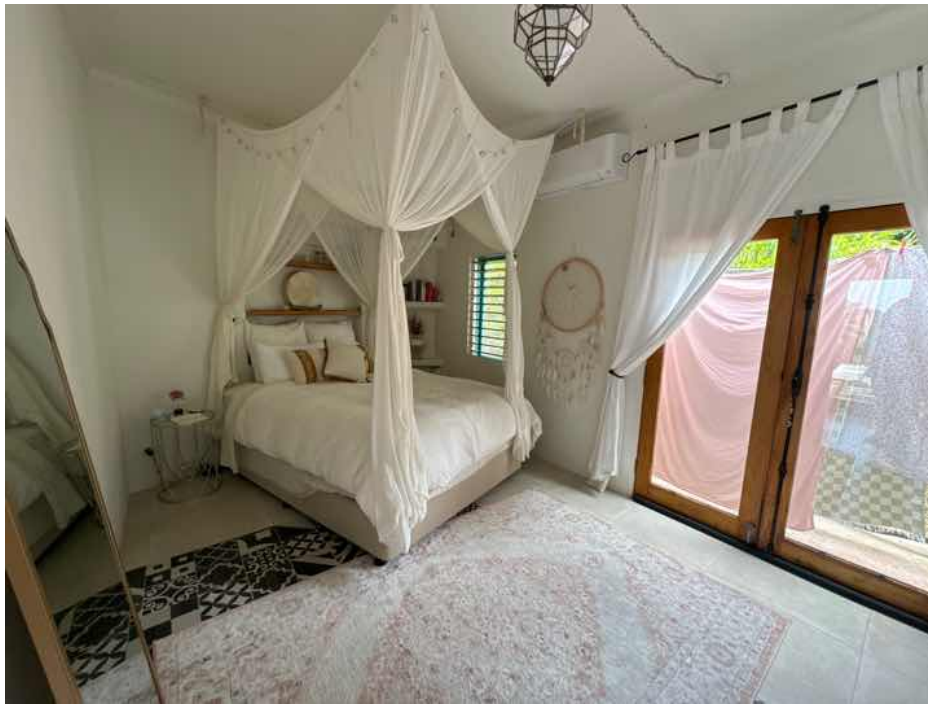
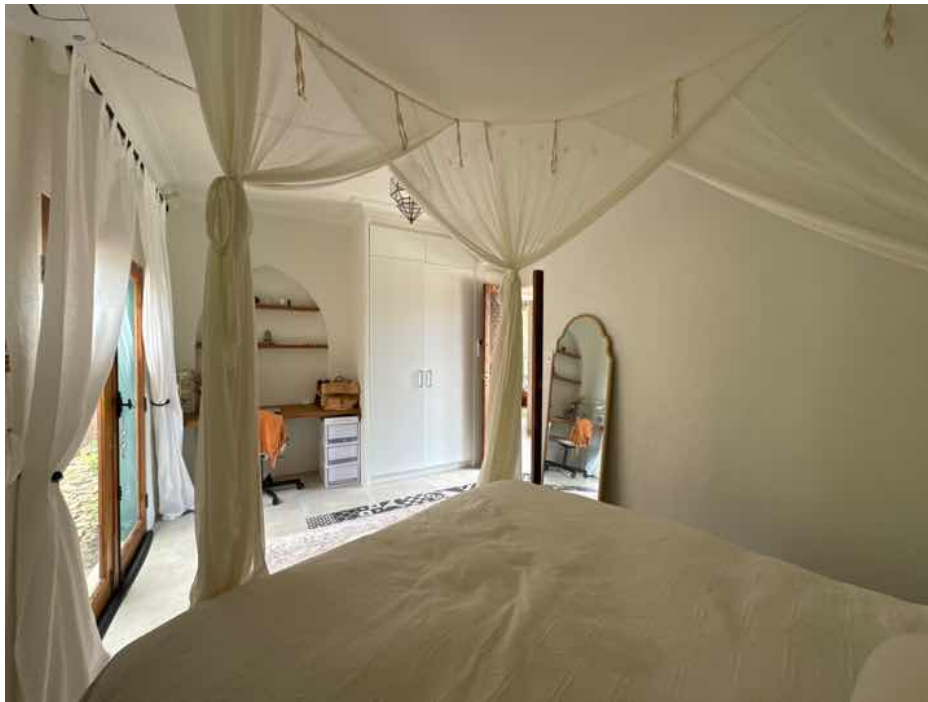
### **Ceiling**

Settlement Cracks Noted. These are typical and generally patch and paint will suffice, however monitoring these cracks is advised for 12 months and if they become worse, further investigation by a suitably qualified professional is advised.

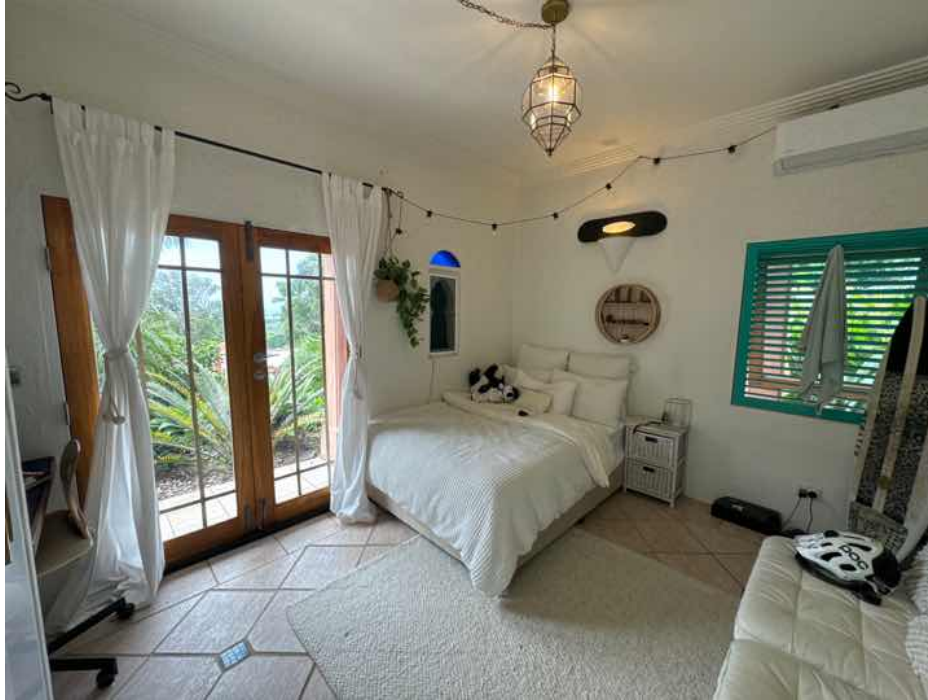
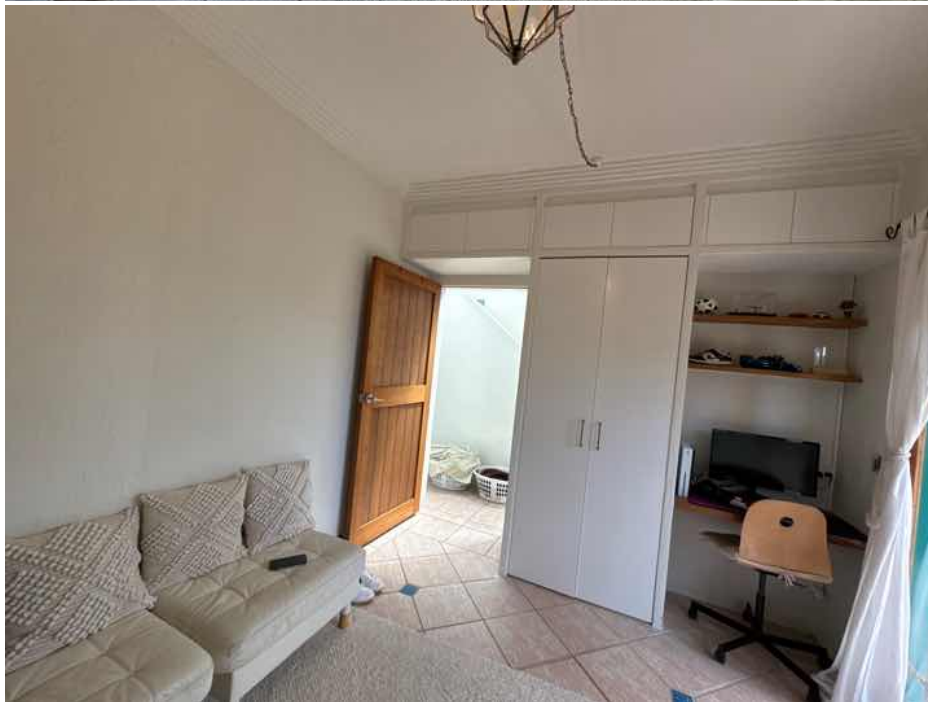
From the visible and accessible areas, this bedroom appears to be in a serviceable condition for the age of the property with no notable structural defects sighted.

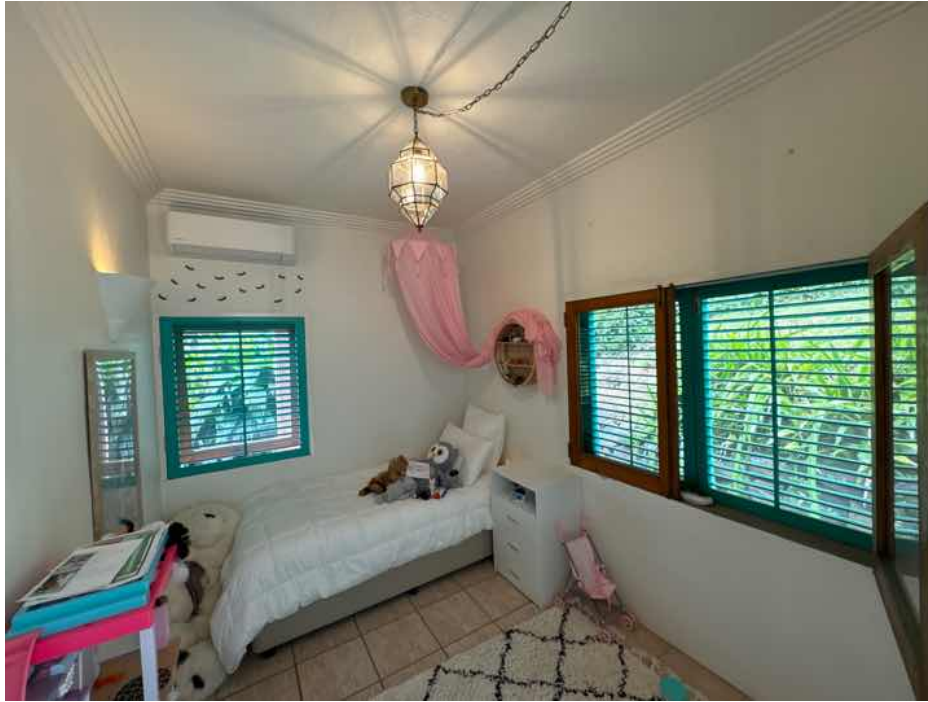
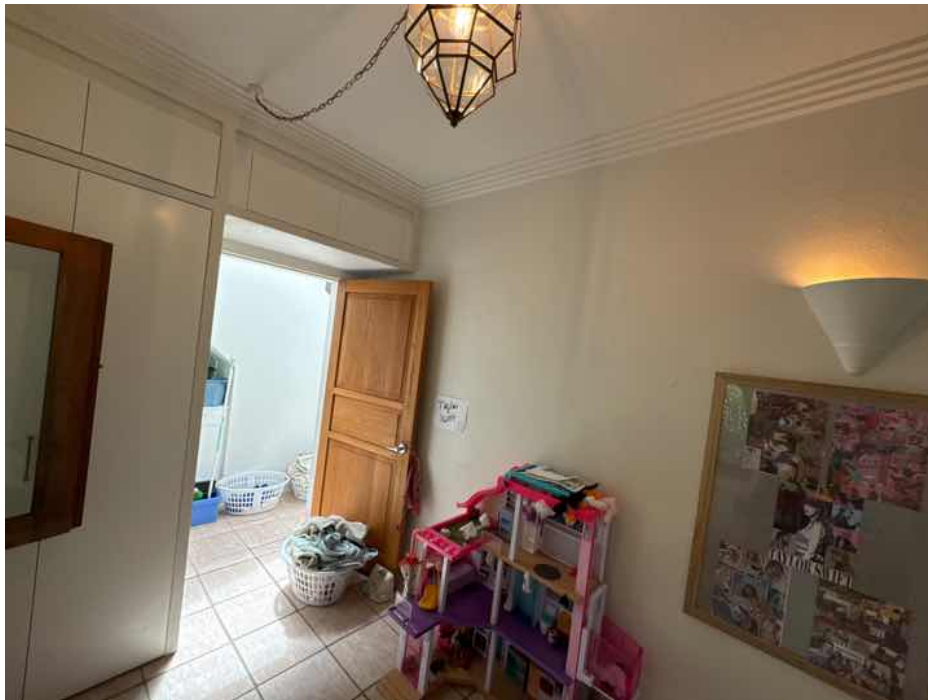
## **Bedroom 6**

From the visible and accessible areas, this bedroom appears to be in a serviceable condition for the age of the property with no notable structural defects sighted.

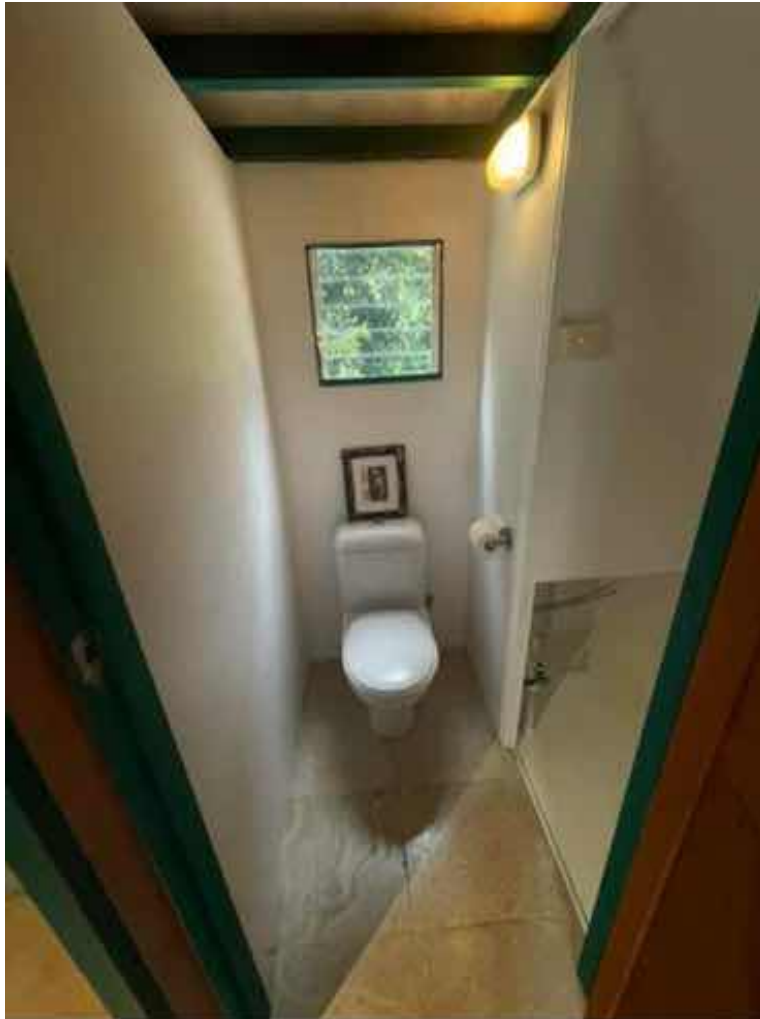
Of the visible areas, the general condition of this bathroom is serviceable or in reasonable condition for age of dwelling.

Binding/out of square door frame - This can relate to some differential settlement in the footings, frame movement, age, expansion, shrinkage and the like. A qualified carpenter should be engaged for advice and recommendations.

No exhaust fan is installed - Recommend having one installed.

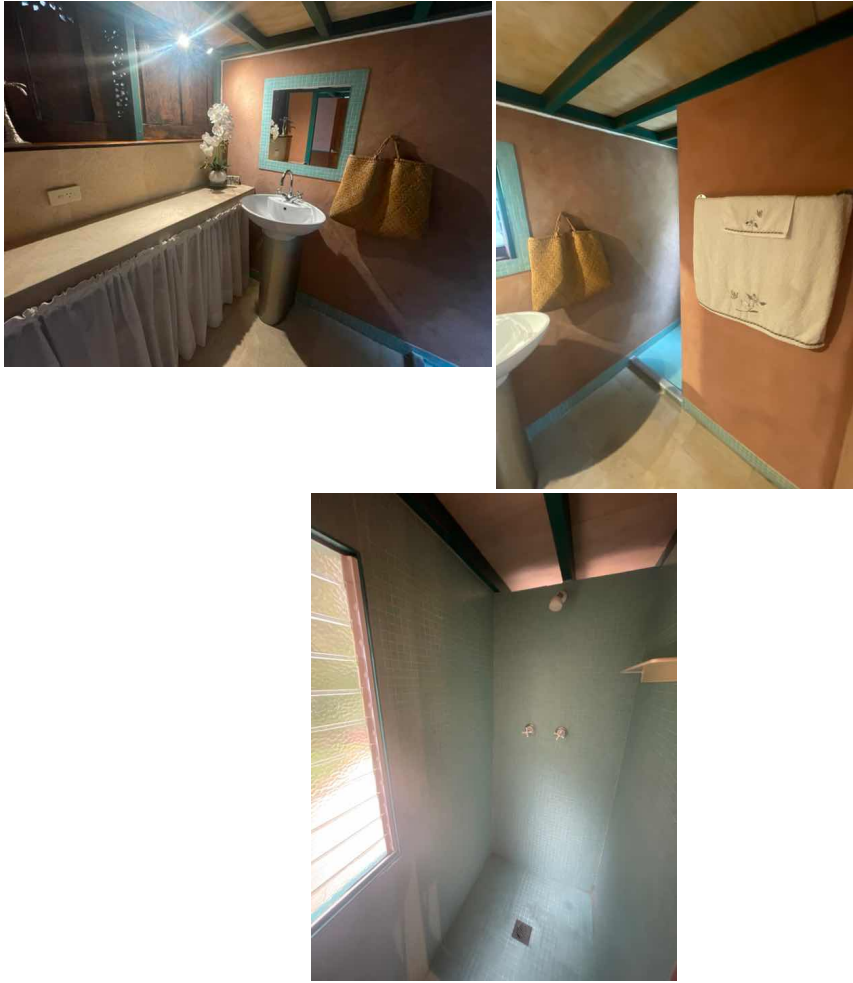
Of the visible areas, the general condition of this bathroom is serviceable or in reasonable condition for age of dwelling.

No exhaust fan is installed - Recommend having one installed.

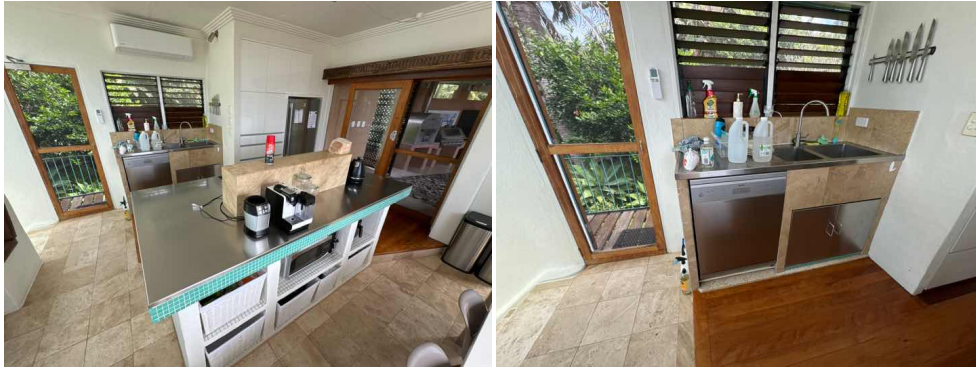
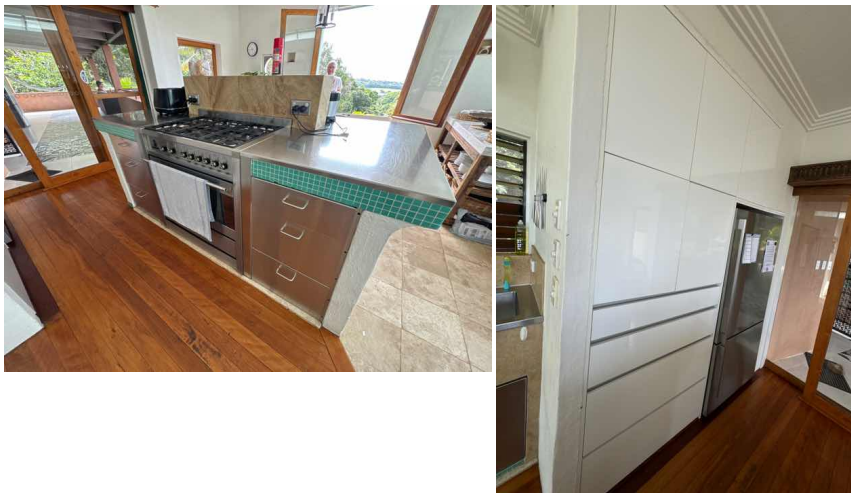
Of the visible areas, the general condition of the kitchen is serviceable or in reasonable condition for age of dwelling.

These components appear to be in a serviceable condition

Adjustment to cabinet doors required, in some instance hinges may need to be replaced.

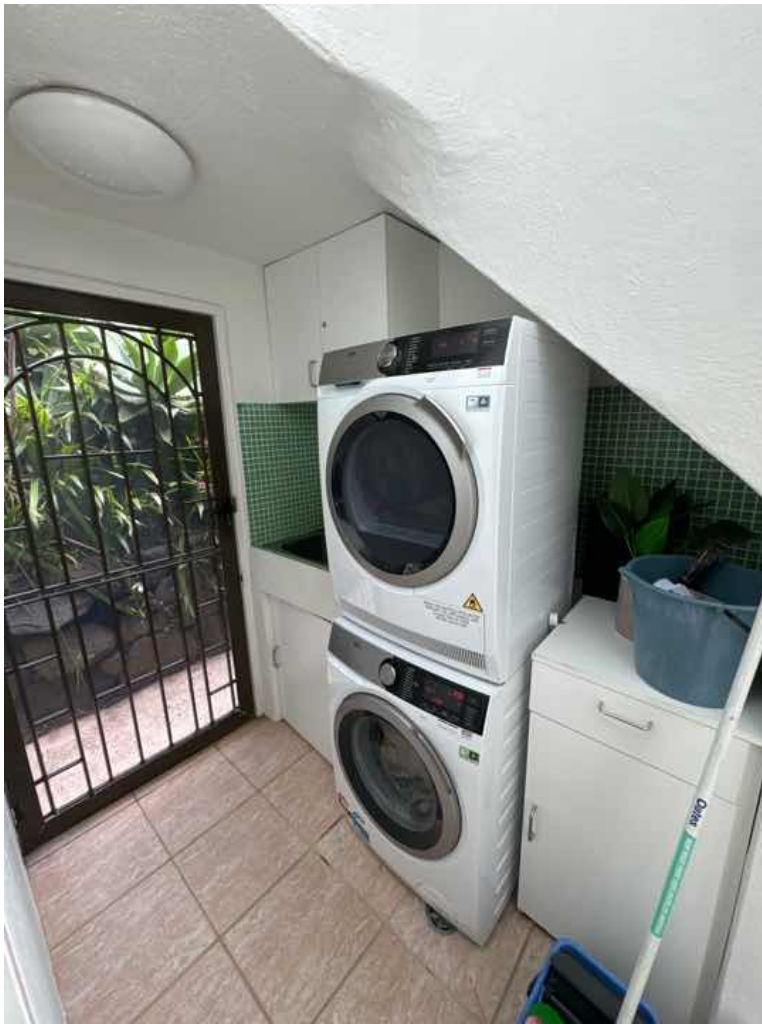
Of the visible areas, the general condition of the laundry is serviceable or in reasonable condition for age of dwelling.
