# Inspection Report

## East Coast Building Solutions

**24 Antrim Street, East Ballina, NSW, 2478**

### Pest And Building Inspection

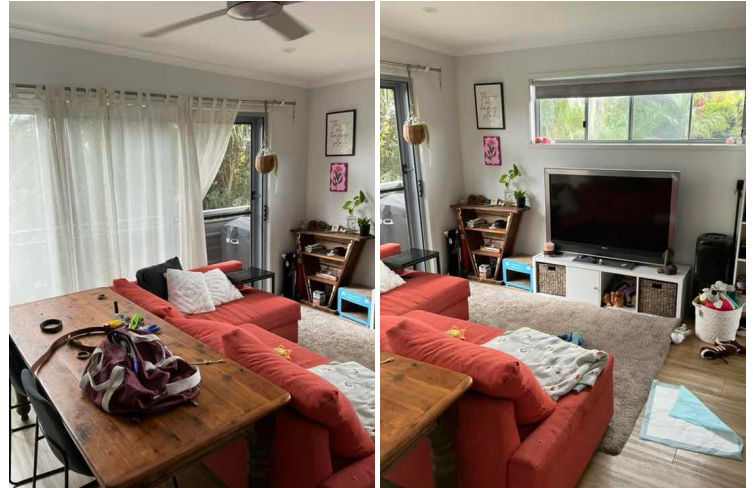
From the visible and accessible areas, this room appears to be in a serviceable condition for the age of the property with no notable structural defects sighted.

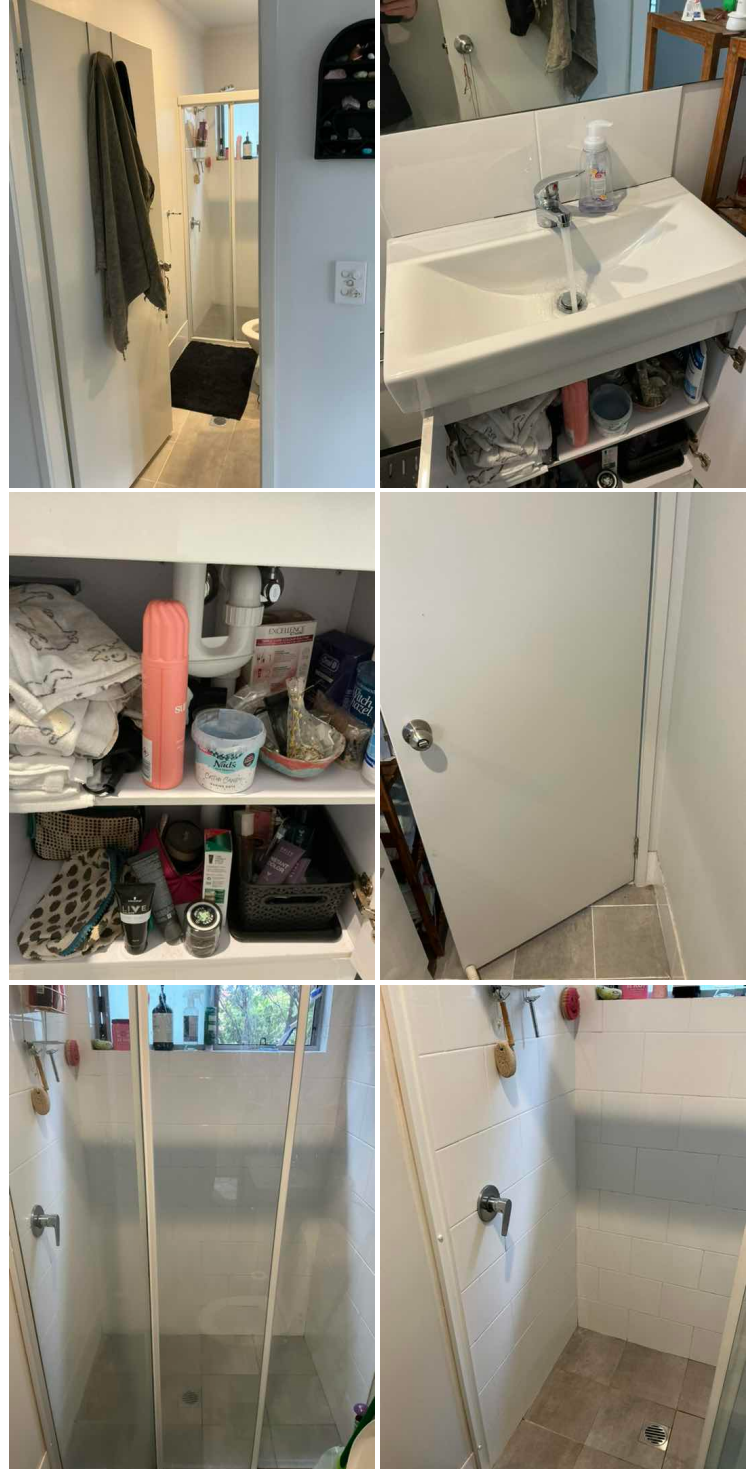
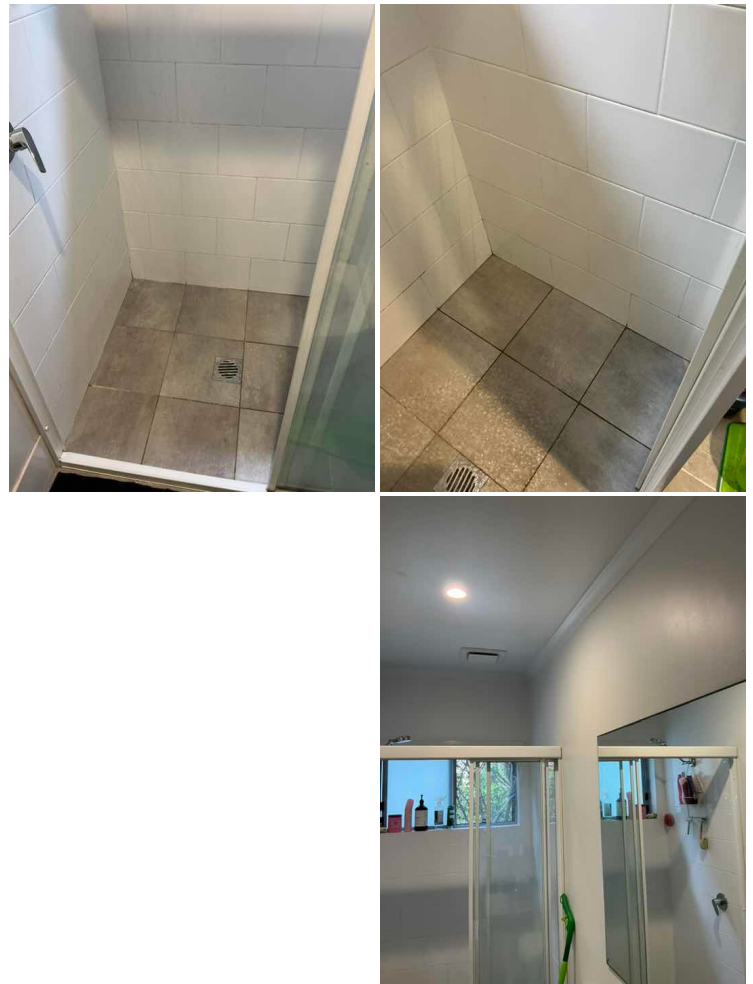
Of the visible areas, the general condition of this bathroom is serviceable or in reasonable condition for age of dwelling.

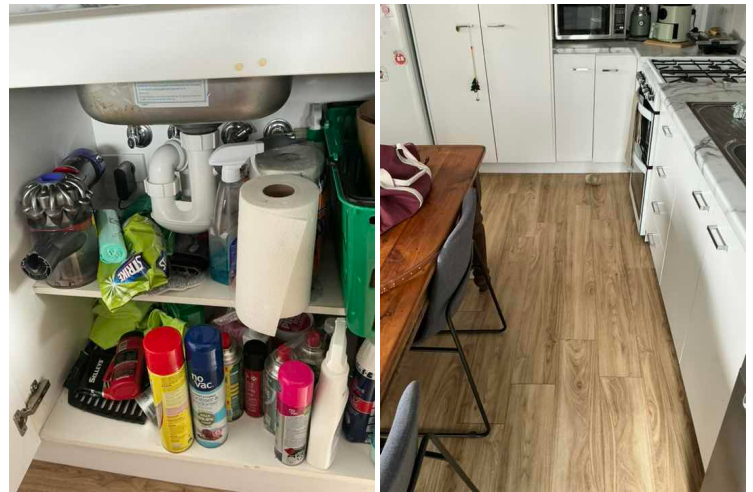
Of the visible areas, the general condition of the kitchen is serviceable or in reasonable condition for age of dwelling.
