Building and Pest Report

2/32 Sunrise Cres Lennox Head

Pest And Building Inspection

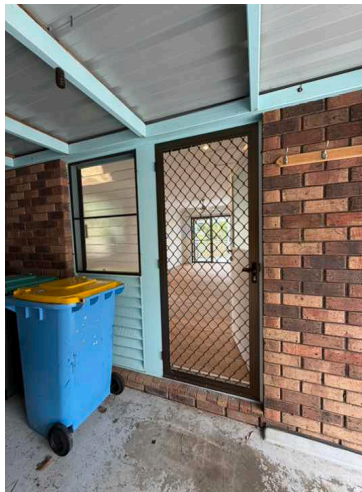
Overall Condition

The entry porch serviceable or in reasonable or condition for the age of this dwelling.

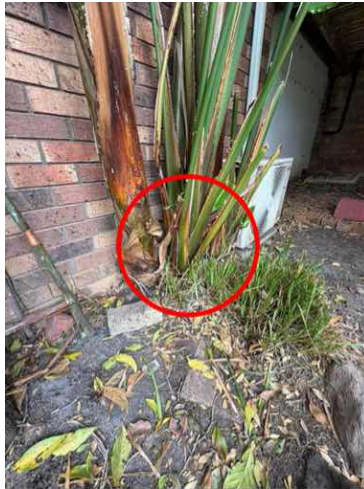
Weep holes blocked by soil. Recommendations: Lower finished ground levels to fully expose all weep holes on the lower brick courses around the dwelling.

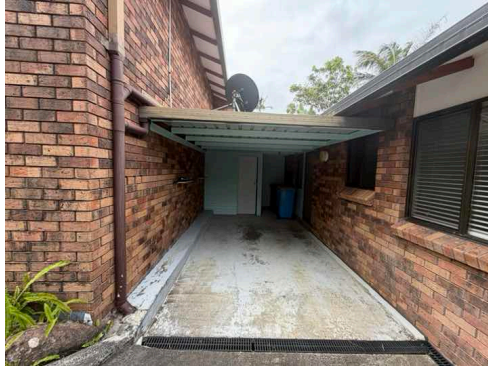
Overall Condition

The overall condition of the carport is serviceable for the age.

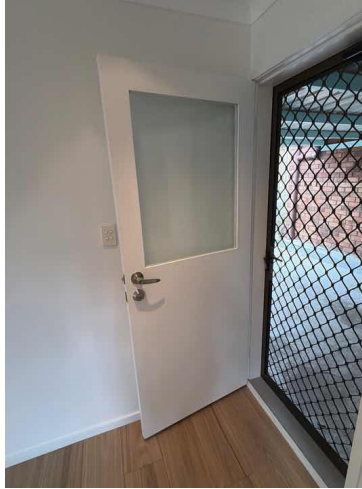
Other Doors

Other doors such as sliding , side entry etc.. appear to be in serviceable condition.

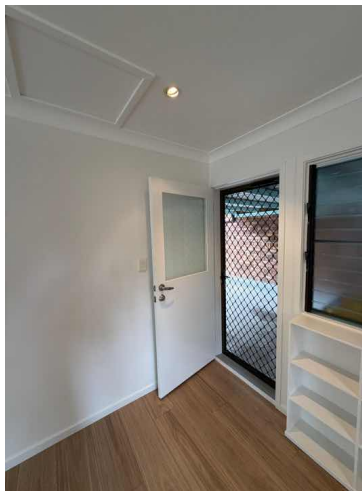
Overall Condition

From the visible and accessible areas, this area appears to be in a serviceable condition for the age of the property with no notable structural defects sighted.

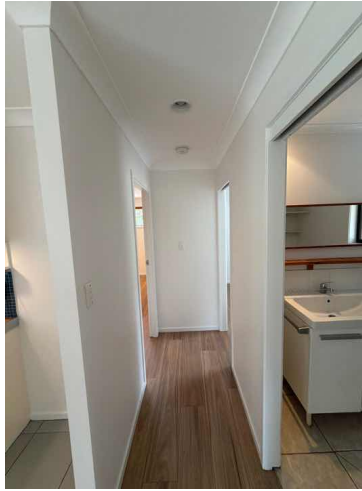
Overall Condition

From the visible and accessible areas, the hallway/ appears to be in a serviceable condition for the age of the property with no notable structural defects sighted.

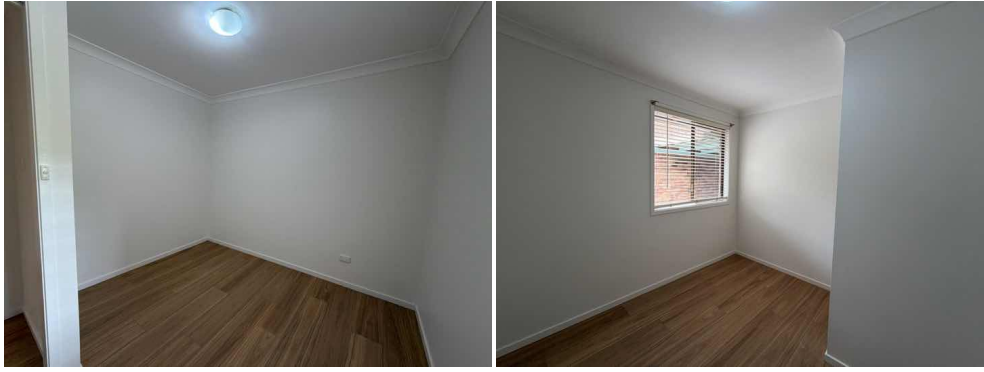
Overall Condition

From the visible and accessible areas, this bedroom appears to be in a serviceable condition for the age of the property with no notable structural defects sighted.
