# Building and Pest Report

## 57 Lismore Road Alstonville

# BPI - INSPECTION REPORT

57 Lismore Road, Alstonville.

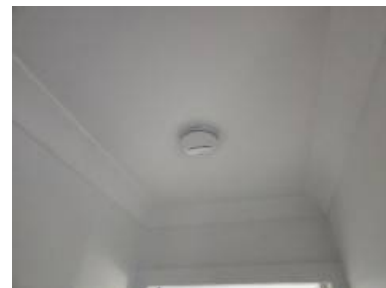
Present - Hall.

- Smoke alarms are noted but not tested, this is outside the scope of a standard building report & our expertise.
- *Pushing the "Test" button only verifies that there is power to the alarm (either a battery or hard wired to the house power) and not the operational workings of the alarm. The operational check is done by filling the sensor with smoke and is beyond the scope of this inspection.*
- A smoke alarm specialist should be consulted to test & advise on those installed or install new detectors / alarms if / where required.
- Any existing smoke alarms manufactured more than 10 years ago should be replaced with photoelectric smoke alarms which comply with Australian Standards (AS) 3786-2014.
- Battery operated smoke alarms should be checked routinely and the batteries changed frequently.

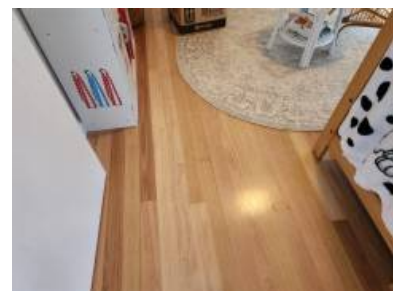
The concrete slabs were covered by flooring coverings and no inspection of the concrete surfaces could be carried out.

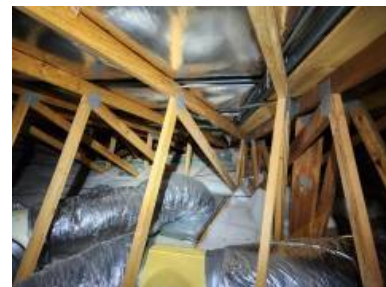
Inspection over the eaves was restricted due to the low pitch and construction allowing only a limited visual inspection from a distance of some areas to be carried out.

Clearance within sections of the roof was too low to allow body access. Outer top wall plates and framing timbers were not inspected due to the area being too low to allow body access. This allows only a limited visual inspection from a distance of some areas to be carried out.

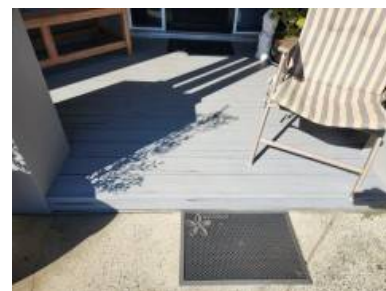
**Restrictions:**  
There is insufficient crawl space below the decking timbers due to the method of construction. There may be concealed defects where access cannot be achieved.

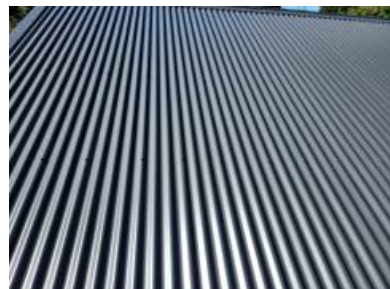
**Condition:**

Satisfactory.

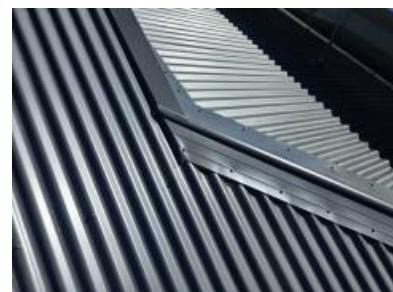
#### **ROOF FLASHINGS**

**Condition:**  
Satisfactory.

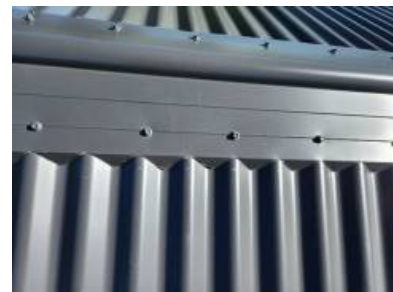
**ROOFING SCREWS / NAILS**

**Condition:**  
Satisfactory.

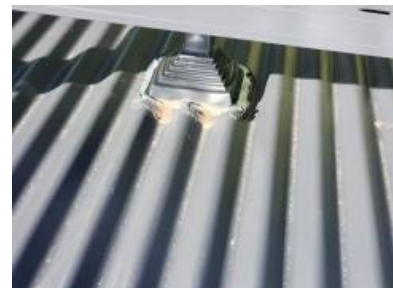
**SKYLIGHTS / VENTS / FLUES**

**Condition:**  
Satisfactory.

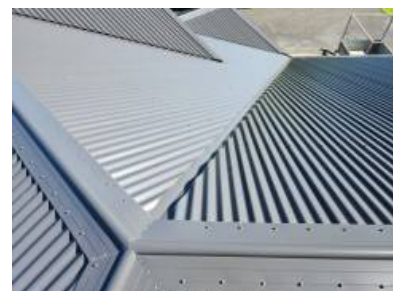
**VALLEYS**

**Condition:**  
Satisfactory.

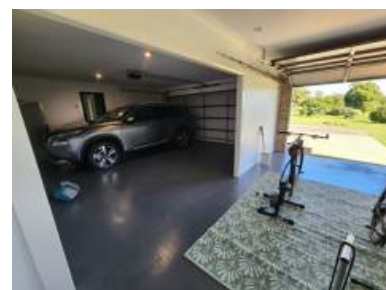
**Condition:**

Minor damage to base of garage doors.

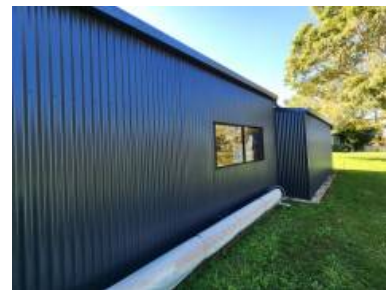
Some wall and floor areas were covered by stored goods and were inaccessible.

Satisfactory.

**Further inspection of these areas is strongly recommended once access has been obtained.**

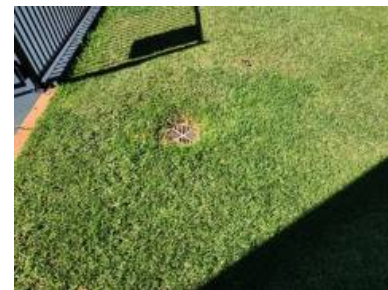
**SURFACE WATER DRAINAGE**

Whilst not a plumber it appears that at the time of the inspection, drainage seems generally adequate.

*No inspection & comment can be made of concealed stormwater pipes and their functionality. I recommend the drainage systems / stormwater be further inspected by a qualified plumber to ensure that they are functional, clear of blockages / damage / cracks and are adequate for the situation.*

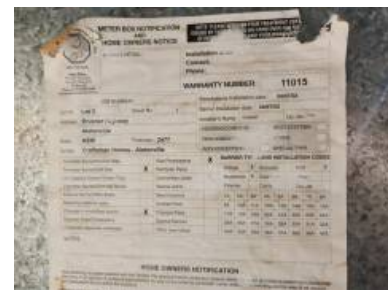
Physical barriers or visual inspection zones have been used as part of the termite treatment / protection.

A termite barrier / treatment notice in the Meter Box / Kitchen Cupboard indicates that the slab penetrations and perimeters are protected from termite activity by the White Ant Company barriers. We strongly recommend you obtain all barrier paperwork & warranty information. These barriers were installed in White ant company 2002.
