Building and Pest Report

1/43 Silver Gull Dr East Ballina

Report/Agreement #	290426092547399
Inspection Date:	29 Apr 2026
Inspection Time:	09:25 am

Pest And Building Inspection

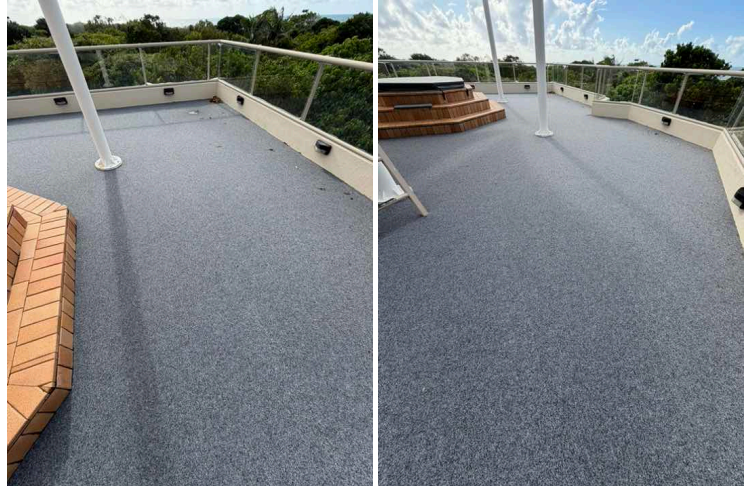
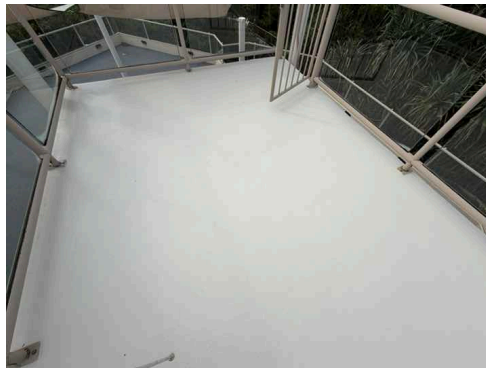
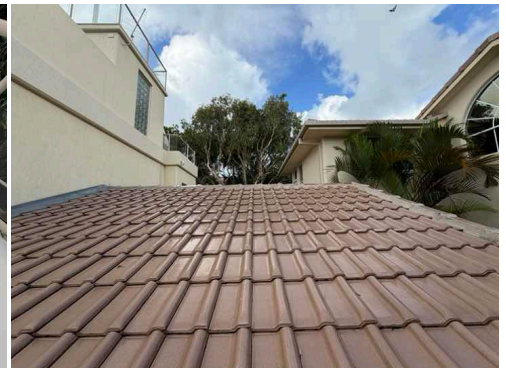
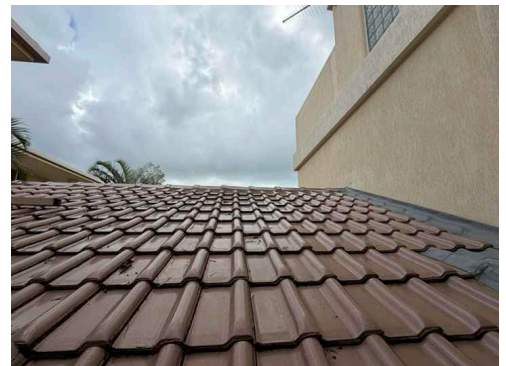
Recommend installing a drainage point under the tap to assist with drainage.

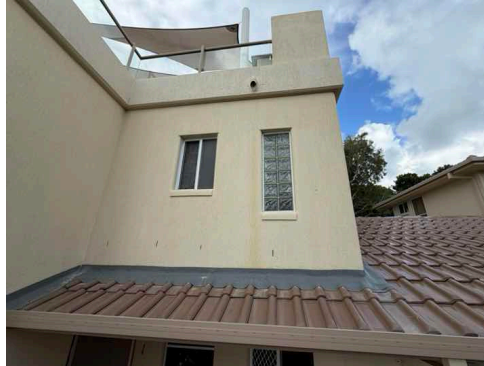
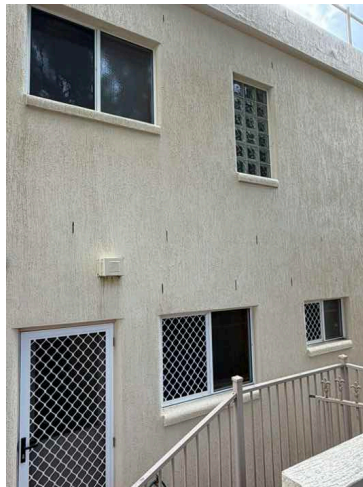
On visual inspection, the general condition of the exterior walls is serviceable for the age. External cladding is in contact with the ground. This is a conducive condition for moisture penetration causing decay and/or concealed termite entry. Contact a licensed builder for recommendations.

There appears to have been some settlement in the building which has caused some cracking to the walls. These cracks are categorized as 0 to 2. This can also cause some doors to bind or be out of square. In the inspectors opinion these cracks are due to settlement, usually due to ground movement and subsequent movement to building materials can be expected. Any cracks should be monitored and if cracks increase in size, further investigation should be carried out by a structural engineer.

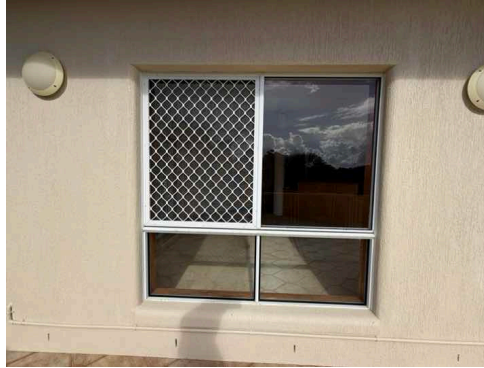
On visual inspection, the general condition of the windows is serviceable for the age. General age/damage has occurred to window components. Recommendations: Restoration work recommended. A qualified carpenter should be engaged for advice and recommendations.

Rust is evident in sections of the homes window framework. Some areas should be repaired. A suitably qualified tradesman should be engaged for advice and recommendations.

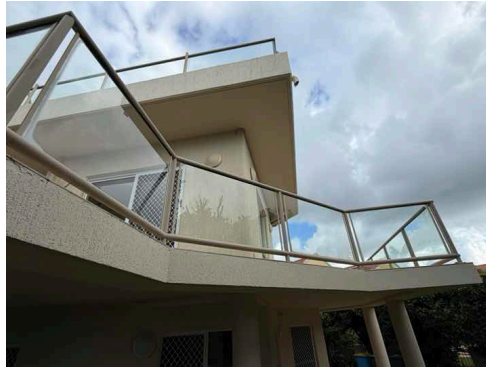
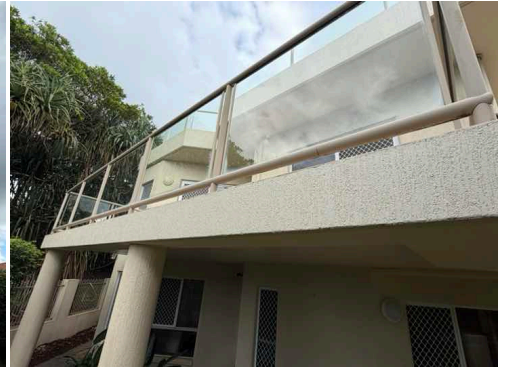
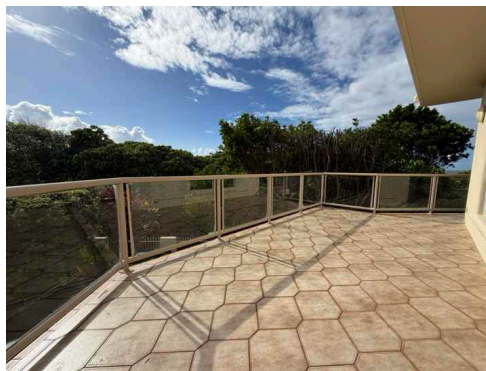
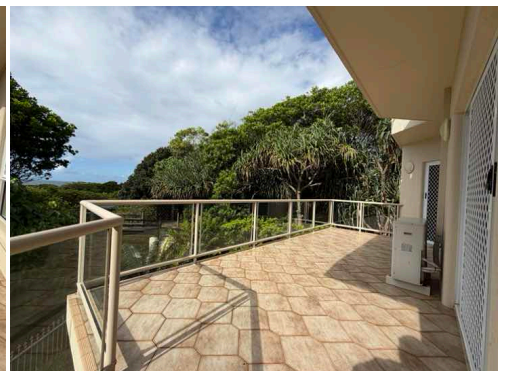
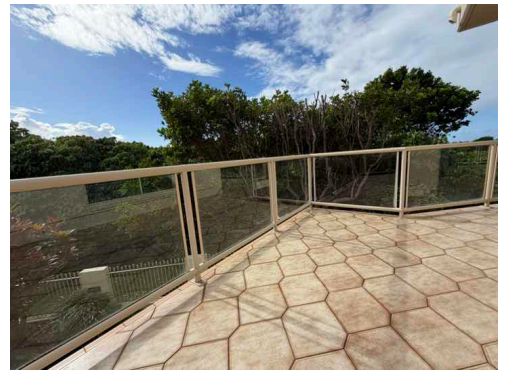
Upon visual inspection, the glass balustrade shows chipping on the edges, compromising safety and aesthetics. Immediate attention is required to prevent further damage or potential injury. It is recommended to engage a licensed glazier to assess the extent of the damage and replace the affected panels. Ensure all installations comply with safety standards to maintain structural integrity and visual appeal.

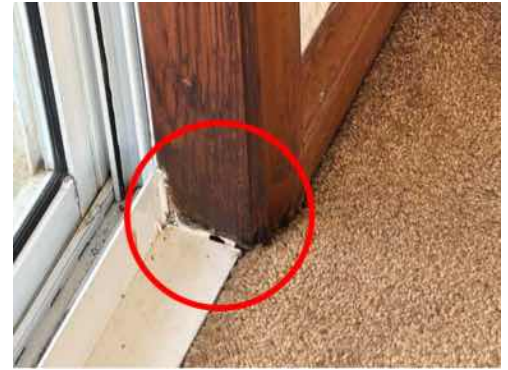
General ageing and/or denting and the like is evident on wall linings - Recommendations: A qualified painter should be engaged to assess and repair as required.

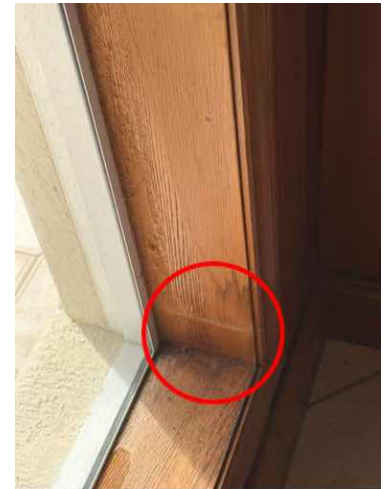
Upon visual inspection, moisture staining was observed on the architrave/skirting. This indicates potential water ingress or plumbing issues. It is recommended to engage a licensed tradesperson to assess the source of moisture, repair any leaks, and replace damaged sections. Ensuring proper sealing and ventilation will prevent future occurrences. Regular maintenance checks are advised to maintain the integrity of the area.

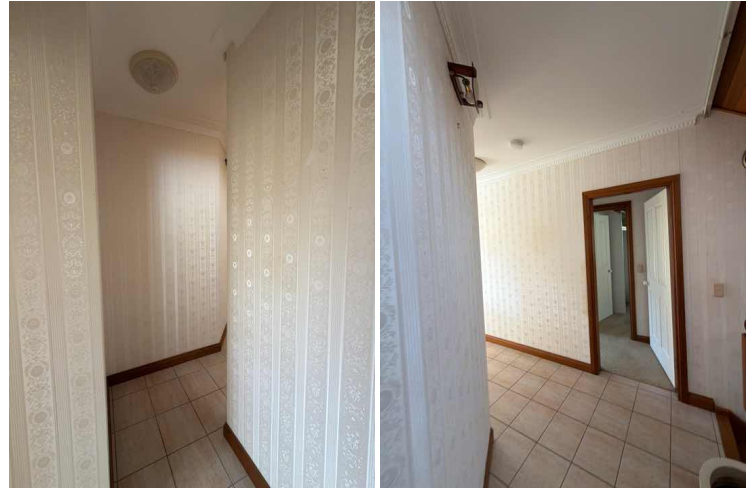
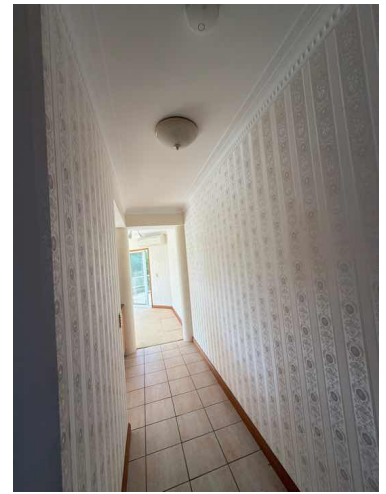
Typical cornice separation/detachment observed. I recommend you contact a qualified painter for repairs.

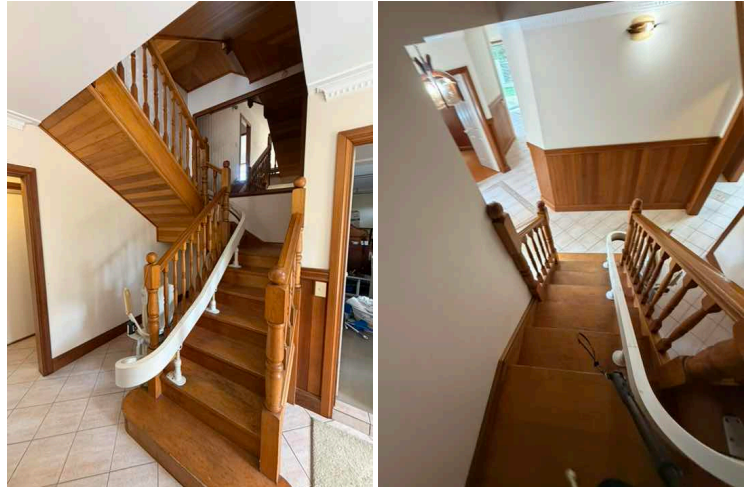
Settlement Cracks Noted. These are typical and generally patch and paint will suffice, however we recommend you monitor these cracks and if they become wider or longer, you will need to contact a structural engineers to assess.

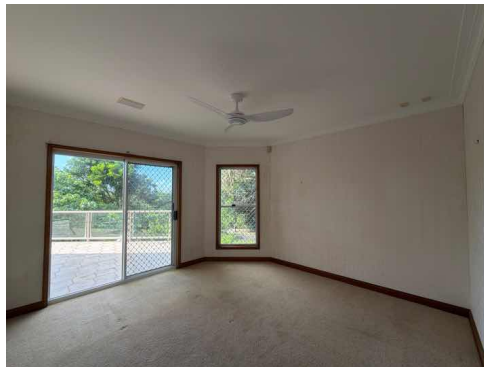
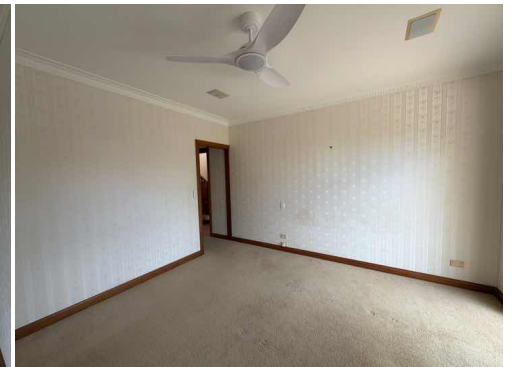
General ageing and/or denting and the like is evident on wall linings - Recommendations: A qualified painter should be engaged to assess and repair as required.

Upon visual inspection, moisture staining was observed on the architrave/skirting. This indicates potential water ingress or plumbing issues. It is recommended to engage a licensed tradesperson to assess the source of moisture, repair any leaks, and replace damaged sections. Ensuring proper sealing and ventilation will prevent future occurrences. Regular maintenance checks are advised to maintain the integrity of the area.

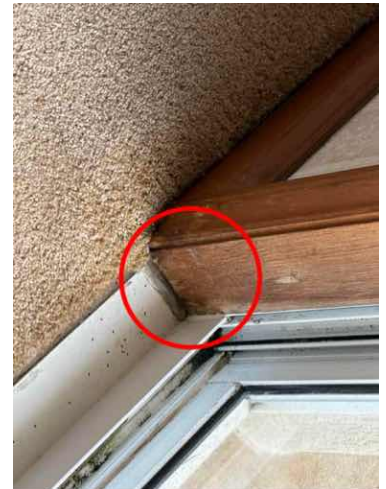
Stains observed - Steam cleaning may rectify stained areas but they appear entrenched.

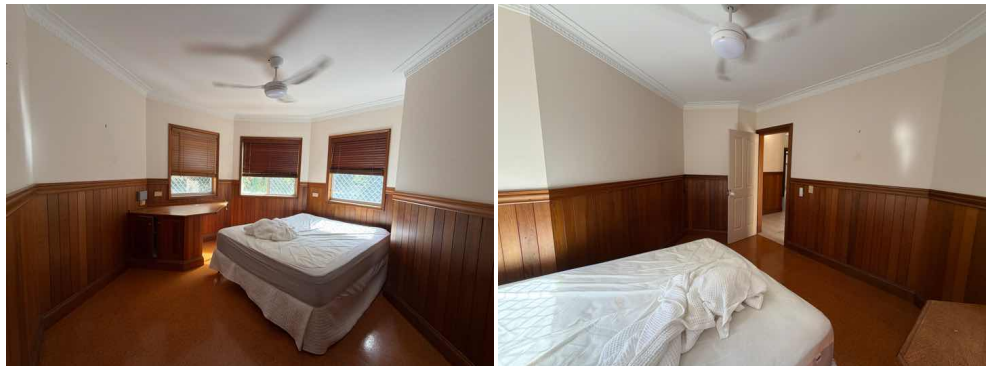
Door lock hardware is loose possibly damaged. Maintenance as required.

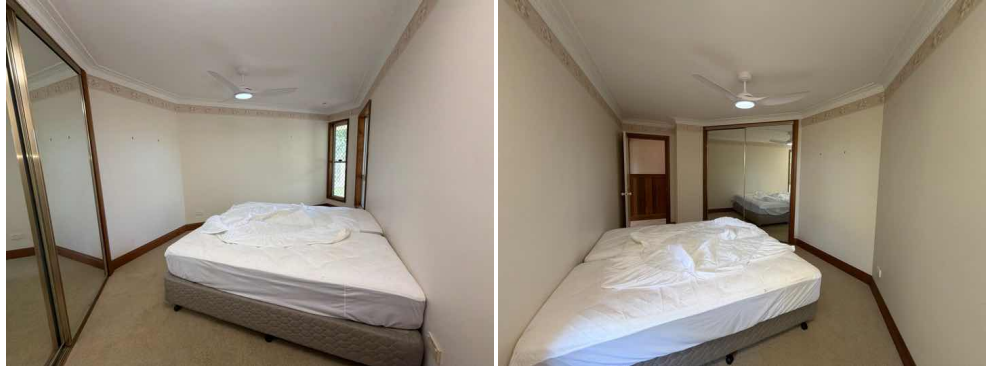
General ageing and/or denting and the like is evident on wall linings - Recommendations: A qualified painter should be engaged to assess and repair as required.

Stains observed - Steam cleaning may rectify stained areas but they appear entrenched.

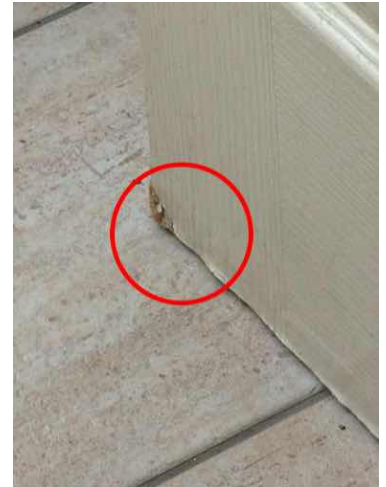
Water damaged door. Possible due to leak in bathroom. Replacement recommended.

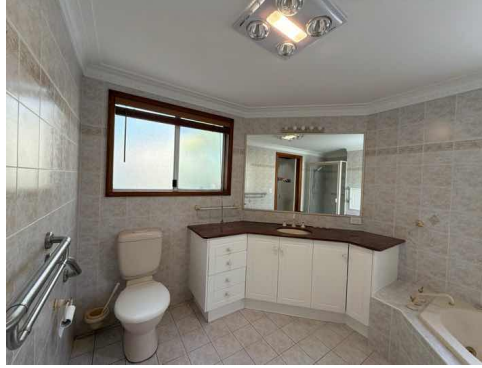
Damaged tile/s observed . Have repaired by a qualified tiler.

Deteriorated grout noted. This should be repaired as this will lead to water ingress under the tiles causing uplifting and possible water penetration.

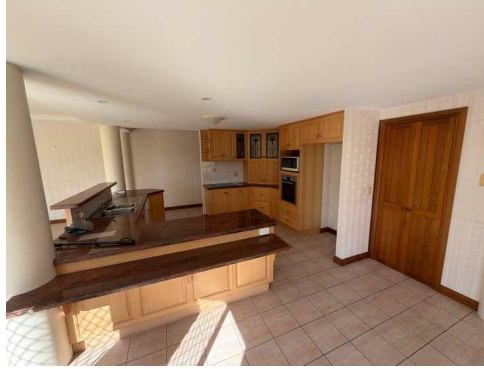
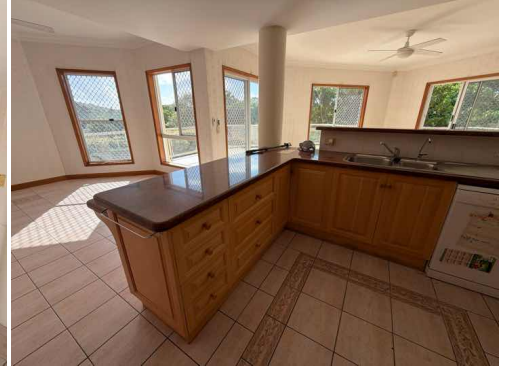
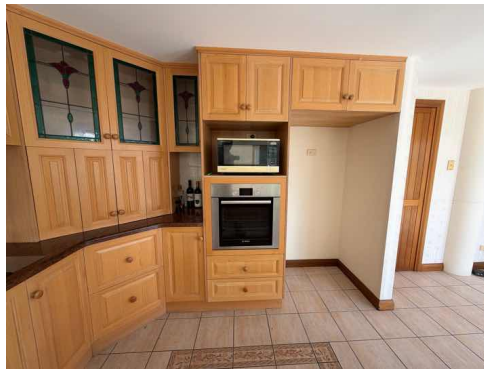
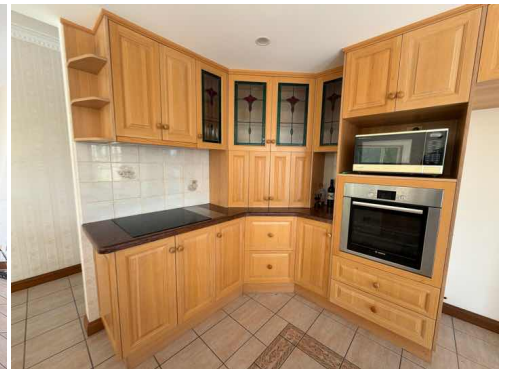
Adjustment to cabinet doors required, in some instance hinges may need to be replaced.

Damage was noted to the cabinets, contact a joinery company for repairs

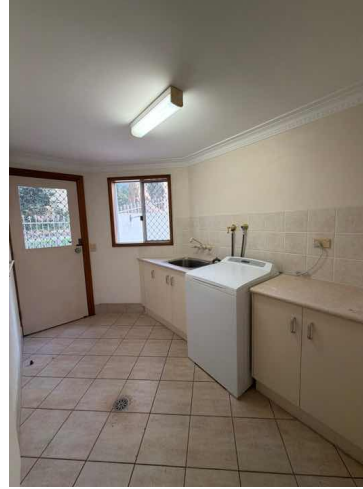
Door / frame deterioration - General age/damage has occurred to door frame, face or components. Recommendations: A qualified carpenter should be engaged for advice and recommendations.
