# Inspection Report

## East Coast Building Solutions

**58 Hutley Drive , Lennox Head , NSW, 2478**

### Pest And Building Inspection

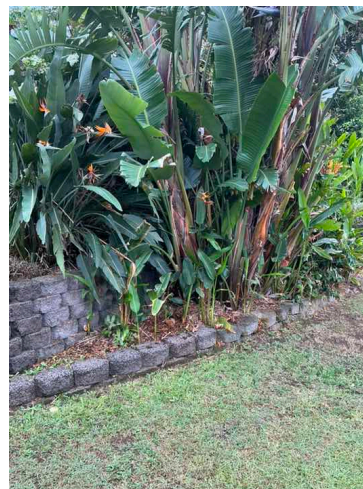
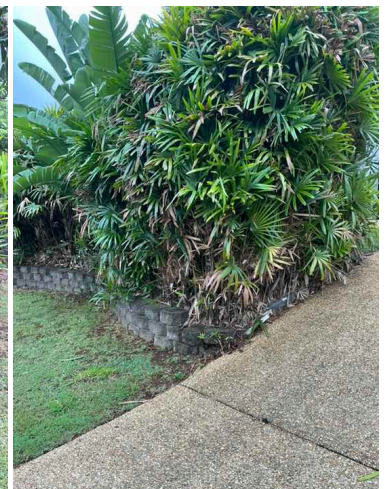
Trees are close to the dwelling. These currently do not appear to have caused any defects/wall cracking. Recommendations: Engage a qualified arborist to carry out an assessment on potential issues.

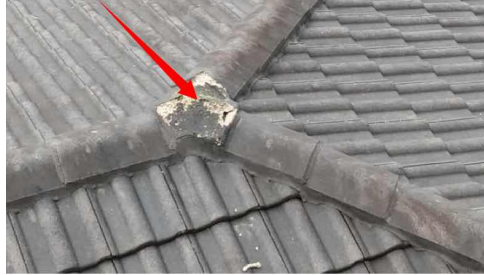
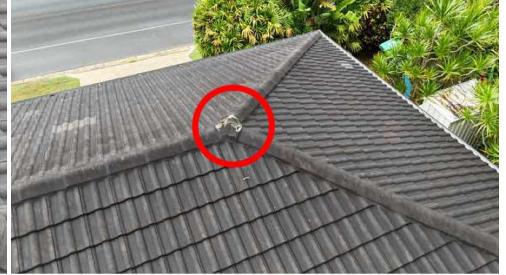
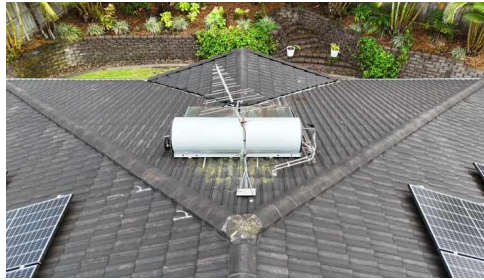
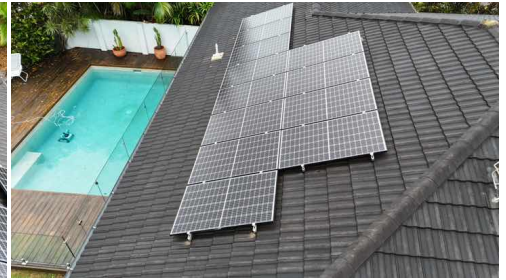
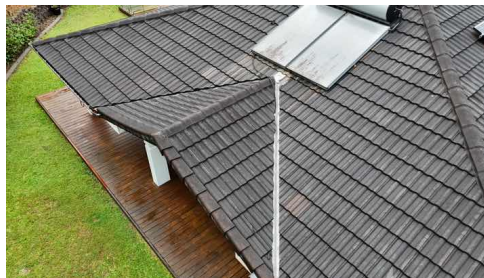
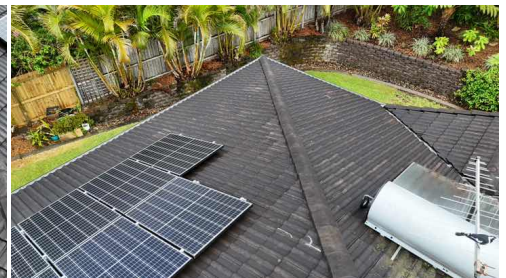
The roof is of concrete tiles.  
Upon visual inspection, the roof ridge shows mortar deterioration. Recommend engaging a licensed roofer to repair the damaged mortar to prevent water ingress and further structural issues. Regular maintenance checks should be scheduled to ensure ongoing roof integrity.

#1. Mortar cracks visible. We recommend having these repaired by a qualified roofer as they may contribute to water ingress.

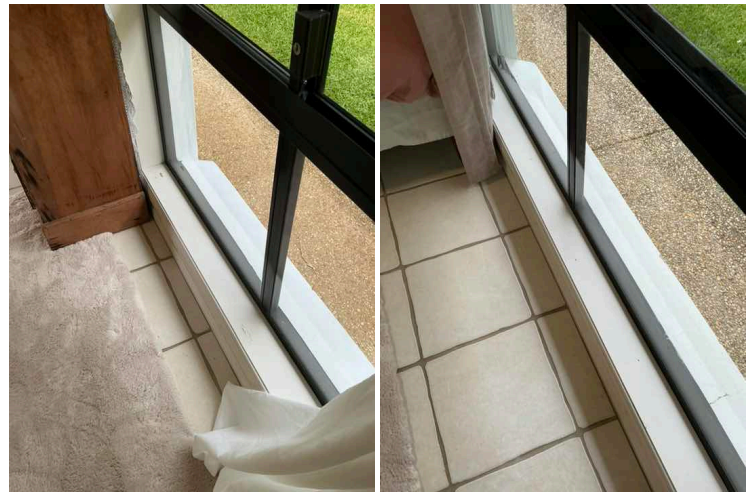
On visual inspection, the general condition of the windows is serviceable for the age.

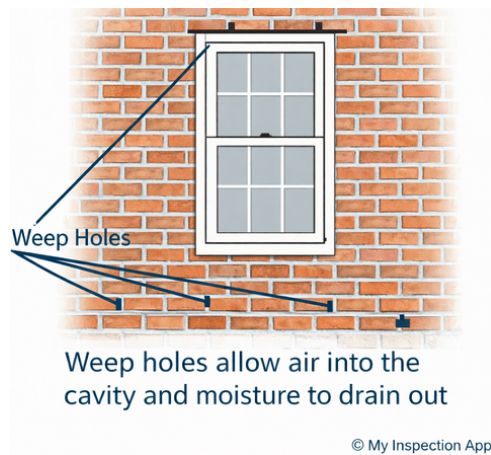
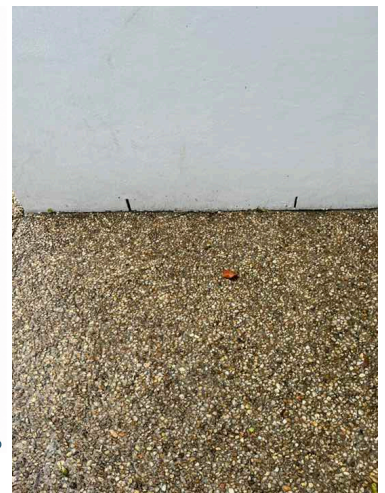
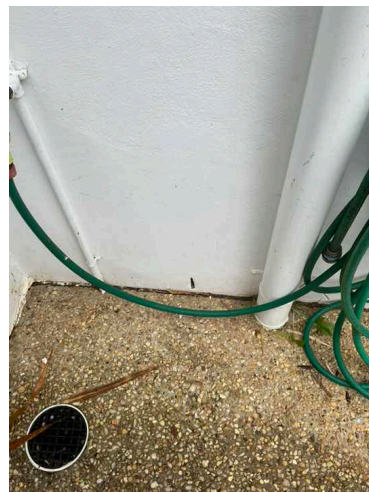
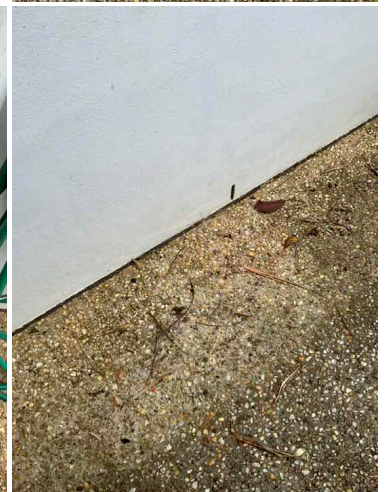
## Weep Holes and Ventilation

The weep holes are unobstructed .

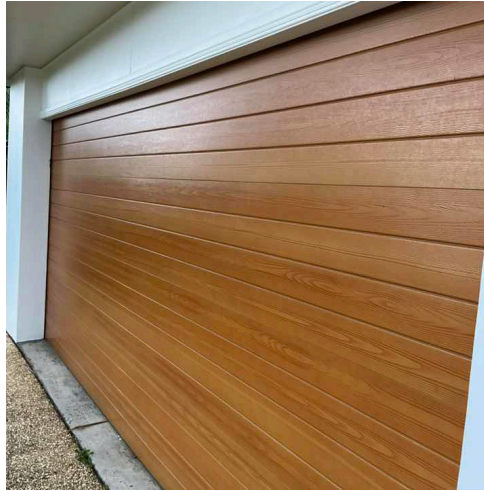
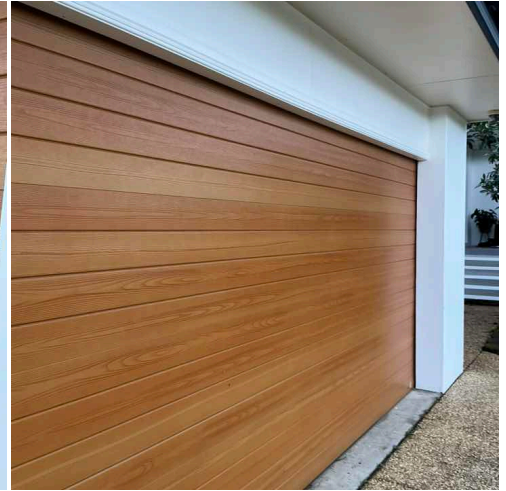
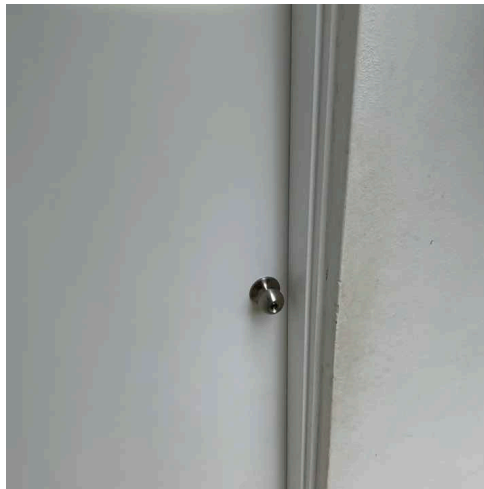
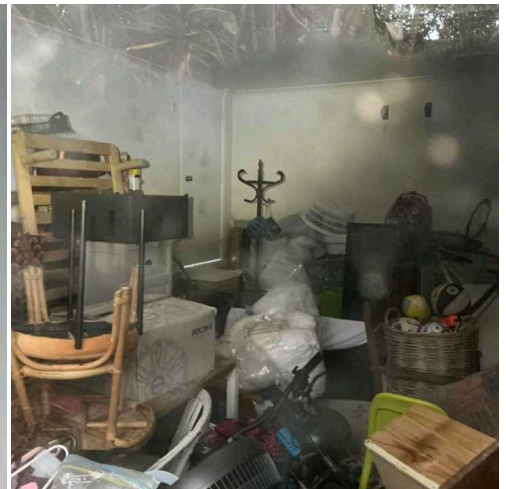
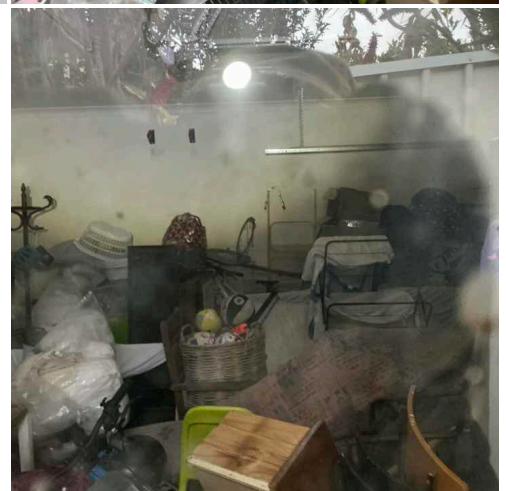
Stored items restricted a full and thorough inspection of this area. Defects may exist in the obstructed and inaccessible areas. It is strongly recommended that full access be granted to enable a thorough inspection as there may be timber pest activity, damage or defects. Note: Where vehicles and storage has restricted a full inspection it is advised that this area be cleared so a full and unobstructed inspection can be carried out.

From the visible and accessible areas, the garage appears to be in a serviceable condition for the age of the property with no notable structural defects sighted.

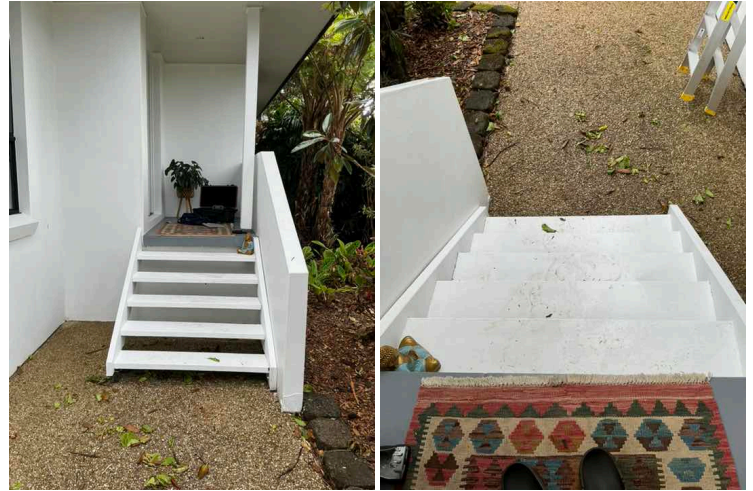
The stairs/steps appear to be serviceable with no notable defects.

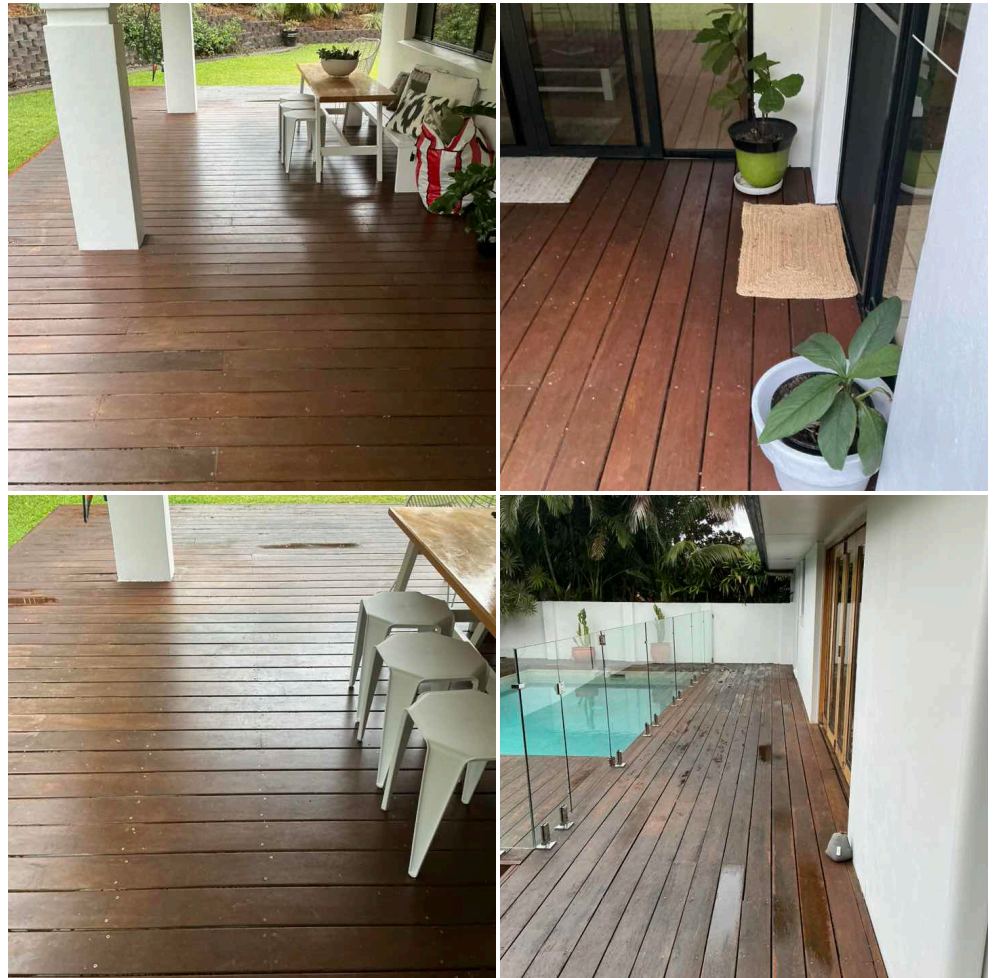
Of areas visible, the decking appears to be in a serviceable condition.

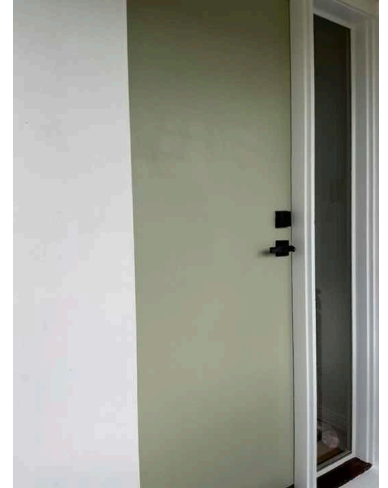
#### Front Entry Doors

The doors are in serviceable condition with no notable defects observed.

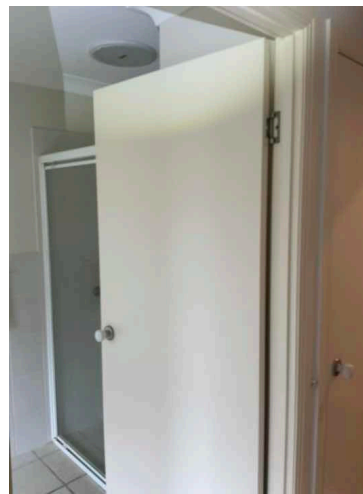
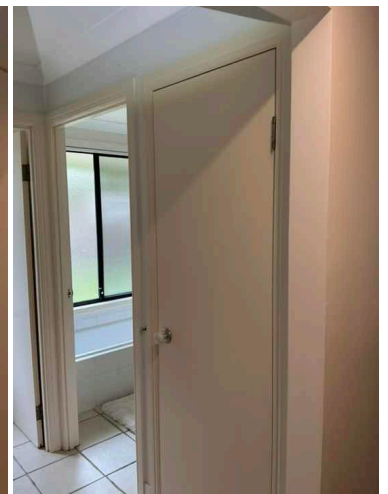
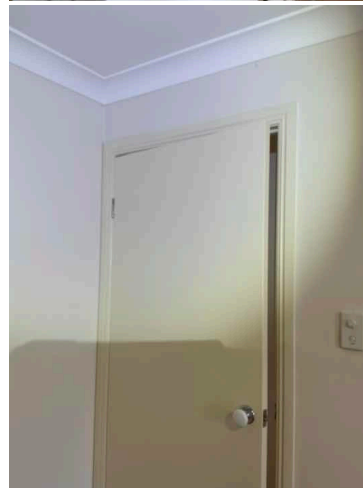
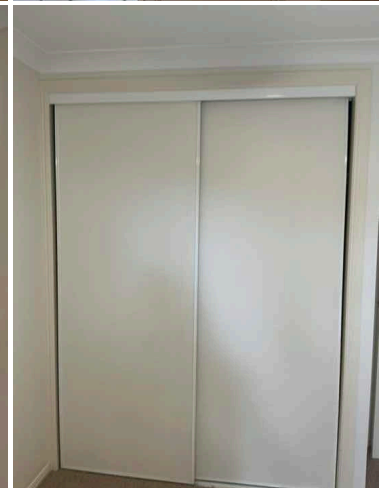
#### Other Doors

Other doors such as sliding , side entry etc.. appear to be in serviceable condition.

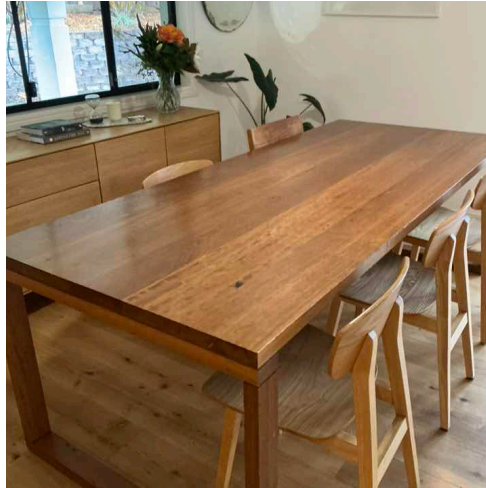
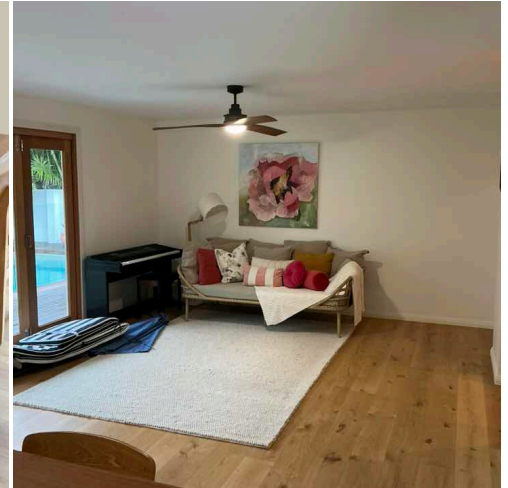
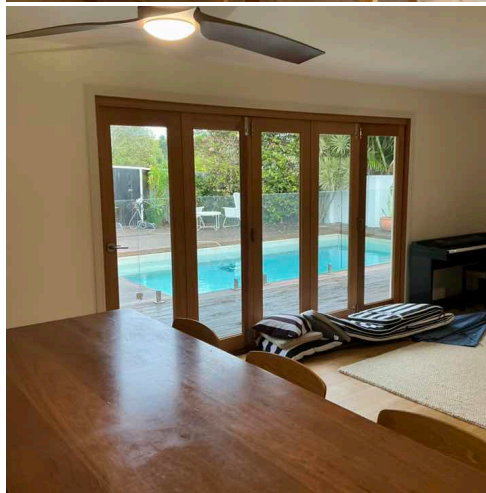
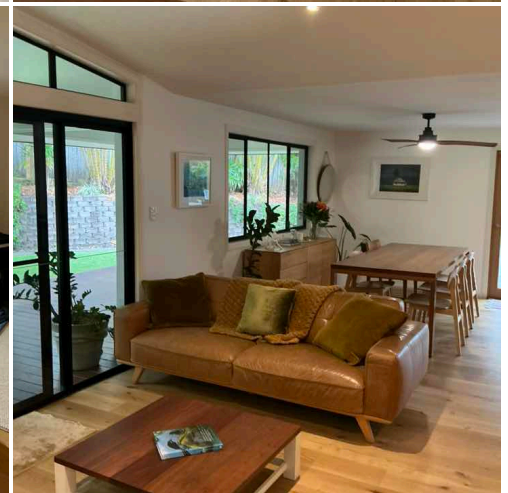
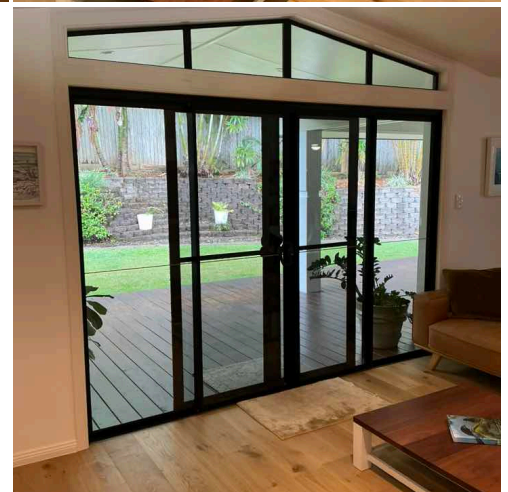
## **Combined Living & Dining**

From the visible and accessible areas, this room appears to be in a serviceable condition for the age of the property with no notable structural defects sighted.

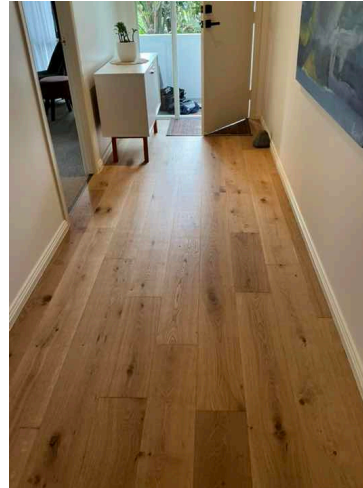
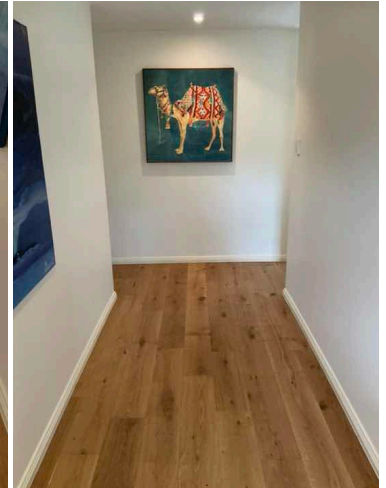
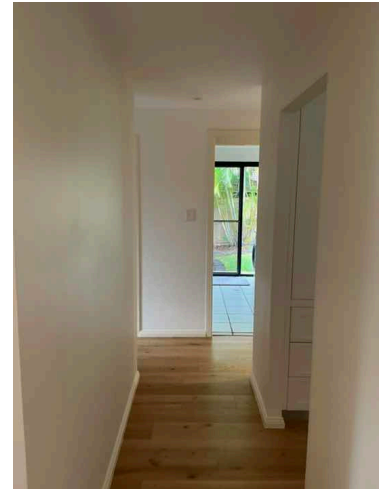
## Hallway/s

From the visible and accessible areas, the hallway/s appears to be in a serviceable condition for the age of the property with no notable structural defects sighted.

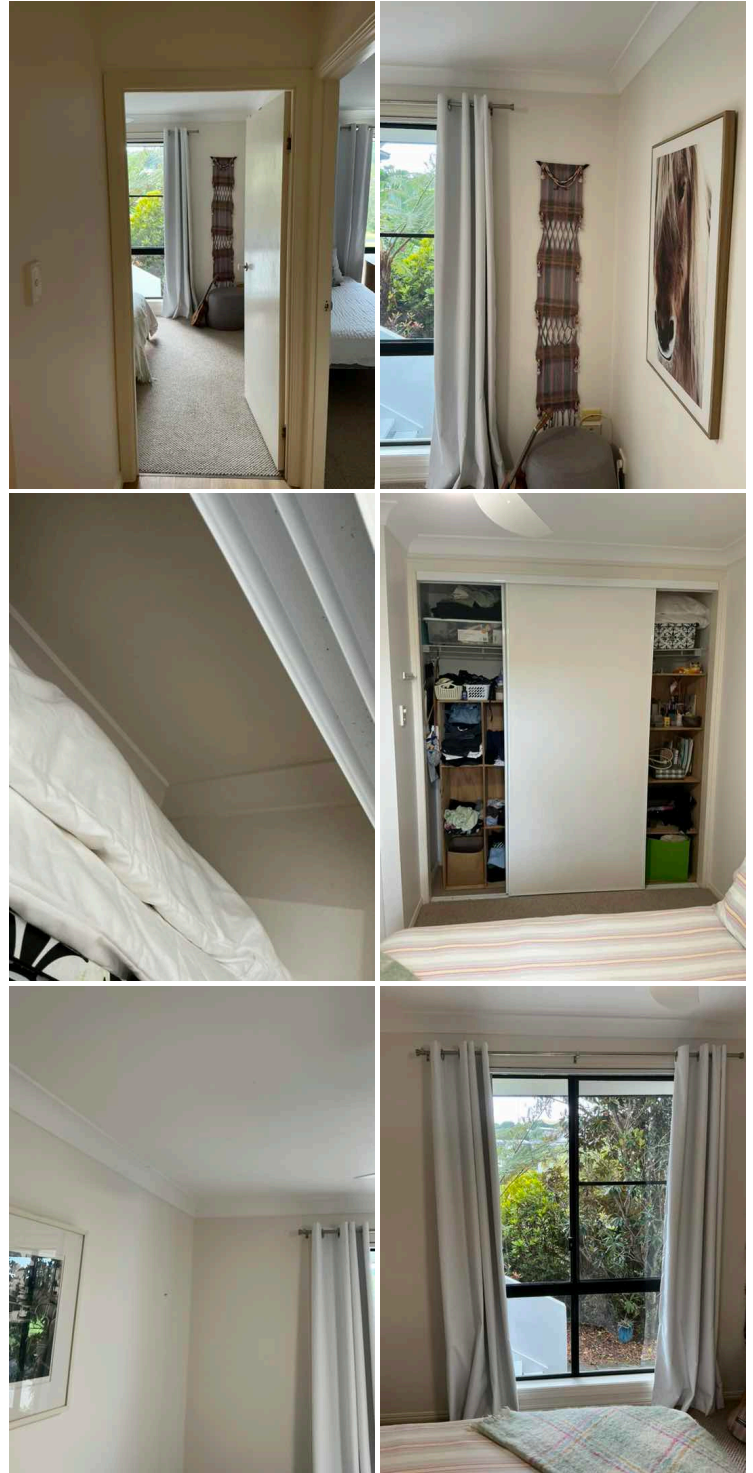
## **Bedroom 1**

From the visible and accessible areas, this bedroom appears to be in a serviceable condition for the age of the property with no notable structural defects sighted.

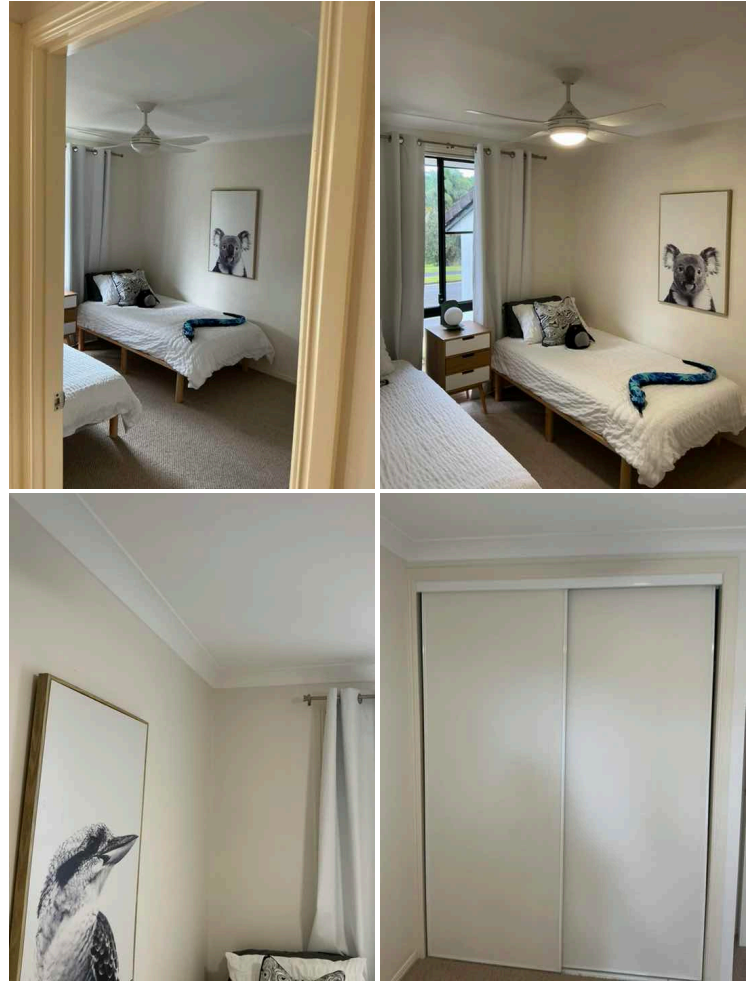
## **Bedroom 2**

From the visible and accessible areas, this bedroom appears to be in a serviceable condition for the age of the property with no notable structural defects sighted.

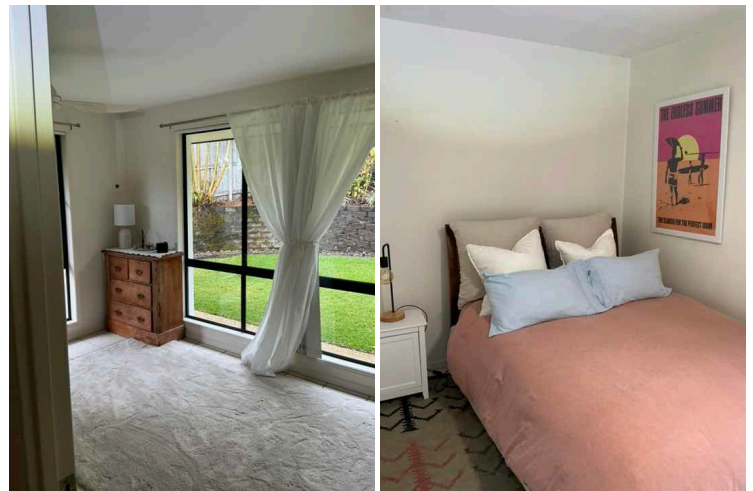
## **Bedroom 3**

From the visible and accessible areas, this bedroom appears to be in a serviceable condition for the age of the property with no notable structural defects sighted.

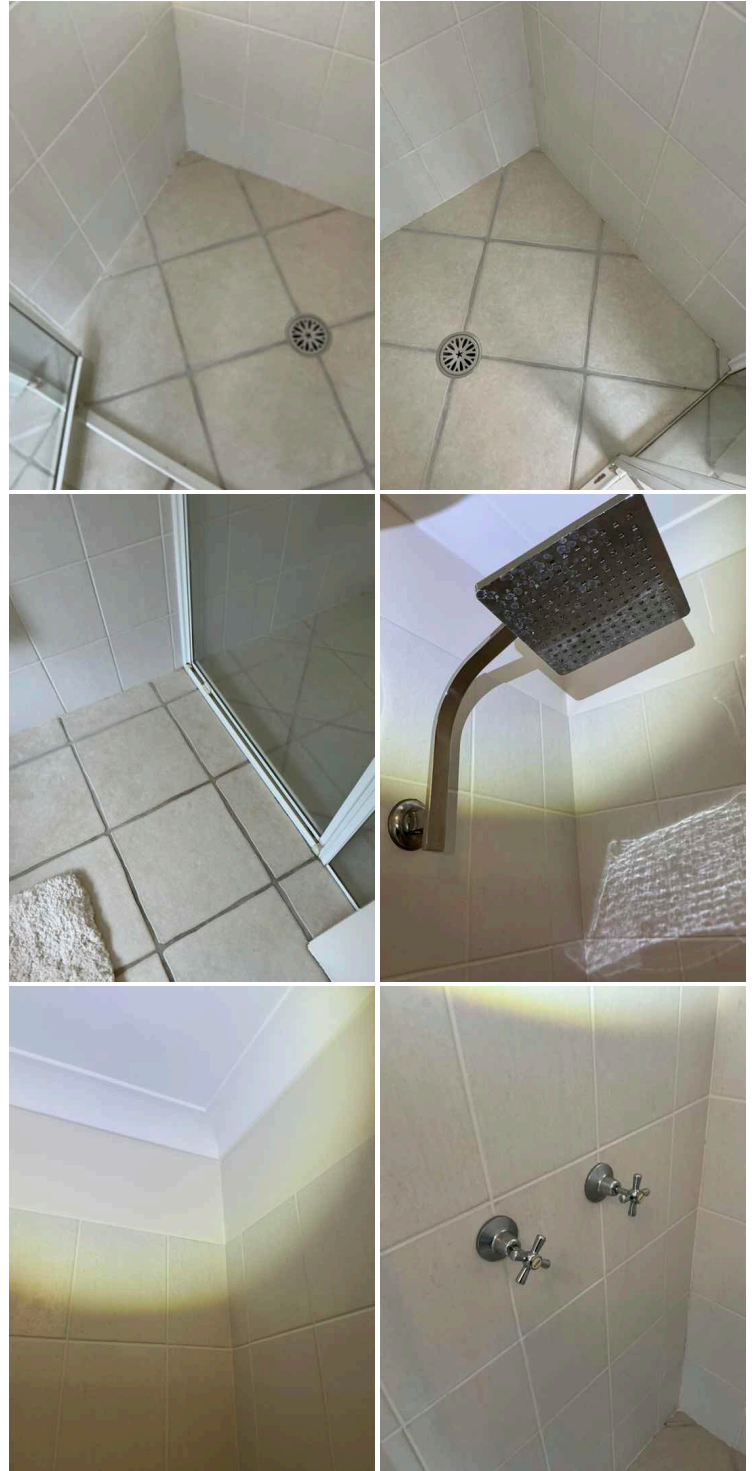
This bathroom is located in the lower level.

Of the visible areas, the general condition of this bathroom is serviceable or in reasonable condition for age of dwelling.

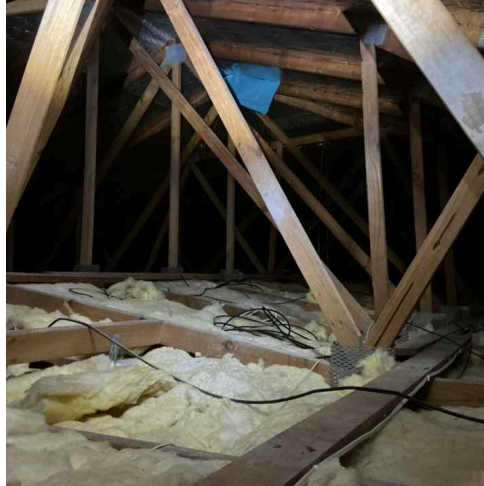
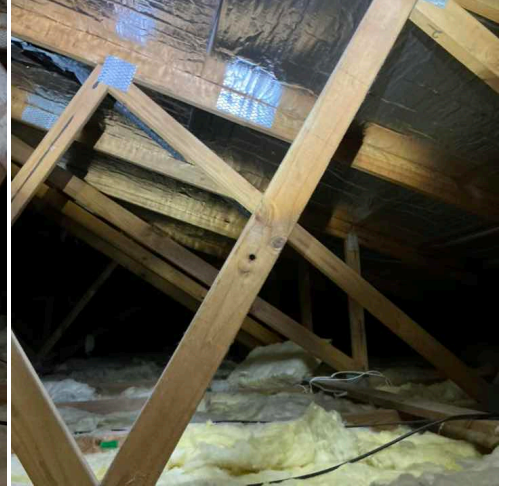
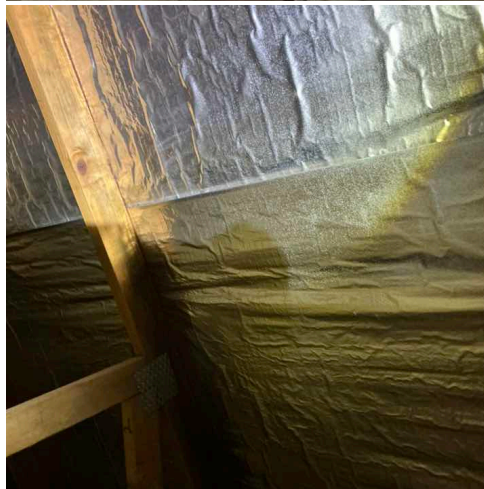
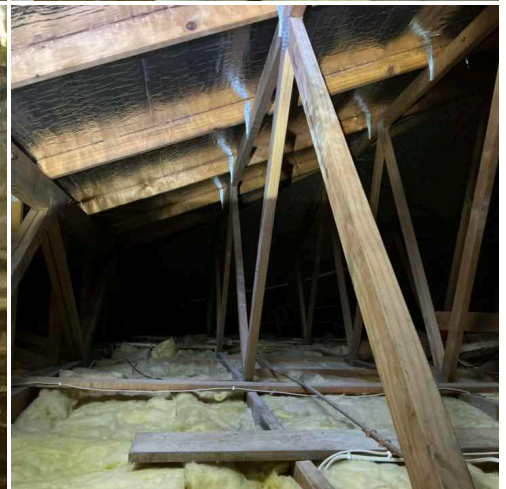
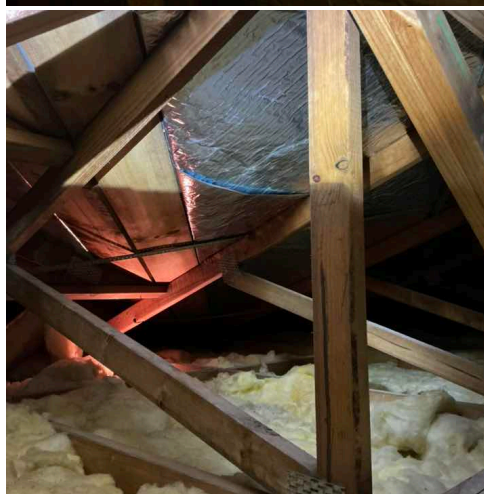
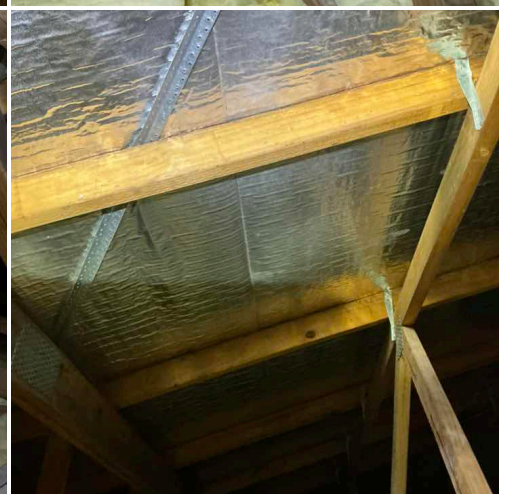
#### Restricted Areas

There is insulation present in the roof space/void. This is preventing a full inspection of ceiling joists from being undertaken. It is strongly recommended that full access be gained as it could be harbouring timber pest activity, damage or defects.

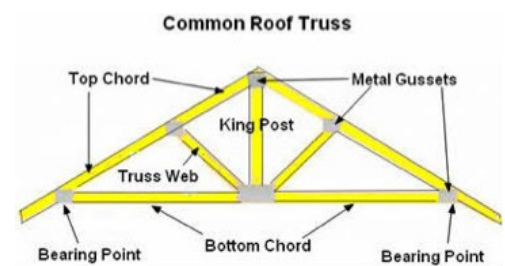
### Roof Frame Type

The roof frame is a truss timber frame.

Visible sections of the roof void is in a serviceable condition for age of this dwelling.

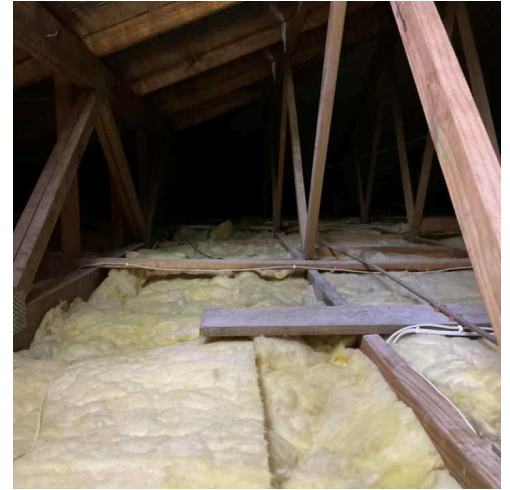
### **Type**

The roof space is insulated with fibreglass batts.

Where visible and accessible, the insulation appears to be in a serviceable condition.

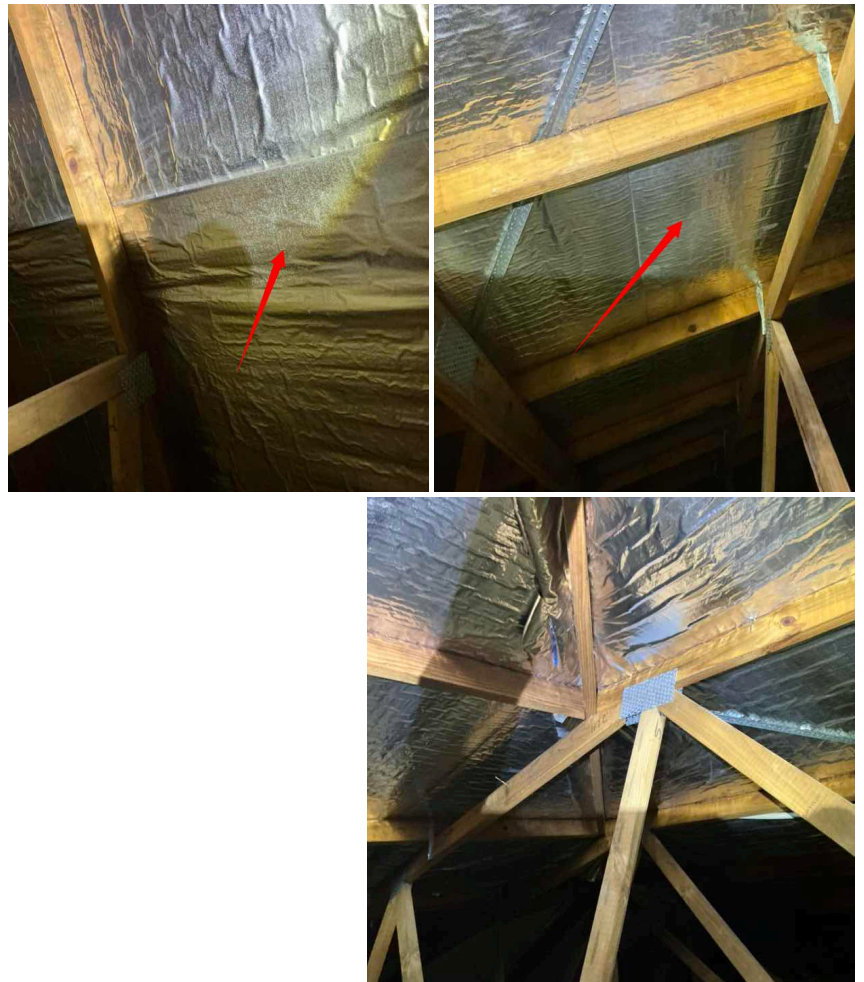
The sarking generally is in a serviceable condition.
