Building and Pest Report

58 Hutley Drive, Lennox Head

Report/Agreement # 2702260927567

Pest And Building Inspection

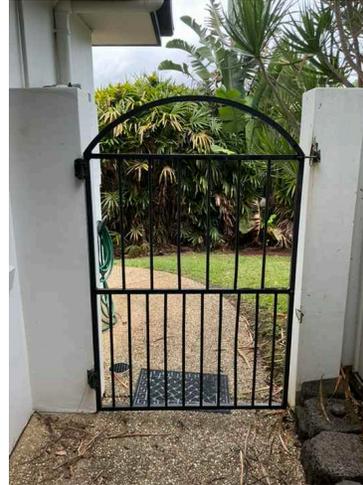
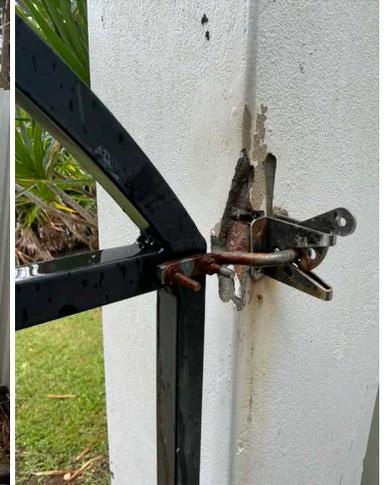
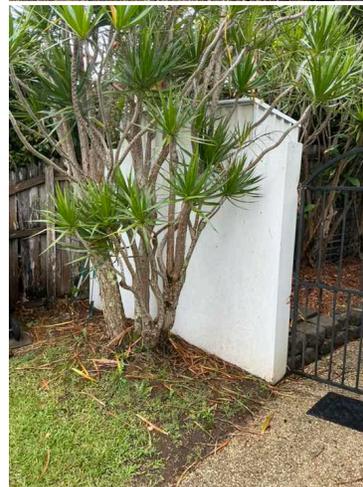
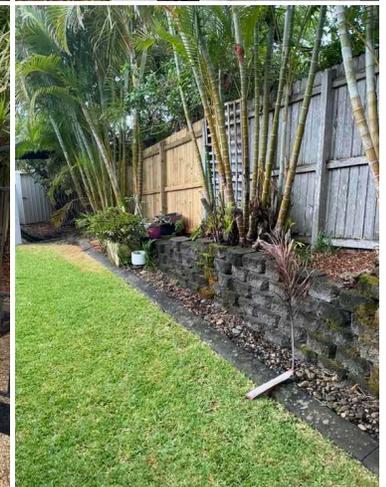
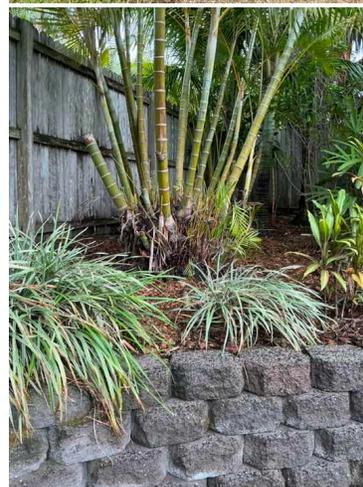
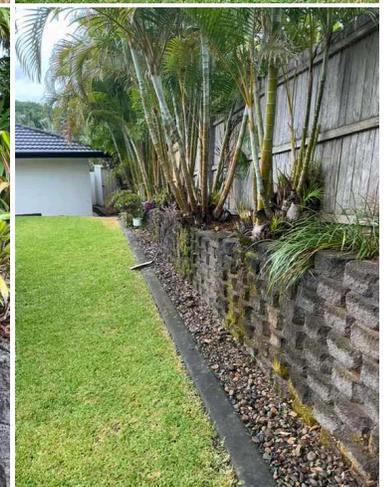
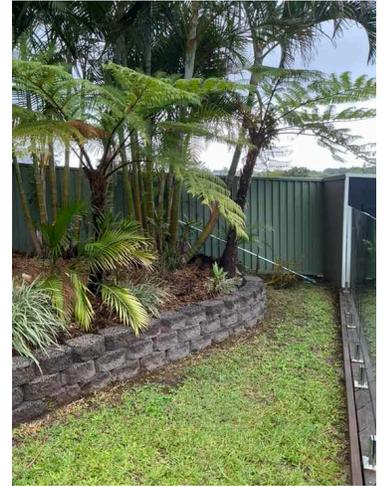
Of the visible areas, the general condition of the fences and gates is serviceable for the age of dwelling.

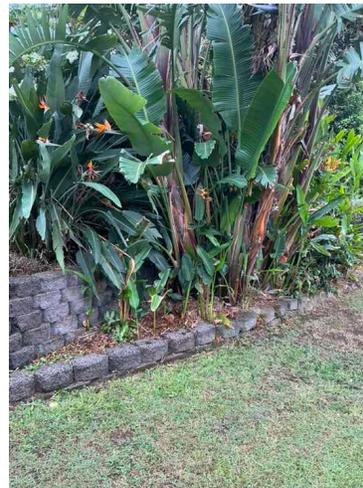
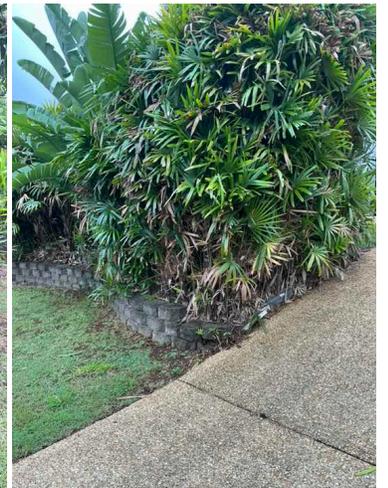
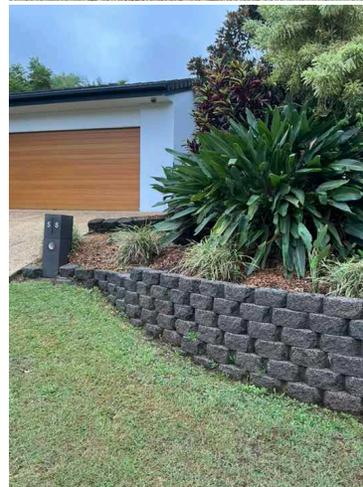
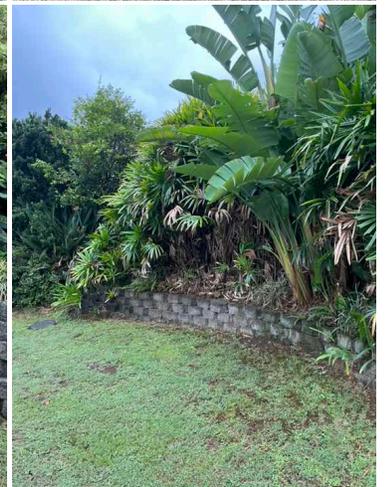
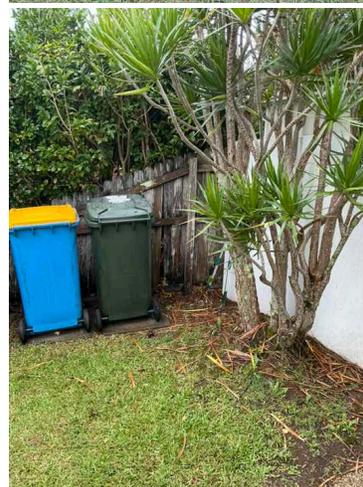
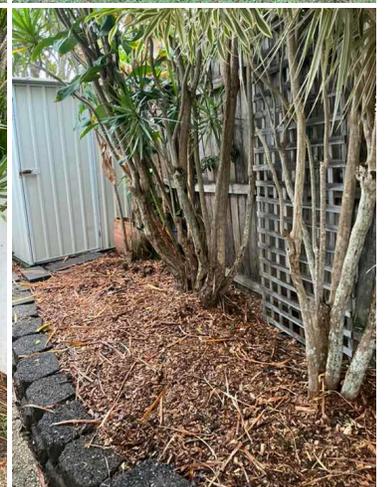
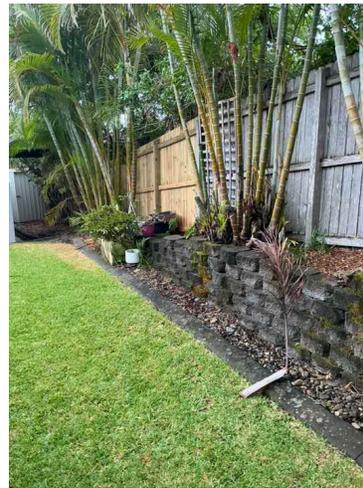
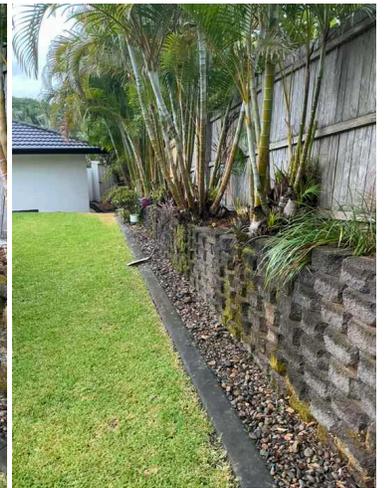
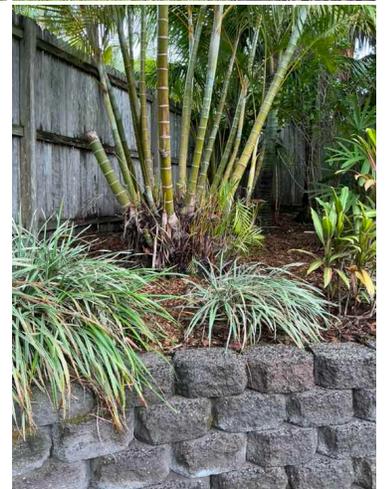
Tree Findings

Trees are close to the dwelling. These currently do not appear to have caused any defects/wall cracking. Recommendations: Engage a qualified arborist to carry out an assessment on potential issues.

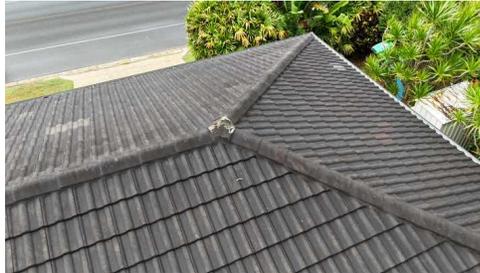
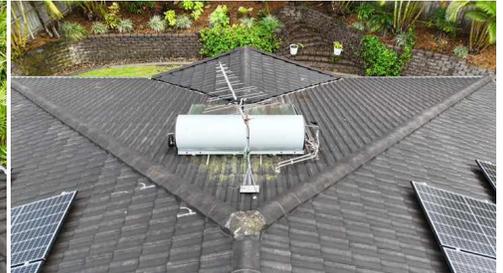
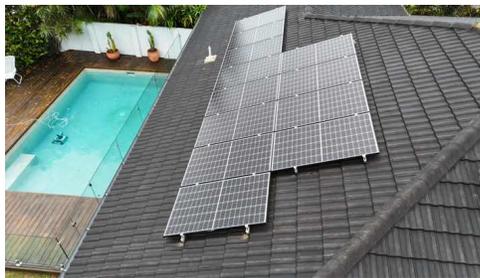
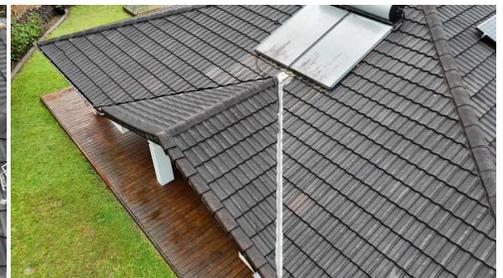
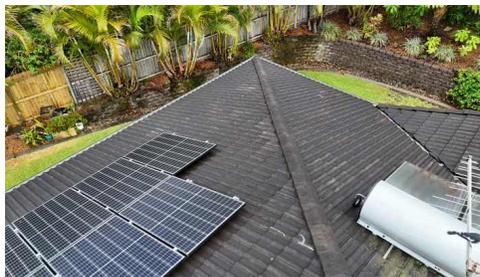
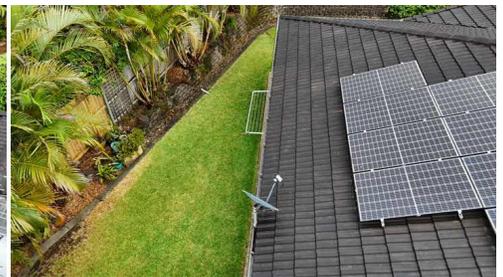
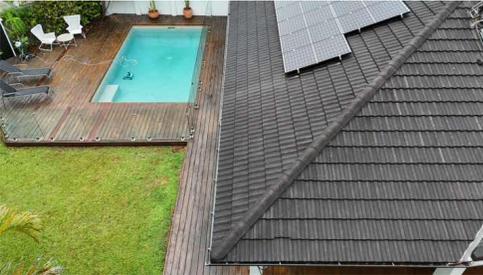
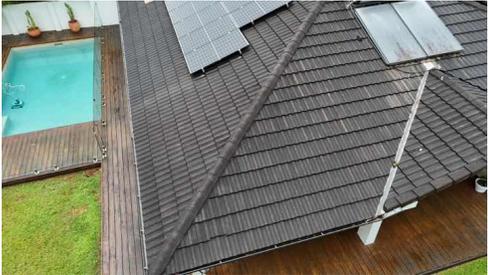
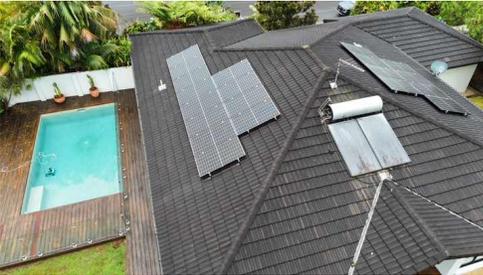
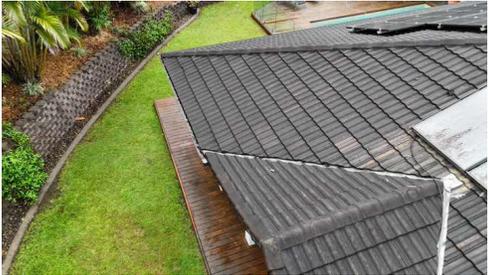
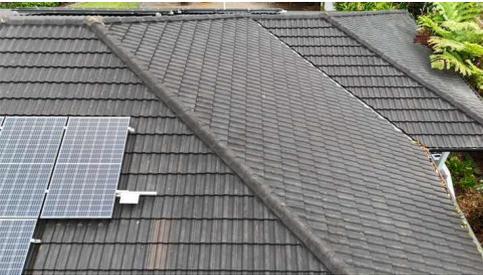
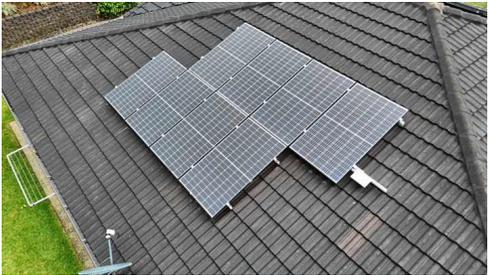
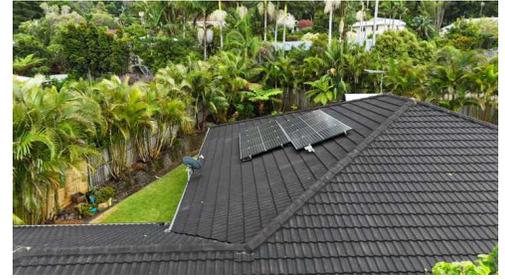
The roof is of concrete tiles.

Of the visible areas, the general condition of the roof is in serviceable condition for the age.

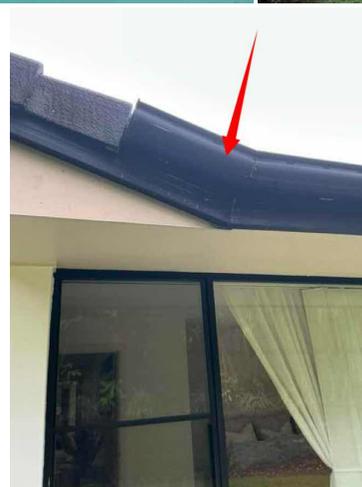
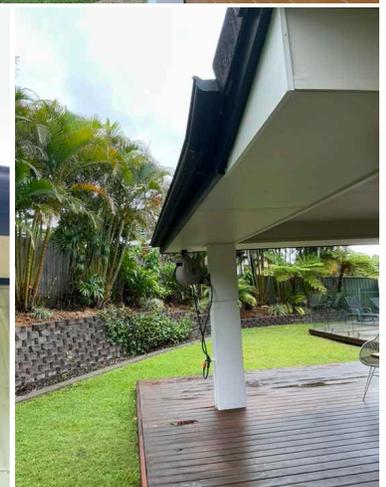
All visible and accessible of the physical nature of the guttering system appears to be in a serviceable condition with no apparent defects at the time of inspection. In the absence of prolonged rain fall efficiency of the guttering can not be assessed and you may find that further investigation or repairs maybe required. Note: Periodic maintenance checks should be carried out for rust penetrations and leaks.

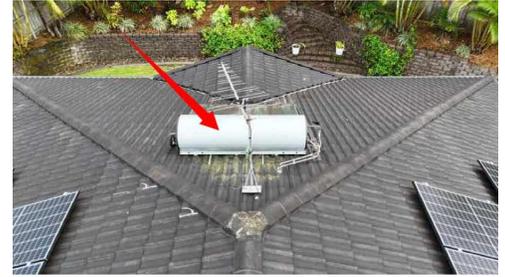
On Visual Inspection the water tank appears serviceable, but should be checked by a qualified plumber.

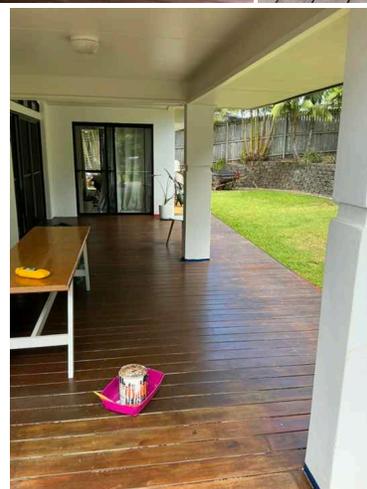
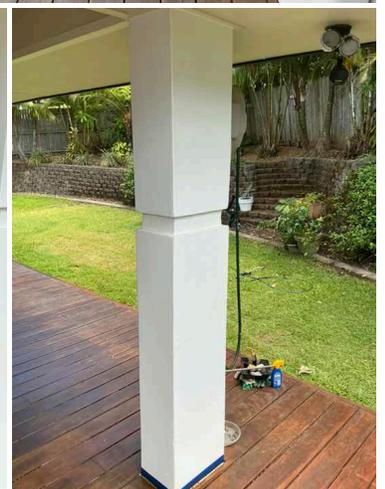
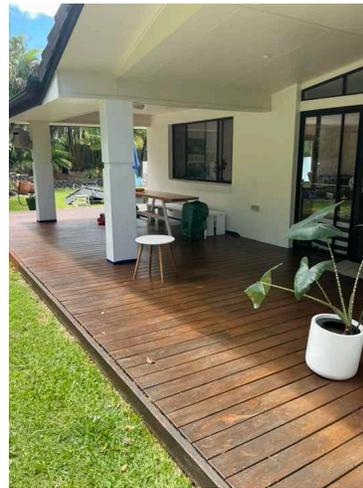
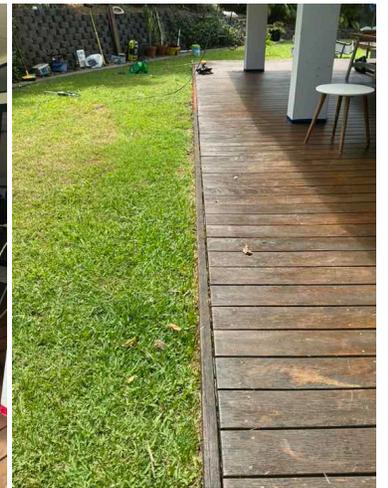
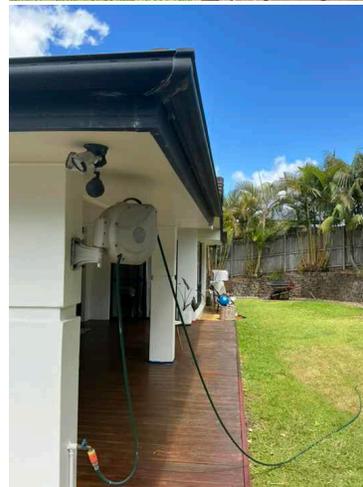
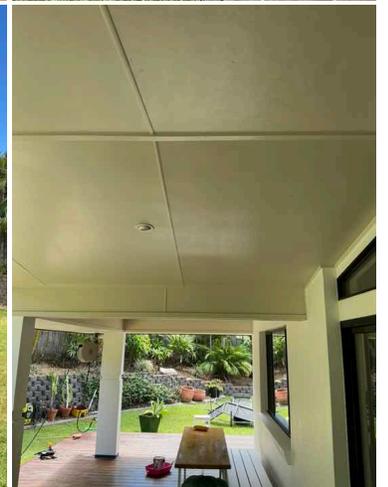
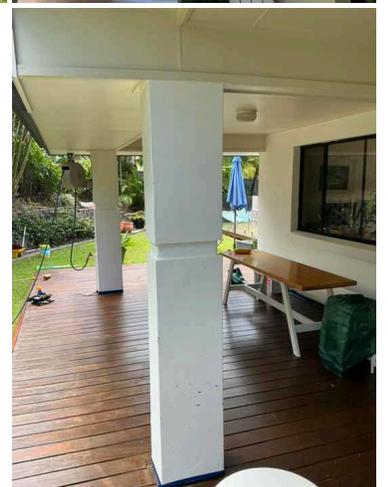
Visible sections of the Alfresco area are serviceable or in reasonable or condition for the age of this dwelling.

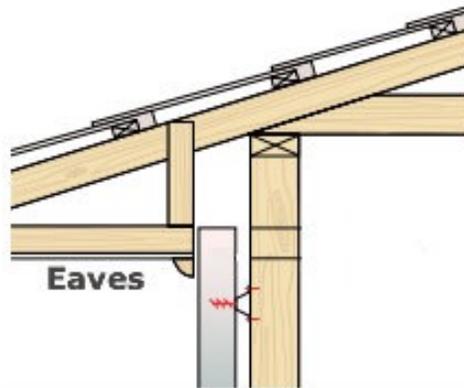
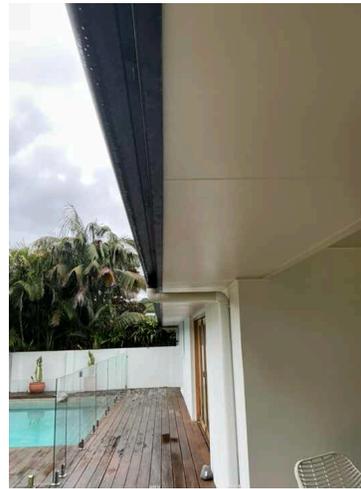
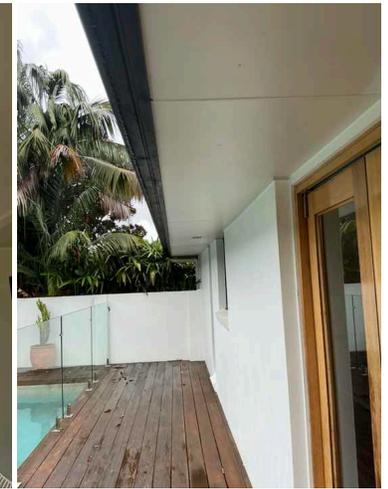
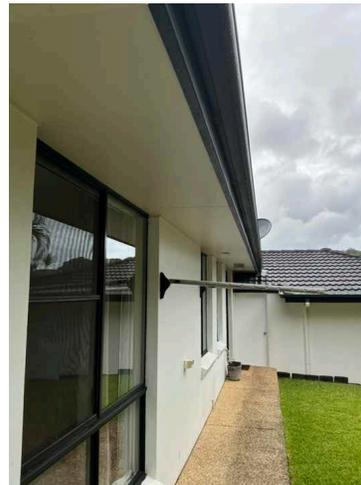
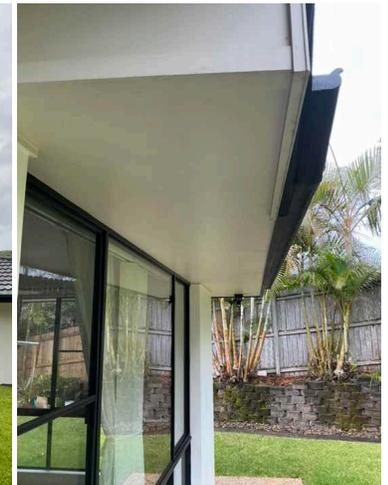
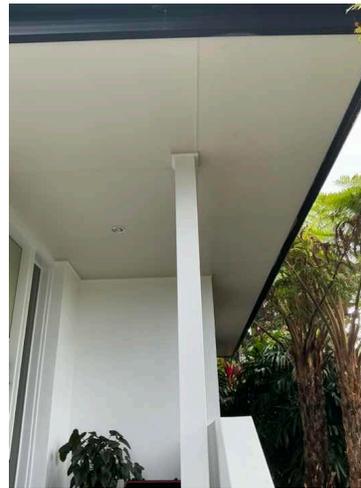
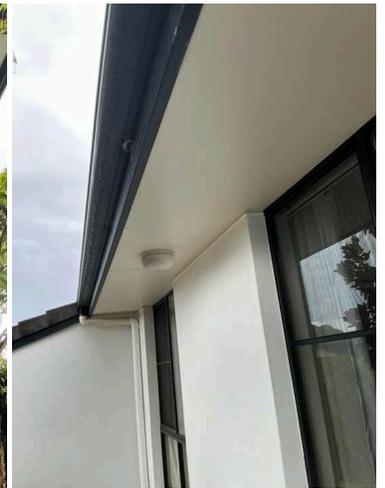
Eave Condition

The soffit lining (eaves) are in a serviceable condition with no notable defects.

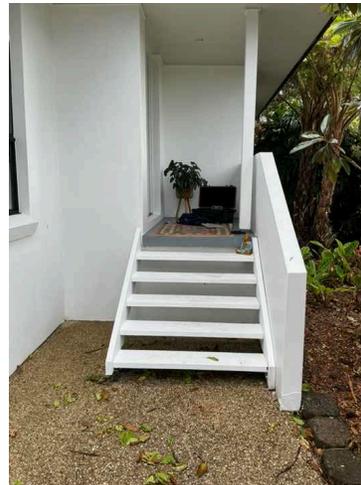
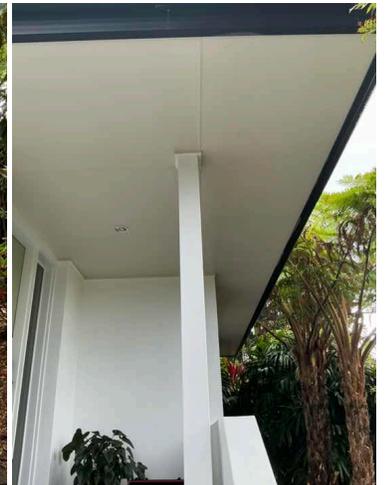
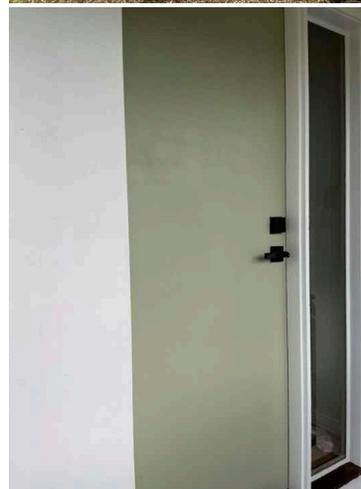
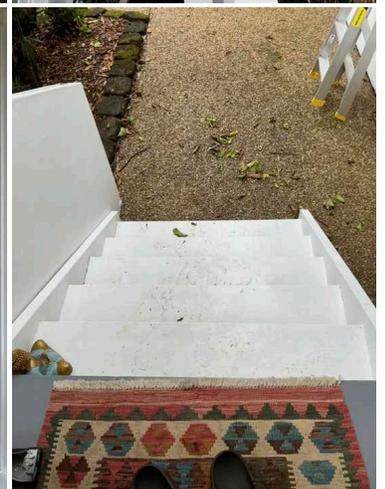
Entry Porch Area

The entry porch serviceable or in reasonable or condition for the age of this dwelling.

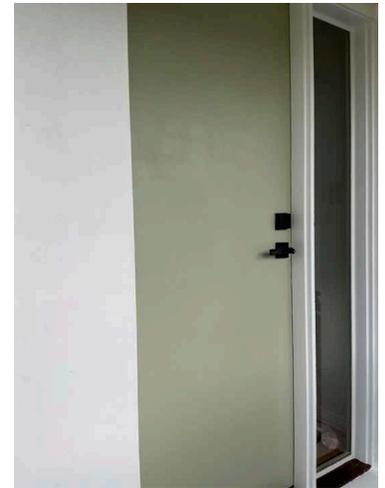
External Door Components

On Visual Inspection the external condition of the doors is serviceable.

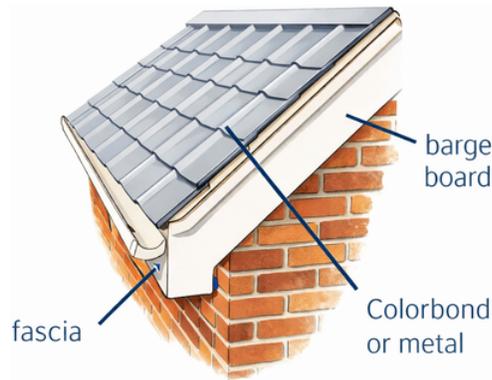
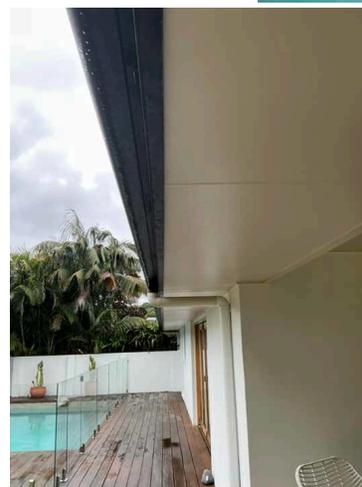
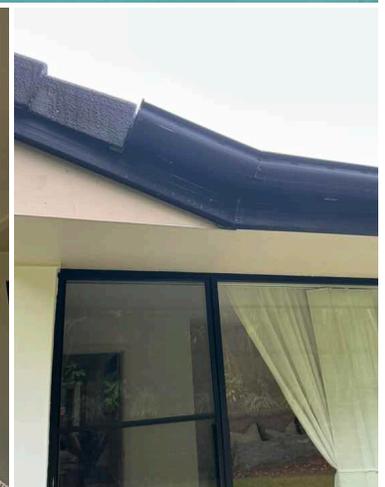
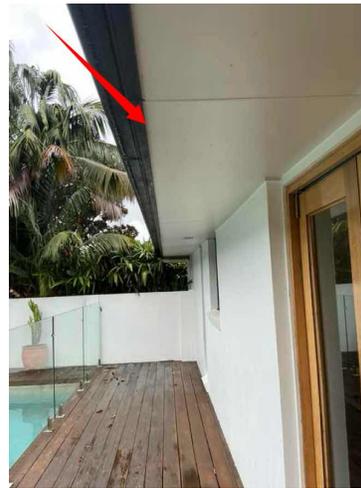
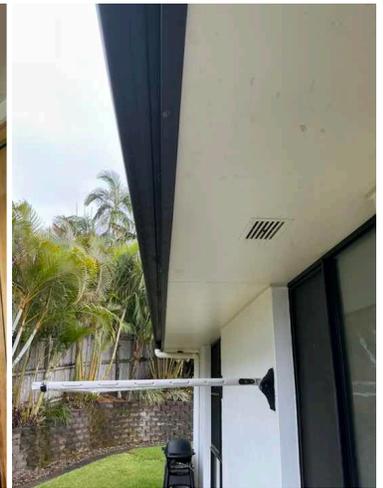
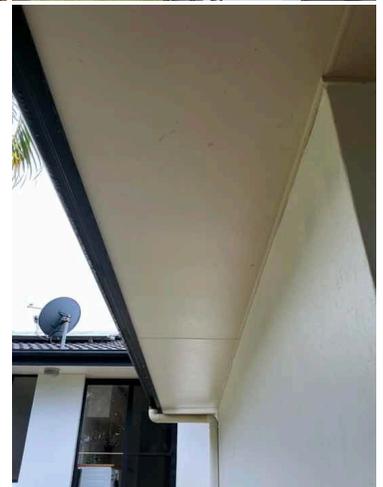
Fascia and Barge Boards

On visual inspection, the general condition of the fascia/barge boards is serviceable.

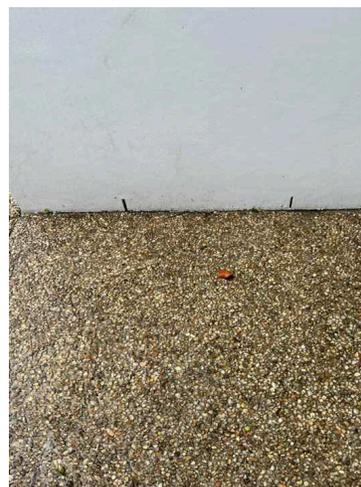
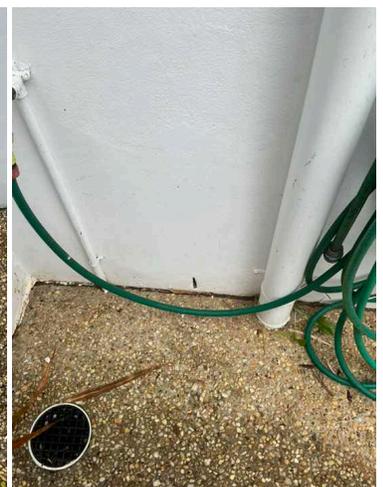
Rising Damp

Of the visible and accessible areas, there was no visible evidence of excessive rising damp on the external walls at time of inspection.

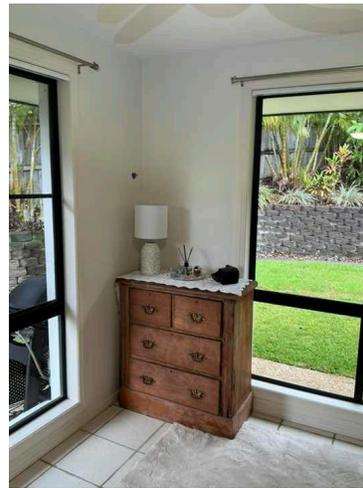
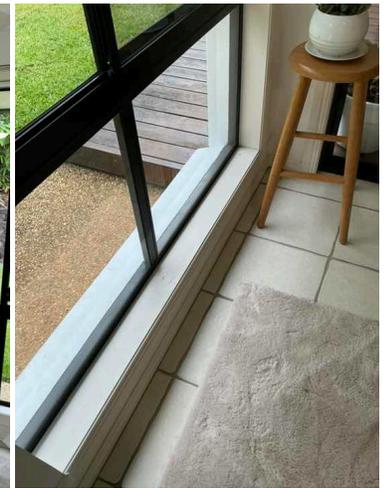
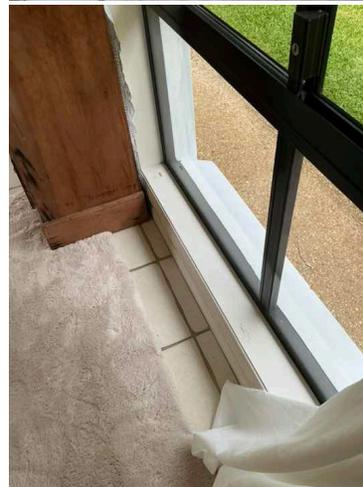
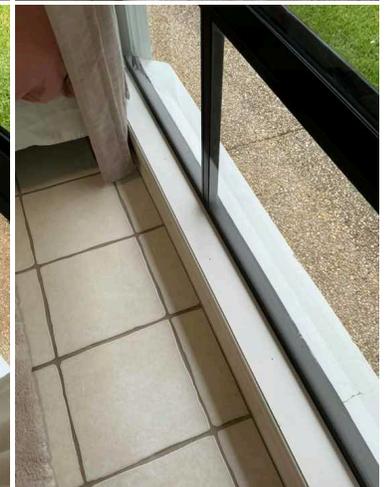
On visual inspection, the general condition of the windows is serviceable for the age.

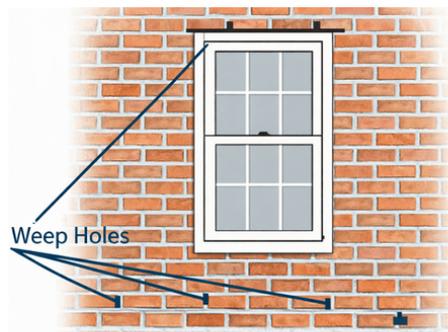
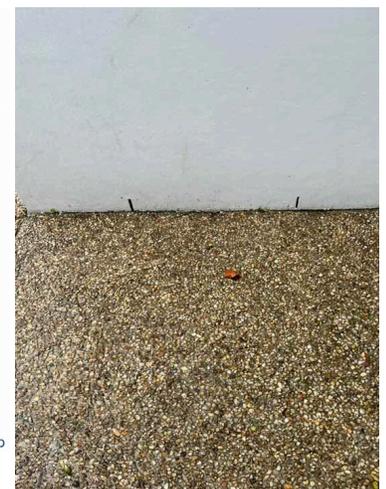
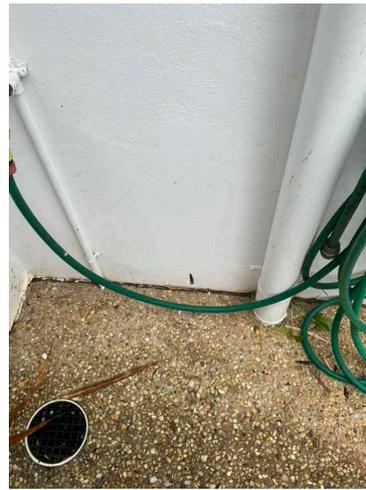
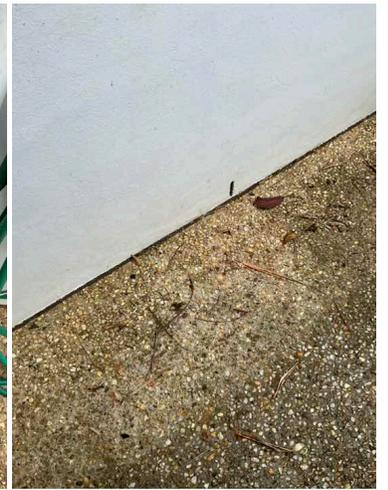
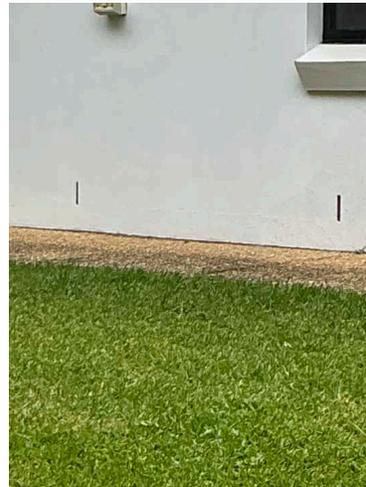
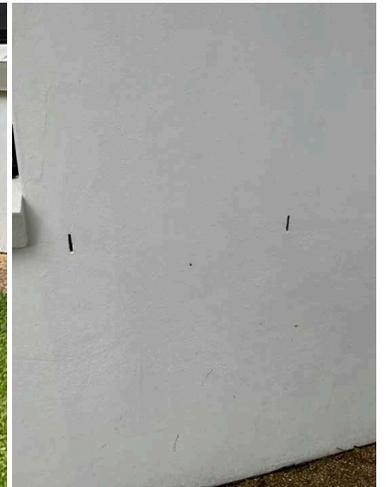
Weep Holes and Ventilation

The weep holes are unobstructed .

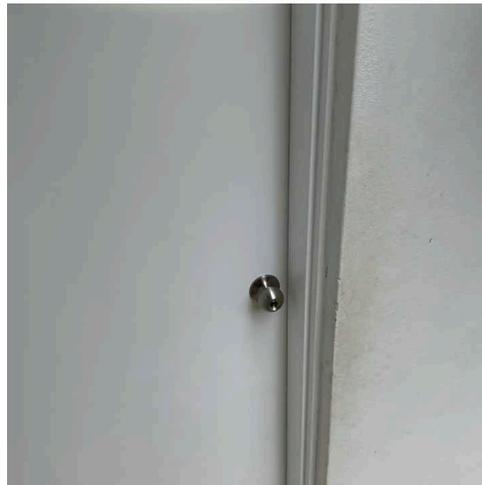
The garage was locked and no internal inspection was carried out. Defects may exist in the inaccessible areas. It is strongly recommended that full access be granted to enable a thorough inspection as there may be timber pest activity, damage or defects.

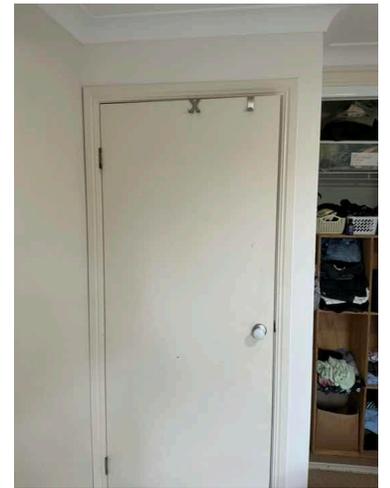
Other doors such as sliding , side entry etc.. appear to be in serviceable condition.

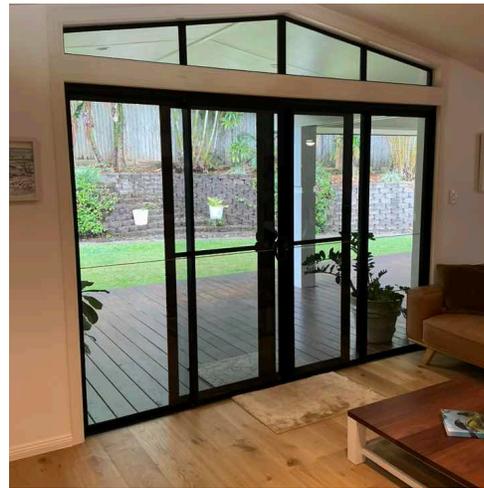
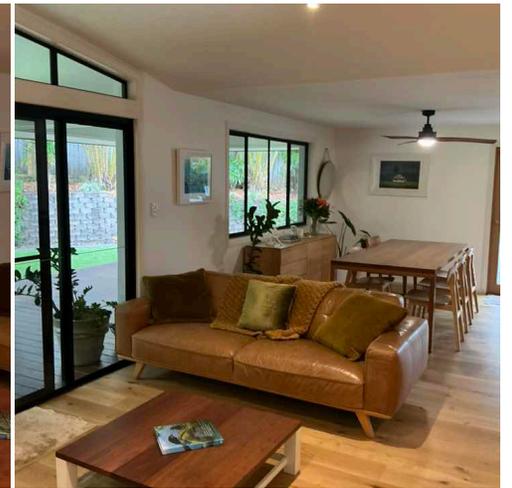
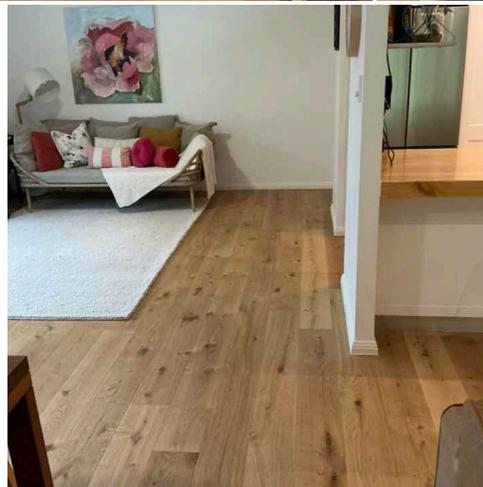
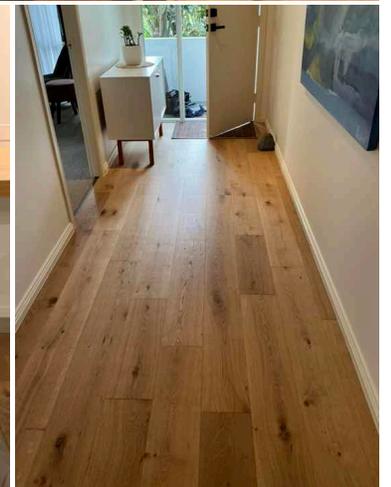
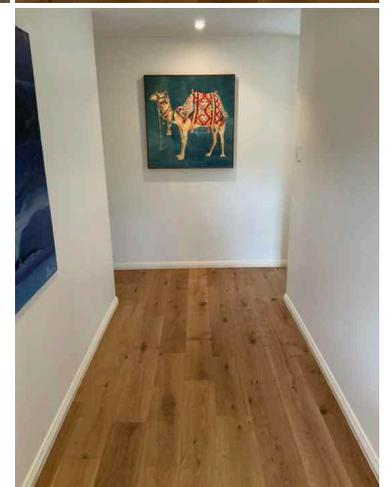
Living Room

From the visible and accessible areas, this room appears to be in a serviceable condition for the age of the property with no notable structural defects sighted.

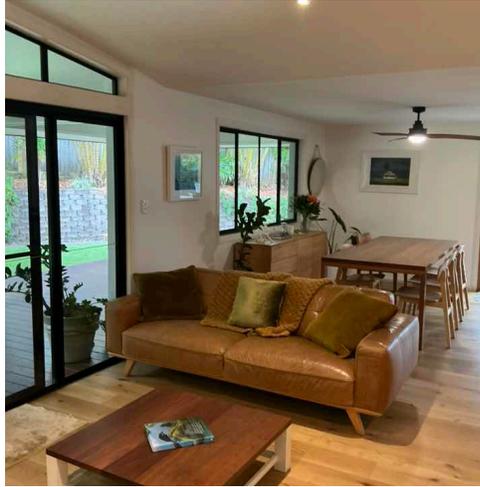
Dining Room

From the visible and accessible areas, this room appears to be in a serviceable condition for the age of the property with no notable structural defects sighted.

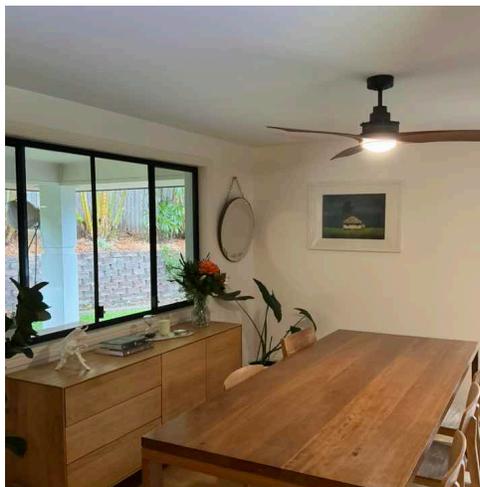
Combined Living & Dining

From the visible and accessible areas, this room appears to be in a serviceable condition for the age of the property with no notable structural defects sighted.

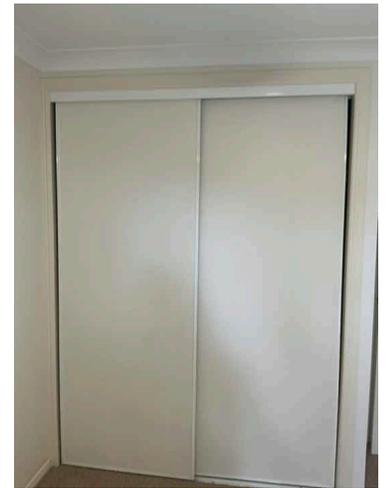
Bedroom 2

From the visible and accessible areas, this bedroom appears to be in a serviceable condition for the age of the property with no notable structural defects sighted.

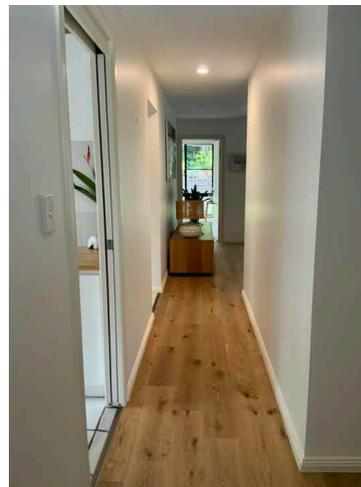
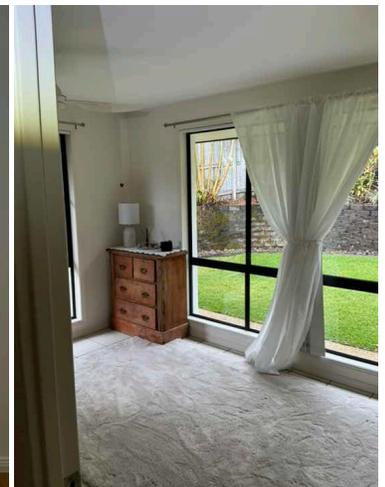
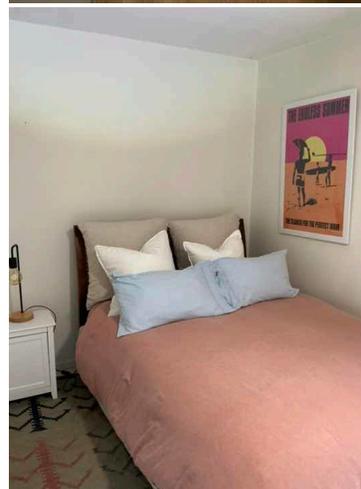
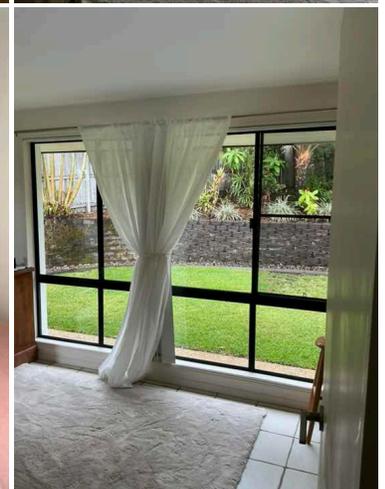
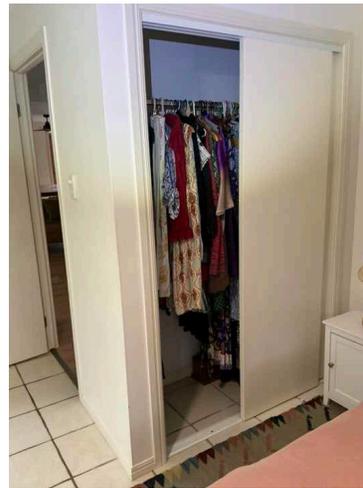
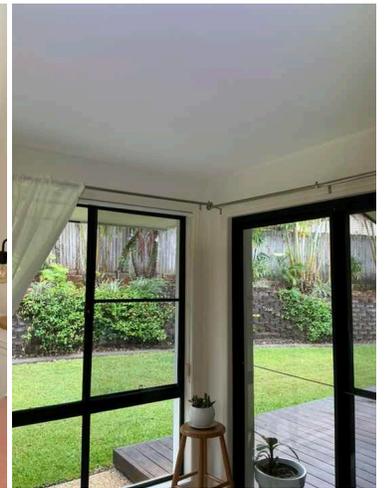
Bedroom 3

From the visible and accessible areas, this bedroom appears to be in a serviceable condition for the age of the property with no notable structural defects sighted.

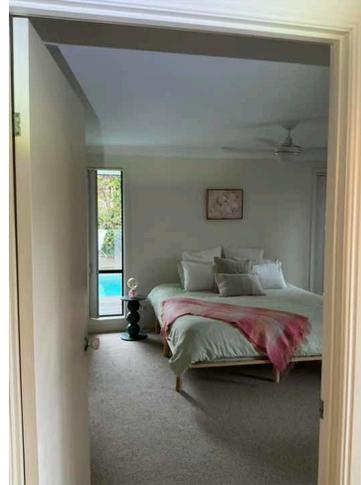
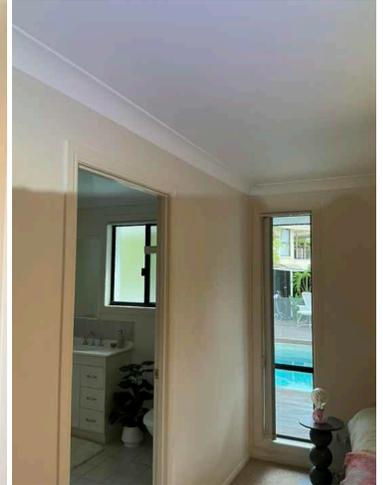
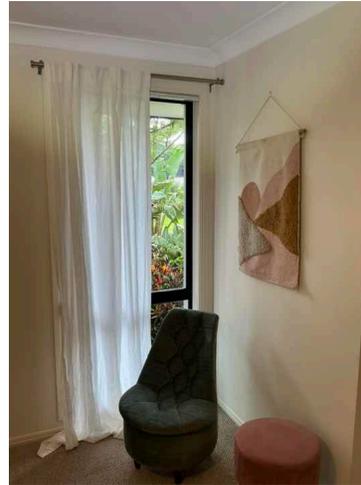
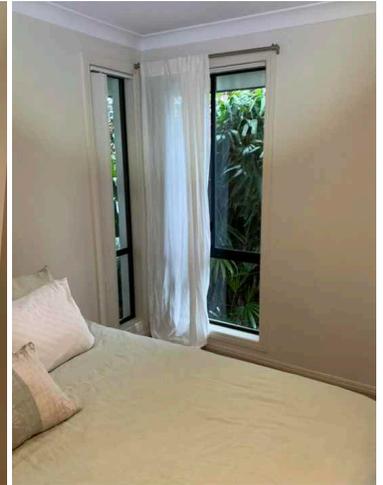
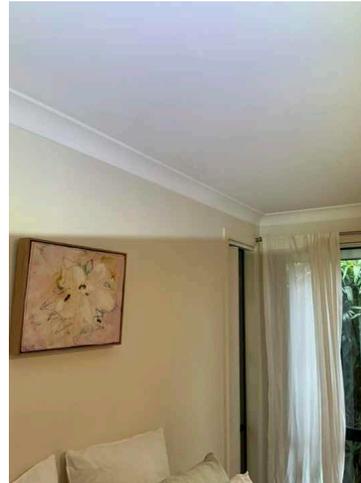
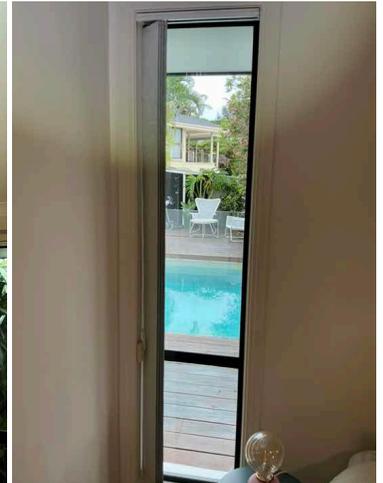
Bedroom 4

From the visible and accessible areas, this bedroom appears to be in a serviceable condition for the age of the property with no notable structural defects sighted.

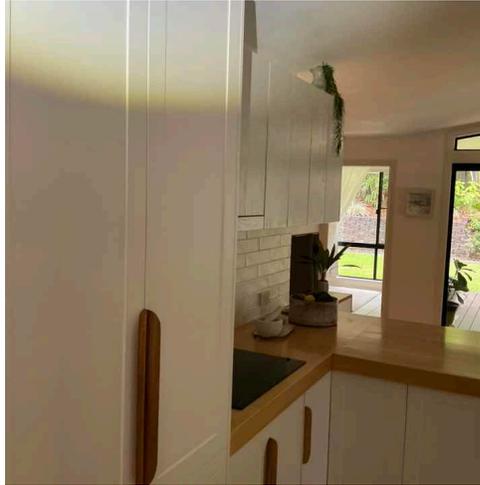
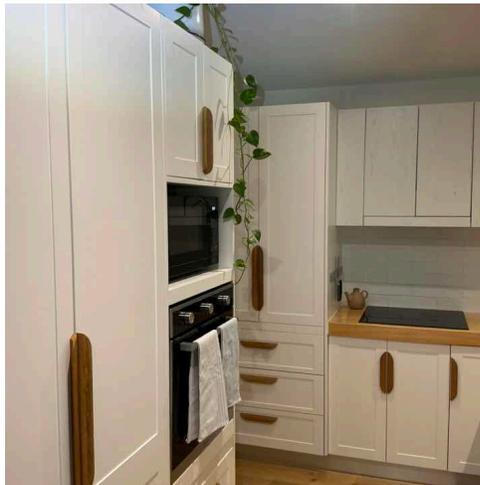
Of the visible areas, the general condition of the kitchen and pantry is serviceable or in reasonable condition for age of dwelling.

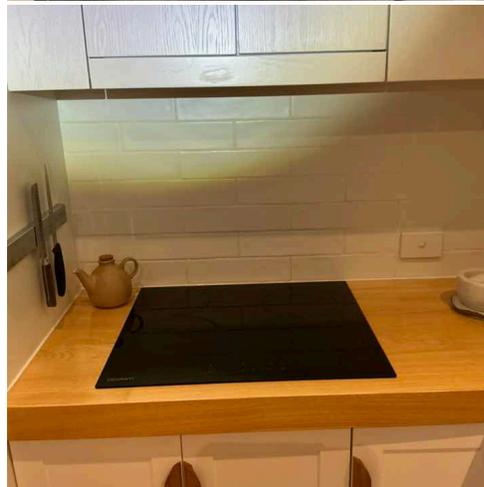
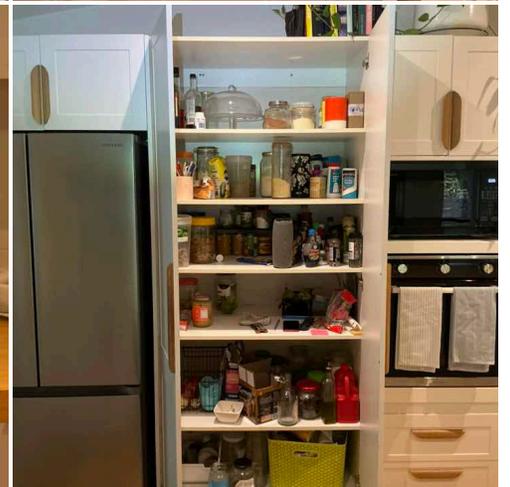
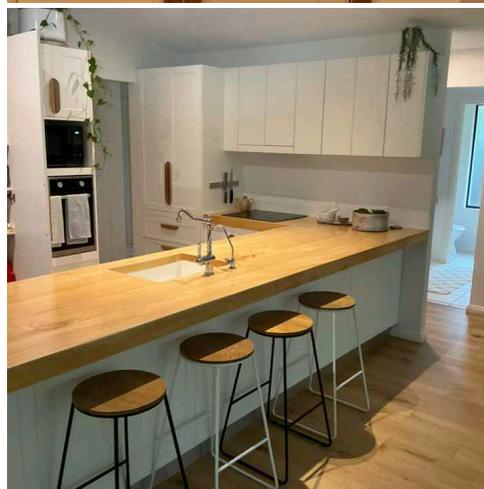
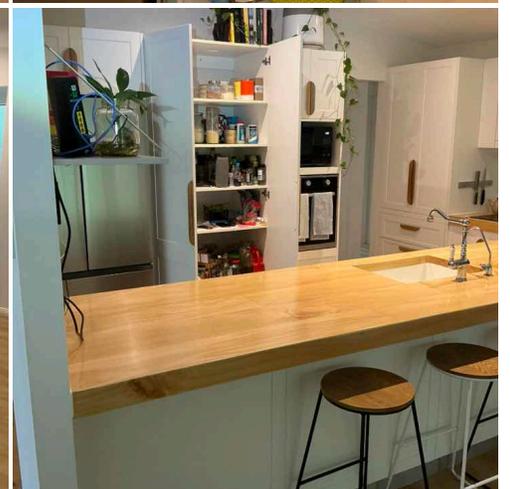
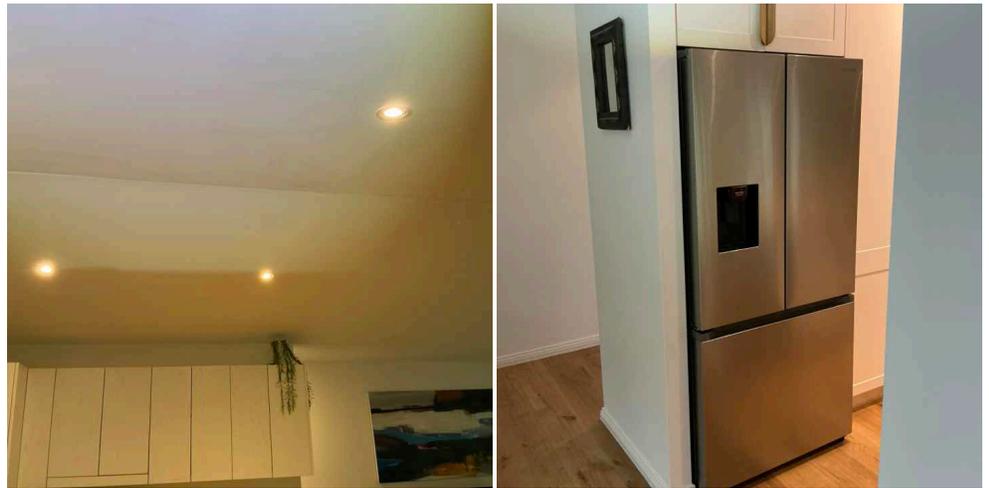
Cupboards And Bench Tops

These components appear to be in a serviceable condition

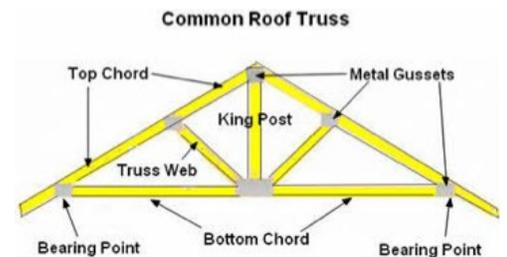
The roof frame is a truss timber frame.

Visible sections of the roof void is in a serviceable condition for age of this dwelling.
