Building and Pest Report

1/20 Barrett Drive Lennox Head

Pest And Building Inspection

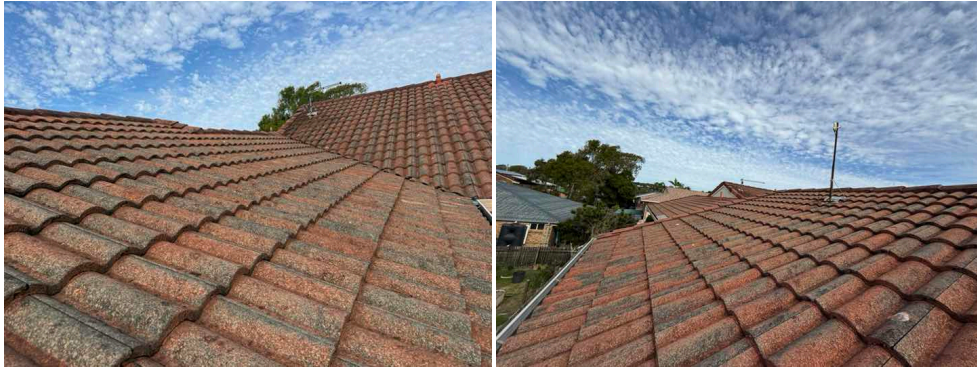
Of the visible areas, the general condition of the roof is in serviceable condition for the age.

Note: In the absence of rainfall there is no guarantee that the roof won't leak.

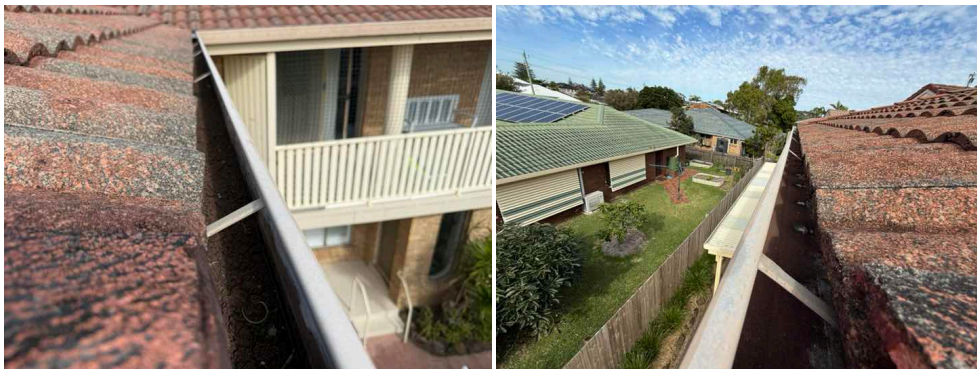
Guttering

All visible and accessible of the physical nature of the guttering system appears to be in a serviceable condition with no apparent defects at the time of inspection. In the absence of prolonged rain fall efficiency of the guttering can not be assessed and you may find that further investigation or repairs maybe required. Note: Periodic maintenance checks should be carried out for rust penetrations and leaks.

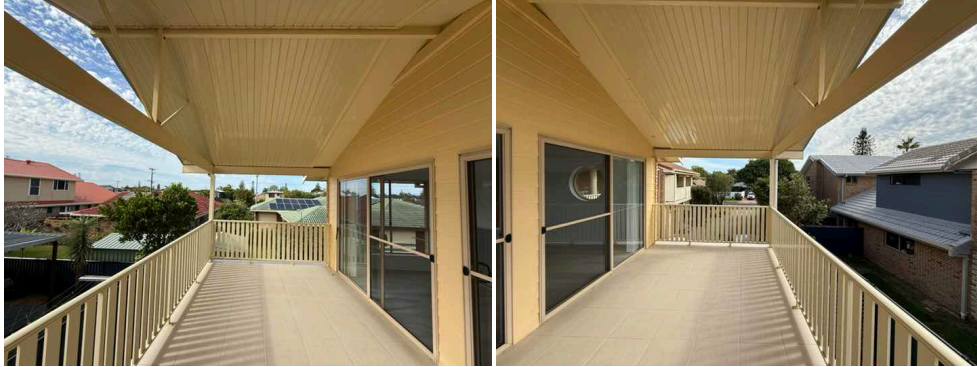
Eaves

The soffit lining (eaves) are in a serviceable condition with no notable defects.

Upon visual inspection, several rusty fixings were identified, indicating potential structural weakness. It is recommended to replace all affected fixings with corrosion-resistant alternatives to ensure structural integrity. Additionally, inspect surrounding areas for further corrosion or damage. Engage a licensed tradesperson to assess and carry out necessary repairs, ensuring compliance with relevant building standards and safety regulations. Regular maintenance checks are advised to prevent future issues.

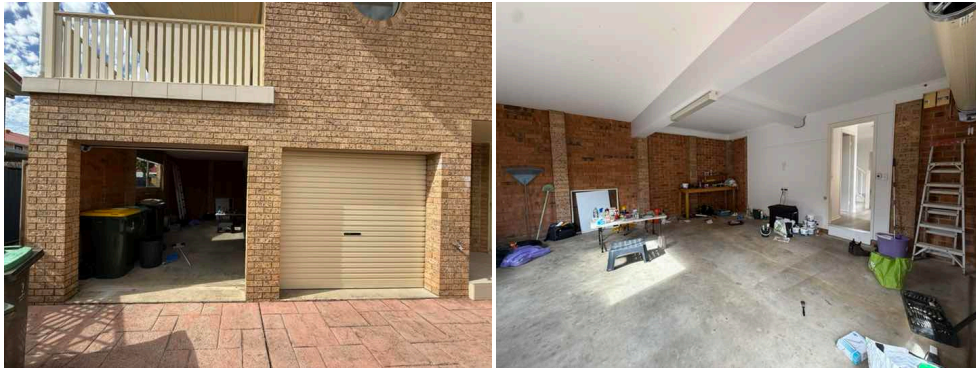
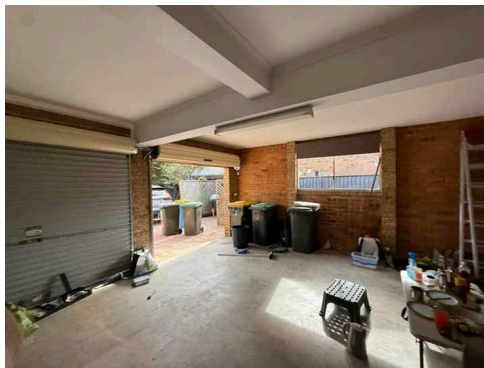
From the visible and accessible areas, the garage appears to be in a serviceable condition for the age of the property with no notable structural defects sighted.

Upon visual inspection, a movement crack was observed on the engaged pier. This defect may compromise structural integrity if not addressed. It is recommended to engage a licensed masonry contractor to assess and repair the crack. Repairs may include repointing or reinforcing the affected area to prevent further deterioration and ensure stability. Regular monitoring is advised to detect any future movement.

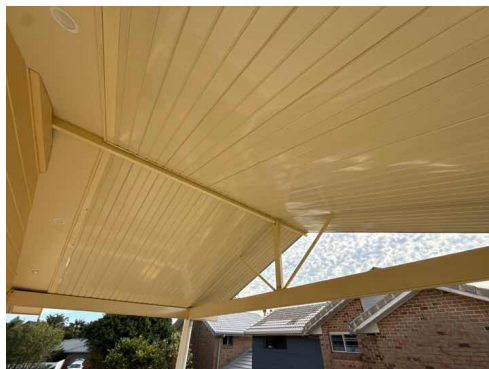
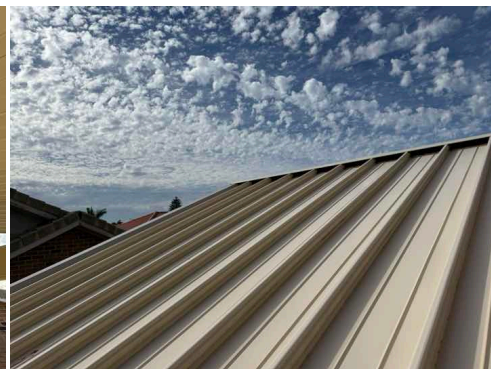
Pergola Findings(1)

The Pergola is in a serviceable condition with no notable defects sighted.

Upon visual inspection, surface rust was observed on metal components. This corrosion may lead to structural weakening if not addressed. It is recommended to clean the affected areas thoroughly, apply a rust-inhibiting primer, and repaint with a suitable metal paint. Regular maintenance checks should be scheduled to prevent recurrence and ensure the longevity of the metal surfaces.

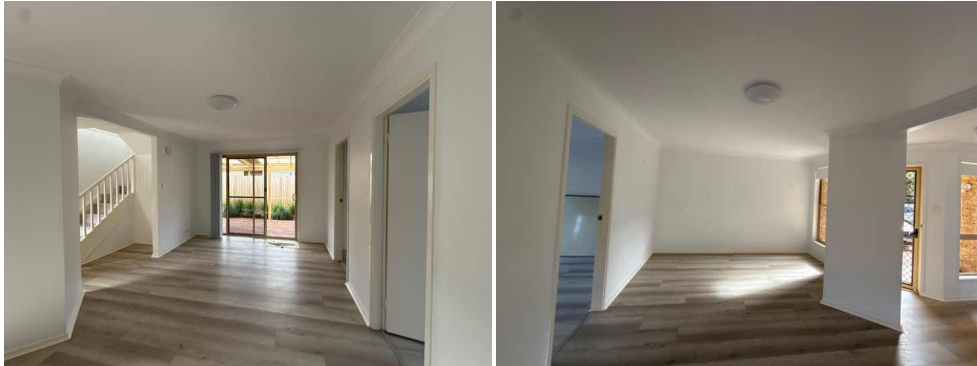
Ceiling

From the visible and accessible areas, this room appears to be in a serviceable condition for the age of the property with no notable structural defects sighted.

Typical cornice separation/detachment observed. I recommend you contact a qualified painter for repairs.

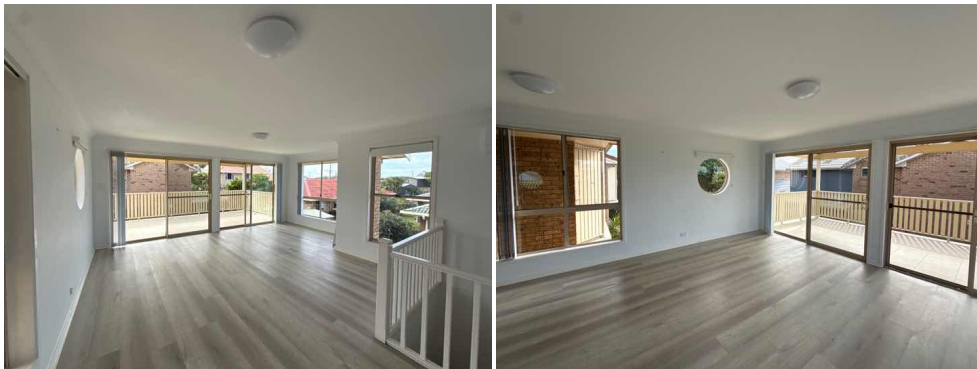
Walls

From the visible and accessible areas, this room appears to be in a serviceable condition for the age of the property with no notable structural defects sighted.

Settlement Cracks Noted. These are typical and generally patch and paint will suffice, however we recommend you monitor these cracks and if they become wider or longer, you will need to contact a structural engineers to assess.

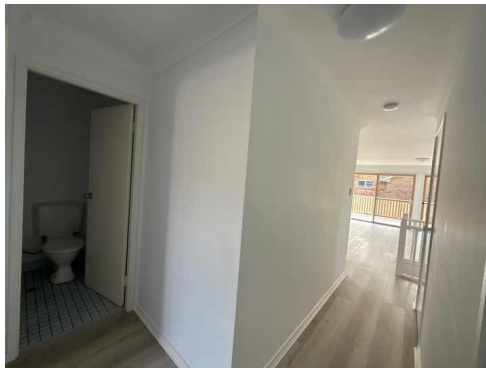
Ceiling

From the visible and accessible areas, the hallway/s/ appears to be in a serviceable condition for the age of the property with no notable structural defects sighted.

Typical cornice separation/detachment observed. I recommend you contact a qualified painter for repairs.

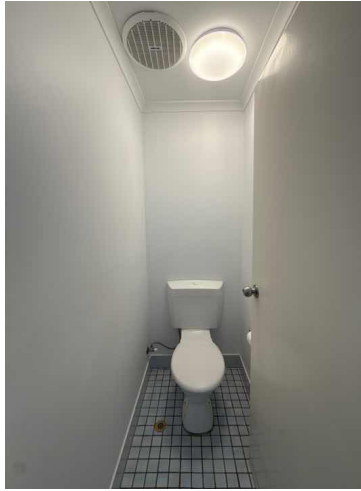
Ceiling

Of the visible areas, the general condition of this bathroom is serviceable or in reasonable condition for age of dwelling.

Cornice separation. I recommend you contact a licensed plasterer for repairs.
