# Building and Pest Report

## 37 Alison Avenue, Lennox Head

| Report/Agreement # | 090326113621317 |
| Inspection Date: | 09 Mar 2026 |

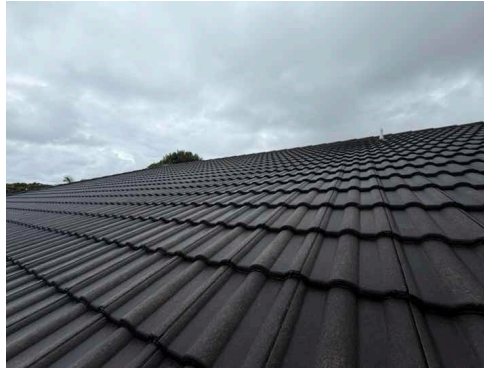
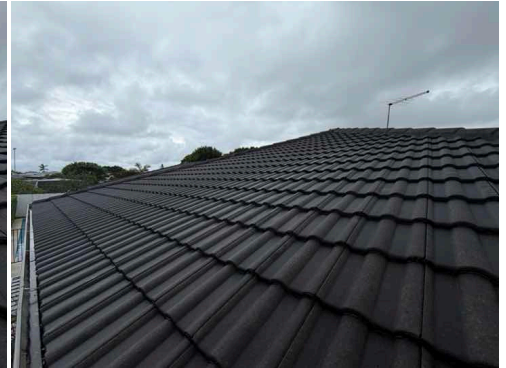
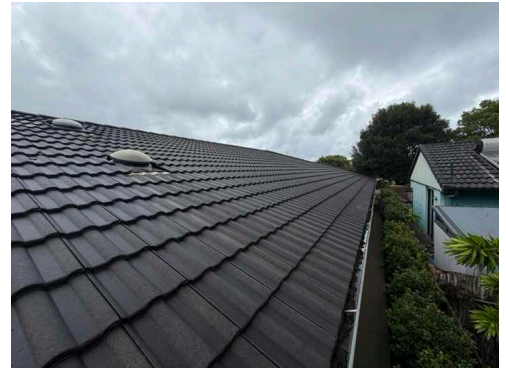
Visible section of The roof cladding appeared in a serviceable condition for the age of this dwelling. Annual maintenance inspection recommended. Cracked tile ends visible. A qualified roof tiling contractor should be engaged for advice and recommendations. Considered a minor defect but has the potential to become a Major defect if repairs aren't carried out immediately due to water ingress into the roof cavity.

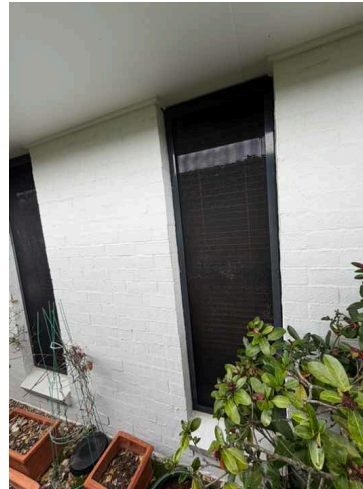
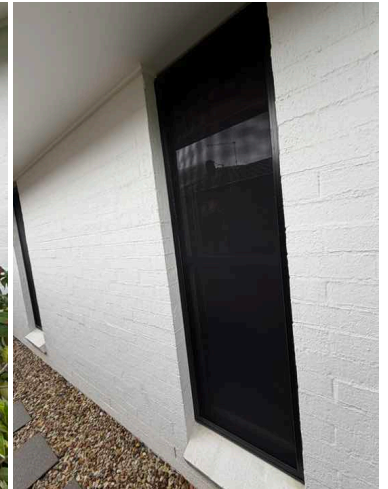
The weep holes are unobstructed .  
Vents are covered by soil/vegetation or have debris restricting ventilation to the sub floor  
Recommendations: Remove vegetation and or lower soil levels so that sub floor vents are unobstructed and allowing free flowing air.

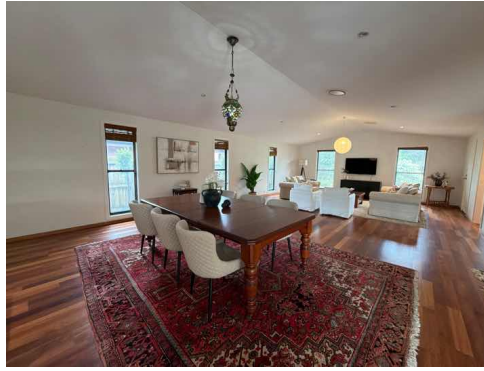
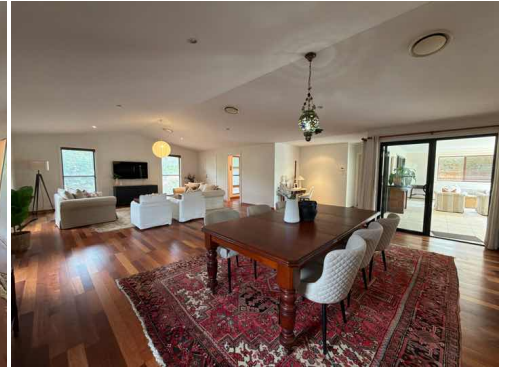
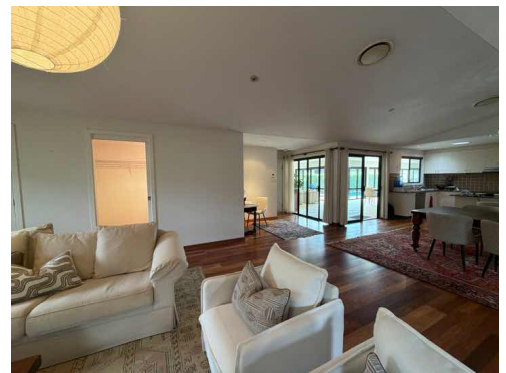
Settlement Cracks Noted. These are typical and generally patch and paint will suffice, however monitoring these cracks is advised for 12 months and if they become worse, further investigation by a suitably qualified professional is advised.

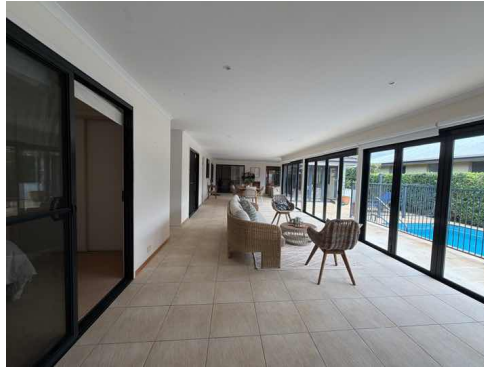
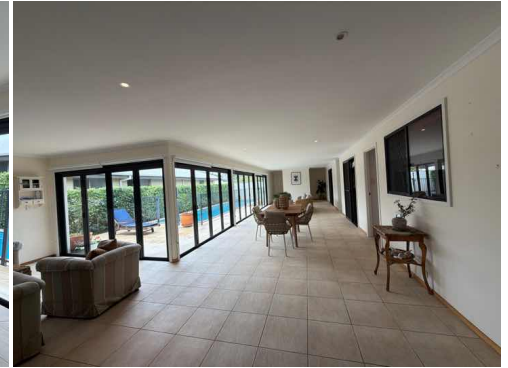
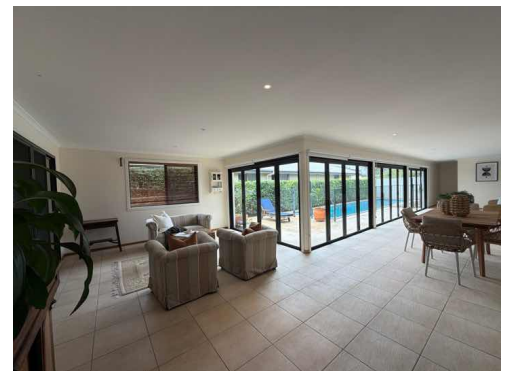
Settlement Cracks Noted. These are typical and generally patch and paint will suffice, however monitoring these cracks is advised for 12 months and if they become worse, further investigation by a suitably qualified professional is advised.

Typical cornice separation/detachment observed. I recommend you contact a qualified painter for repairs.

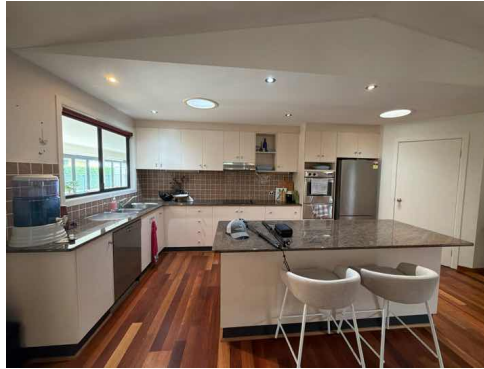
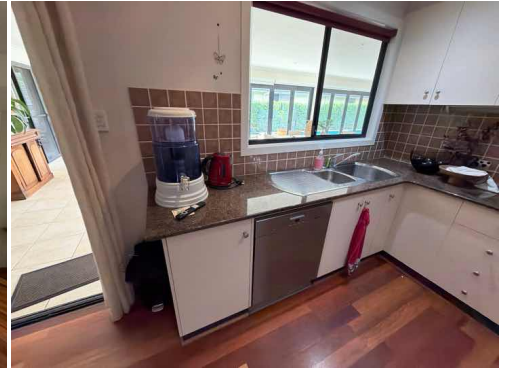
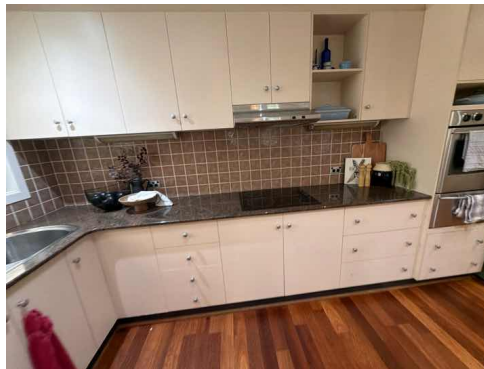
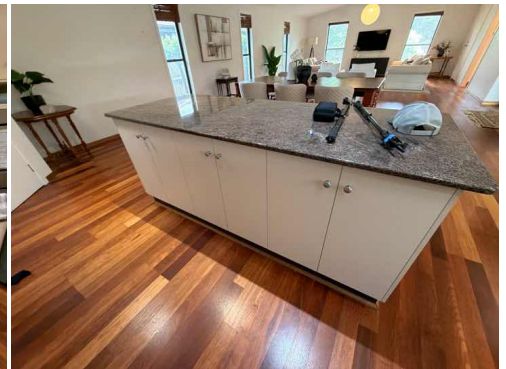
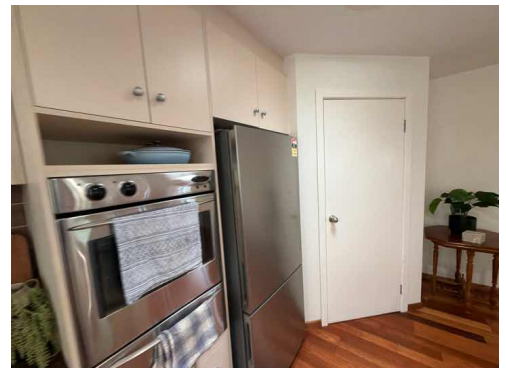
Of the visible areas, the general condition of the kitchen and pantry is serviceable or in reasonable condition for age of dwelling.

These components appear to be in a serviceable condition

Adjustment to cabinet doors required, in some instance hinges may need to be replaced.

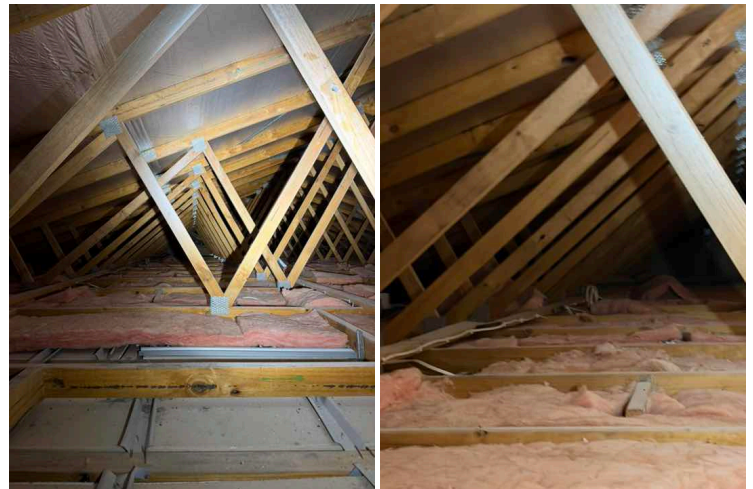
Visible sections of the roof void is in a serviceable condition for age of this dwelling.
