# Building and Pest Report

## 6 Seaward Street Lennox Head

| Report/Agreement # | 280126122333105 |
| Inspection Date: | 28 Jan 2026 |

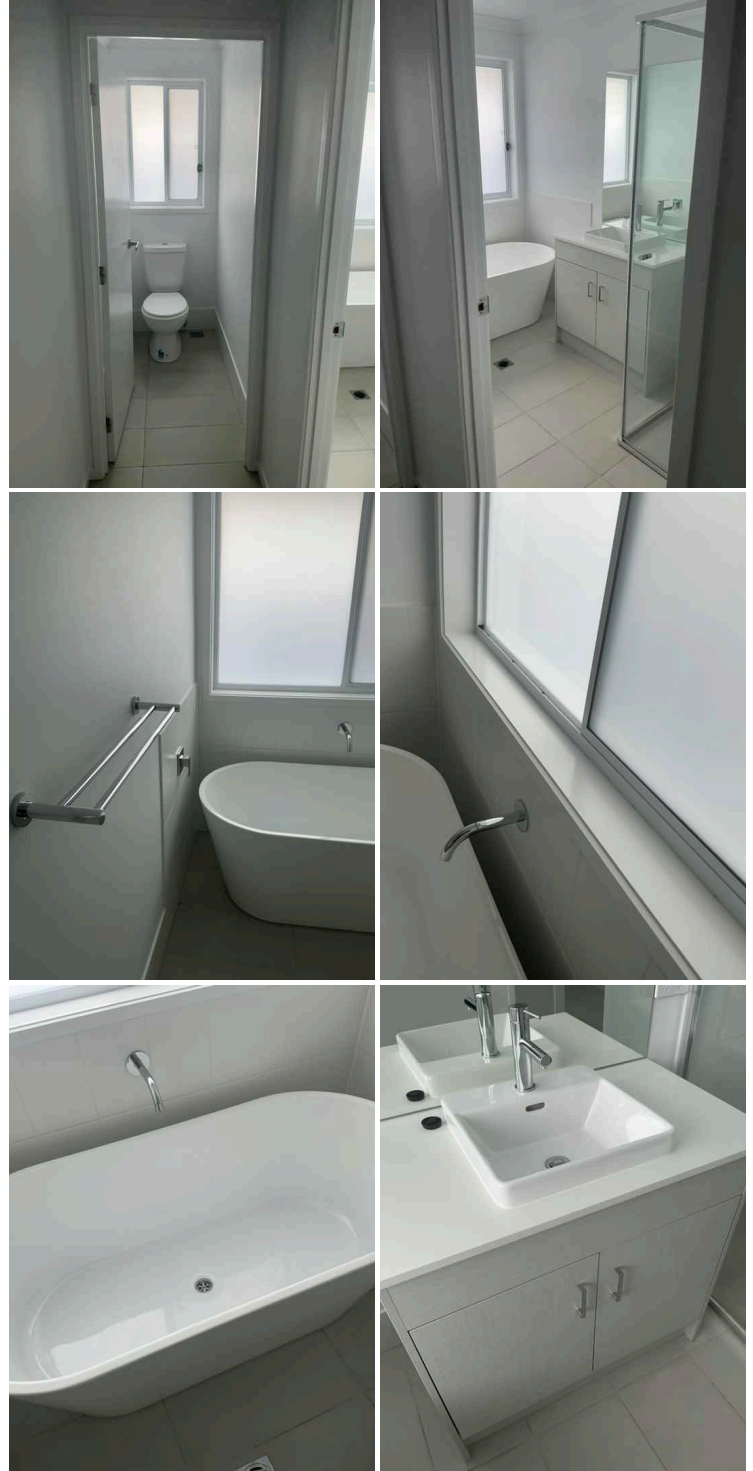
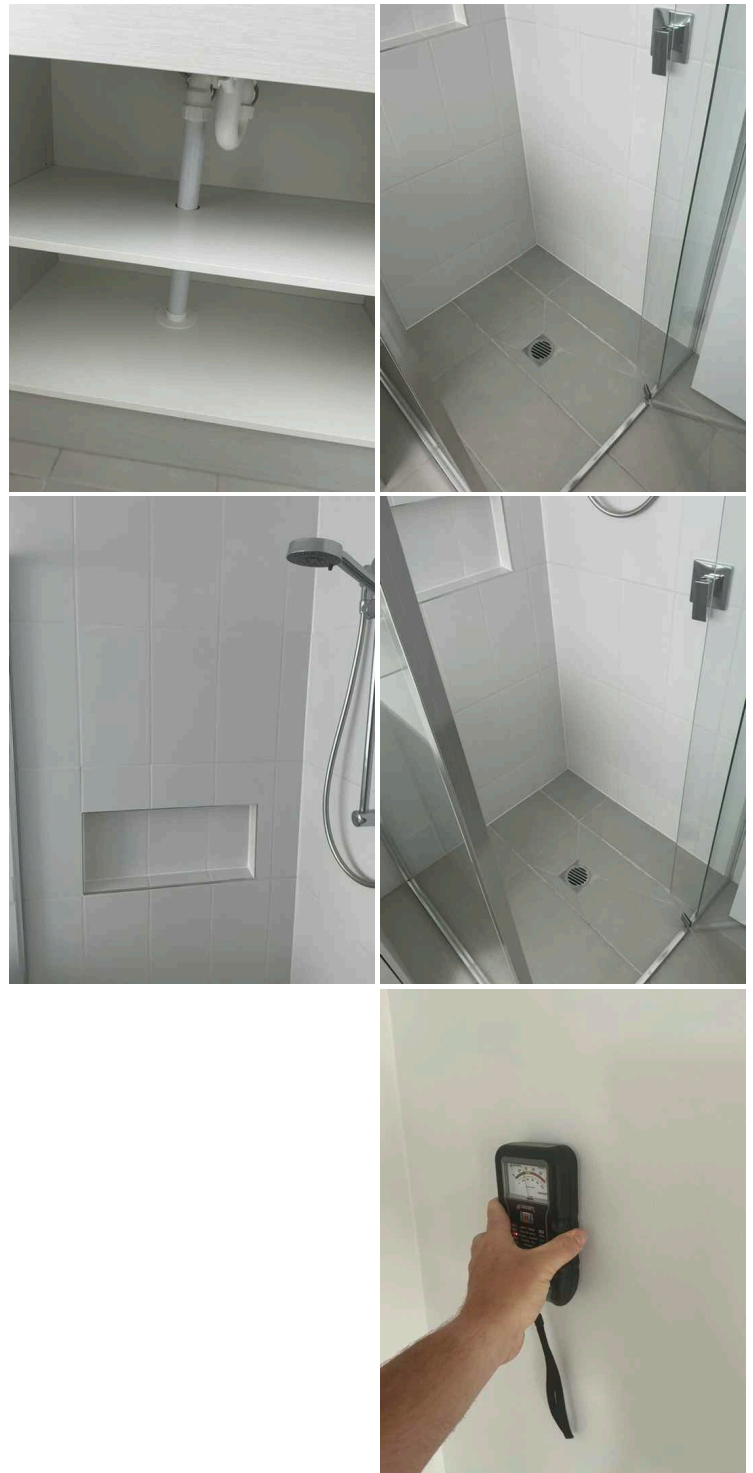
Of the visible areas, the general condition of this bathroom is serviceable or in reasonable condition for age of dwelling.

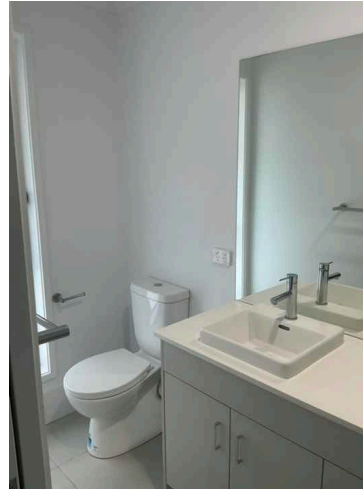
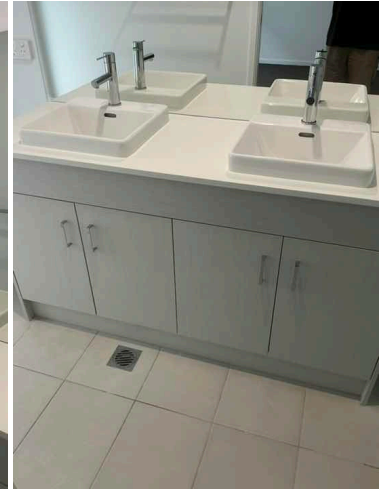
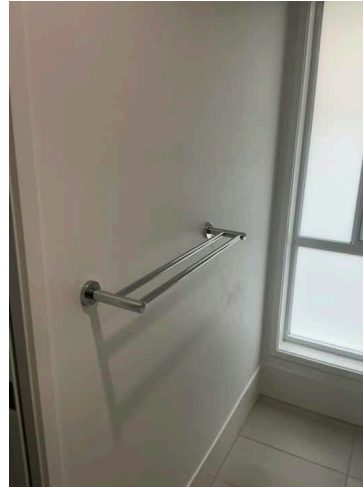
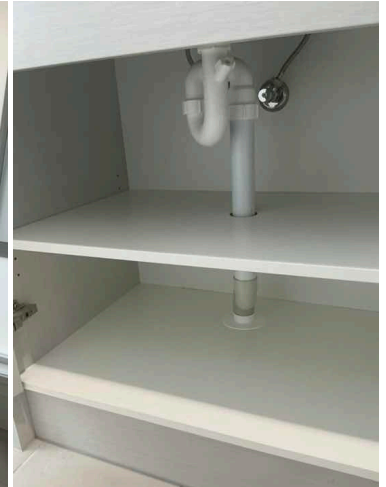
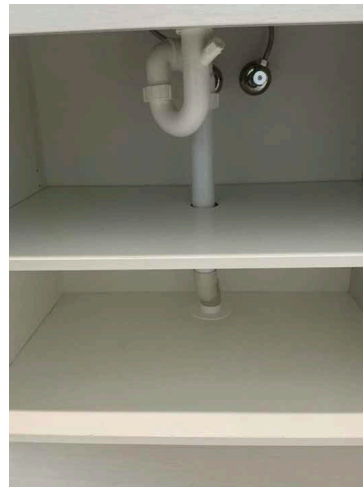
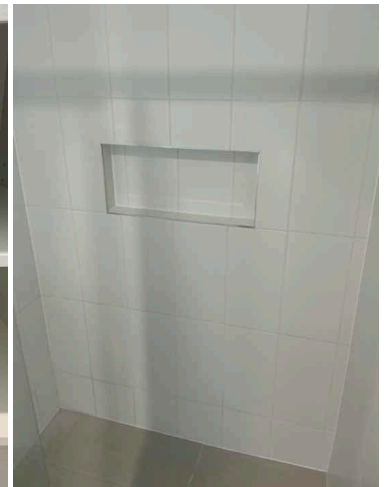
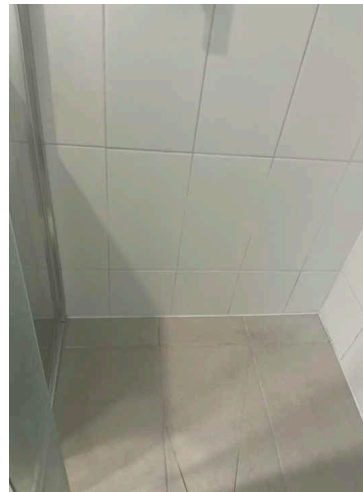
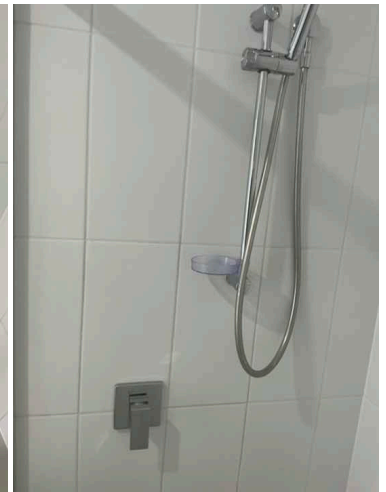
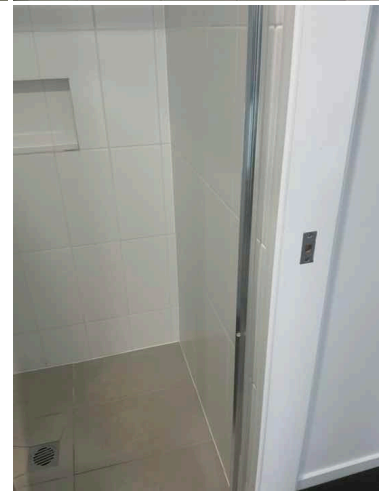
Of the visible areas, the general condition of this bathroom is serviceable or in reasonable condition for age of dwelling.

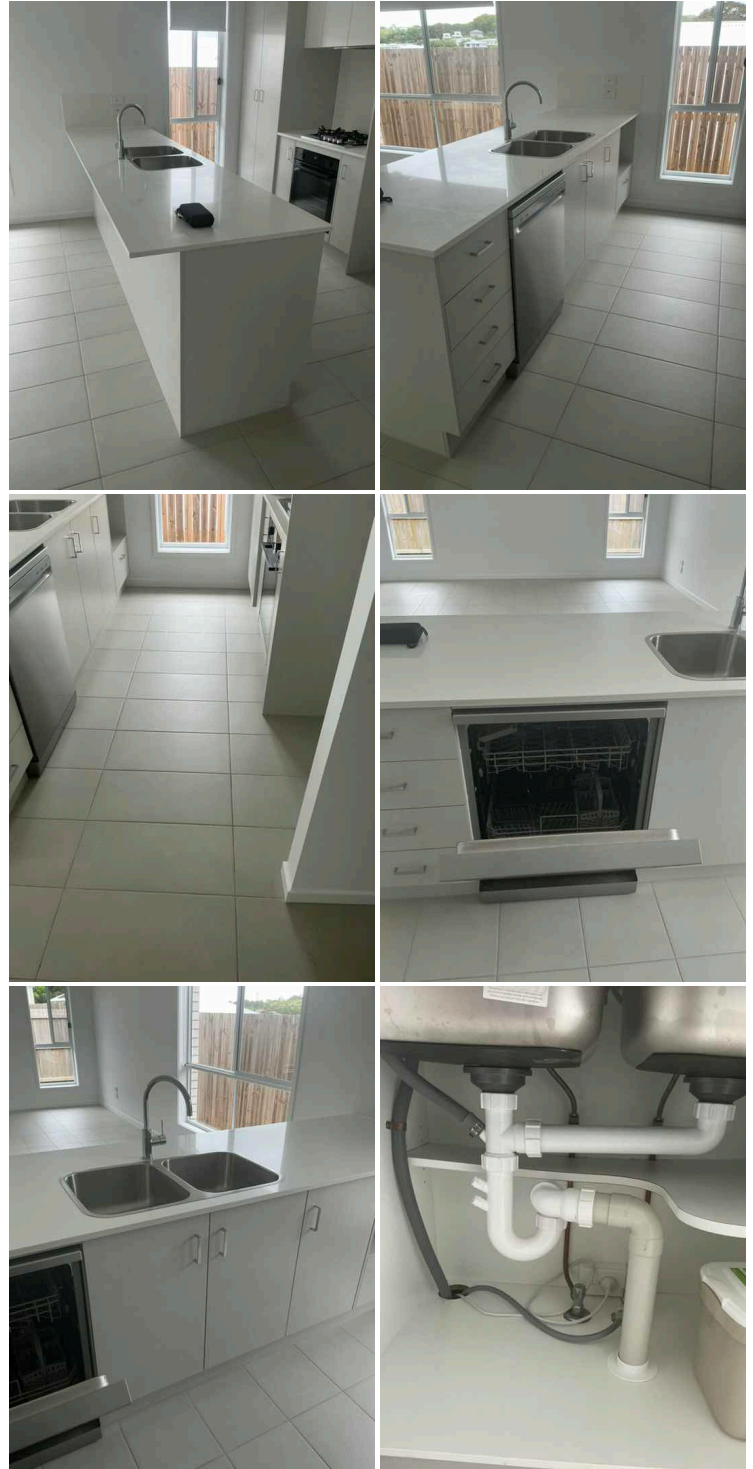
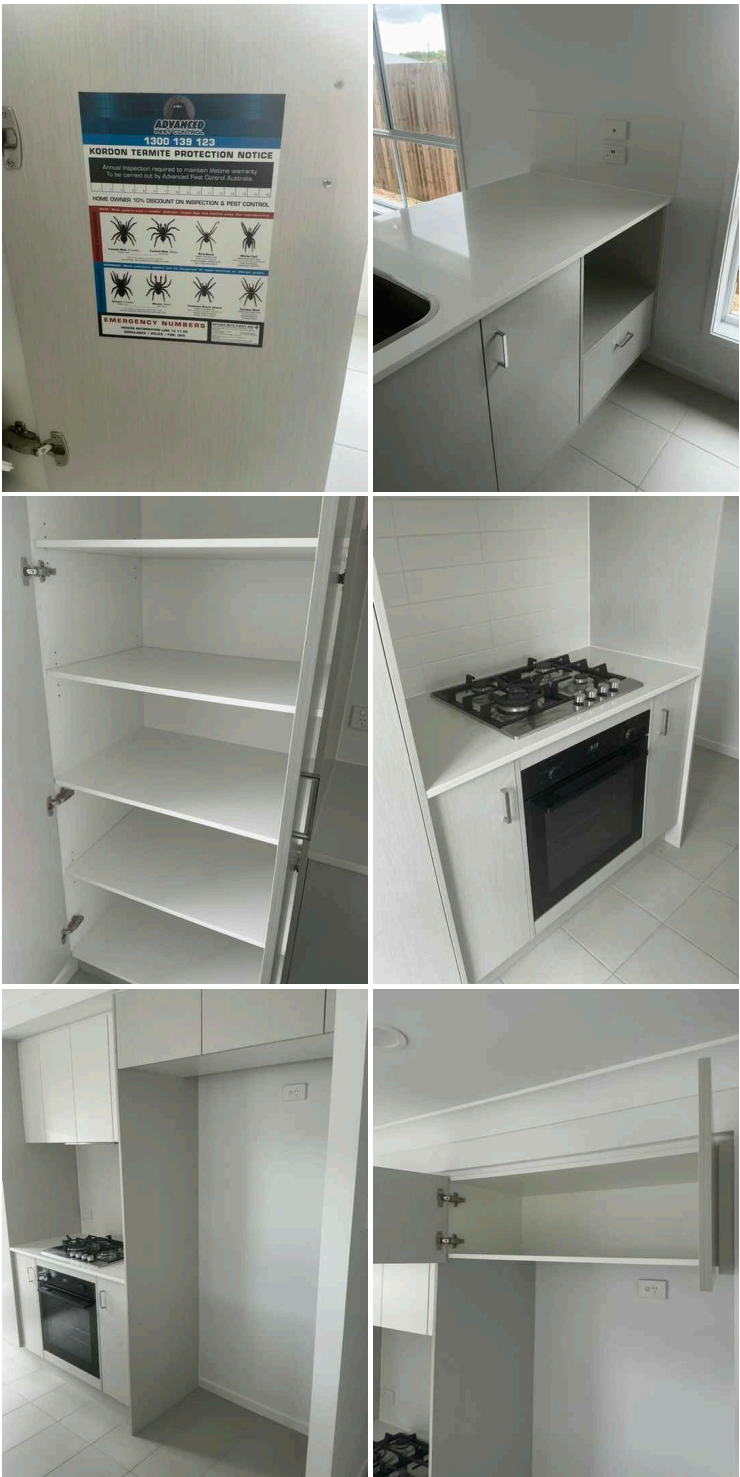
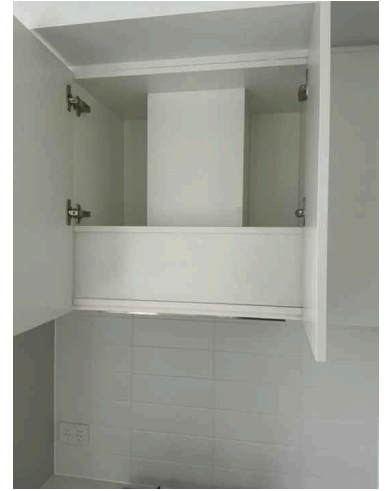
Of the visible areas, the general condition of the kitchen and pantry is serviceable or in reasonable condition for age of dwelling.

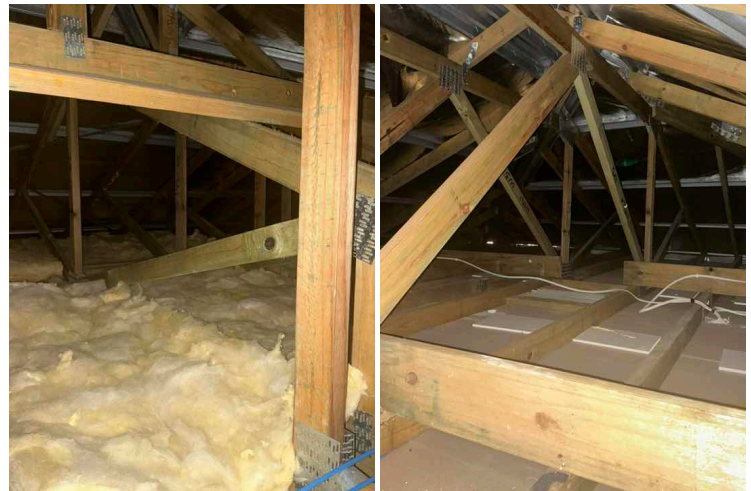
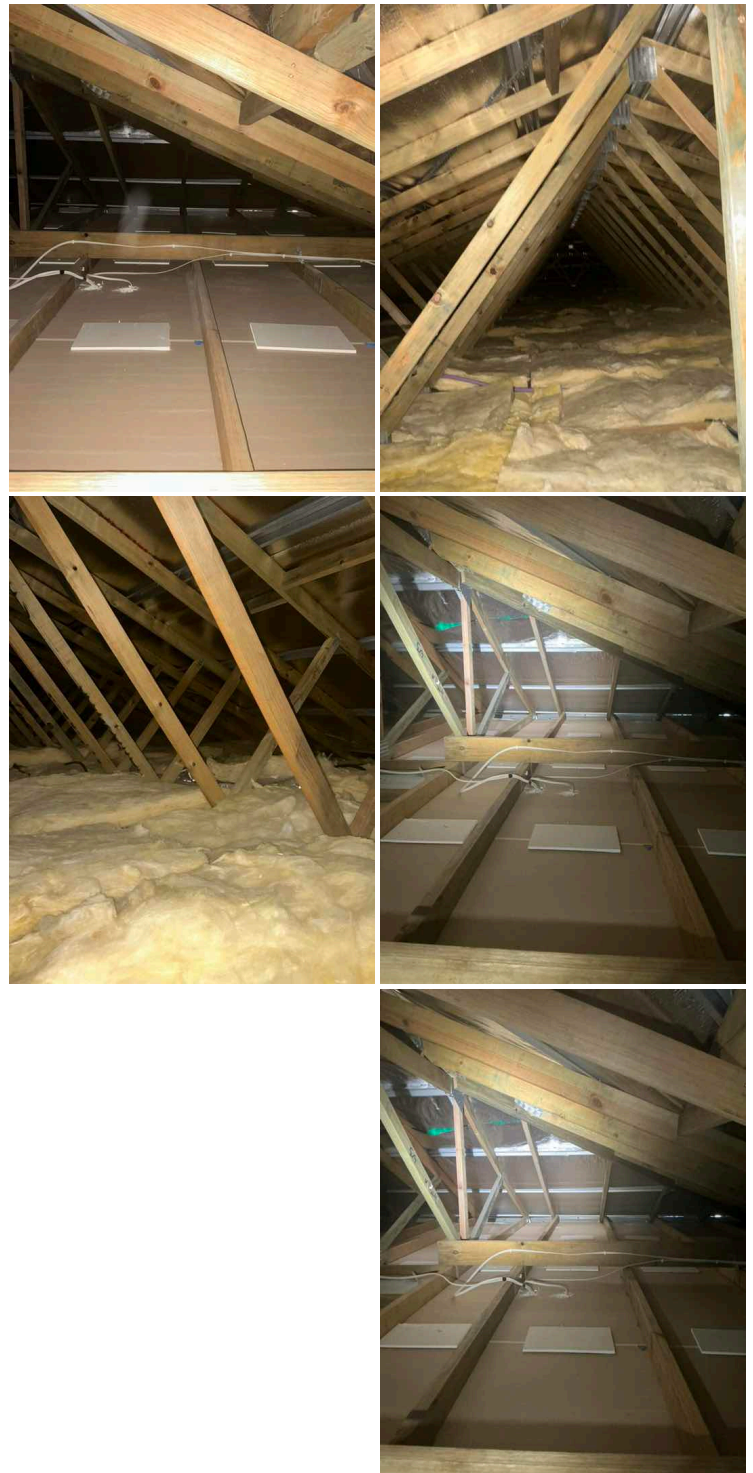
Visible sections of the roof void is in a serviceable condition for age of this dwelling.

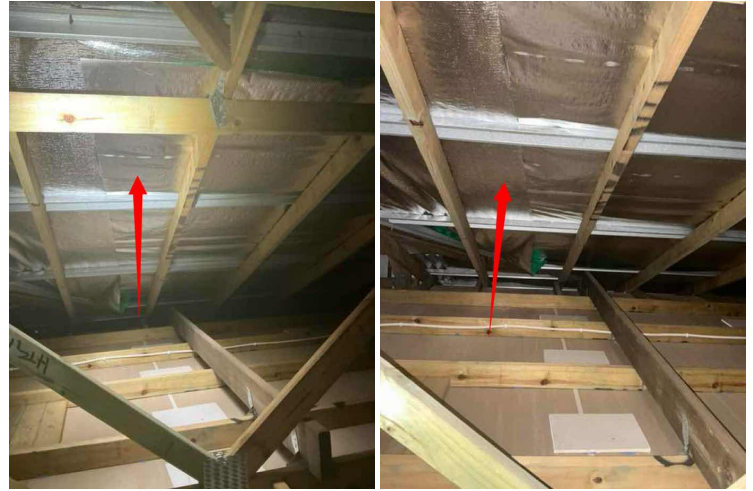
The sarking generally is in a serviceable condition.
