# Building and Pest Report

## 246 Martins Lane Knockrow

Report/Agreement #	101125084427120
Inspection Date:	10 Nov 2025
Inspection Time:	08:44 am

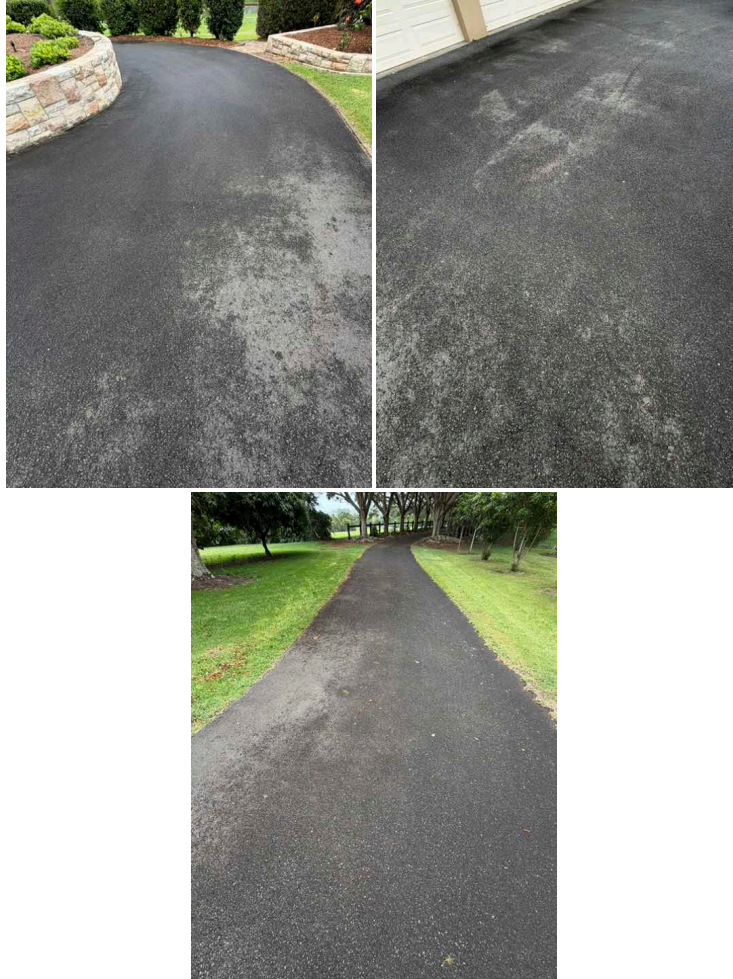
On visual inspection, the general condition of the driveway is serviceable.

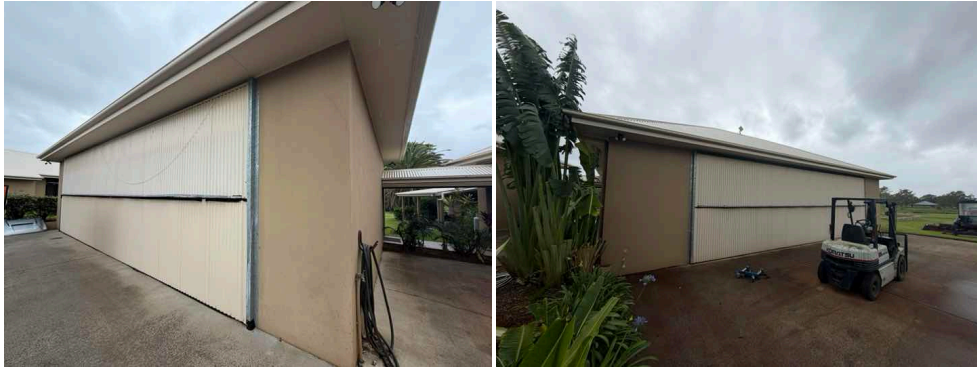
The shed is in fair usable condition.

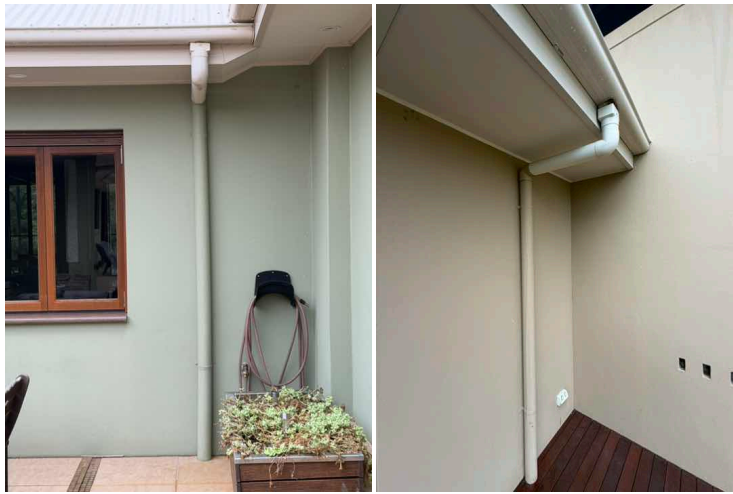
On visual inspection no apparent defects were noted to the down pipes and are considered serviceable, however no comment can be made with regard to blockages or connections to stormwater or functionality in the absence of rain. Note: Periodic maintenance checks should be carried out for rust penetrations and leaks.

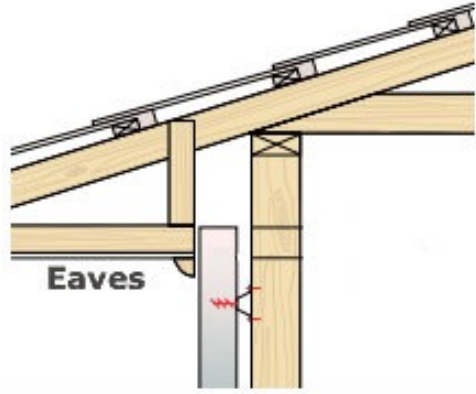
The soffit lining (eaves) are in a serviceable condition with no notable defects.

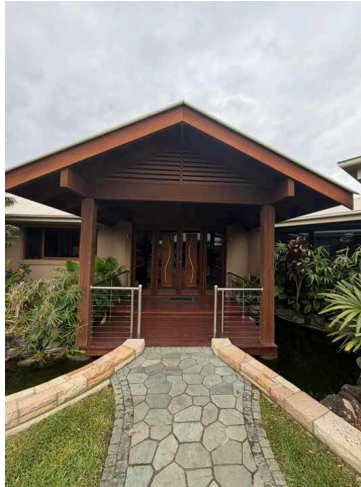
The entry porch serviceable or in reasonable or condition for the age of this dwelling.

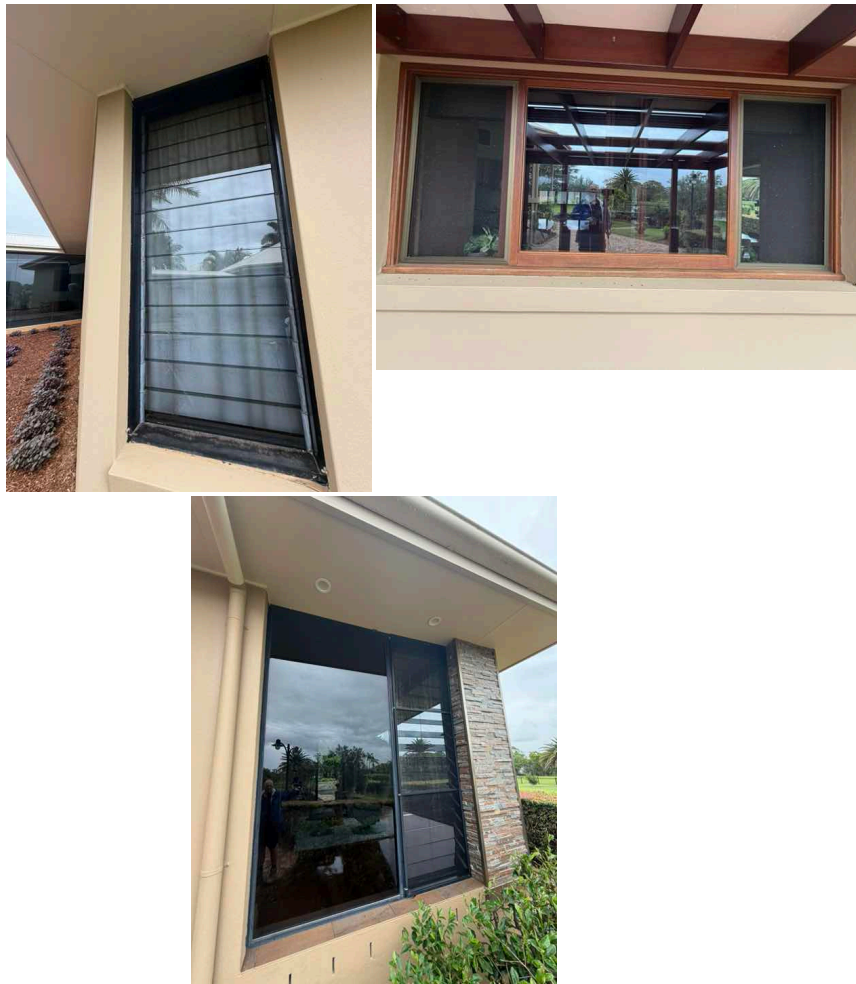
On visual inspection, the general condition of the windows is serviceable for the age.

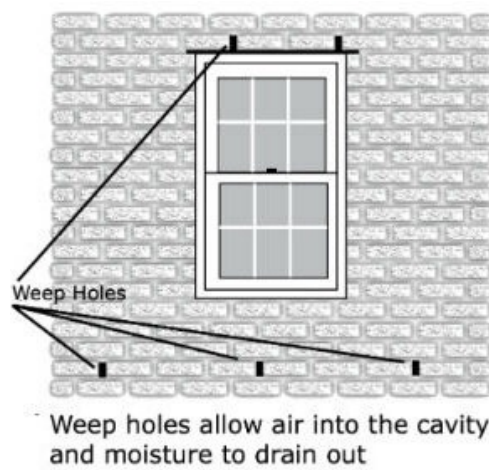
The weep holes are unobstructed .

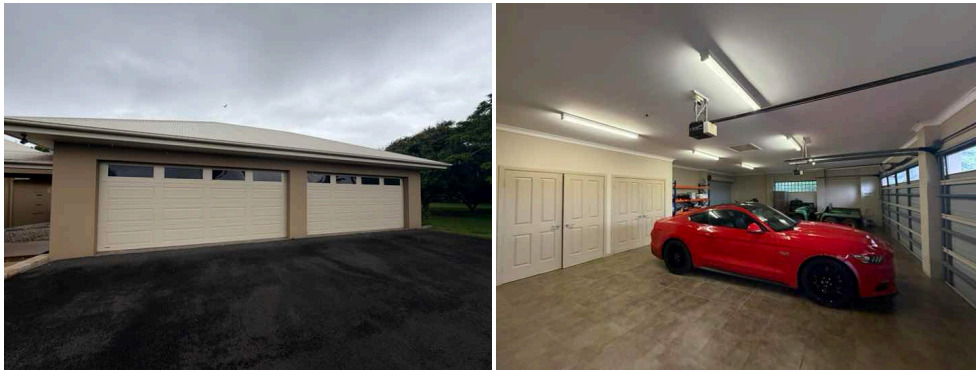
From the visible and accessible areas, the garage appears to be in a serviceable condition for the age of the property with no notable structural defects sighted.

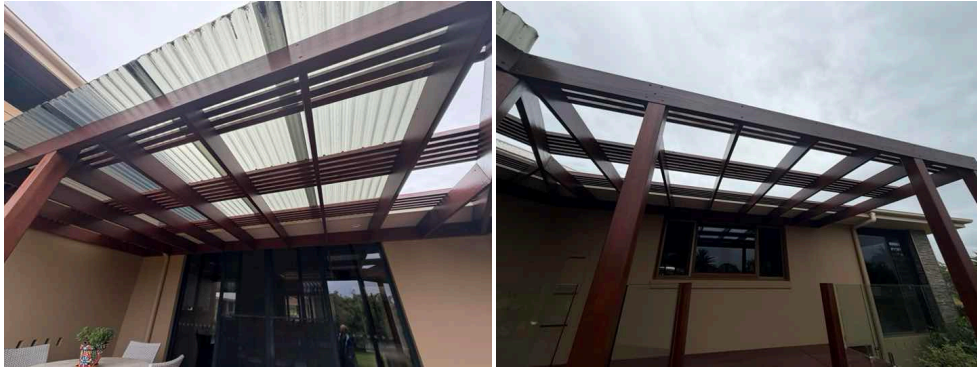
Though we are not structural engineers the balcony/s appear to be in a serviceable condition.

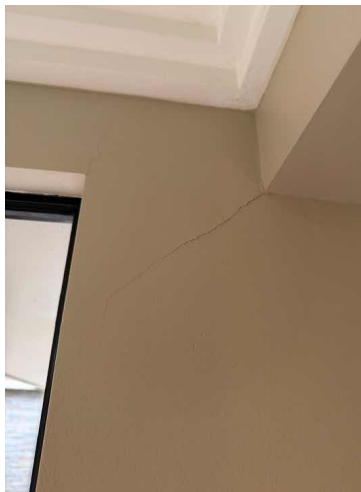
Settlement Cracks Noted. These are typical and generally patch and paint will suffice, however we recommend you monitor these cracks and if they become wider or longer, you will need to contact a structural engineers to assess.

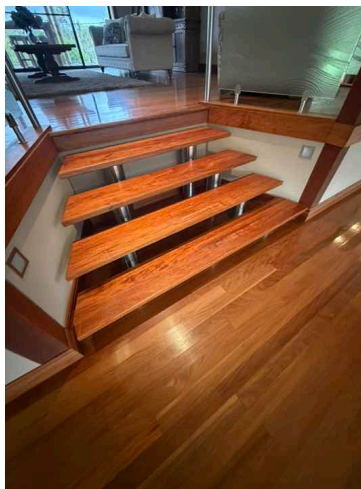
The internal staircase and components appear to be in a serviceable condition for the age with no notable defects sighted.

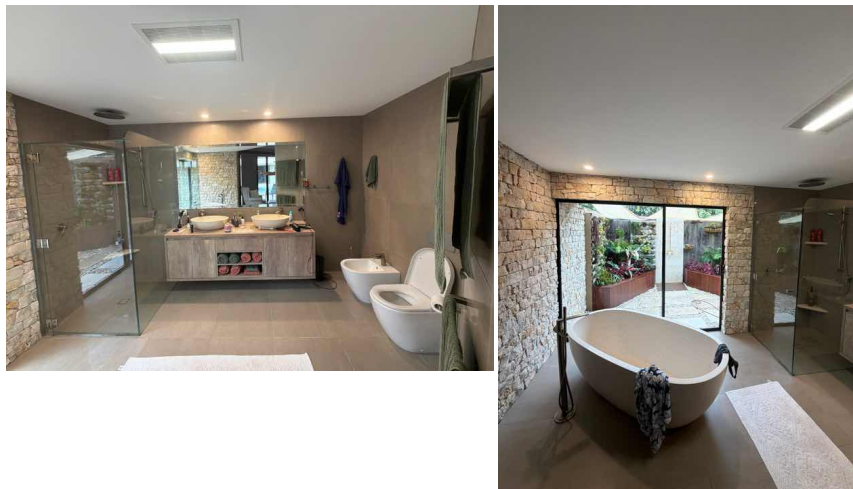
Of the visible areas, the general condition of this bathroom is serviceable or in reasonable condition for age of dwelling.

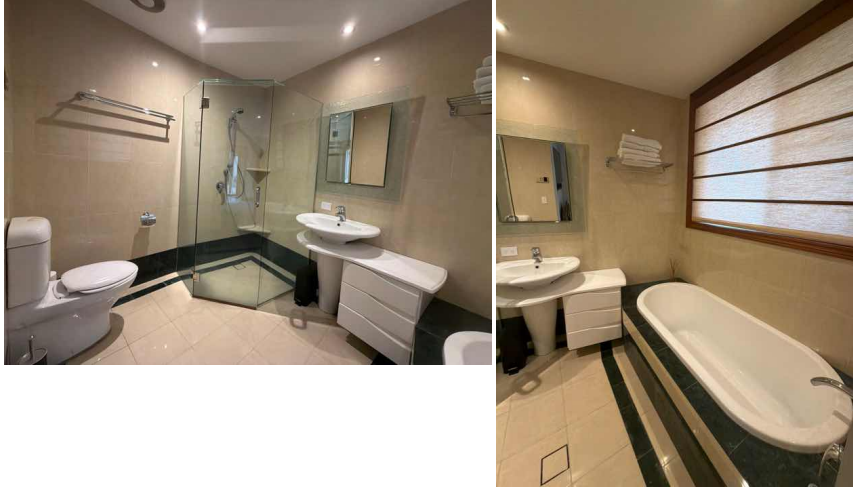
Of the visible areas, the general condition of this bathroom is serviceable or in reasonable condition for age of dwelling.

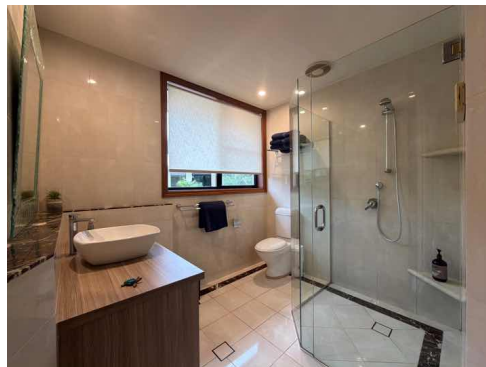
**Bathroom 3****Location**

Of the visible areas, the general condition of this bathroom is serviceable or in reasonable condition for age of dwelling.

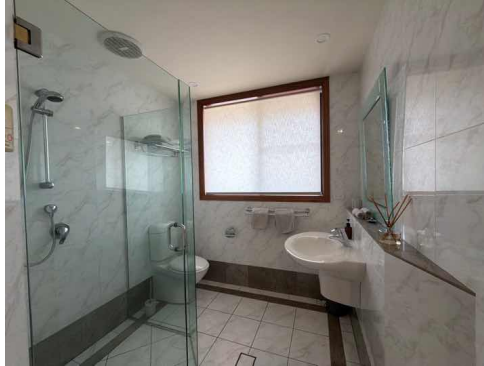
## **Bathroom 4**

Of the visible areas, the general condition of this bathroom is serviceable or in reasonable condition for age of dwelling.

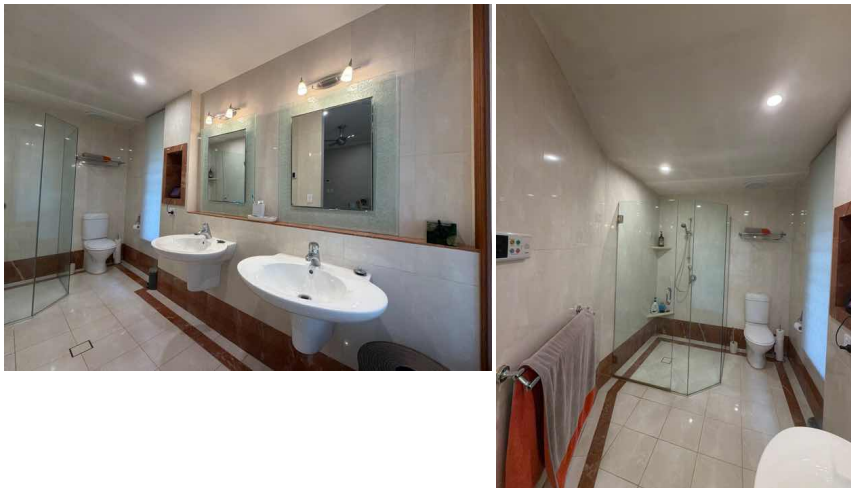
## **Bathroom 5**

Of the visible areas, the general condition of this bathroom is serviceable or in reasonable condition for age of dwelling.

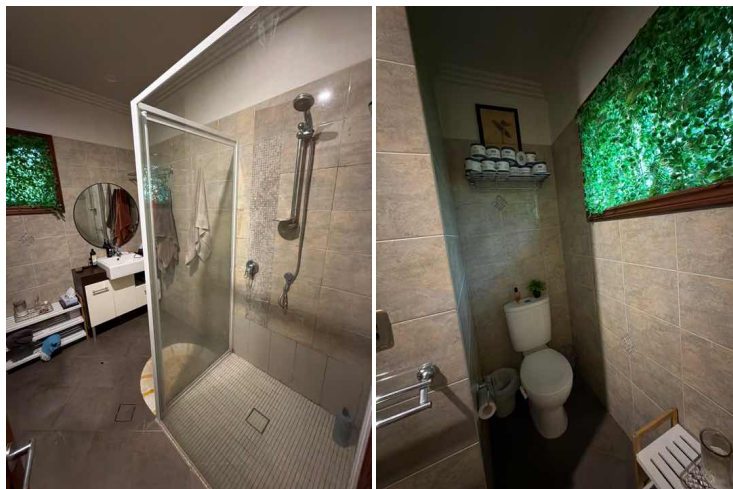
Of the visible areas, the general condition of this bathroom is serviceable or in reasonable condition for age of dwelling.

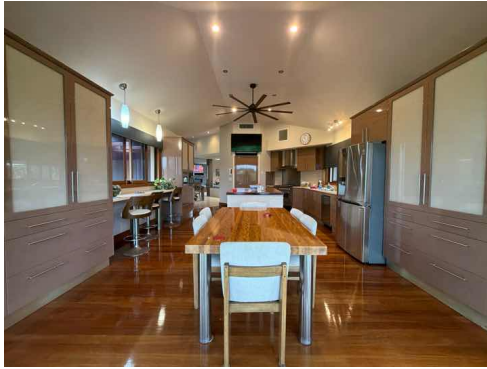
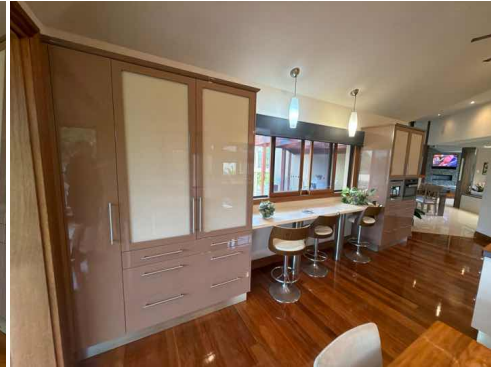
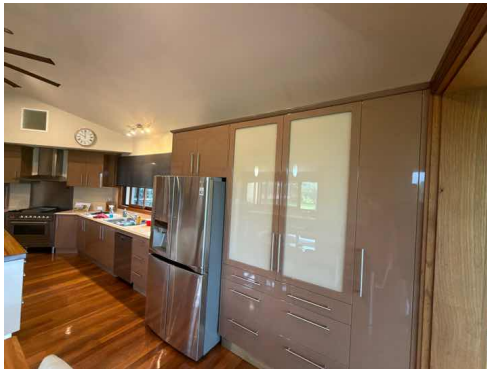
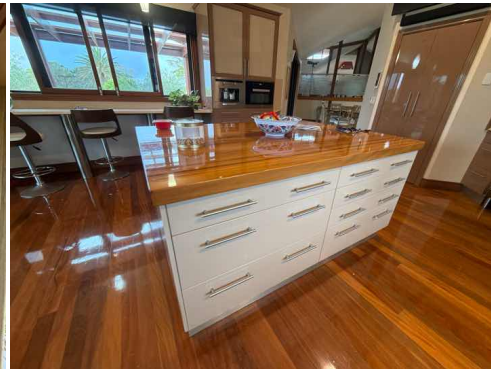
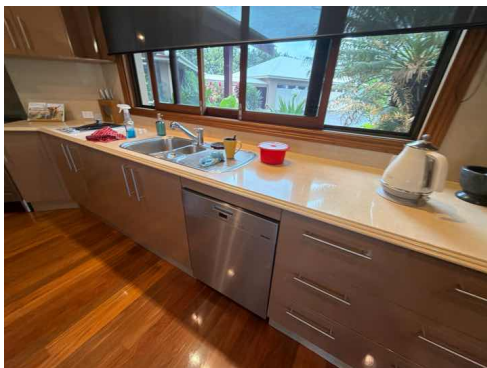
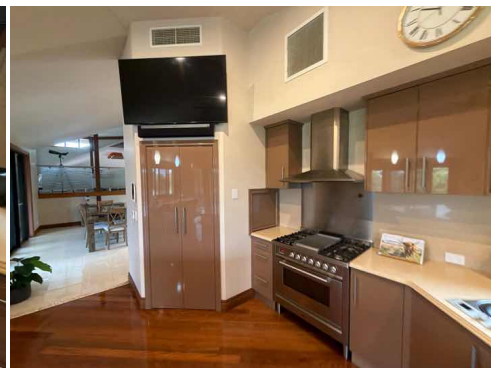
Of the visible areas, the general condition of the kitchen and pantry is serviceable or in reasonable condition for age of dwelling.

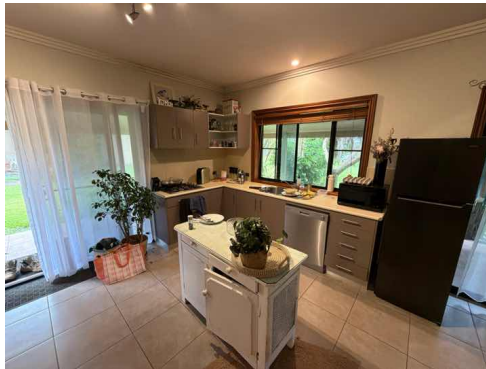
Of the visible areas, the general condition of the kitchen is serviceable or in reasonable condition for age of dwelling.

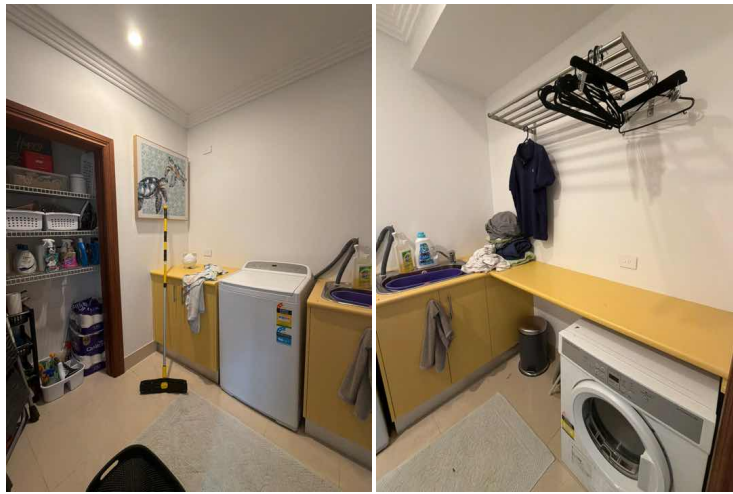
Of the visible areas, the general condition of the laundry is serviceable or in reasonable condition for age of dwelling.

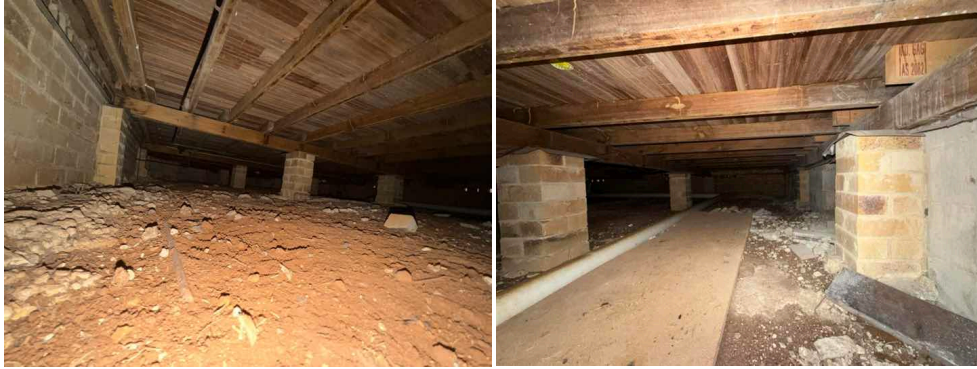
Of areas accessible and visible, the subfloor and components appeared to be in a serviceable condition.
