Building and Pest Report

5 Alexander
Circuit
Lennox Head

Inspection Report

East Coast Building Solutions

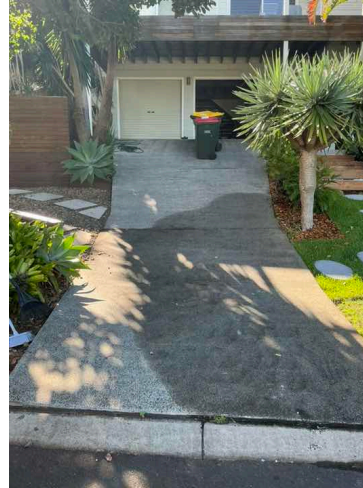
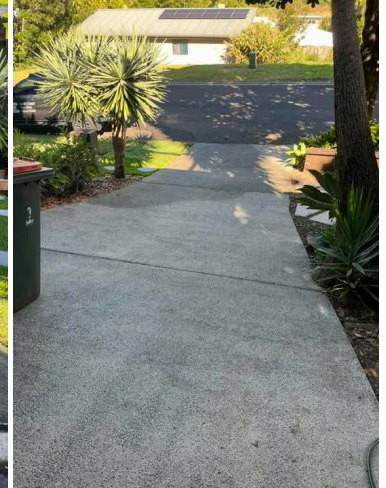
On visual inspection, the general condition of the driveway is serviceable.

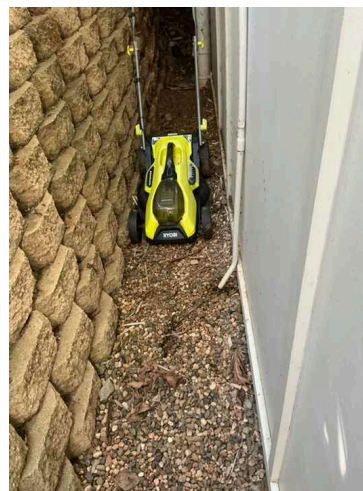
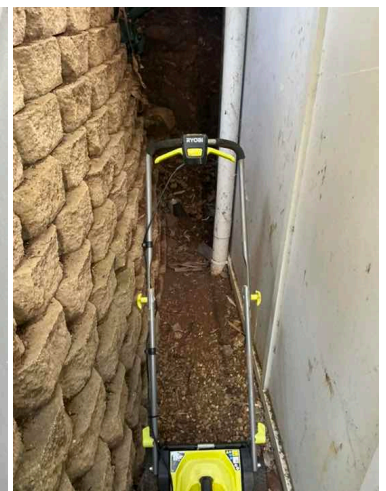
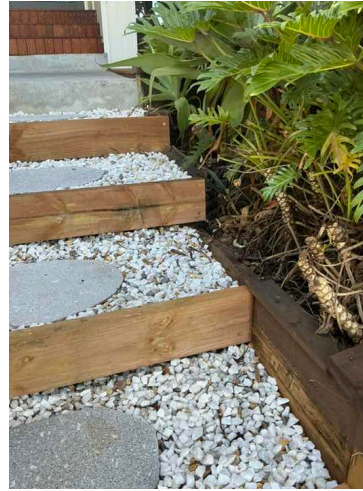
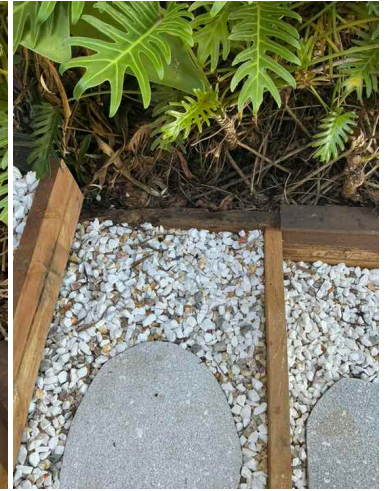
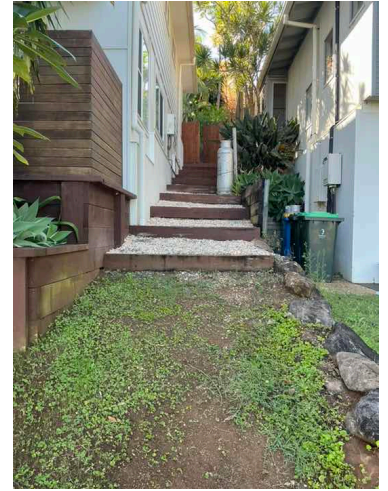
The paths around the home are in a serviceable condition for the age of this dwelling with no major defects visible.

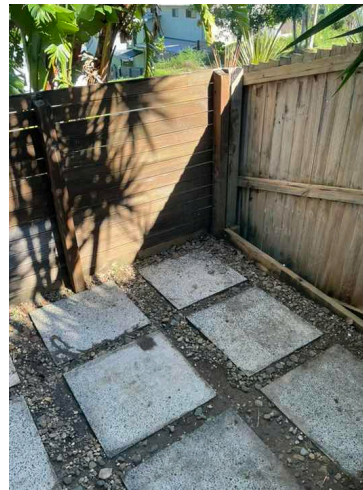
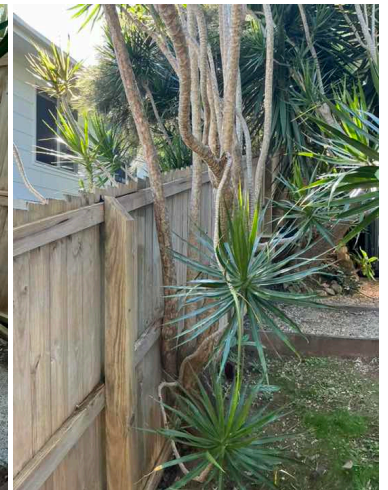
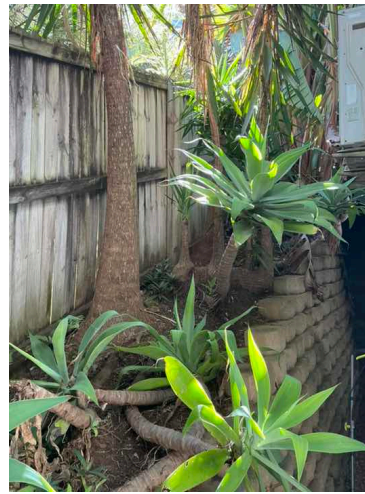
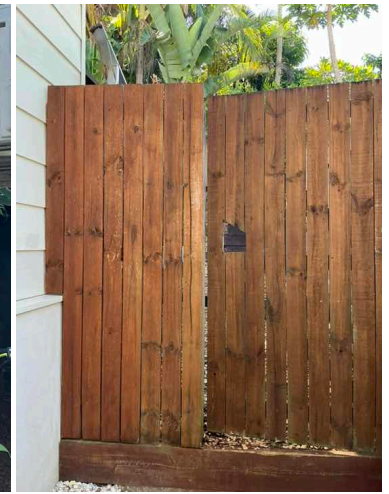
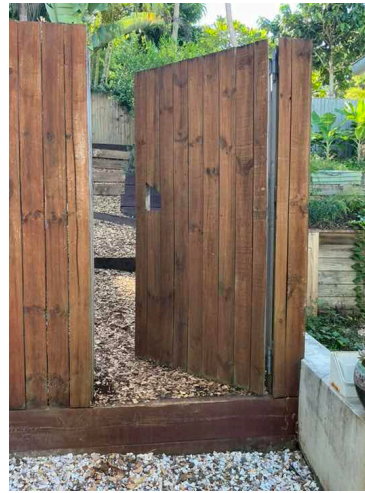
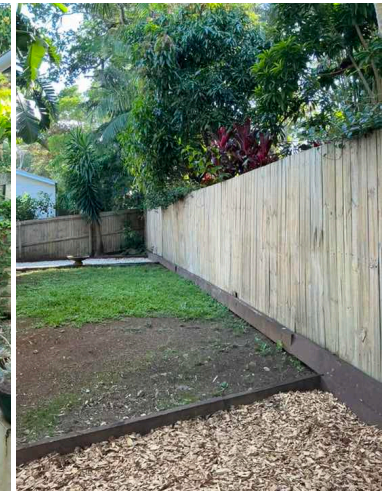
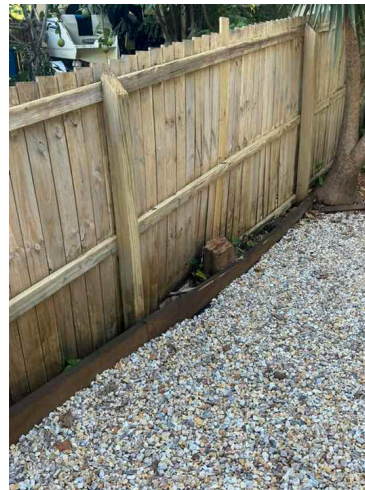
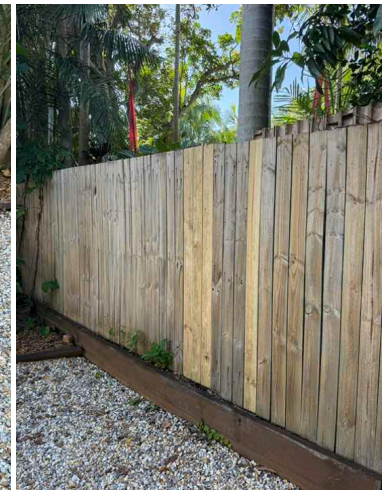
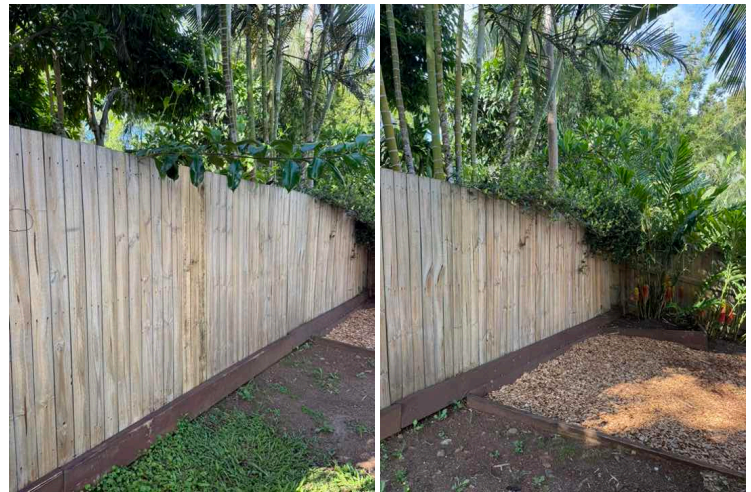
Of the visible areas, the general condition of the fences and gates is serviceable for the age of dwelling.

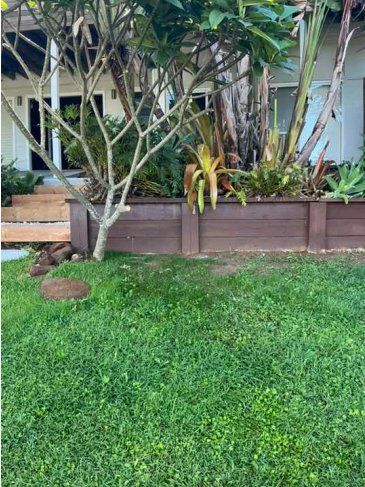
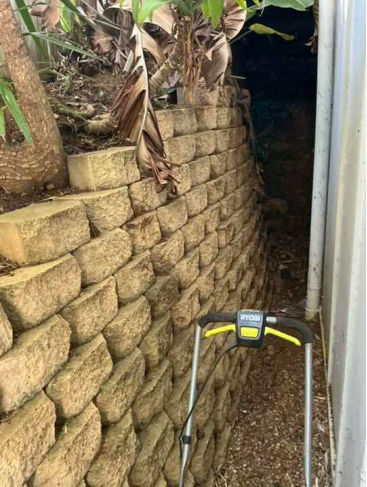
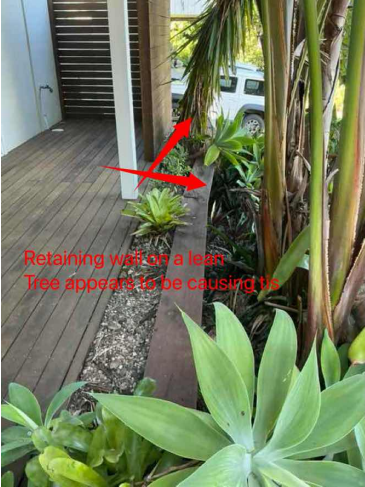
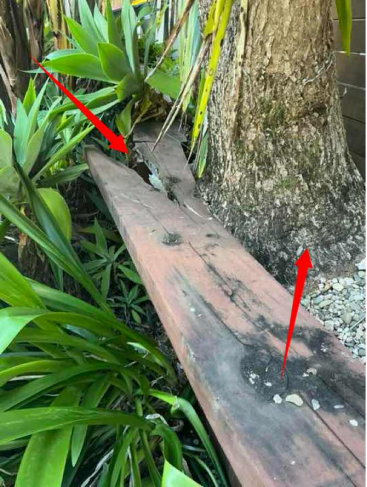
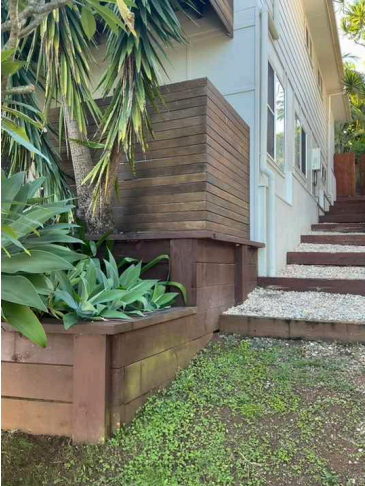
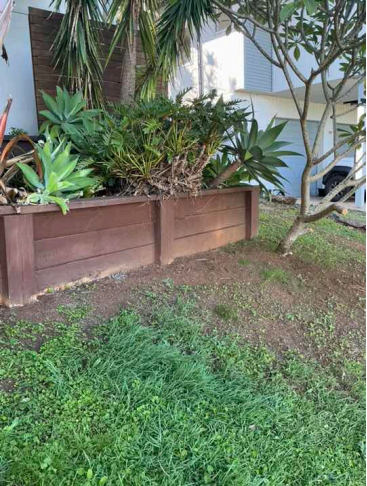
Upon visual inspection, the timber appears cracked and weathered, likely due to moisture exposure and root pressure. Recommend replacing the damaged timber with treated wood to prevent future decay. Ensure proper drainage and clearance from tree roots to avoid similar issues. Consult a licensed tradesperson for assessment and repair.

Upon visual inspection, the wooden retaining wall shows signs of moisture exposure, indicated by discoloration and potential rot. Recommend sealing or replacing affected sections to prevent further deterioration. Ensure proper drainage to reduce moisture contact. Consult a licensed tradesperson for repair and maintenance.

#1. Upon visual inspection, the wooden retaining wall shows signs of moisture exposure, indicated by discoloration and potential rot at the base. Recommend sealing the wood with a waterproof sealant and ensuring proper drainage to prevent further moisture accumulation. Engage a licensed carpenter to assess and repair any structural weaknesses.

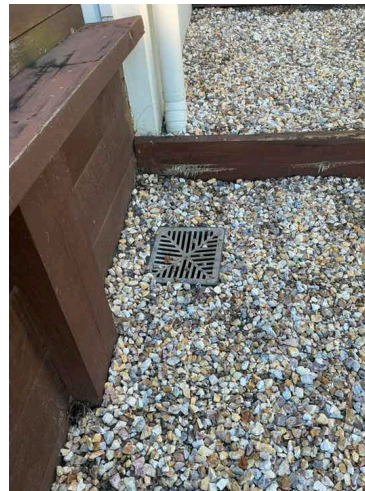
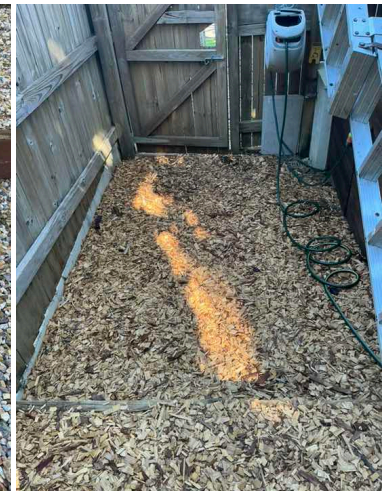
There was no visible evidence of excess ponding or fall towards the property walls at the time of the inspection. Regardless, it is difficult to ascertain in dry conditions and it is therefore recommended that you assess same after a rainfall period to be able to sufficiently ascertain if any problems exist in this regard. If water is ponding around perimeter walls and paths or appears to be flowing into the footings/foundations you must have assessed by a qualified plumber or landscaper.

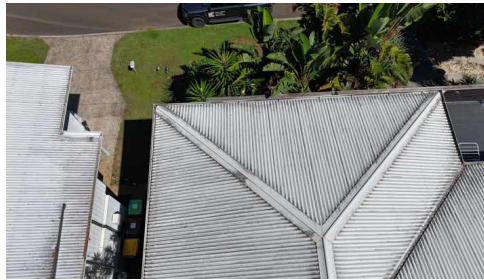
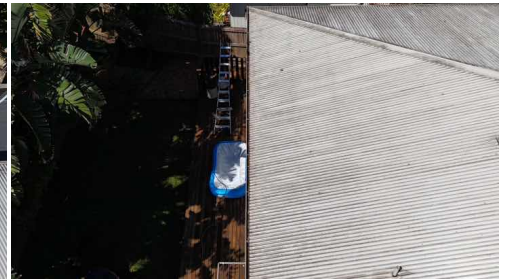
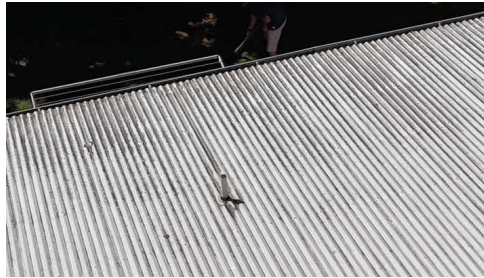
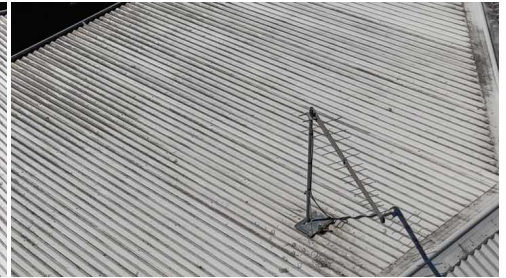
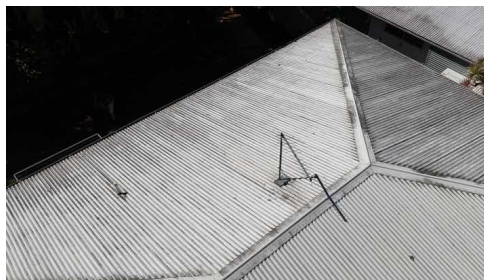
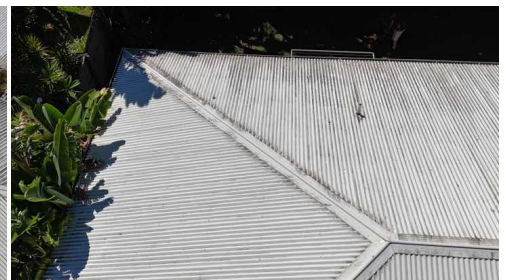
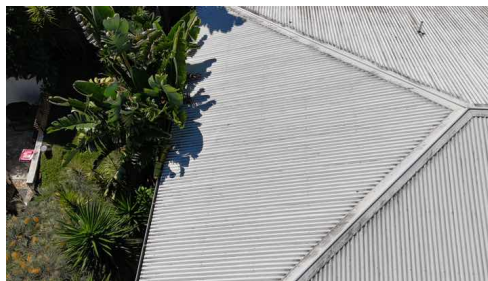
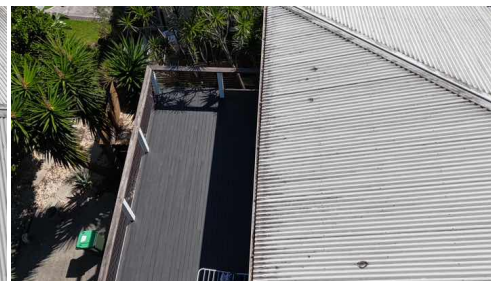
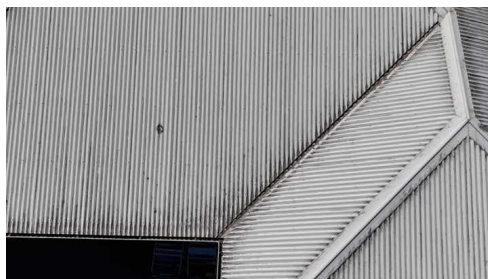
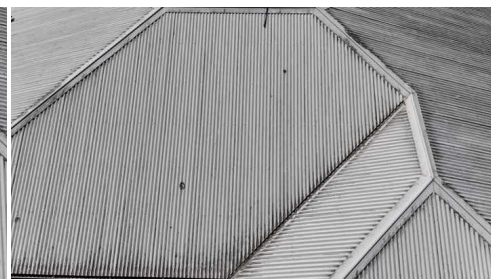
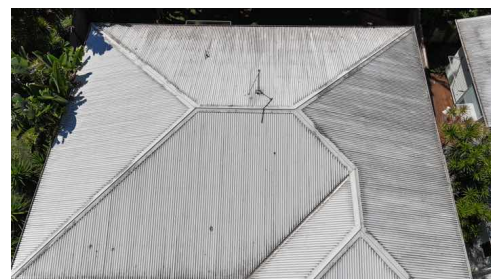
Of the visible areas, the general condition of the roof is in serviceable condition for the age.

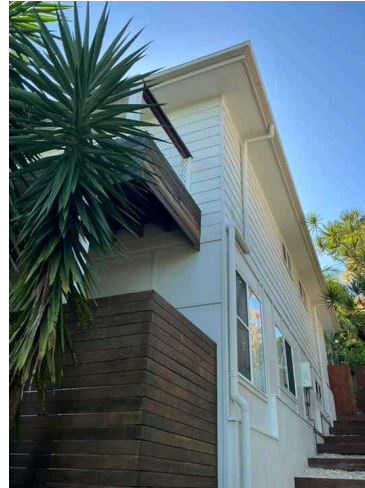
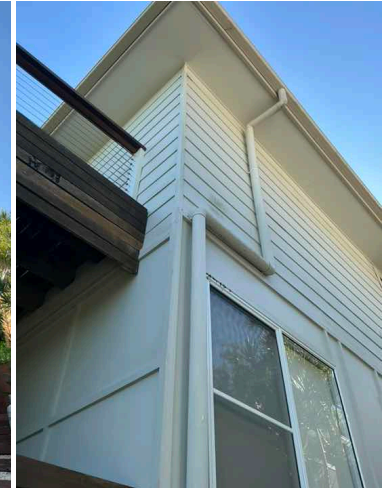
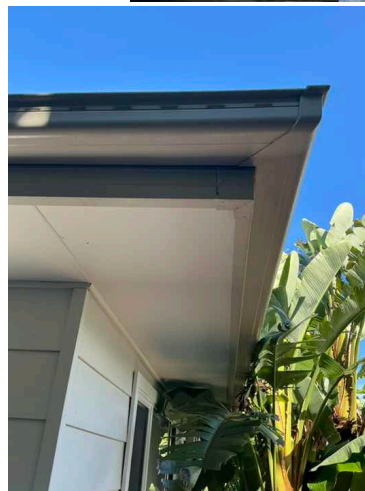
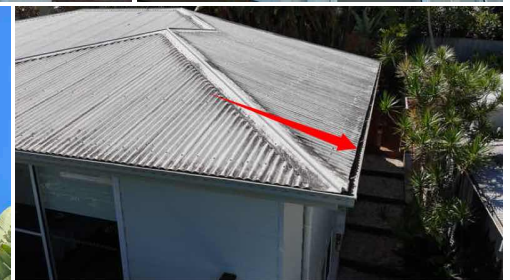
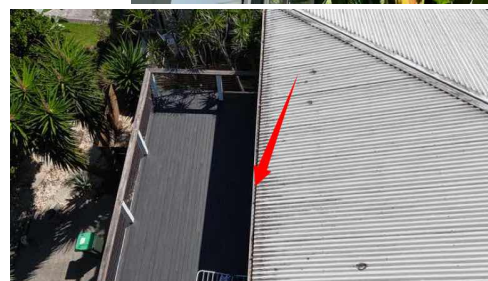
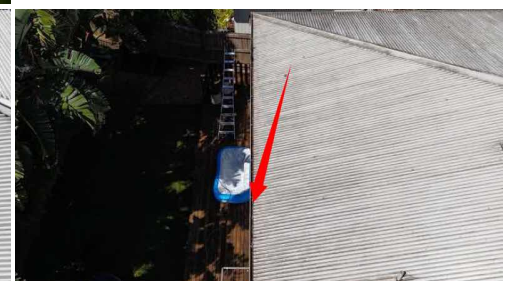
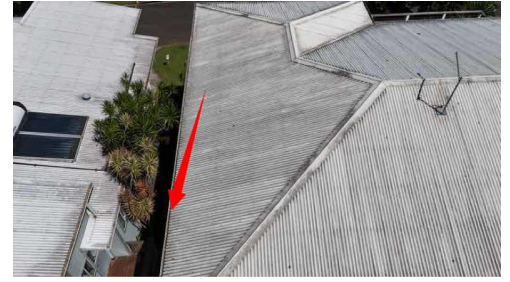
Gutter Findings

All visible and accessible of the physical nature of the guttering system appears to be in a serviceable condition with no apparent defects at the time of inspection. In the absence of prolonged rain fall efficiency of the guttering can not be assessed and you may find that further investigation or repairs maybe required. Note: Periodic maintenance checks should be carried out for rust penetrations and leaks.

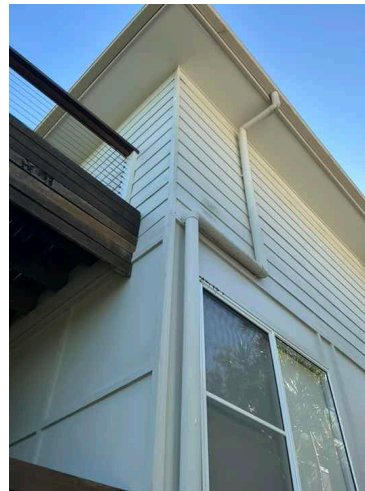
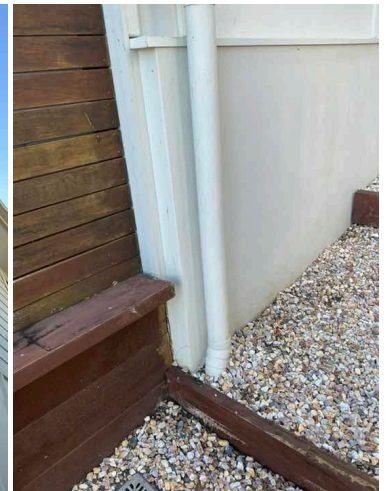
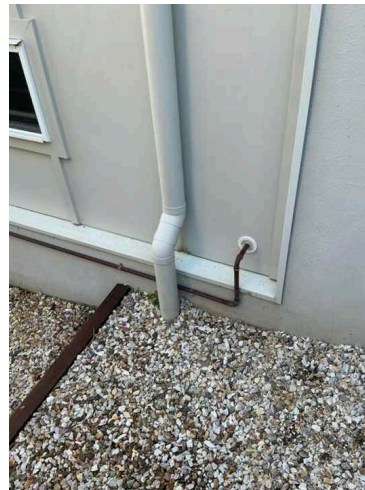
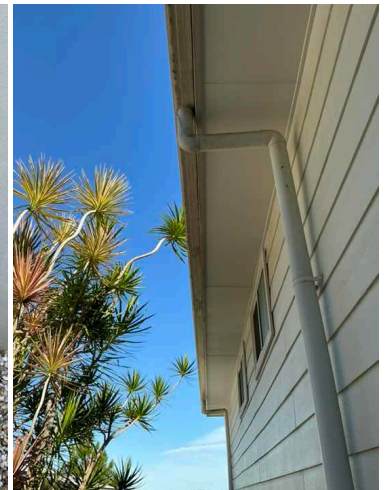
Downpipe Findings

On visual inspection no apparent defects were noted to the down pipes and are considered serviceable, however no comment can be made with regard to blockages or connections to stormwater or functionality in the absence of rain. Note: Periodic maintenance checks should be carried out for rust penetrations and leaks.

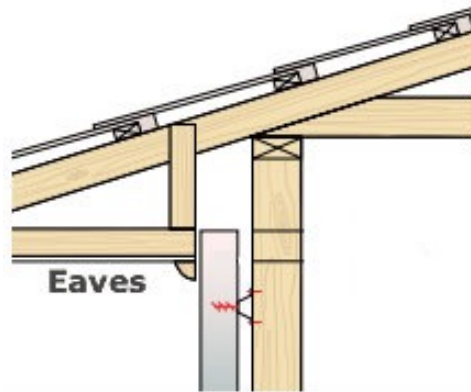
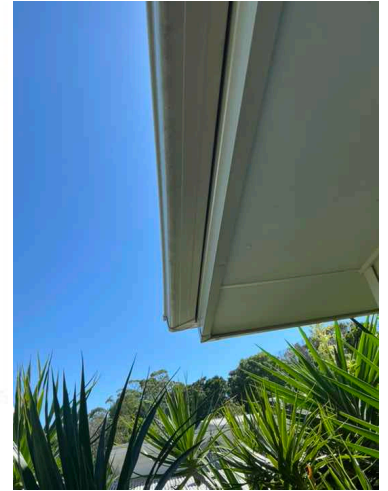
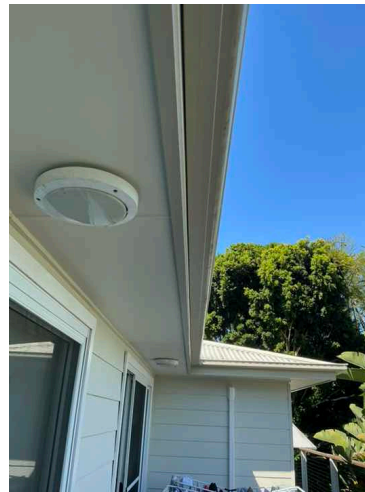
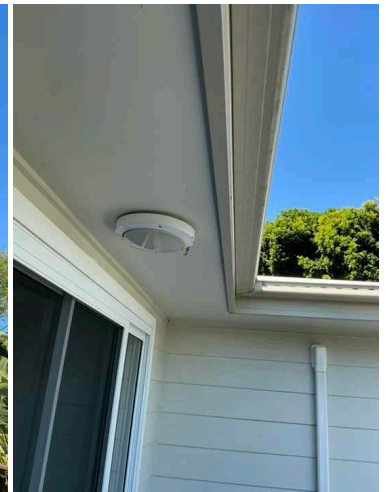
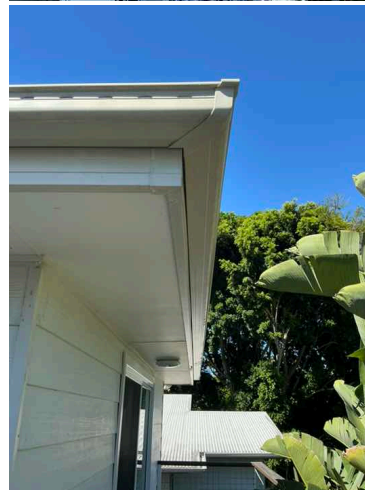
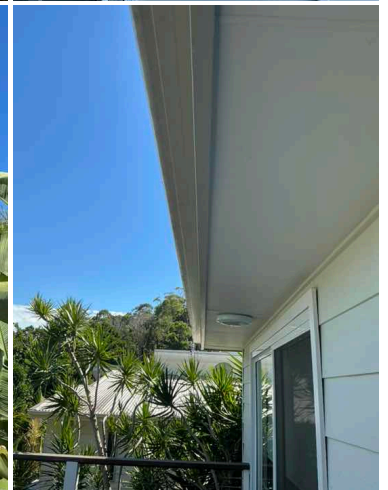
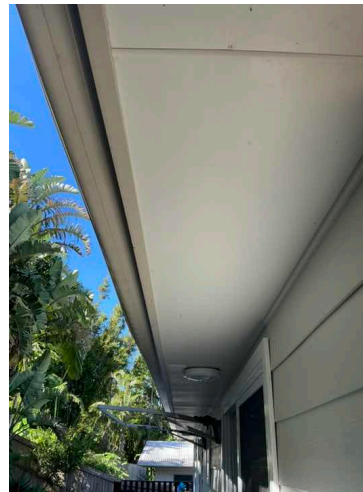
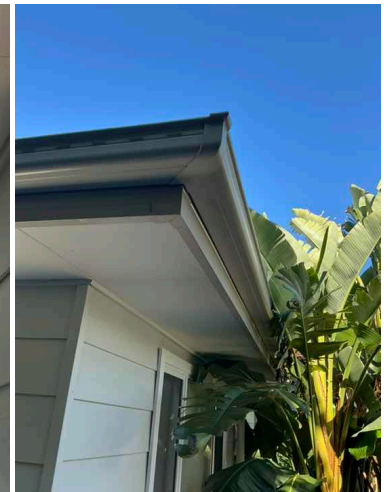
Eave Condition

The soffit lining (eaves) are in a serviceable condition with no notable defects.

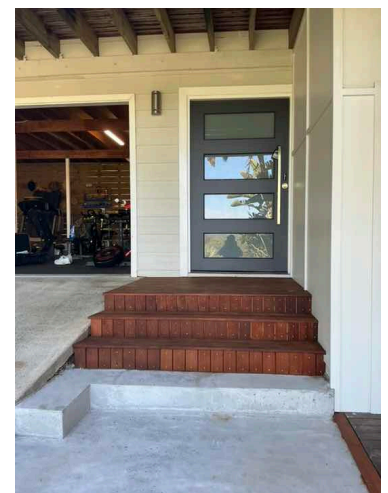
Entry Porch Area

The entry porch serviceable or in reasonable or condition for the age of this dwelling.

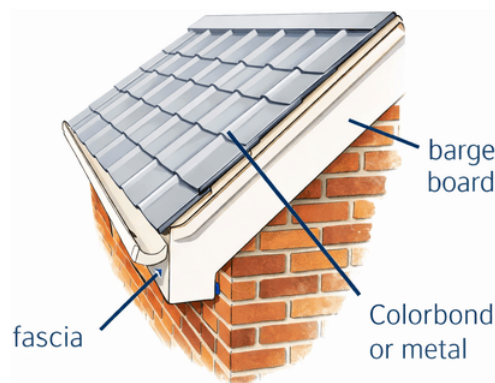
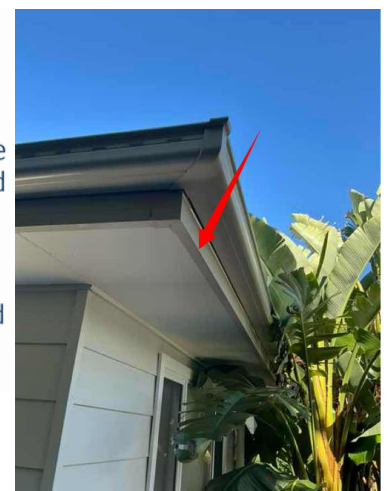
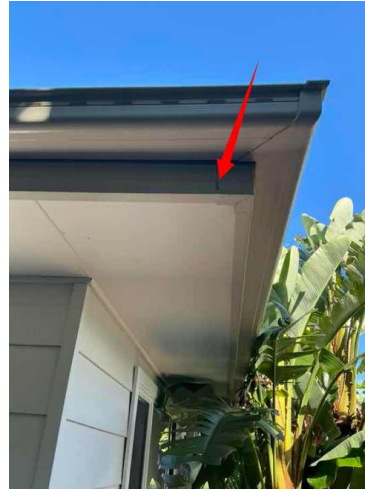
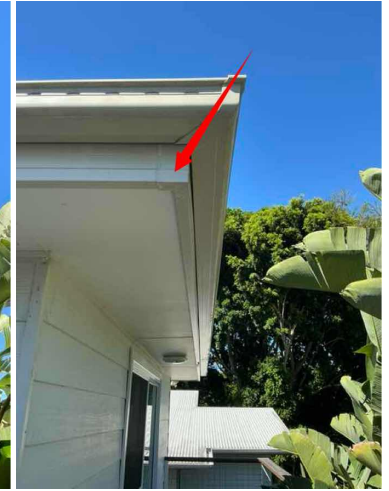
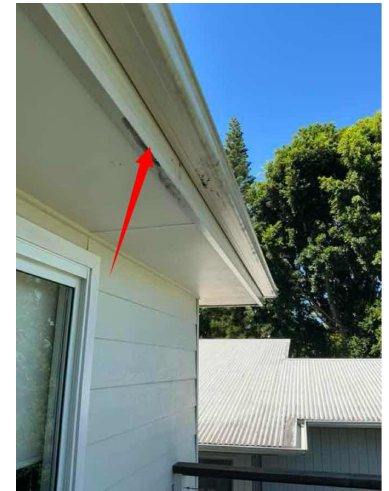
Condition

On visual inspection, the general condition of the fascia/barge boards is serviceable.

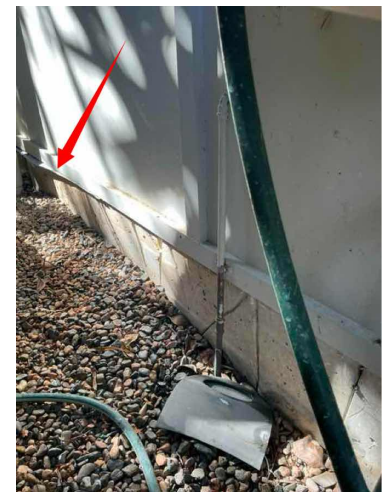
Rising Damp Findings

Of the visible and accessible areas, there was no visible evidence of excessive rising damp on the external walls at time of inspection.

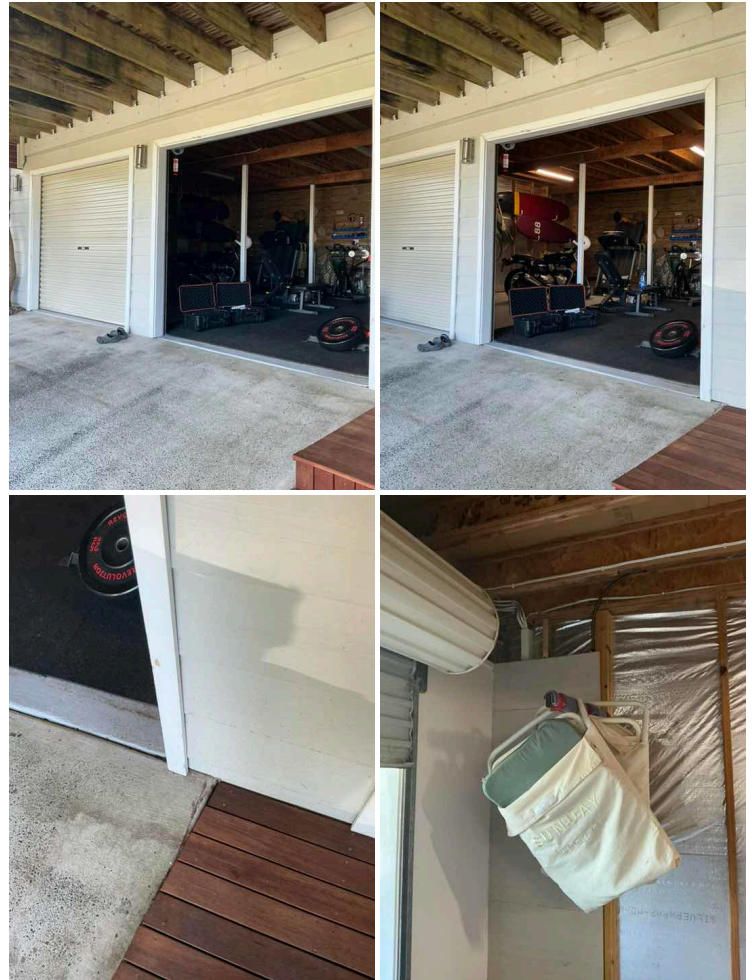
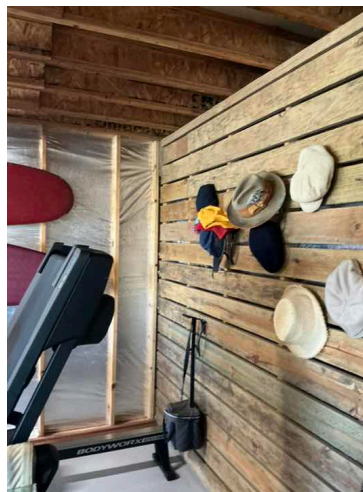
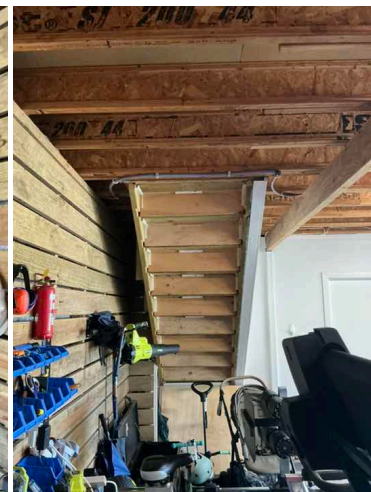
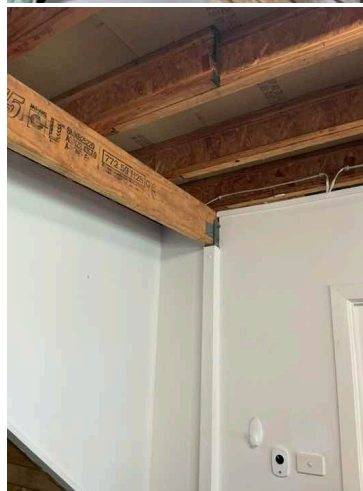
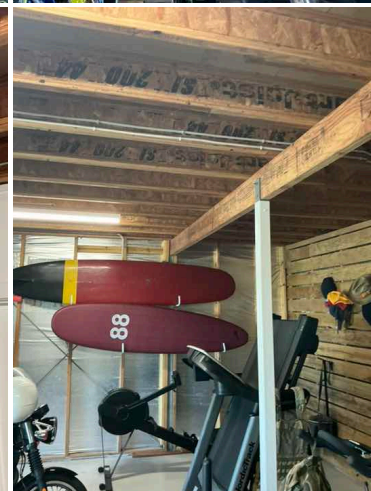
Stored items restricted a full and thorough inspection of this area. Defects may exist in the obstructed and inaccessible areas. It is strongly recommended that full access be granted to enable a thorough inspection as there may be timber pest activity, damage or defects. Note: Where vehicles and storage has restricted a full inspection it is advised that this area be cleared so a full and unobstructed inspection can be carried out.

From the visible and accessible areas, the garage appears to be in a serviceable condition for the age of the property with no notable structural defects sighted.

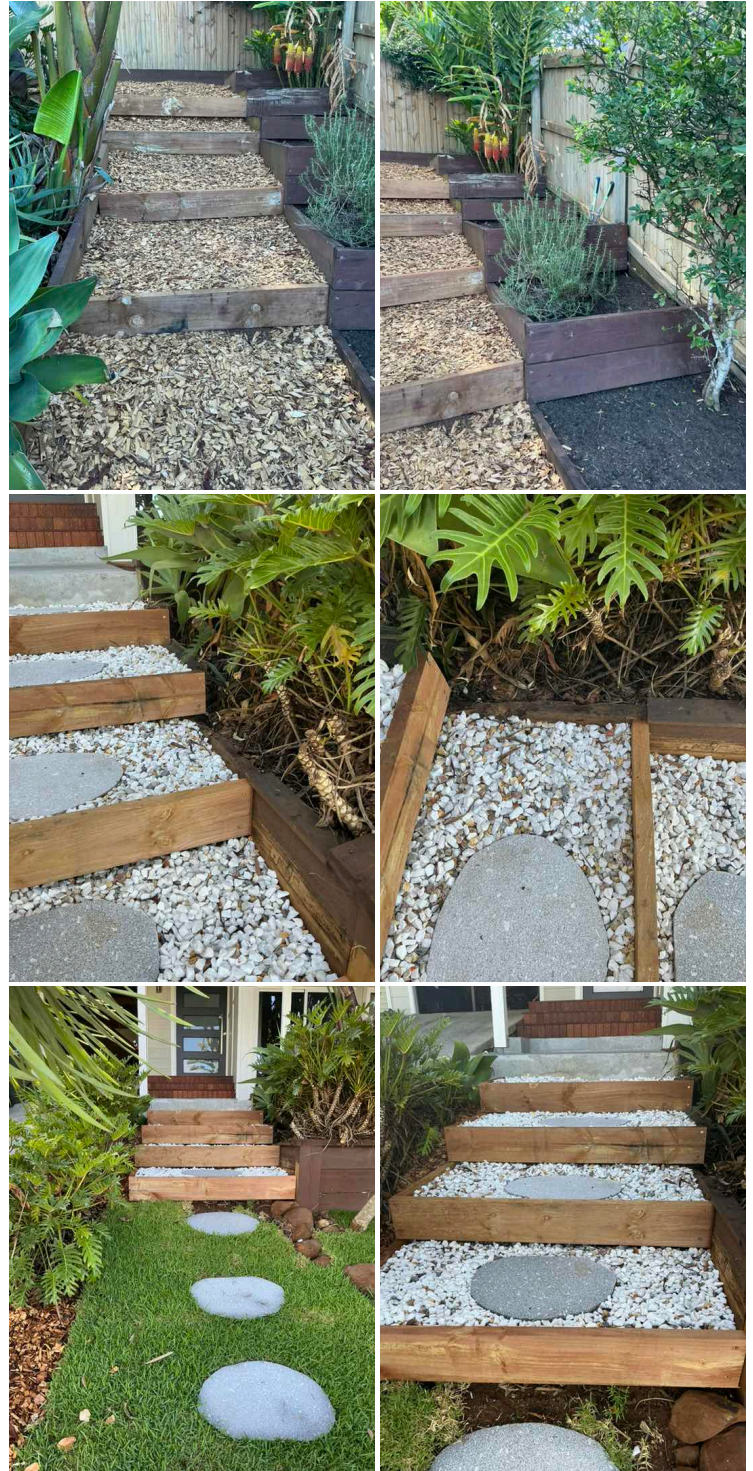
The stairs/steps appear to be serviceable with no notable defects.

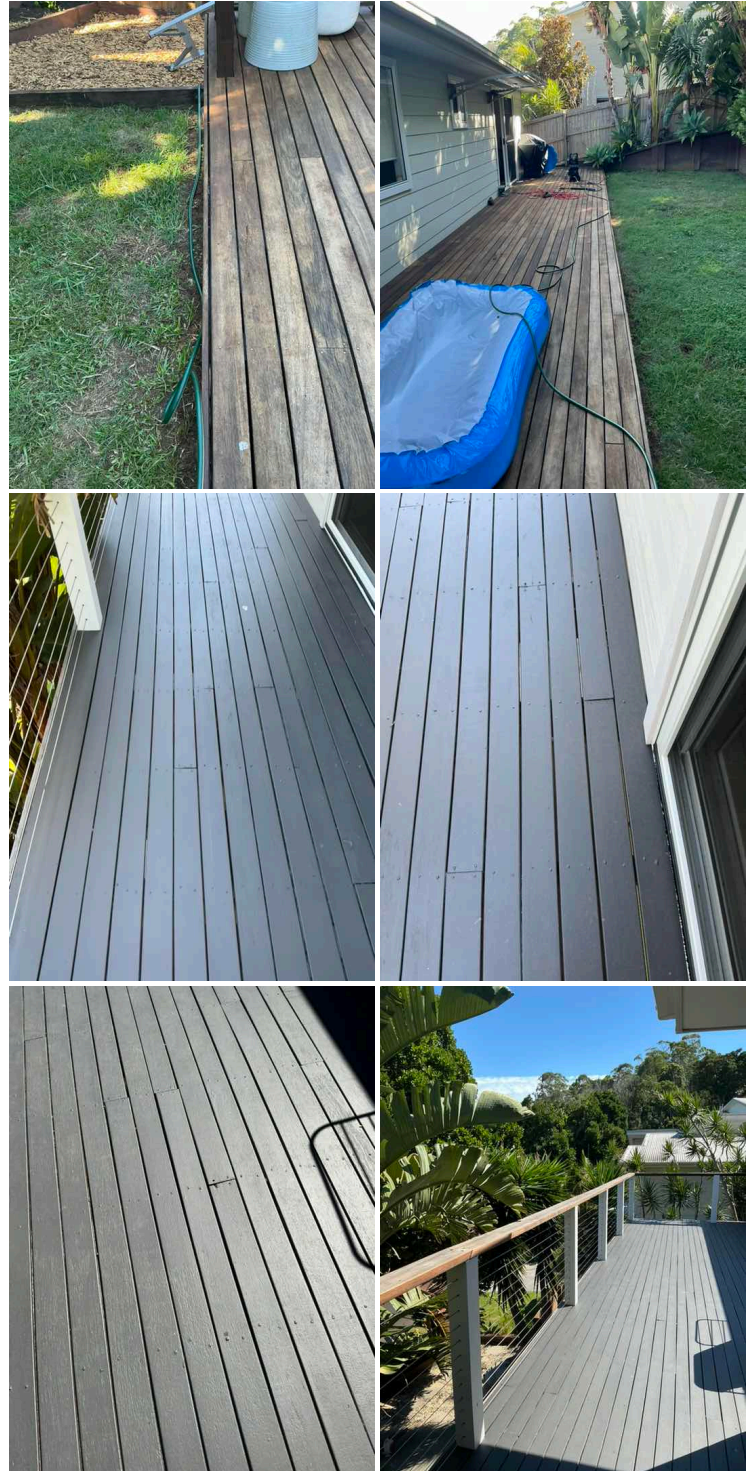
Decking Findings

Of areas visible, the decking appears to be in a serviceable condition.

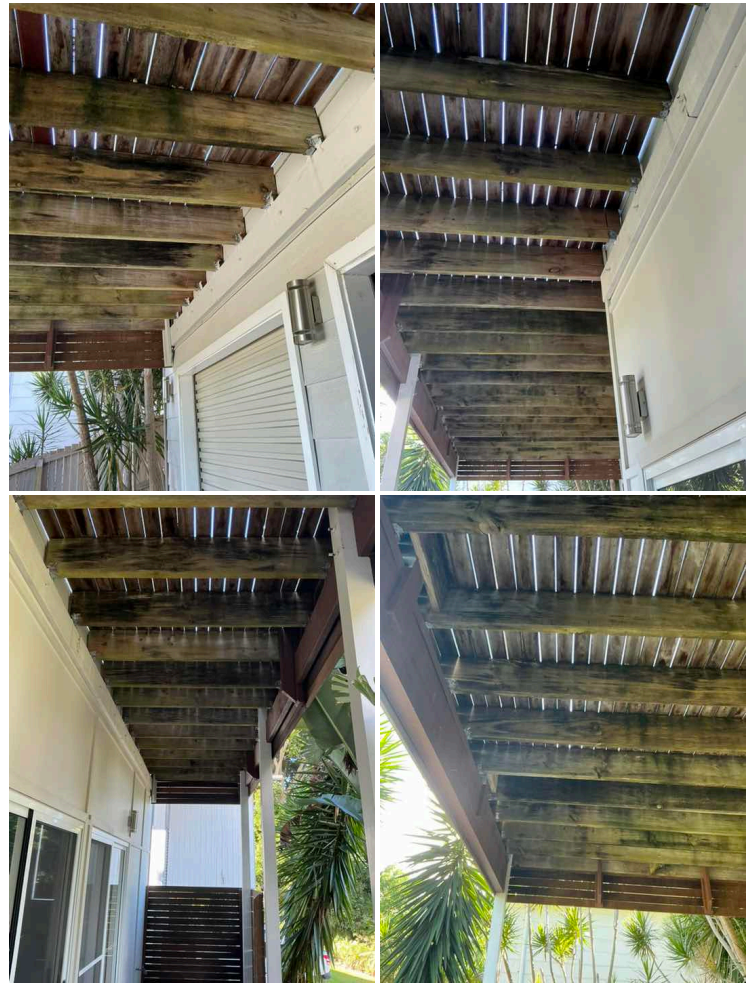
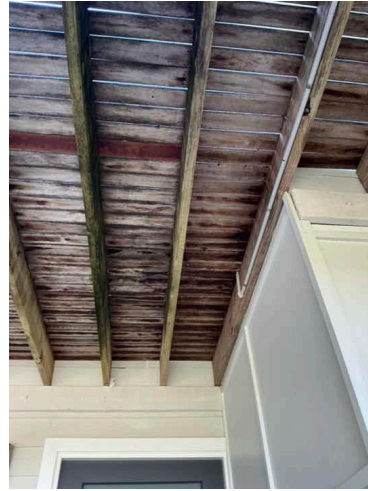
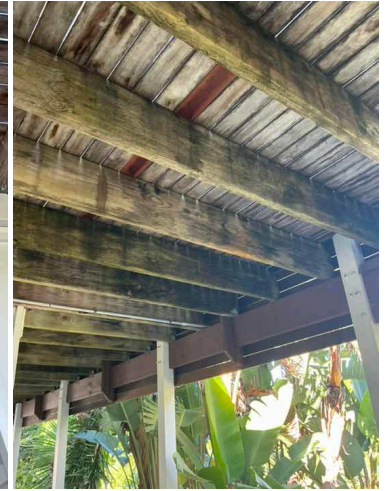
Deck Framework

Upon visual inspection, there is discoloration and potential water damage on the wooden beams. Recommend cleaning and sealing the wood to prevent further moisture intrusion. A licensed carpenter should assess for structural integrity and replace any compromised sections. Regular maintenance and inspection are advised to ensure longevity and safety.

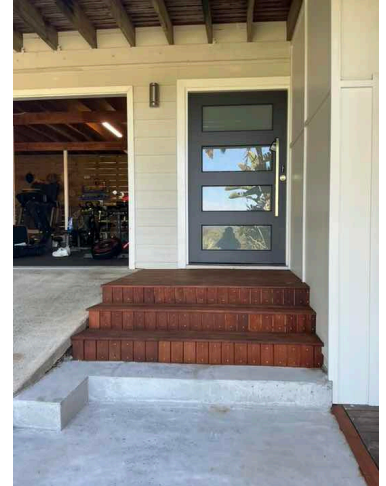
Front Entry Doors

The doors are in serviceable condition with no notable defects observed.

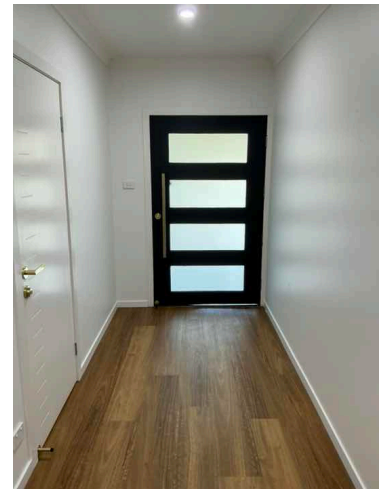
From the visible and accessible areas, this area appears to be in a serviceable condition for the age of the property with no notable structural defects sighted.

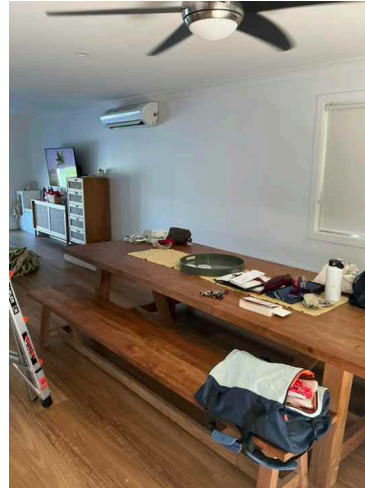
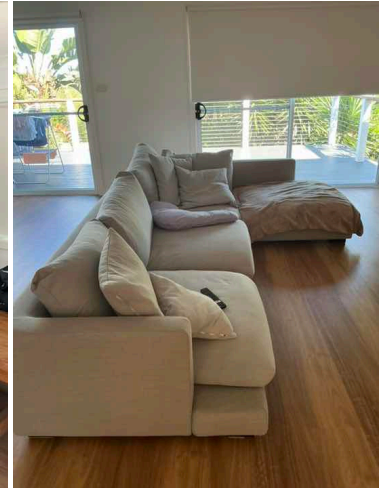
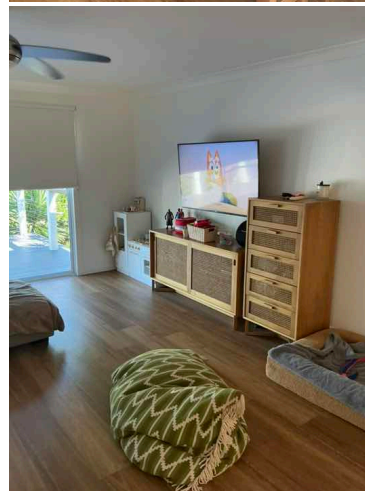
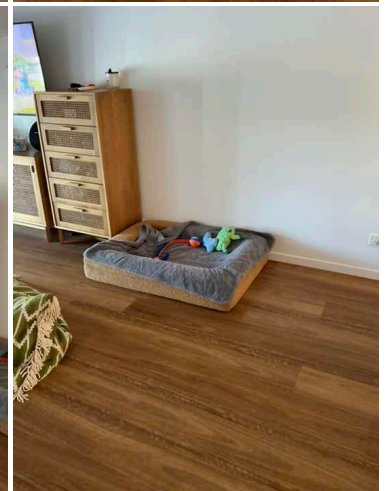
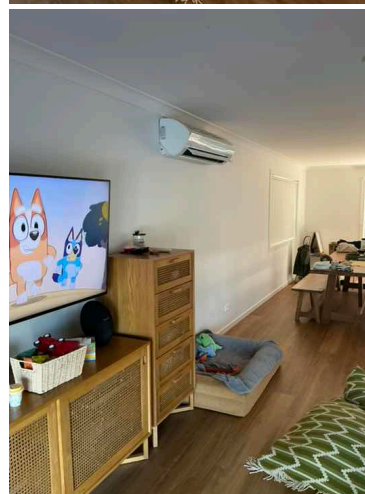
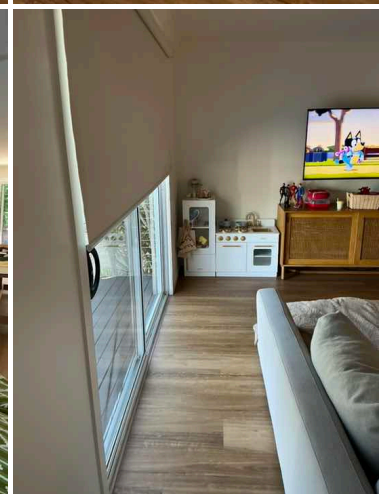
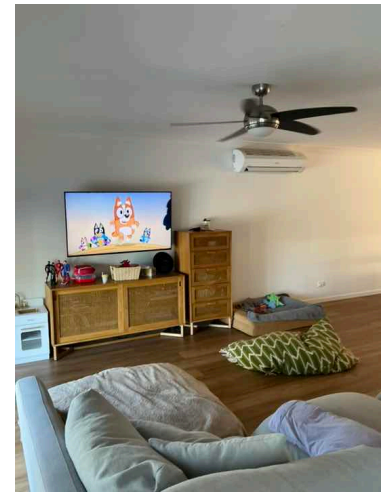
From the visible and accessible areas, this room appears to be in a serviceable condition for the age of the property with no notable structural defects sighted.

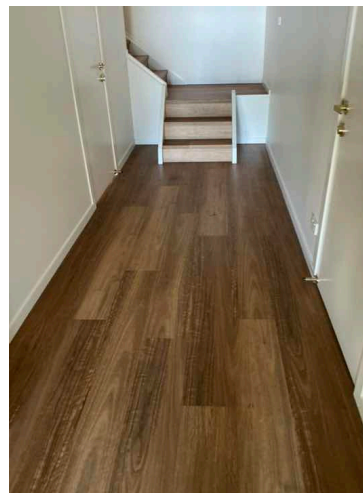
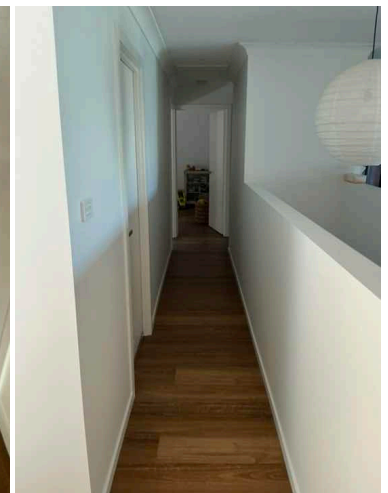
Hallway/s

From the visible and accessible areas, the hallway/ appears to be in a serviceable condition for the age of the property with no notable structural defects sighted.

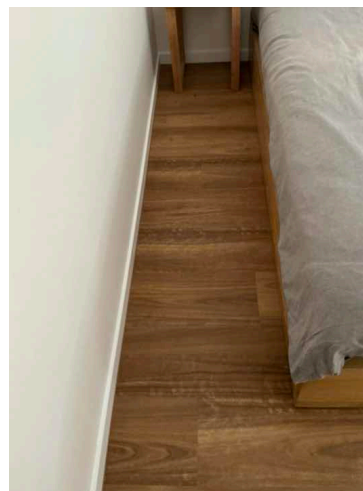
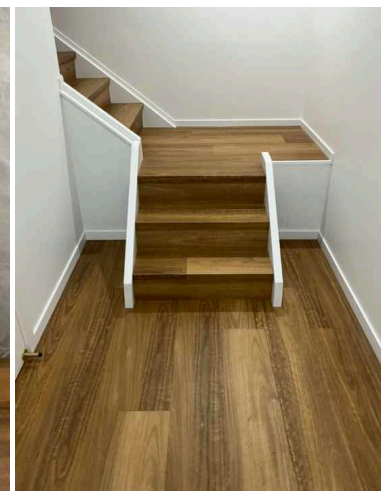
Internal Stair Case

The internal staircase and components appear to be in a serviceable condition for the age with no notable defects sighted.

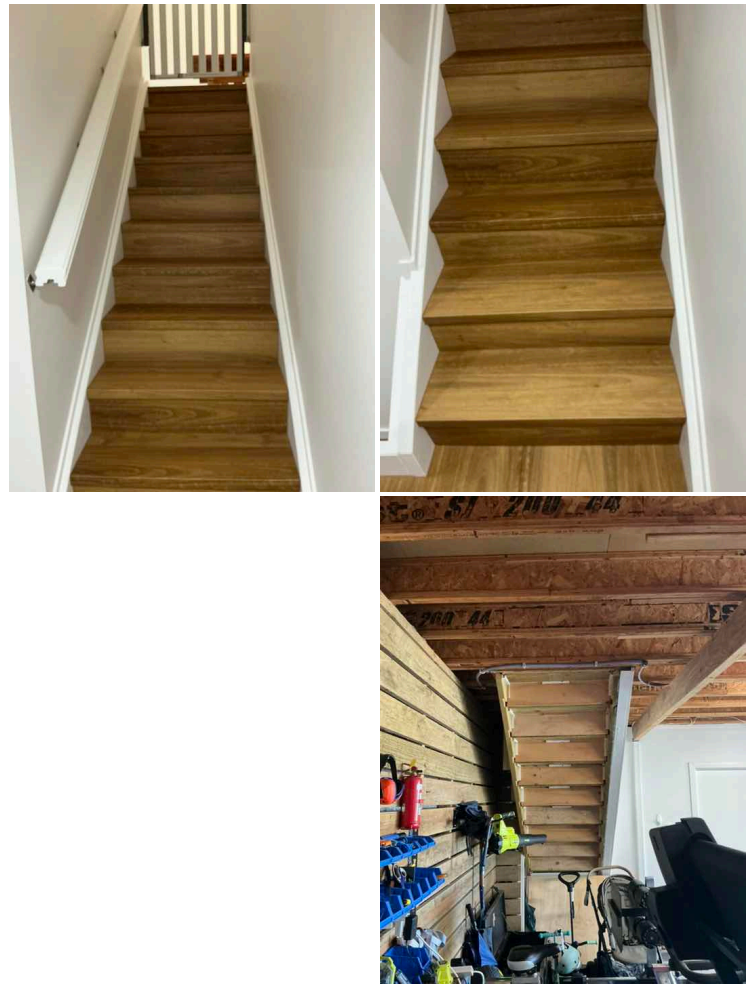
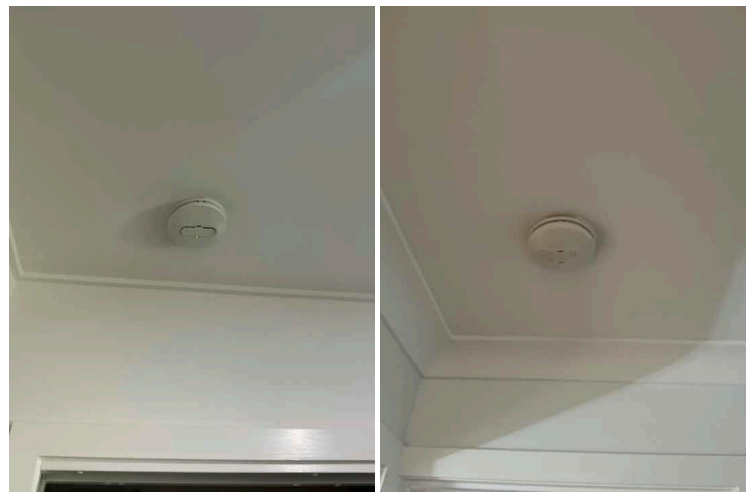
Smoke Alarm

Yes 3 smoke alarms were sighted but not tested.

Legislation requires smoke Alarms to be installed.
Check with your local council regarding type, locations
and other related requirements.

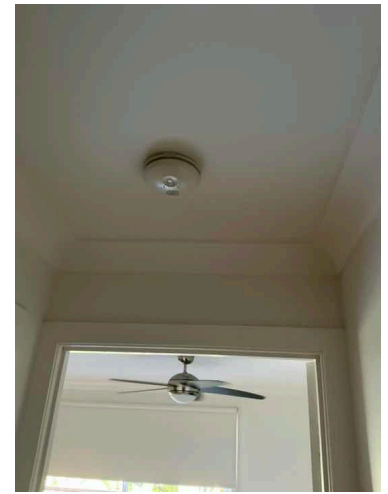
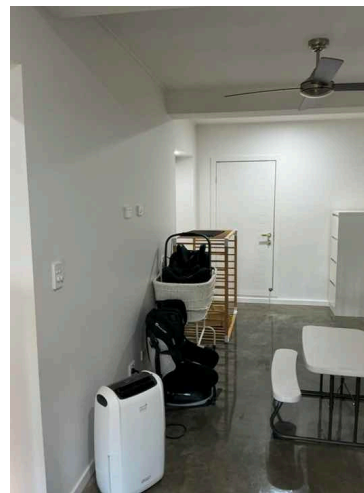
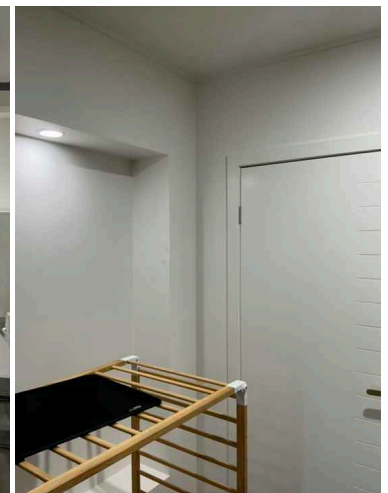
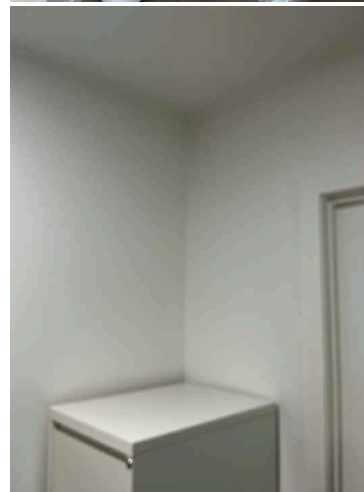
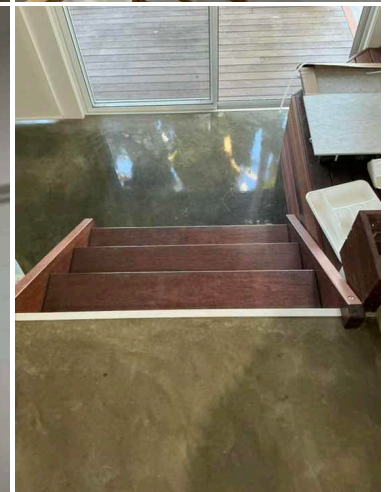
Bedroom 1

From the visible and accessible areas, this bedroom appears to be in a serviceable condition for the age of the property with no notable structural defects sighted.

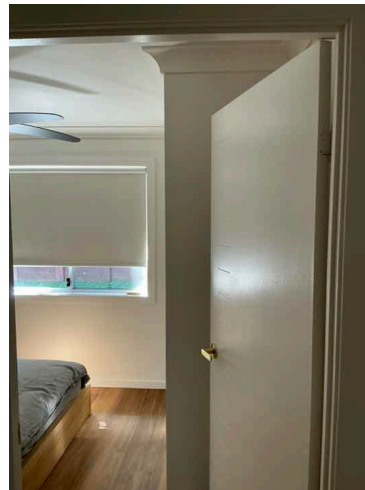
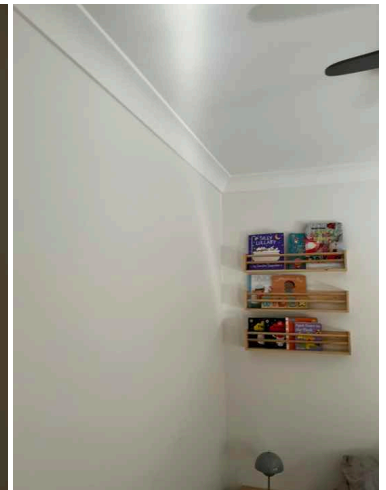
Bedroom 2

From the visible and accessible areas, this bedroom appears to be in a serviceable condition for the age of the property with no notable structural defects sighted.
