Building and Pest Report

5 Alexander
Circuit
Lennox Head

Inspection Report

East Coast Building Solutions

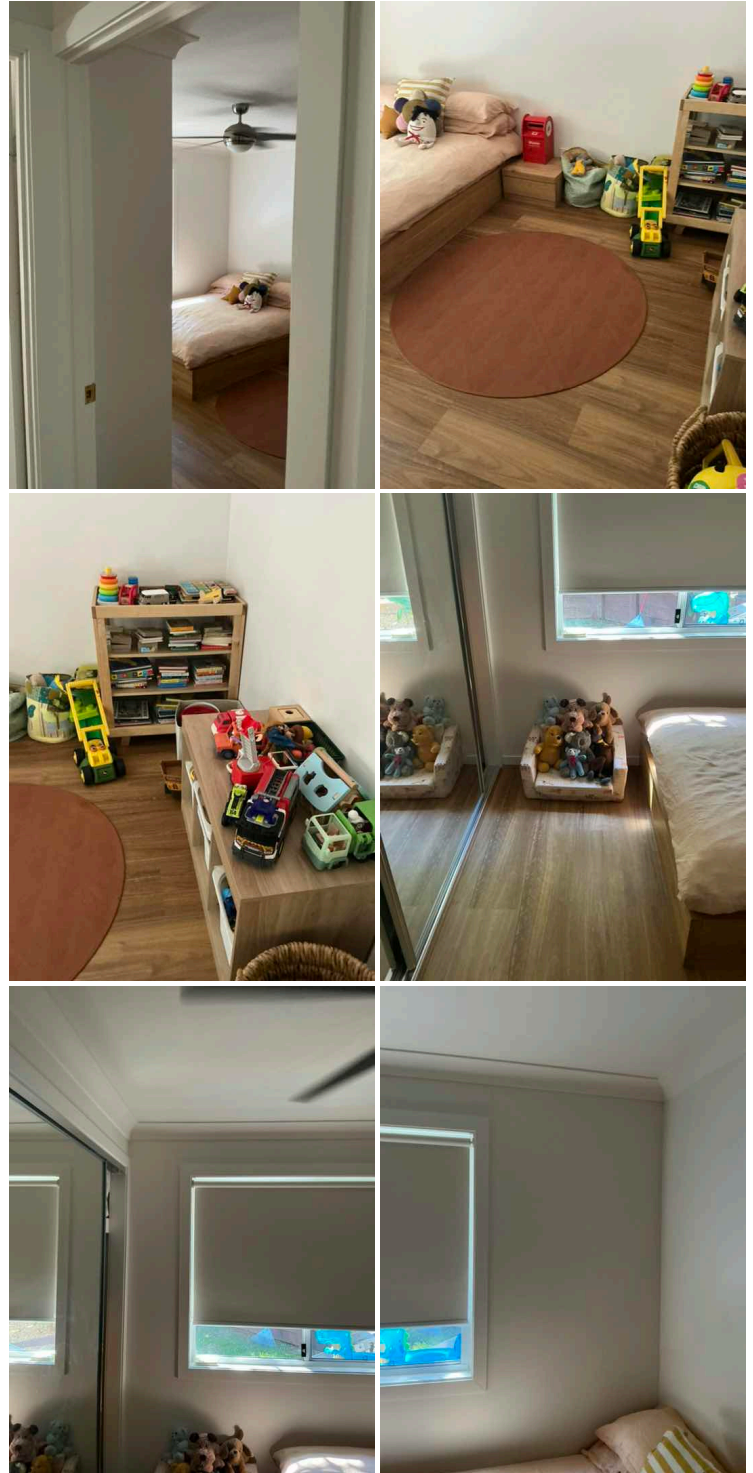
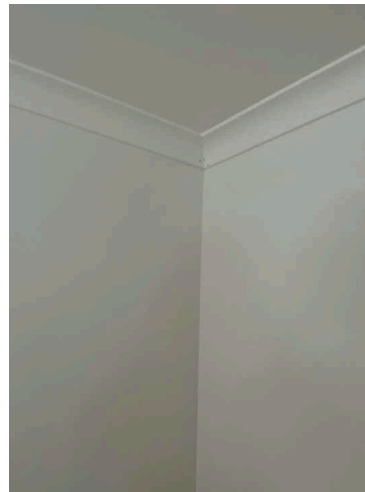
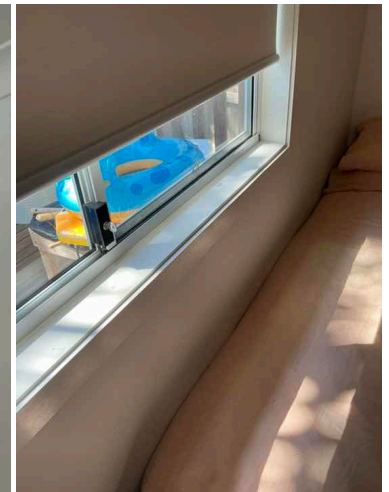
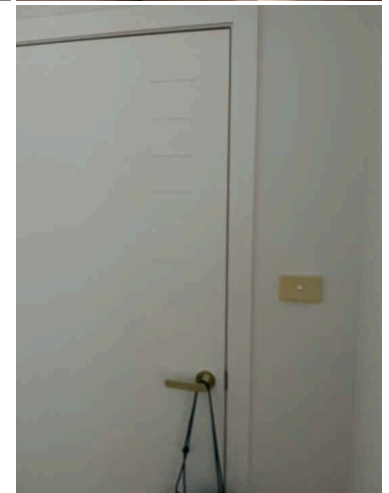
Bedroom 3

From the visible and accessible areas, this bedroom appears to be in a serviceable condition for the age of the property with no notable structural defects sighted.

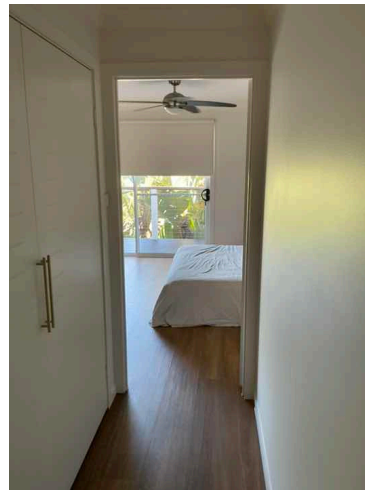
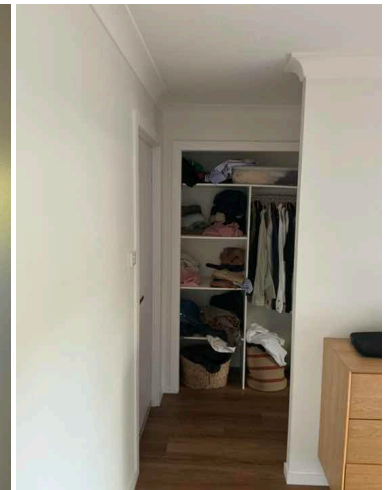
Bedroom 4

From the visible and accessible areas, this bedroom appears to be in a serviceable condition for the age of the property with no notable structural defects sighted.

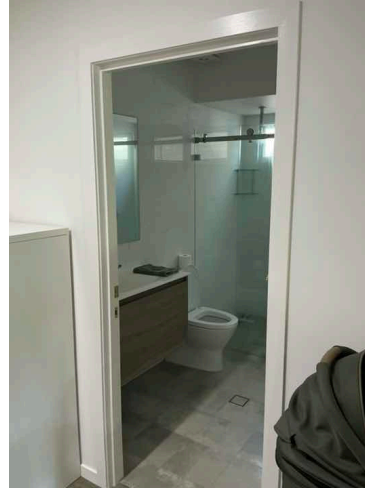
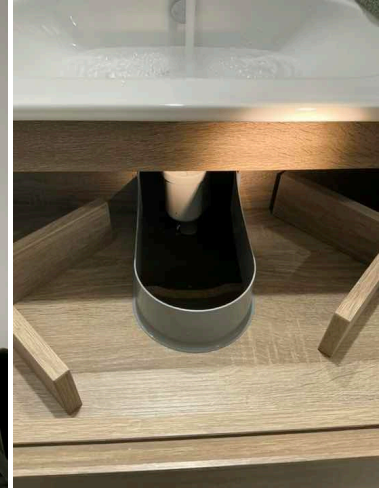
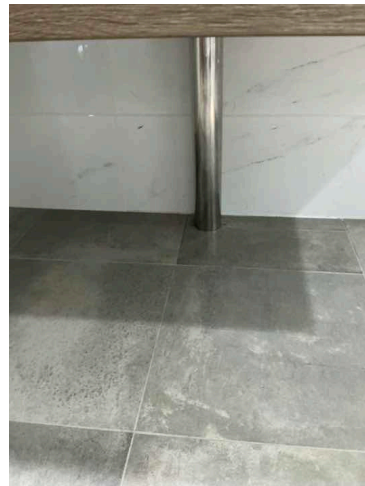
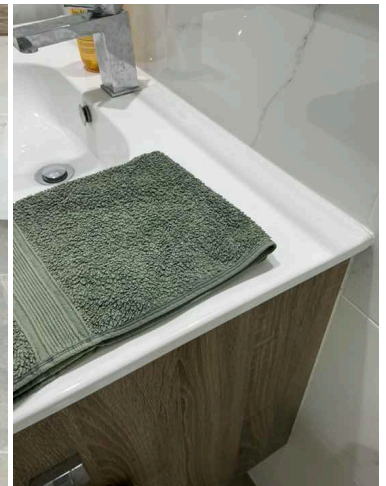
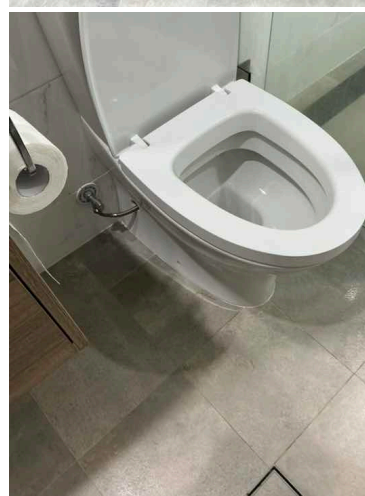
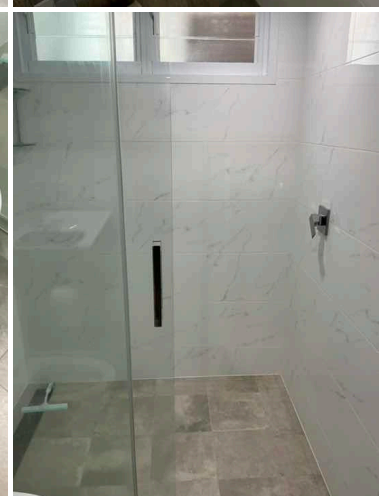
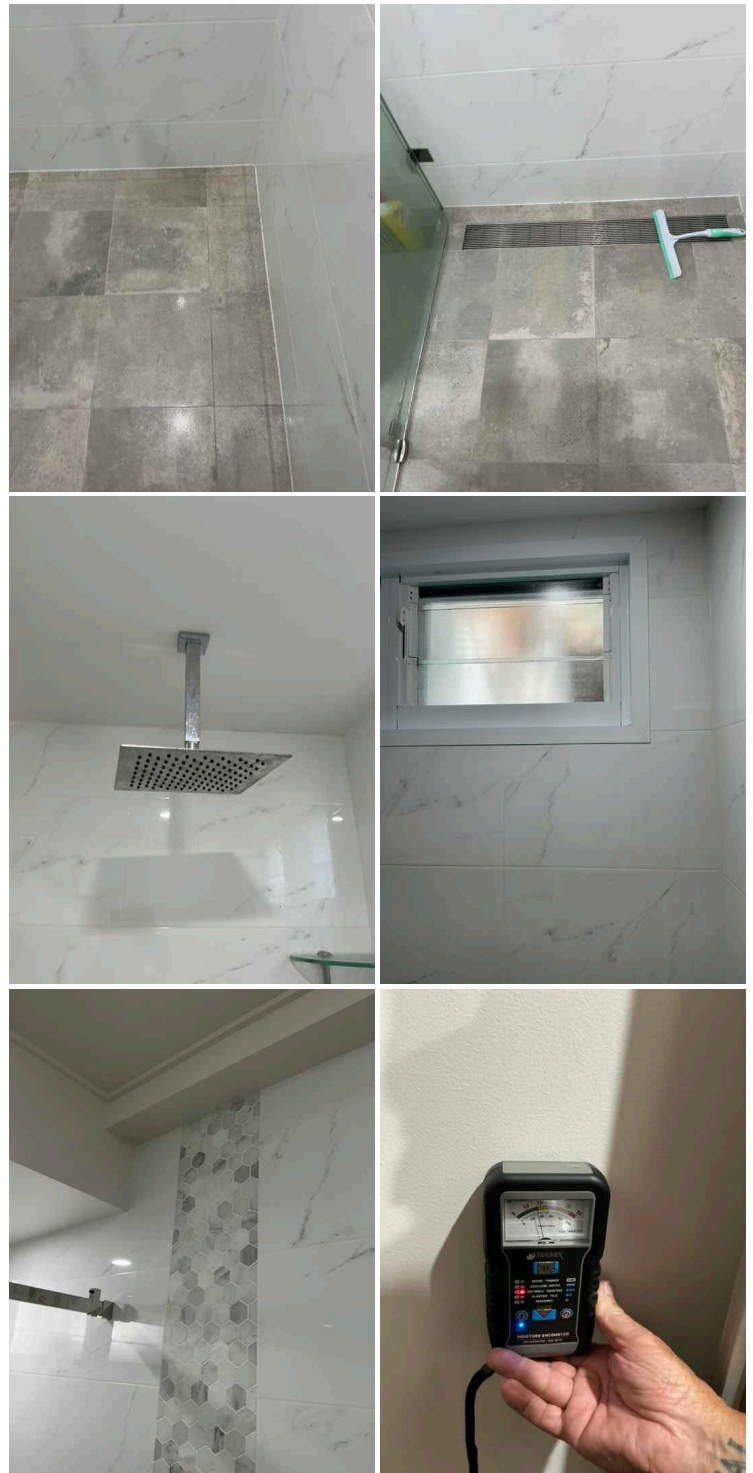
Of the visible areas, the general condition of this bathroom is serviceable or in reasonable condition for age of dwelling.

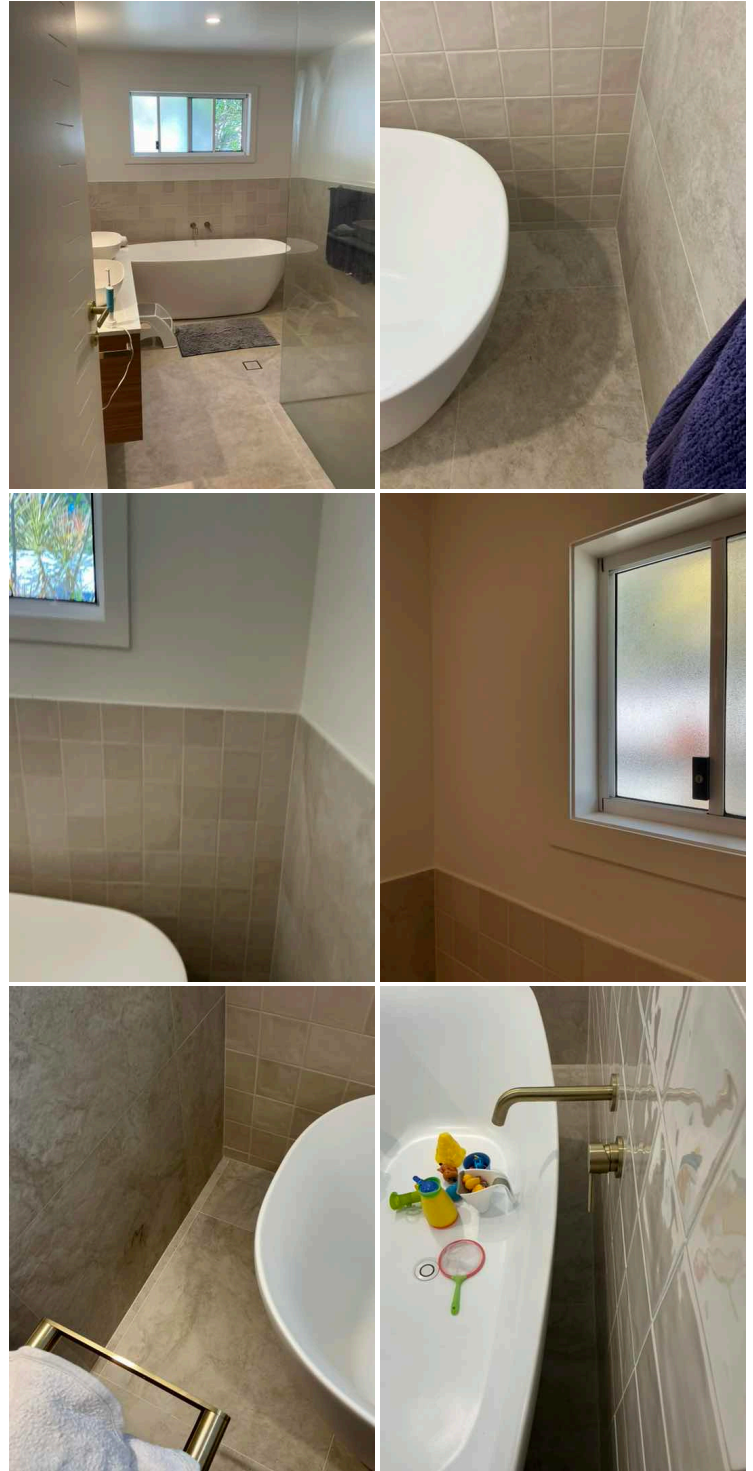
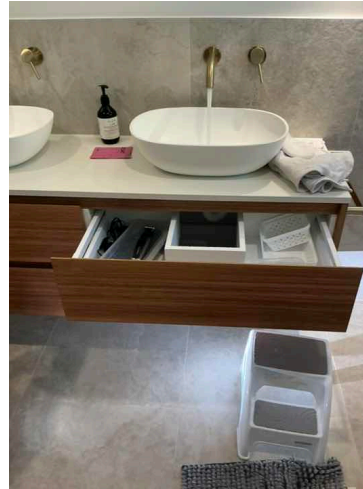
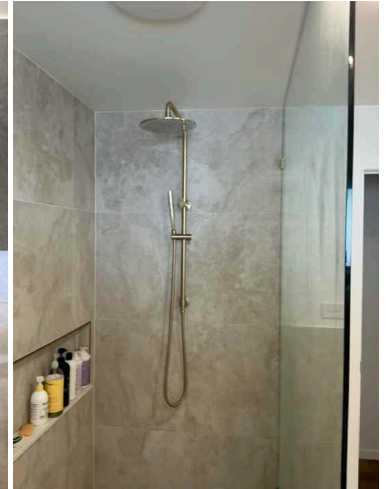
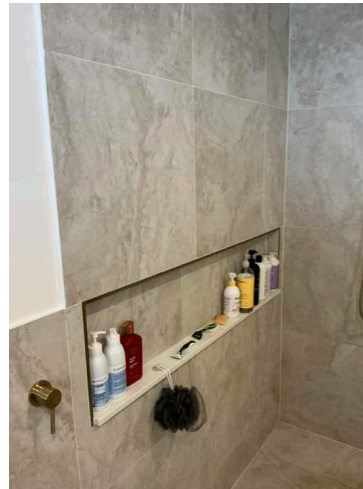
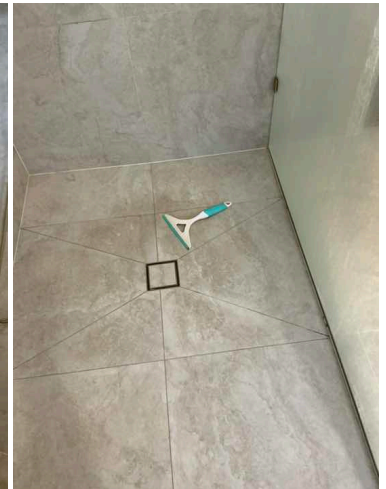
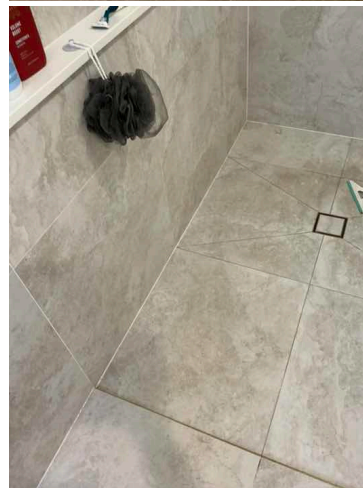
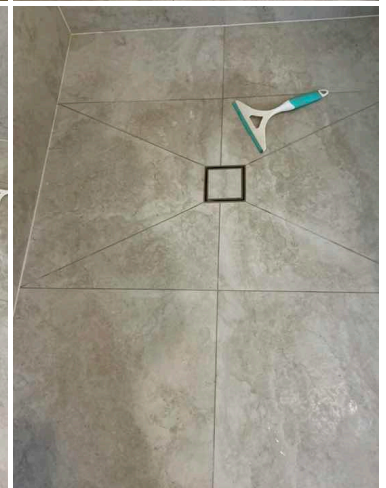
Of the visible areas, the general condition of this bathroom is serviceable or in reasonable condition for age of dwelling.

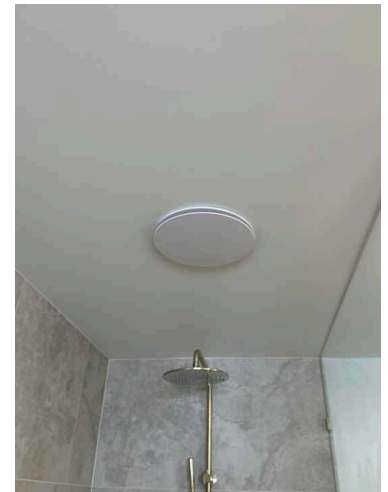
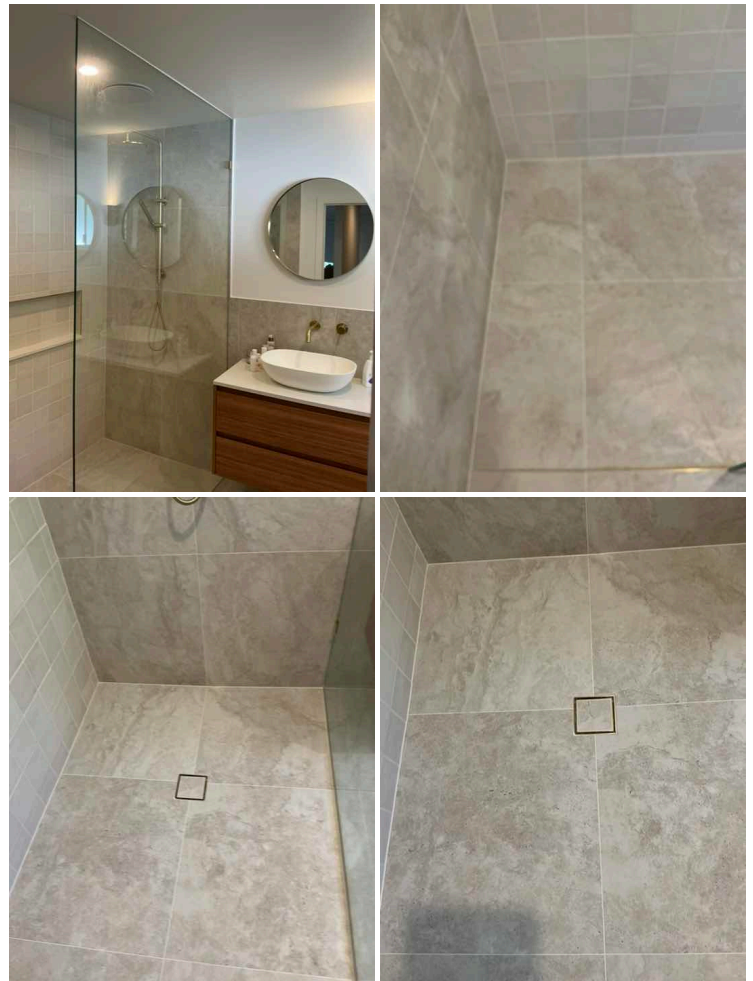
Bathroom 3

Of the visible areas, the general condition of this bathroom is serviceable or in reasonable condition for age of dwelling.

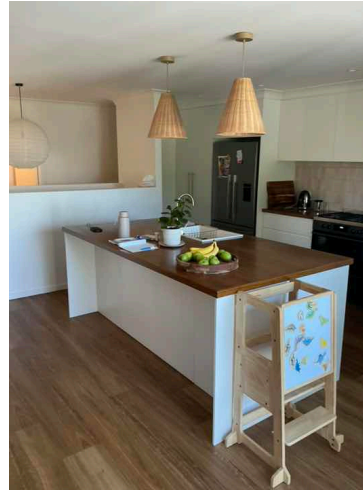
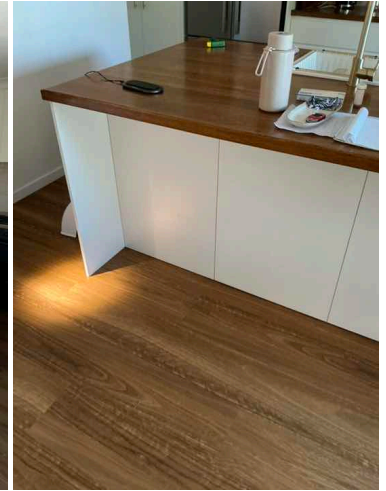
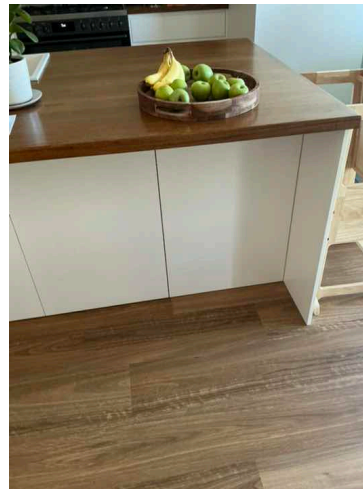
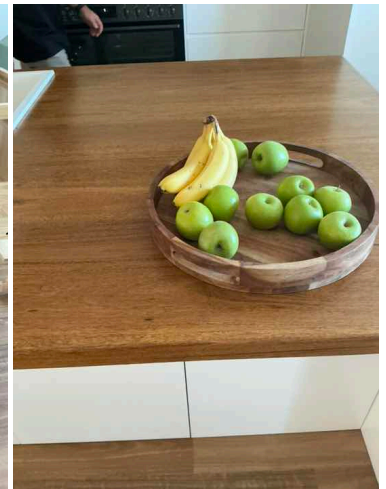
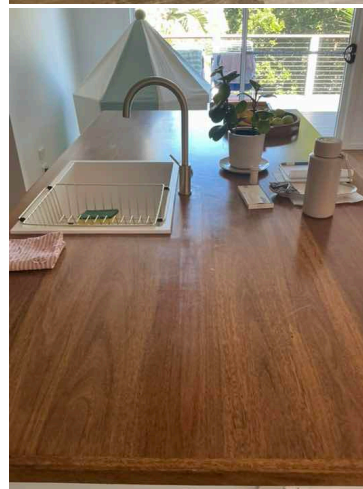
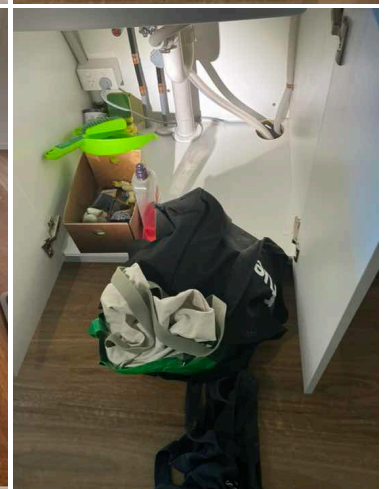
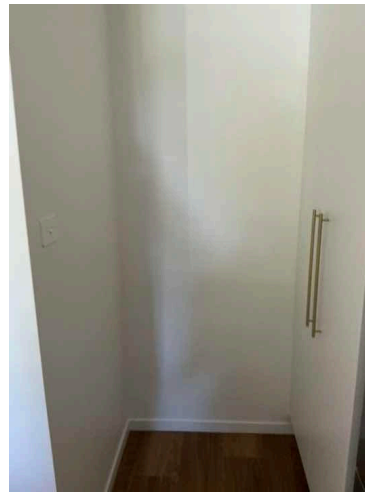
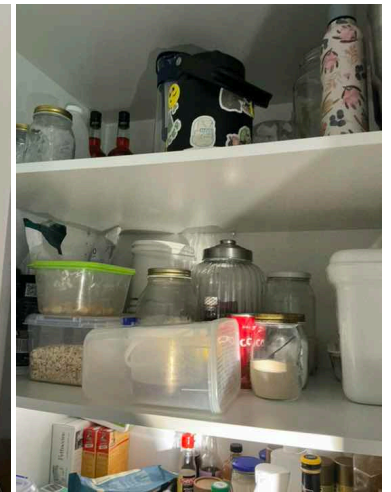
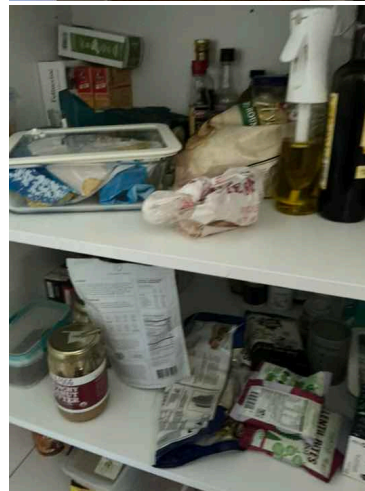
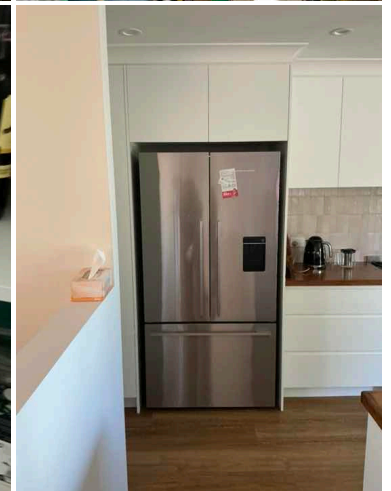
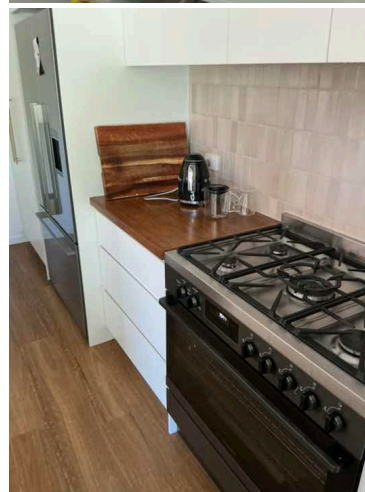
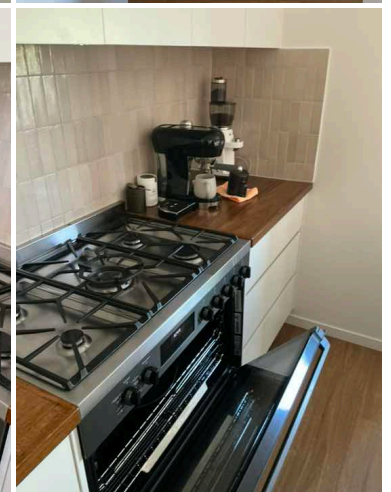
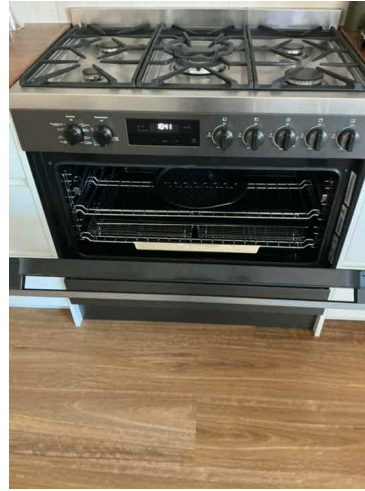
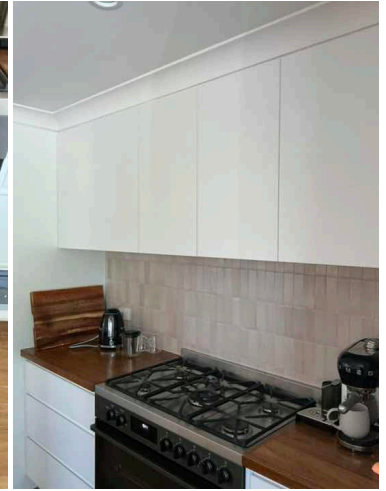
Of the visible areas, the general condition of the kitchen and pantry is serviceable or in reasonable condition for age of dwelling.

These components appear to be in a serviceable condition

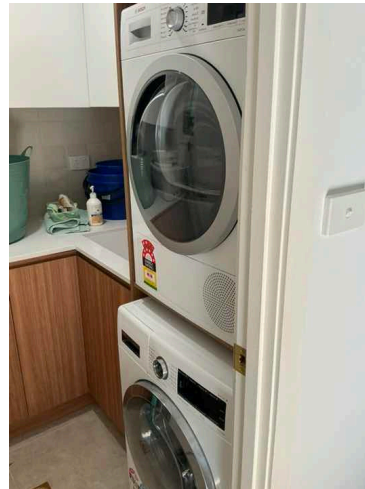
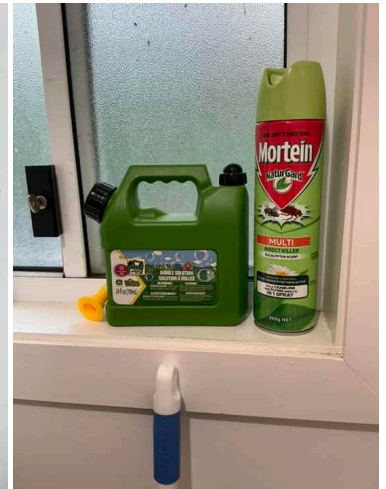
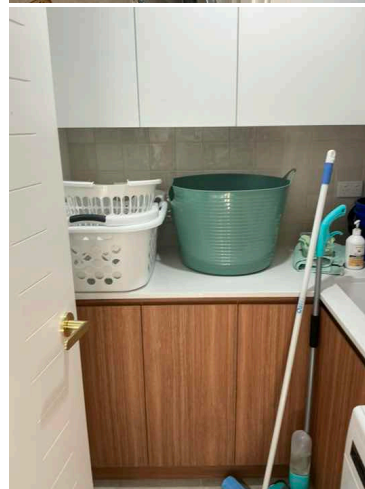
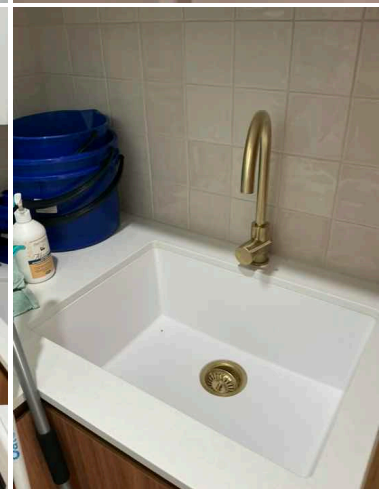
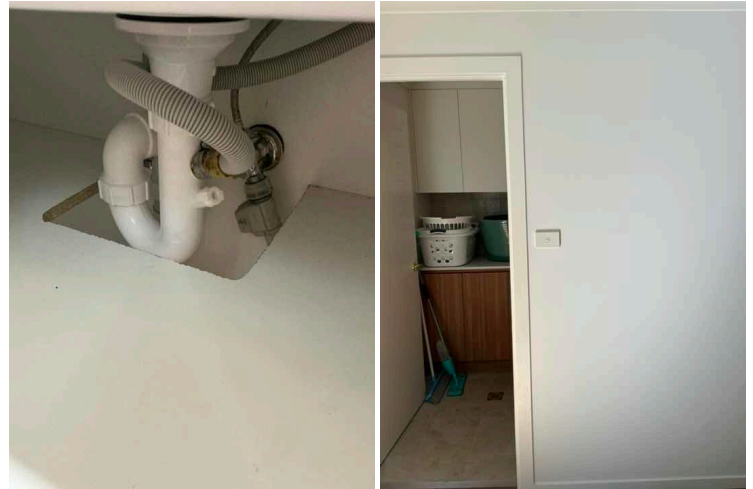
Appliances and the like restricted a full visual inspection.

Of the visible areas, the general condition of the laundry is serviceable or in reasonable condition for age of dwelling.

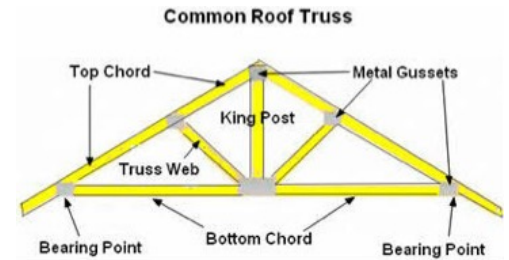
The roof frame is a truss timber frame.

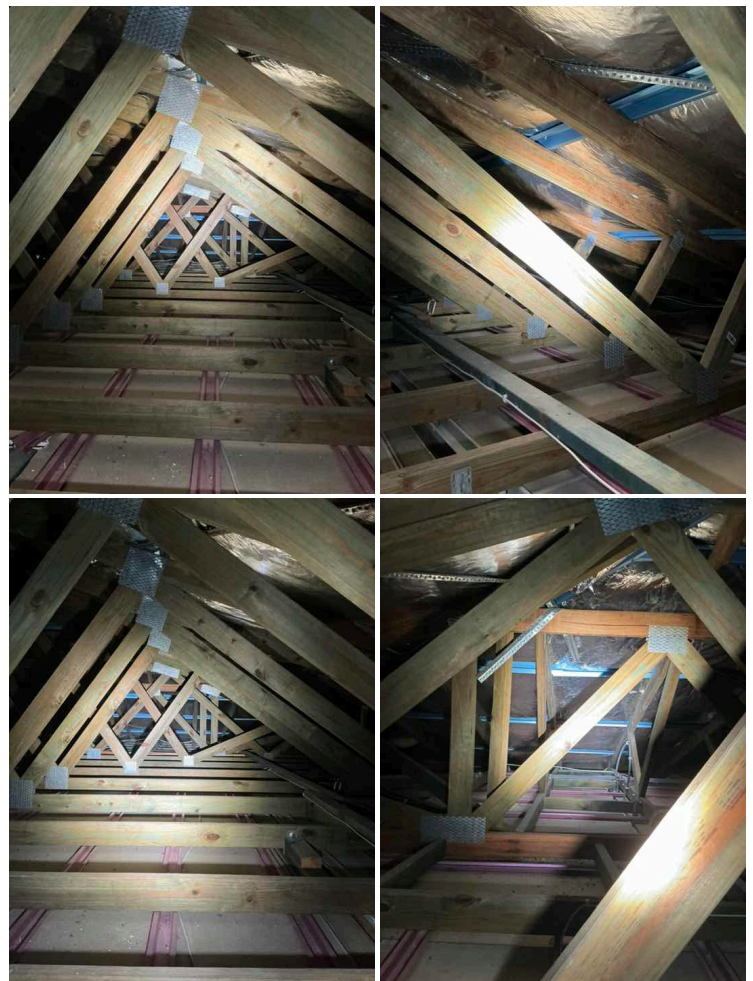
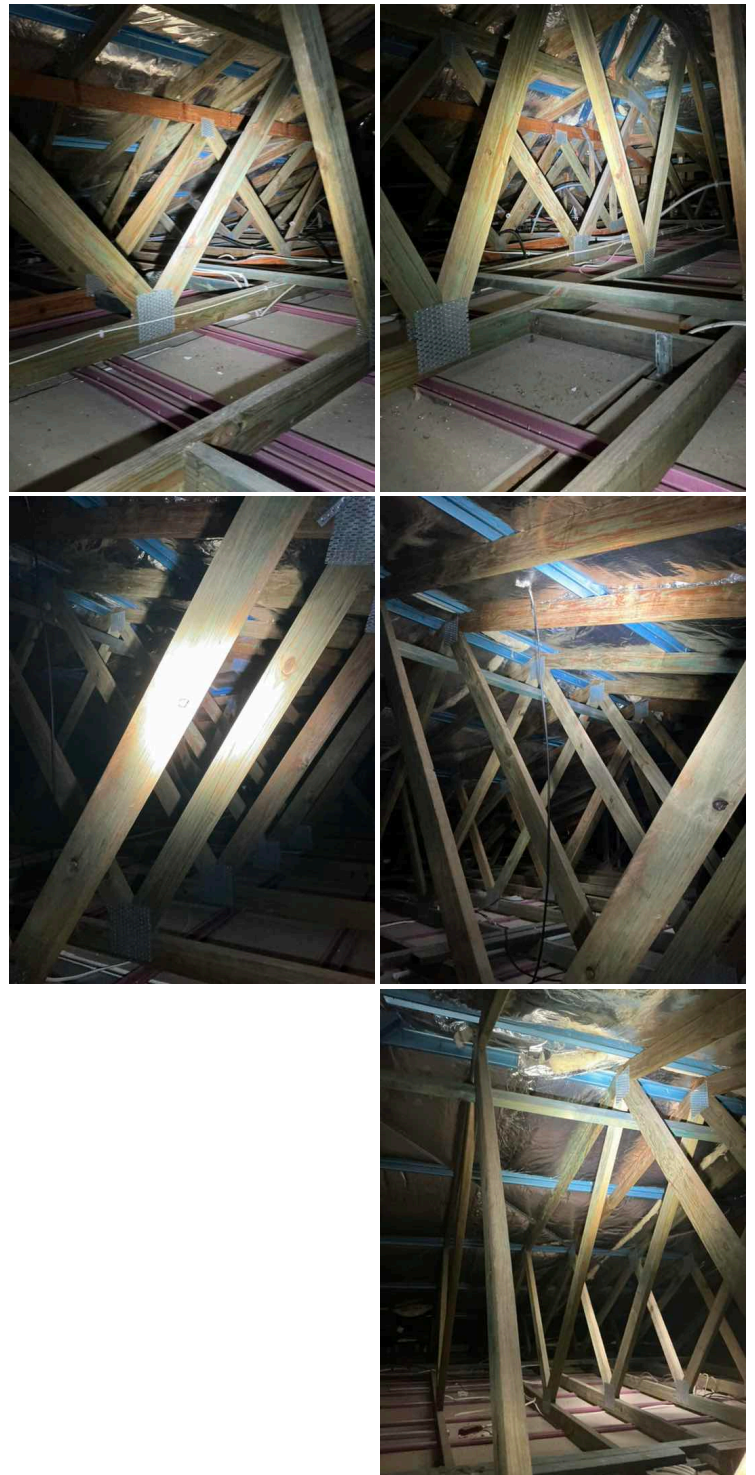
Visible sections of the roof void is in a serviceable condition for age of this dwelling.

No insulation installed. Recommendations: Engage insulation contractor to assess.

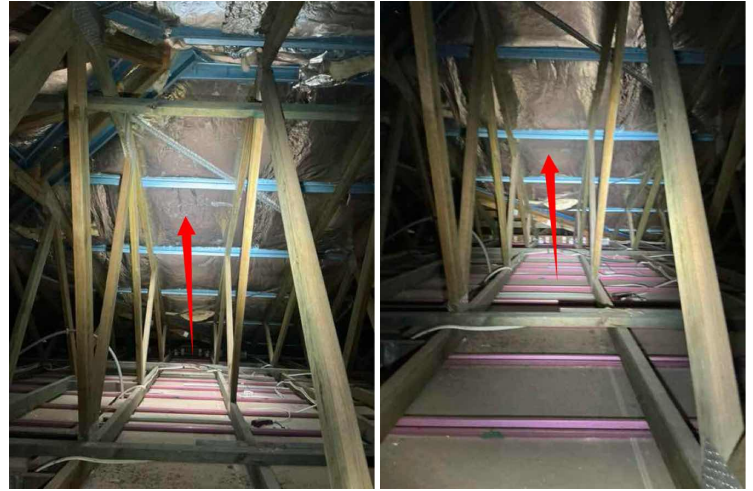
The sarking generally is in a serviceable condition. Sarking is a flexible membrane positioned beneath roof tiles, functions as a shielding layer akin to a second skin. Enhancing insulation efficiency, it safeguards against elements such as storm-driven rain (Leaks), dust, condensation, and embers during bushfires.
