Building and Pest Report

**2/6 Kell Mather Dr
Lennox Head**

Pest And Building Inspection

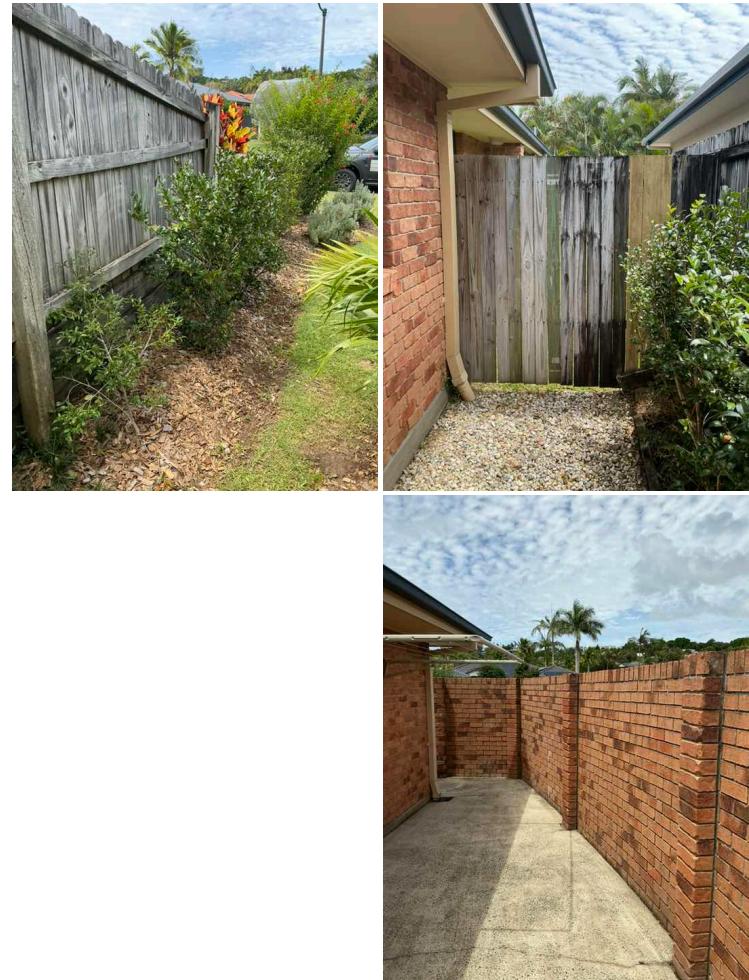
Of the visible areas, the general condition of the fences and gates is serviceable for the age of dwelling.

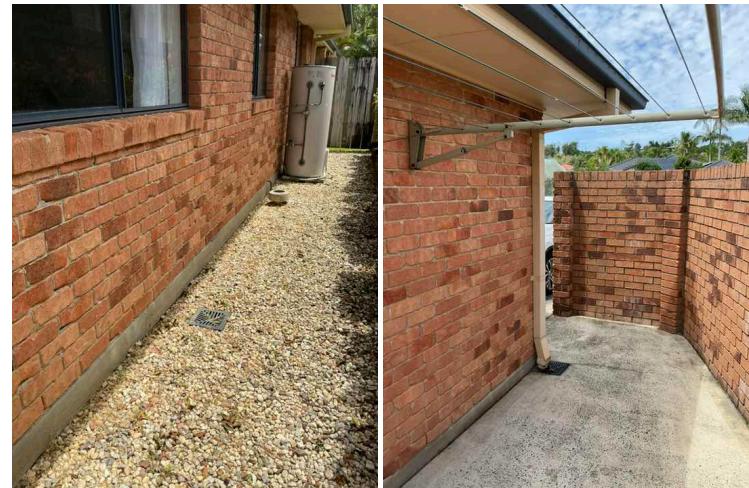
There was no visible evidence of excess ponding or fall towards the property walls at the time of the inspection. Regardless, it is difficult to ascertain in dry conditions and it is therefore recommended that you assess same after a rainfall period to be able to sufficiently ascertain if any problems exist in this regard. If water is ponding around perimeter walls and paths or appears to be flowing into the footings/foundations you must have assessed by a qualified plumber or landscaper.

No evidence of slow or blocked drains at the time of inspections.

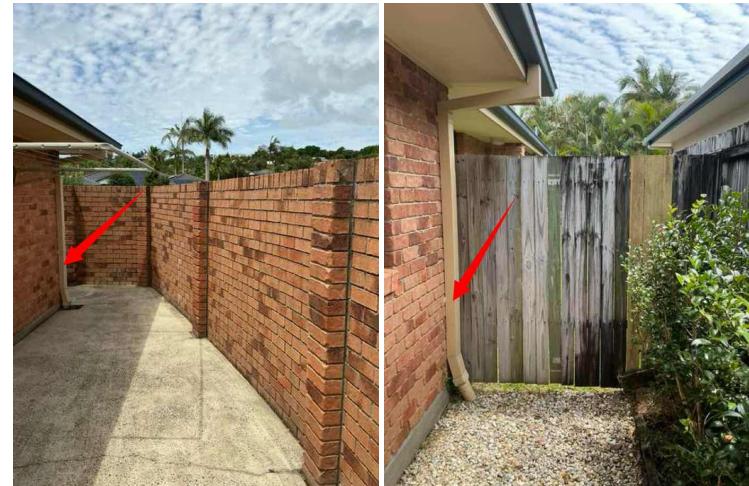
On visual inspection no apparent defects were noted to the down pipes and are considered serviceable, however no comment can be made with regard to blockages or connections to stormwater or functionality in the absence of rain. Note: Periodic maintenance checks should be carried out for rust penetrations and leaks.

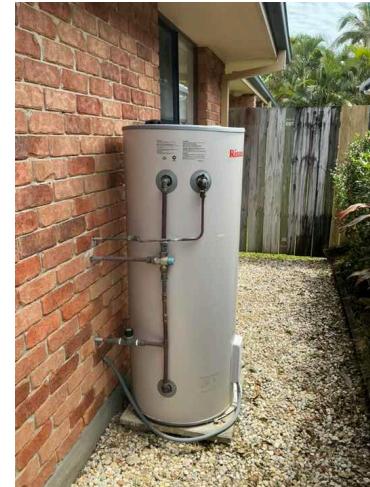
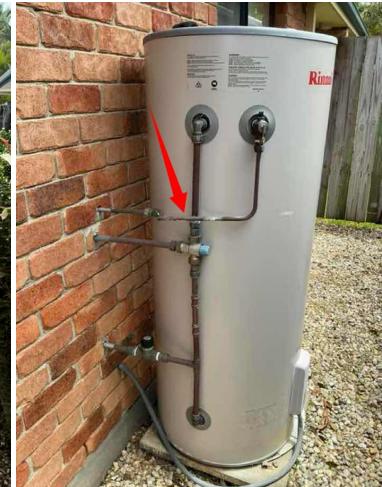
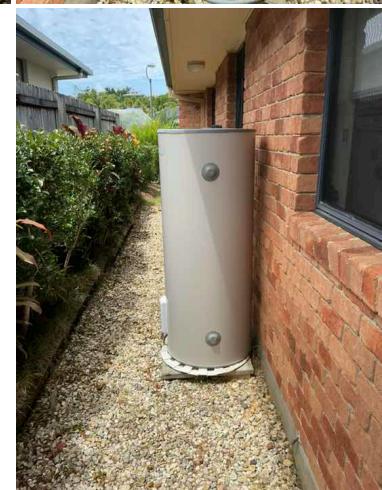
Upon visual inspection, the water heater appears to be in good condition with no visible leaks or corrosion. Ensure regular maintenance by a licensed plumber to check connections and pressure relief valve functionality. Verify that the unit is securely mounted and that all safety standards are met.

The hot water unit is located outside.

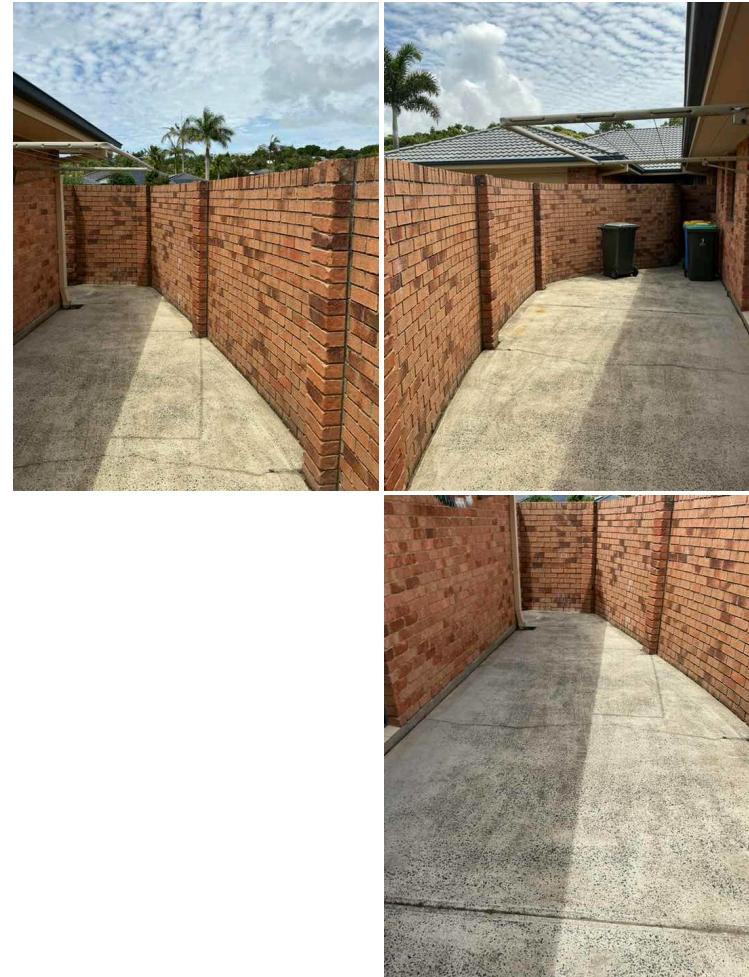
Visible sections of the Alfresco area are serviceable or in reasonable condition for the age of this dwelling.

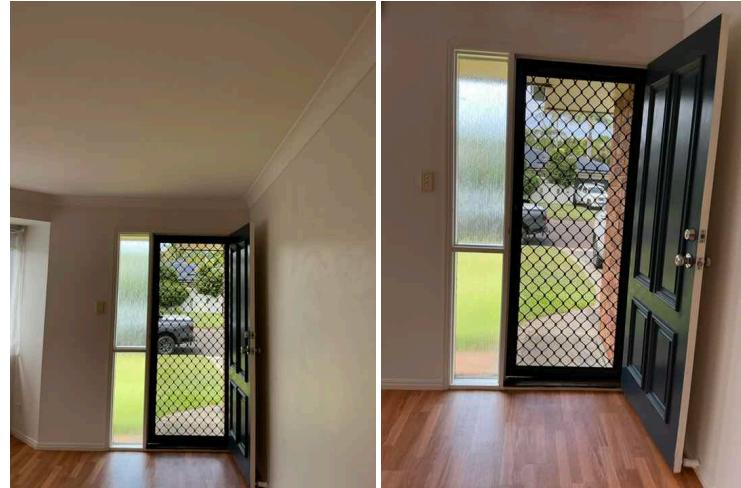
From the visible and accessible areas, this area appears to be in a serviceable condition for the age of the property with no notable structural defects sighted.

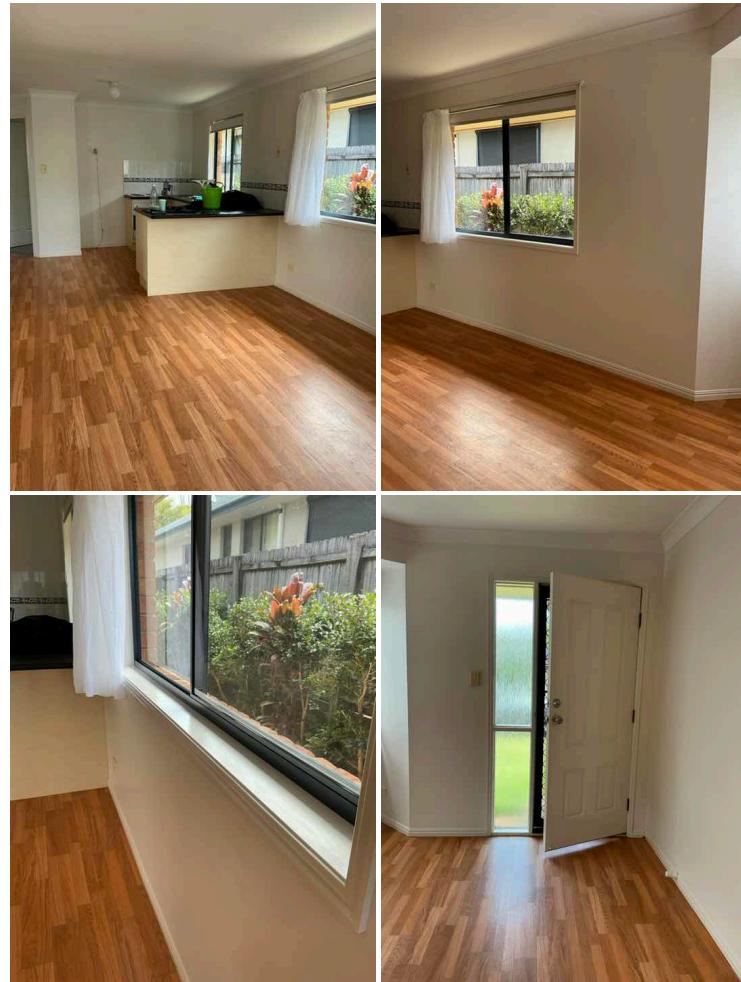
From the visible and accessible areas, this room appears to be in a serviceable condition for the age of the property with no notable structural defects sighted.

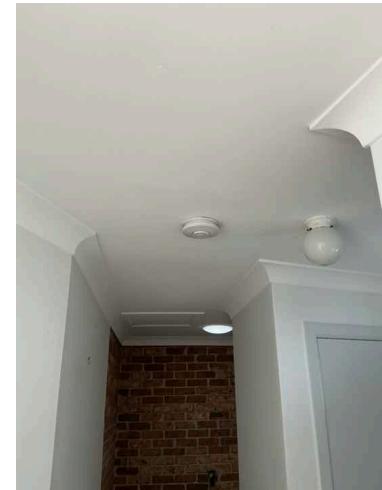
Yes a smoke alarm was sighted but not tested.

Legislation requires smoke Alarms to be installed. Check with your local council regarding type, locations and other related requirements.

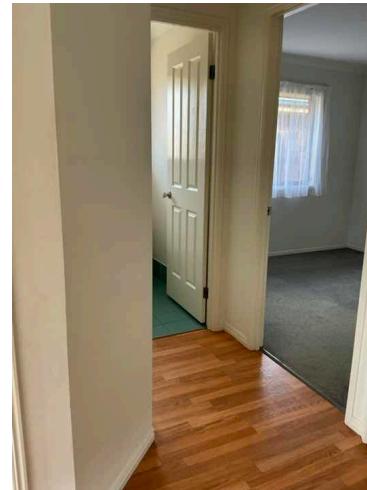
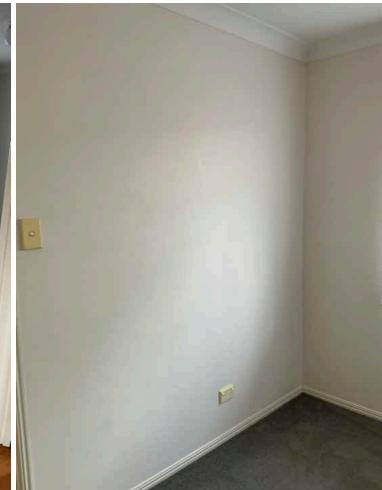
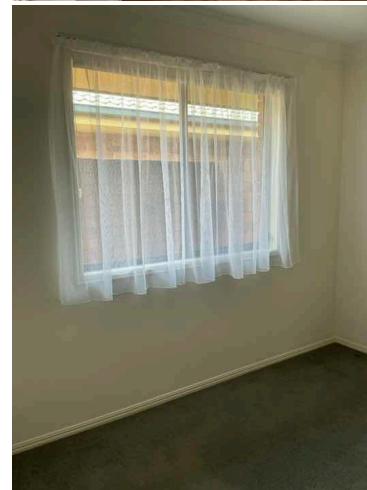
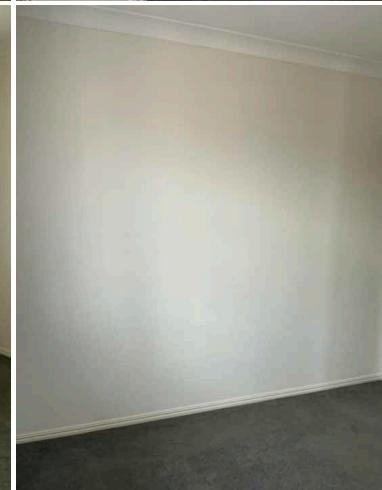
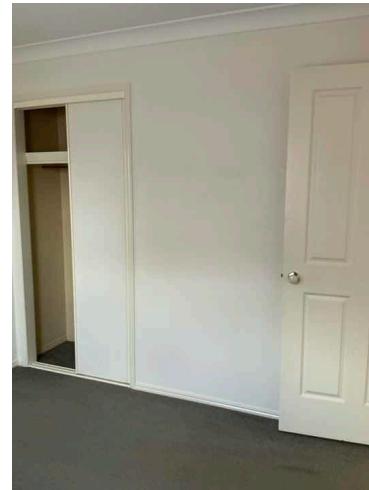
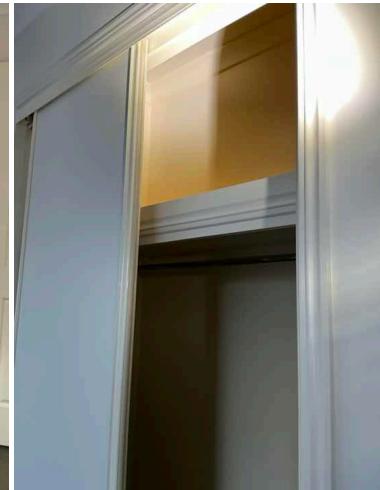
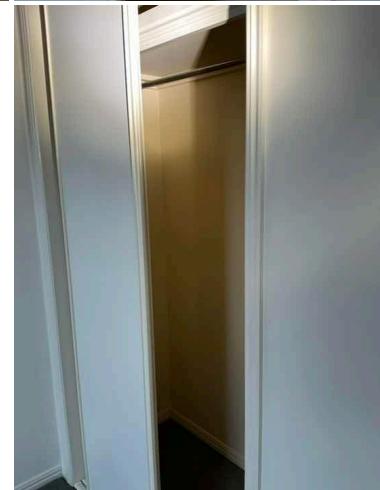
From the visible and accessible areas, this bedroom appears to be in a serviceable condition for the age of the property with no notable structural defects sighted.

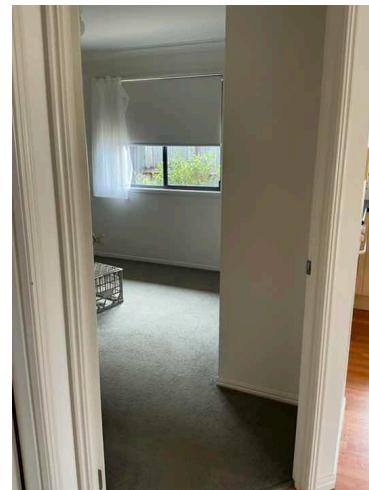
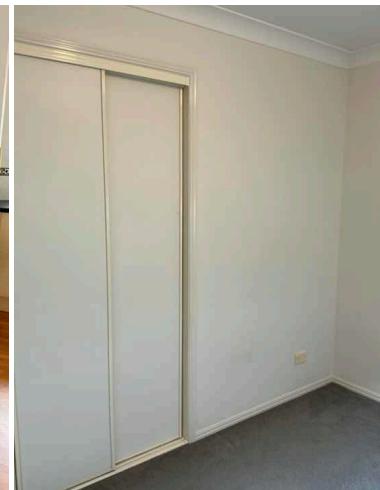
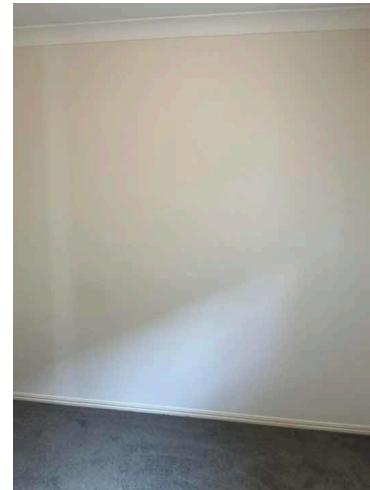
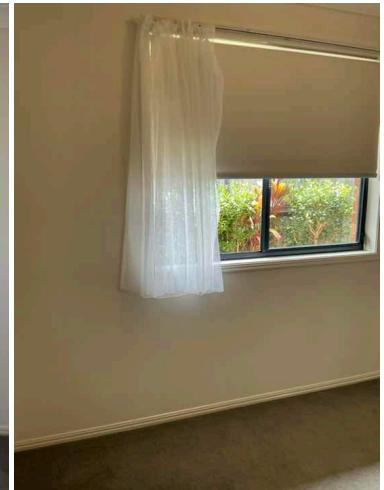
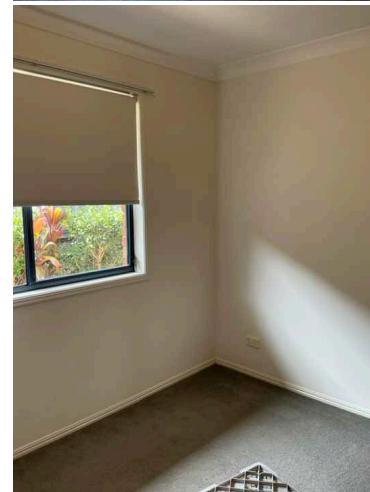
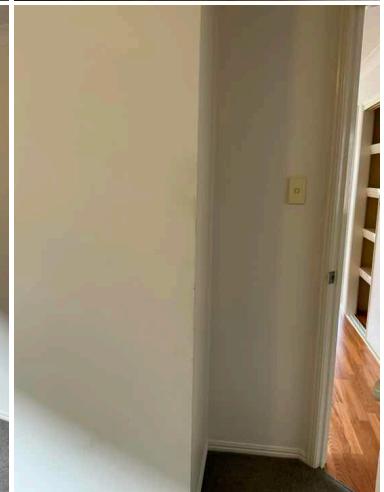
Bedroom 2

From the visible and accessible areas, this bedroom appears to be in a serviceable condition for the age of the property with no notable structural defects sighted.

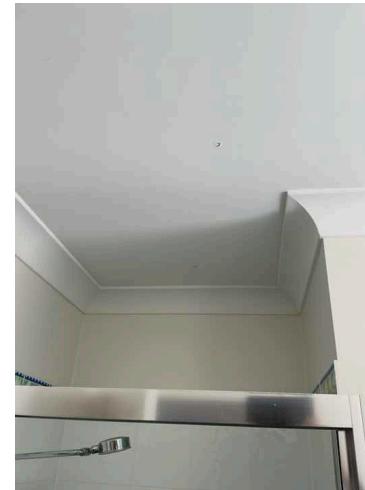
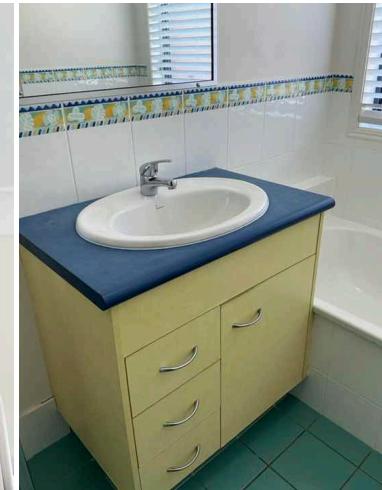
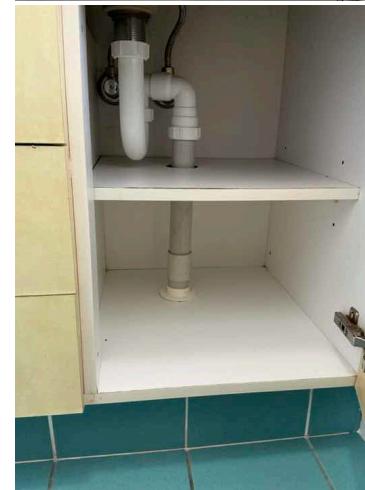
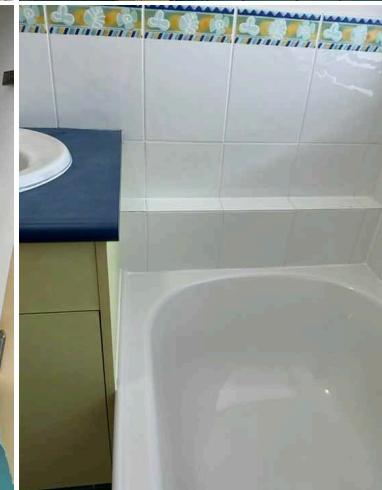
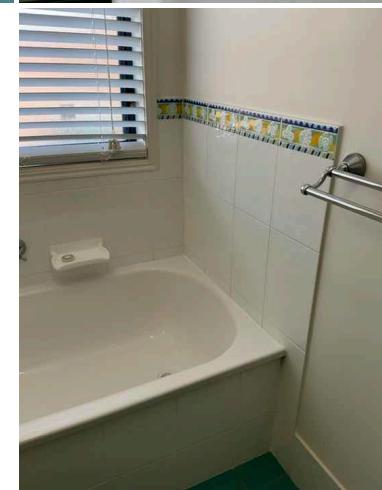
Of the visible areas, the general condition of this bathroom is serviceable or in reasonable condition for age of dwelling.

Upon visual inspection, the door shows signs of wear at the bottom edge, likely due to moisture exposure.

Recommend sanding the affected area and applying a water-resistant sealant. If the damage is extensive, consider replacing the door. Ensure proper ventilation to prevent future moisture-related issues.

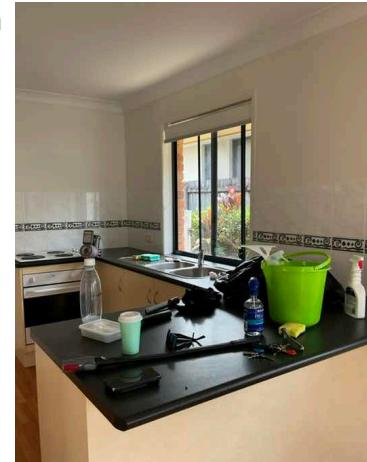
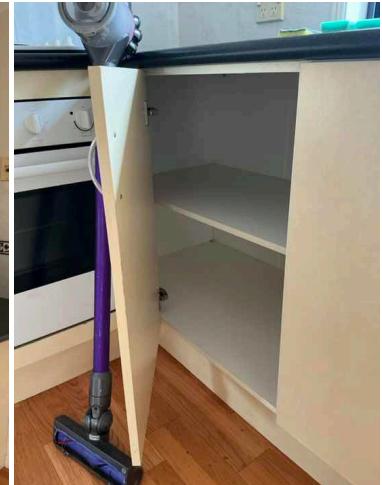
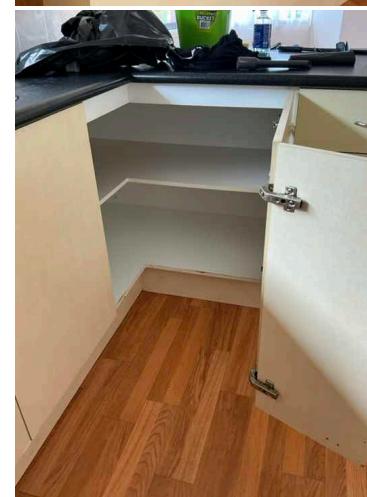
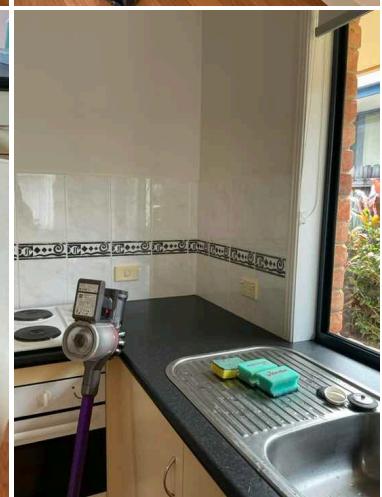
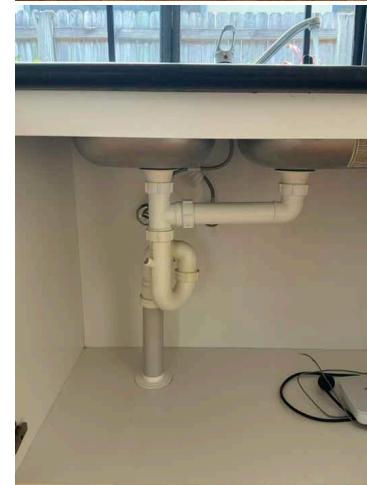
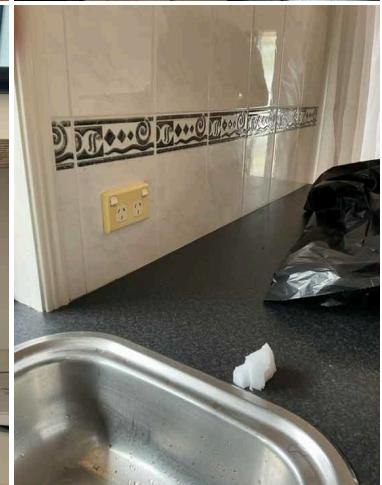
Of the visible areas, the general condition of the kitchen and pantry is serviceable or in reasonable condition for age of dwelling.

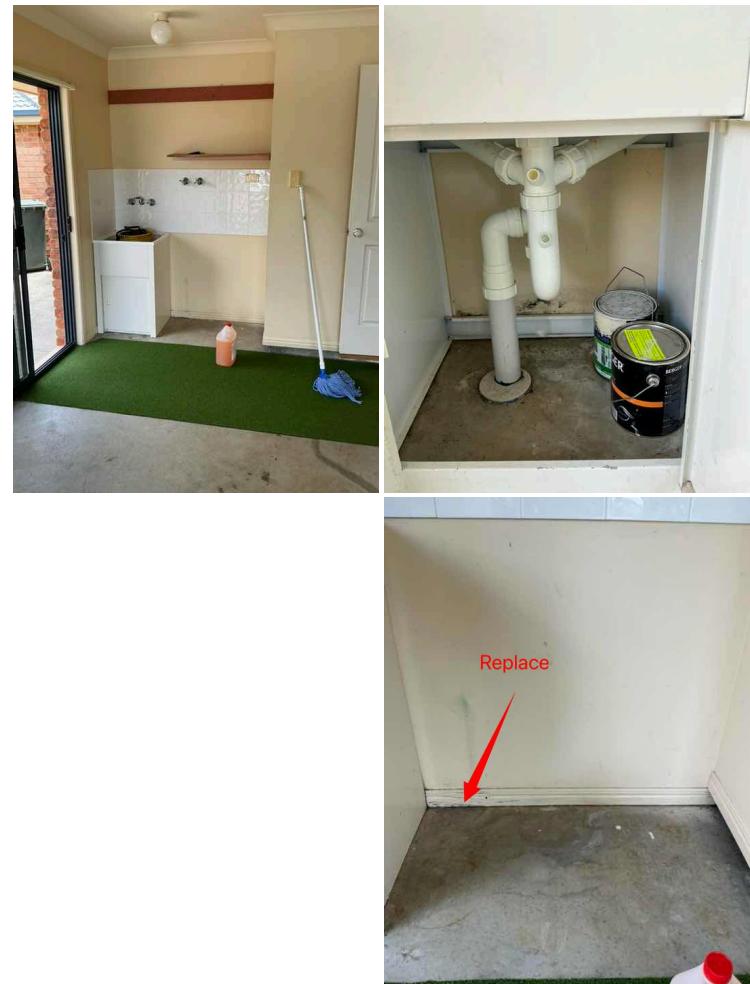
Of the visible areas, the general condition of the laundry is serviceable or in reasonable condition for age of dwelling.

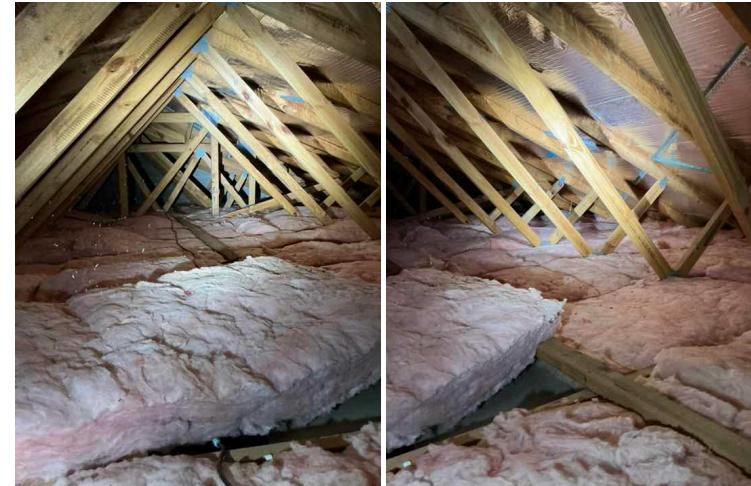
Visible sections of the roof void is in a serviceable condition for age of this dwelling.

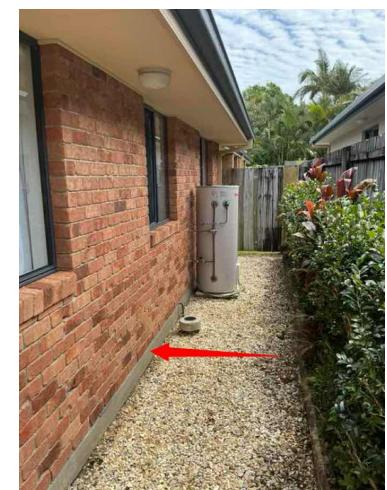
Is the Slab Edge adequately Exposed

Yes in some areas.
