# PEST AND BUILDING PRE-PURCHASE REPORTS

# Inspection Report

**25 Ibis Place , Lennox Head, NSW, 2478**

### Pest And Building Inspection

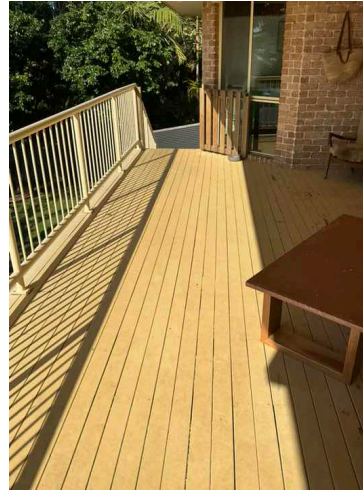
#3. Upon visual inspection, the deck shows signs of paint peeling and surface wear. It is recommended to sand the affected areas and apply a weather-resistant sealant or paint. Ensure proper drainage to prevent future deterioration. Consult a licensed tradesperson for a thorough assessment and repair to maintain structural integrity and appearance.

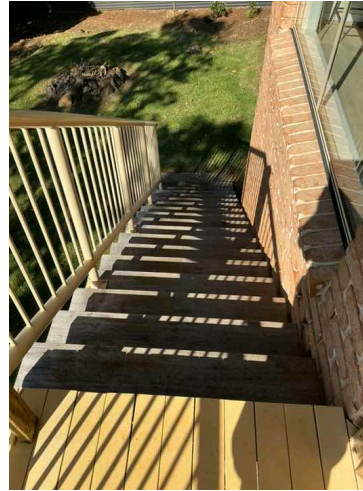
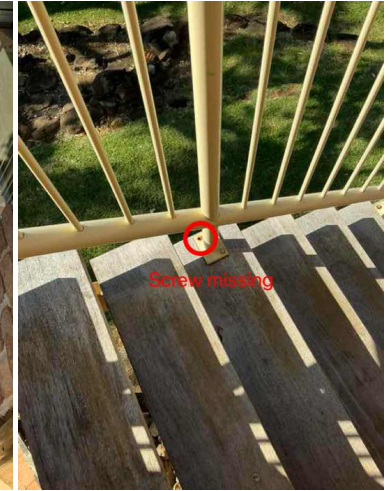
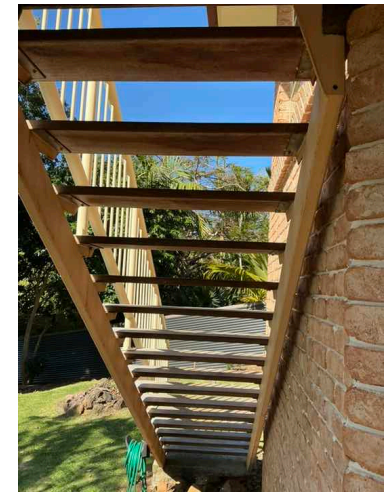
Of areas visible, minor defects and/or maintenance issues were visible. These will require assessment and subsequent repairs by a licensed tradesperson. Please read below for details. Please note that the inspector believes these to be of a minor nature relative to the age of the dwelling and or lack of proper and continual maintenance. Others, including other inspectors may differ in their opinions.

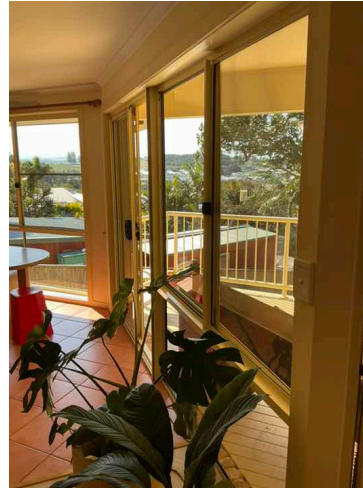
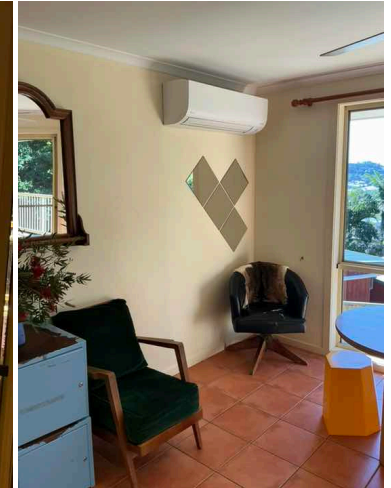
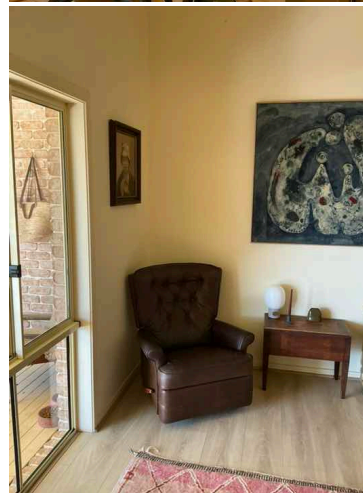
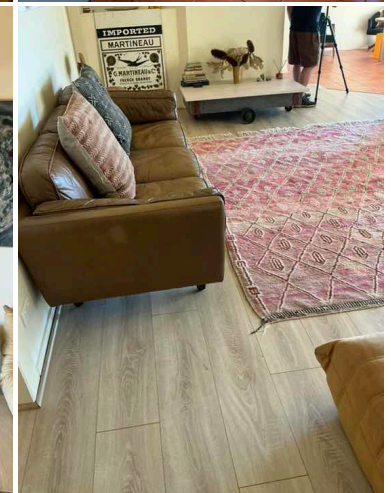
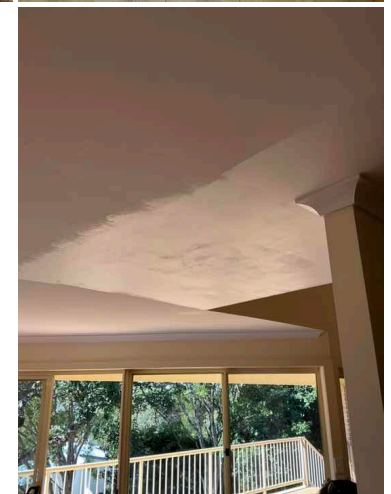
#8. On inspection, defects were present that will require further assessing and recommendations by a qualified trades persons, please read below for details.  
Recommend ceiling to be painted

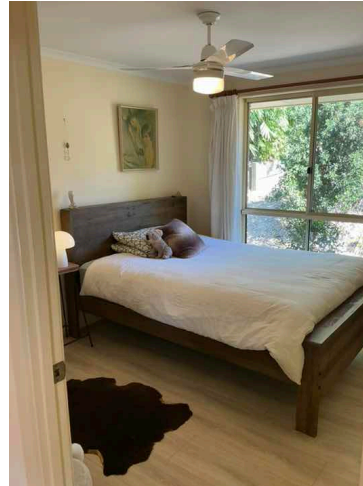
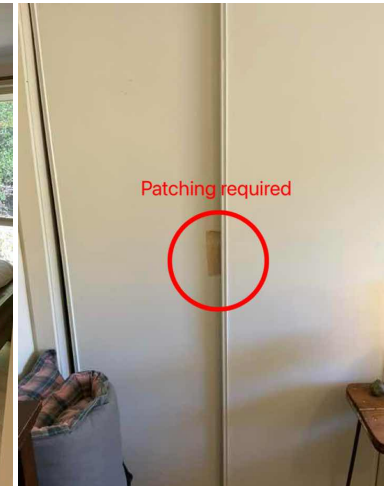
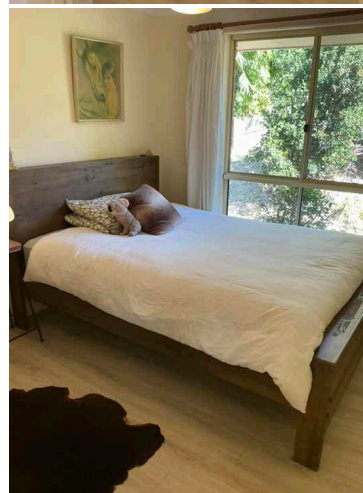
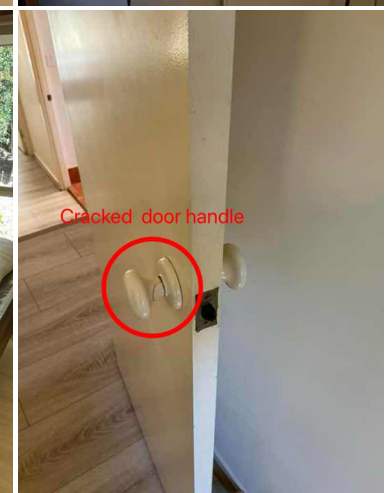
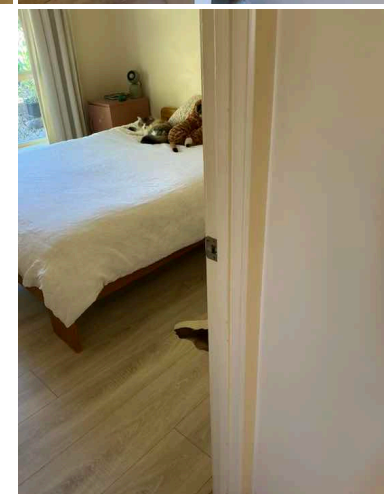
Door lock hardware is loose possibly damaged. Maintenance as required.

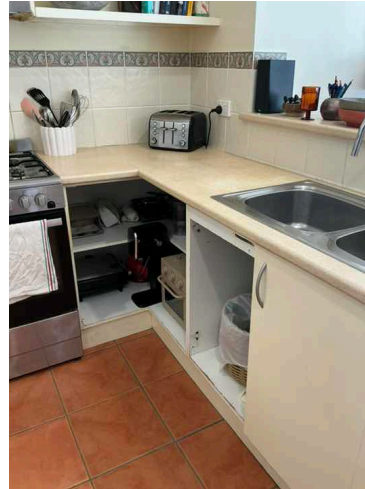
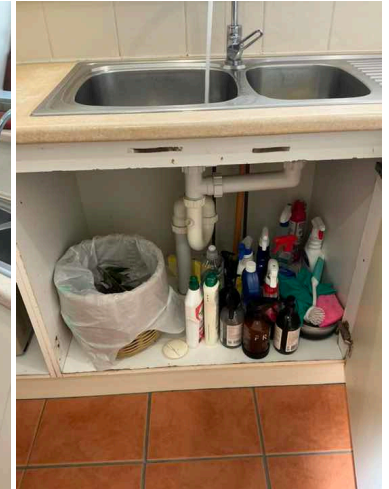
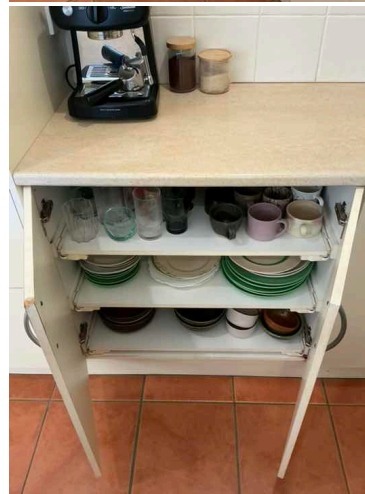
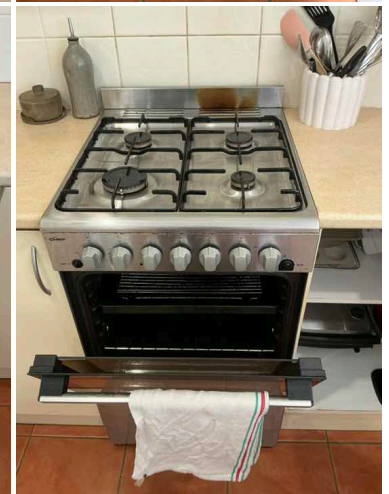
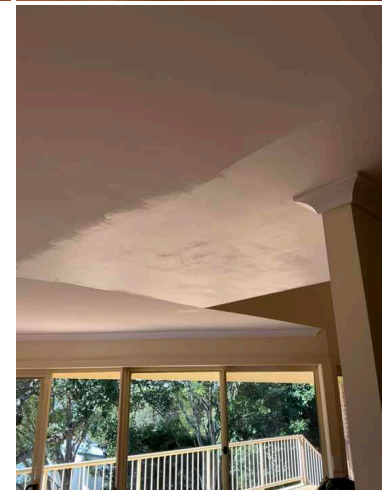
On inspection, defects were present that will require further assessing and recommendations by licensed and qualified trades persons, please read below for details.

No door installed at time of inspection.

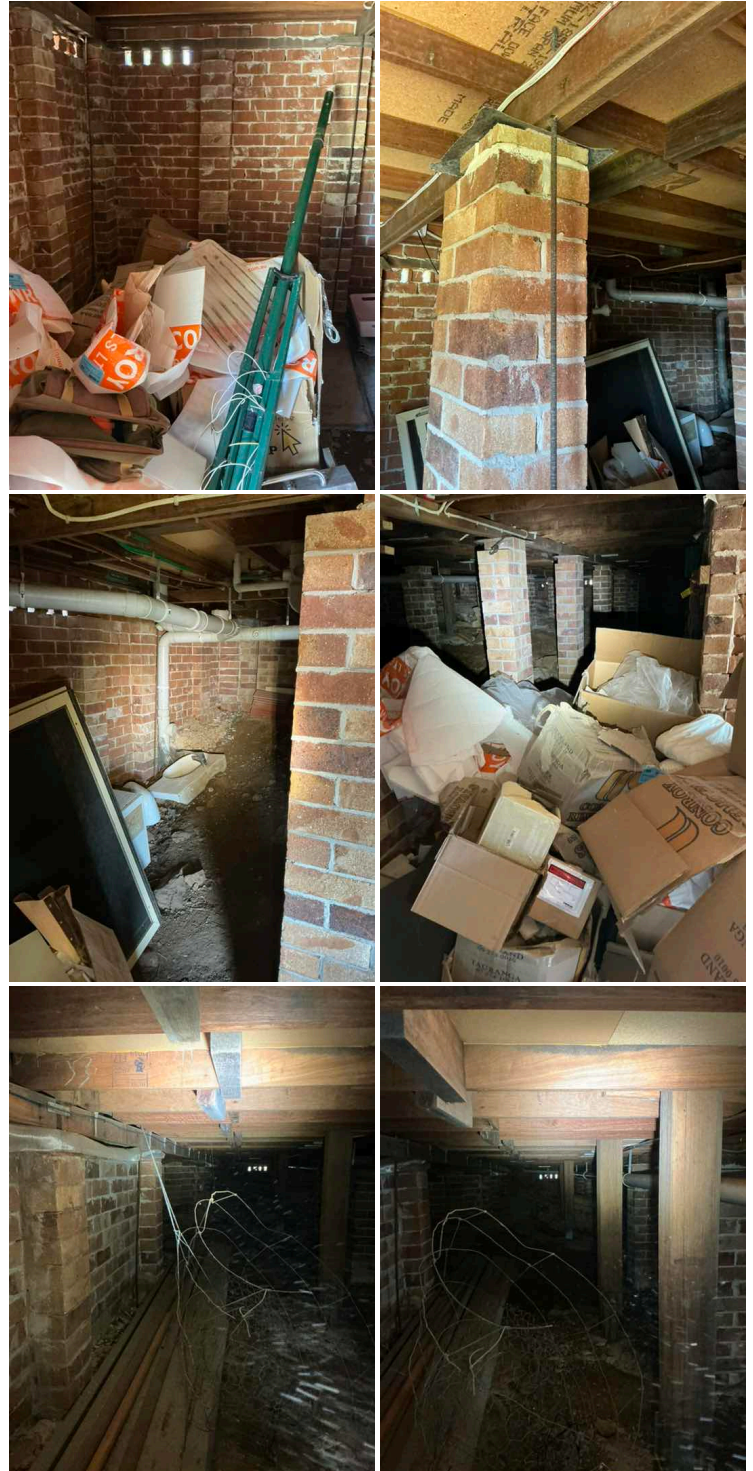
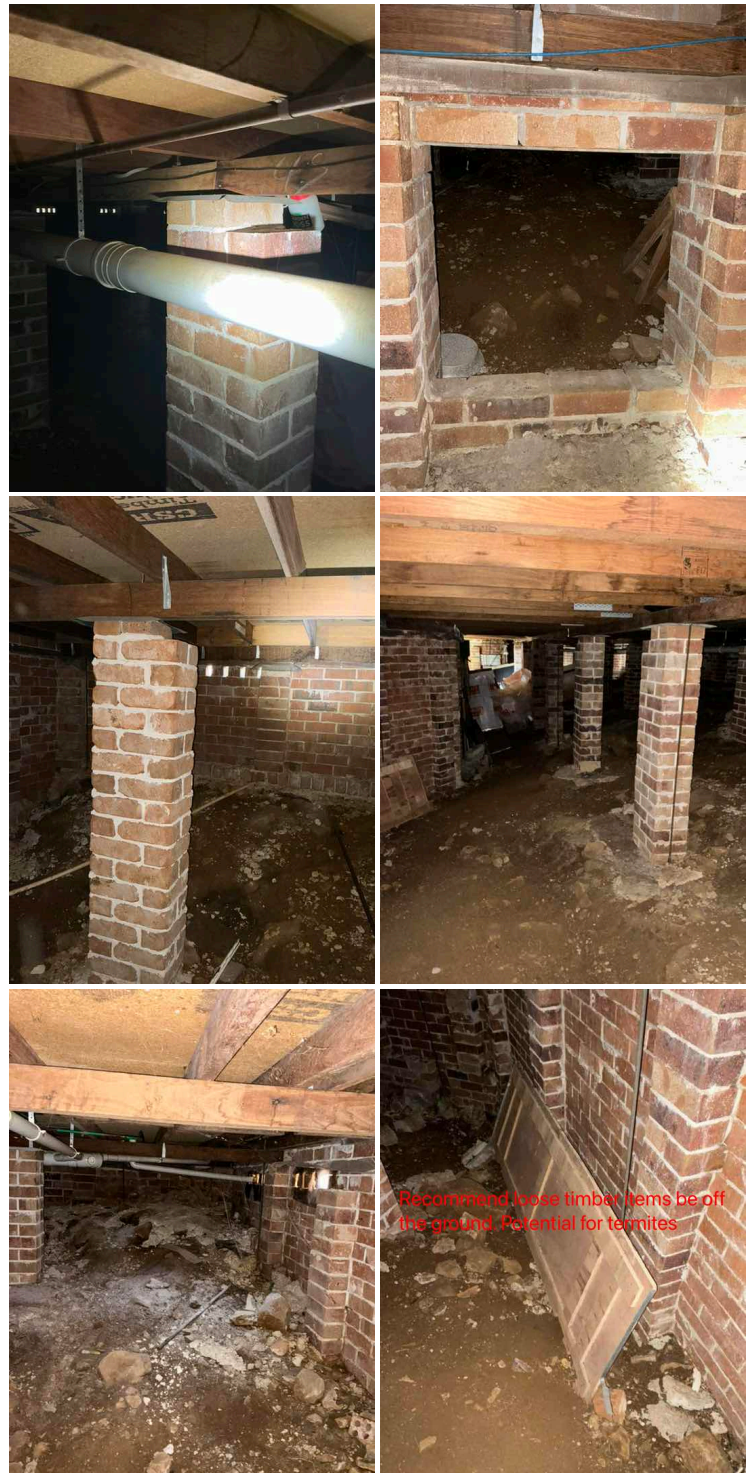
Stored items restricted visual inspection.  
Not all areas/sections of the subfloor could be accessed.

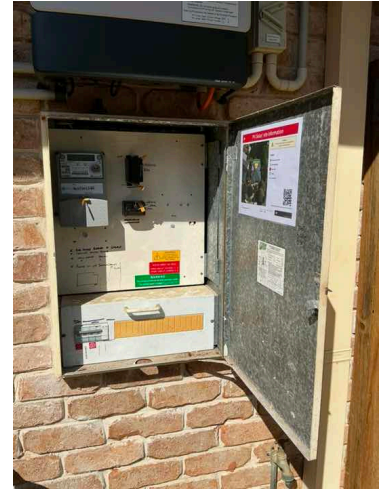
No, a durable notice was not found during the inspection.

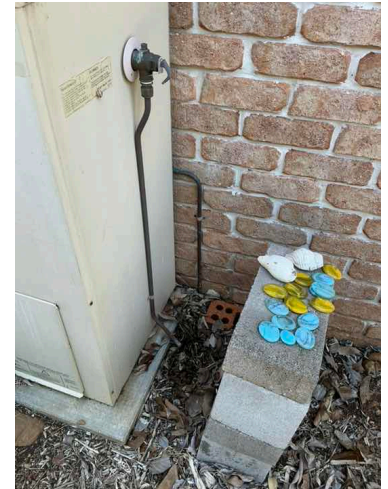
#### **Was the overflow sufficiently drained**

No. Divert hot water overflow away from the building perimeter.
