# Building and Pest Report

91 Newrybar  
Swamp Road  
Kinvara

### Pest And Building Inspection

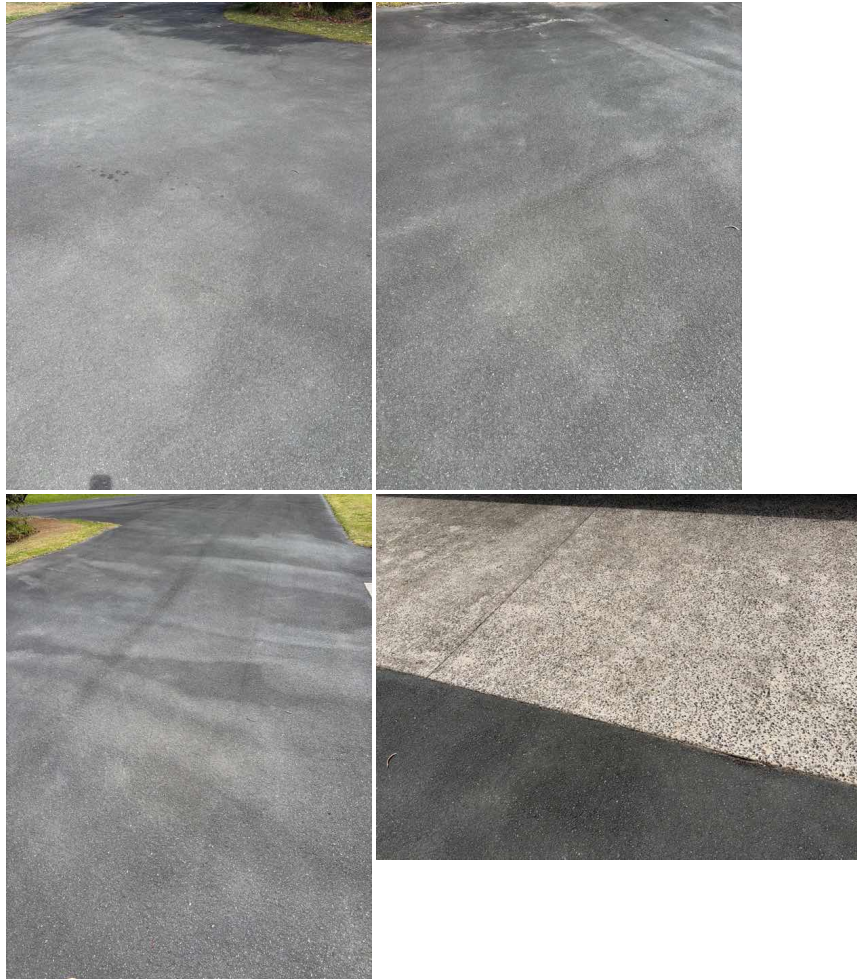
On visual inspection, the general condition of the driveway is serviceable.

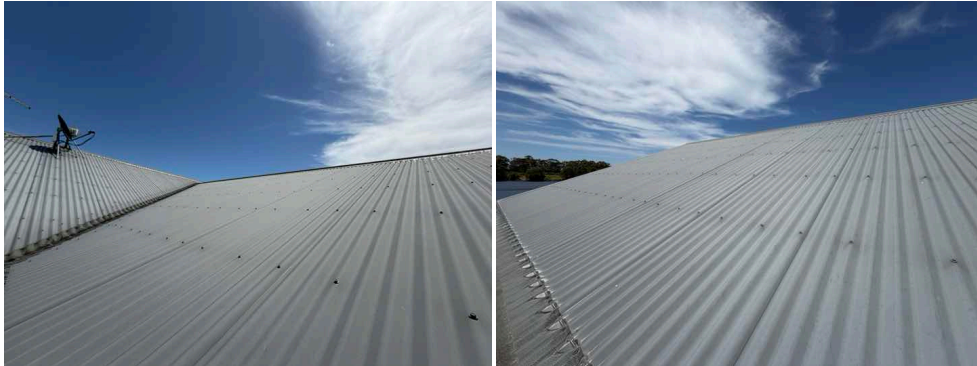
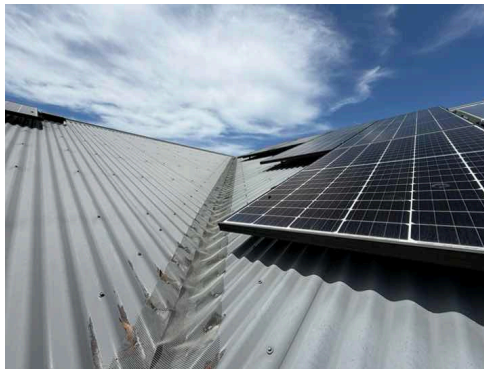
Of the visible areas, the general condition of the roof is in serviceable condition for the age.

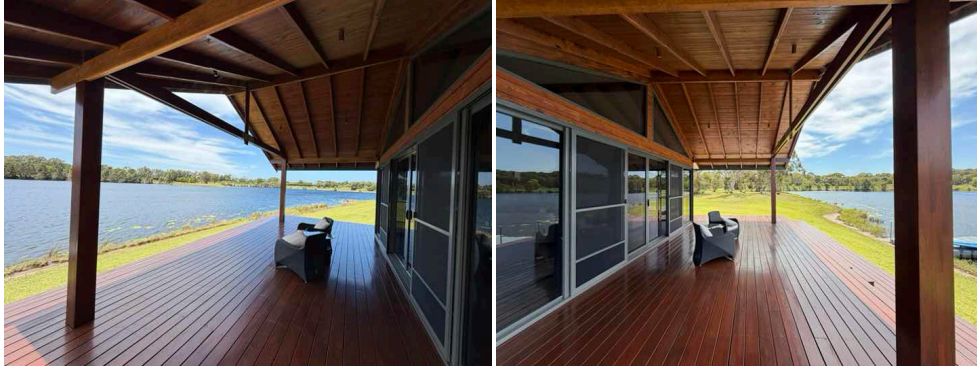
Visible sections of the Alfresco area are serviceable or in reasonable or condition for the age of this dwelling.

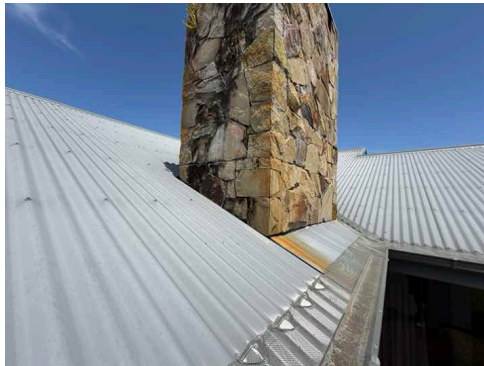
On visual inspection, the general condition of the chimney walls is serviceable for the age.

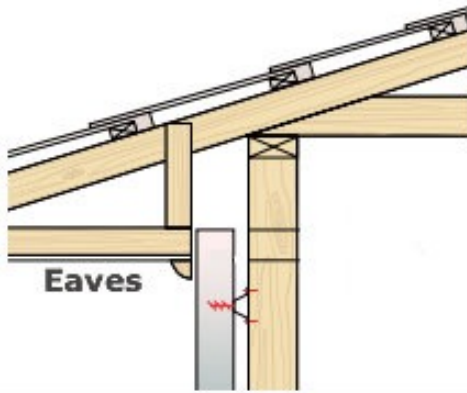
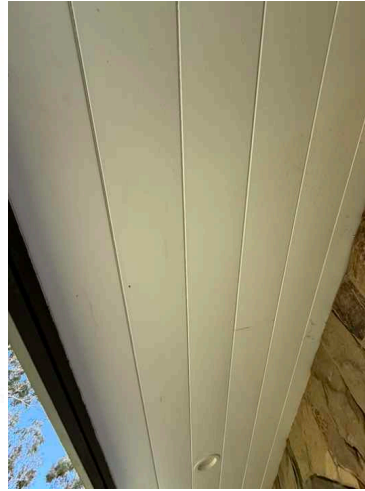
The soffit lining (eaves) are in a serviceable condition with no notable defects.

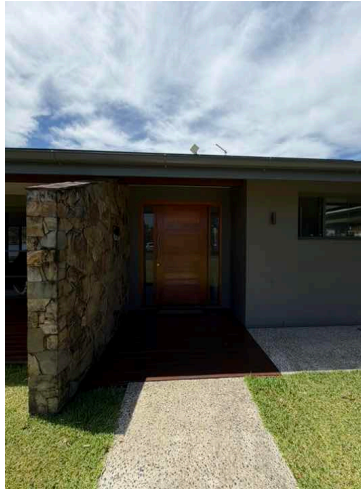
The entry porch serviceable or in reasonable or condition for the age of this dwelling.

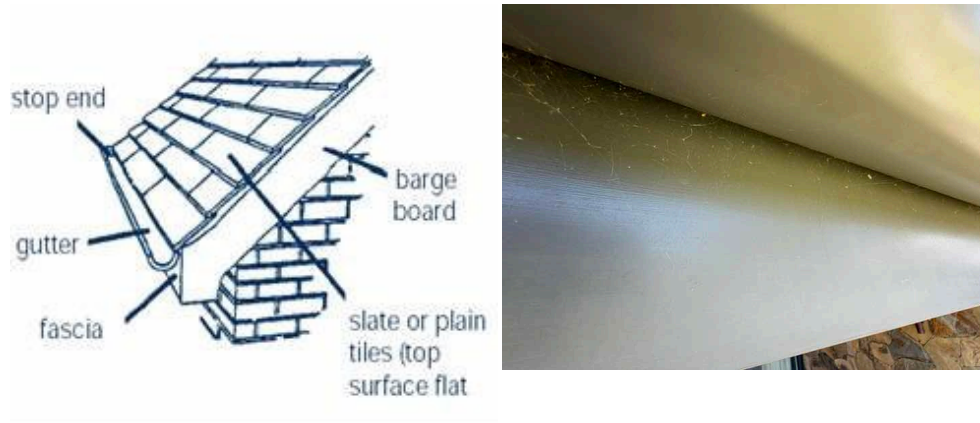
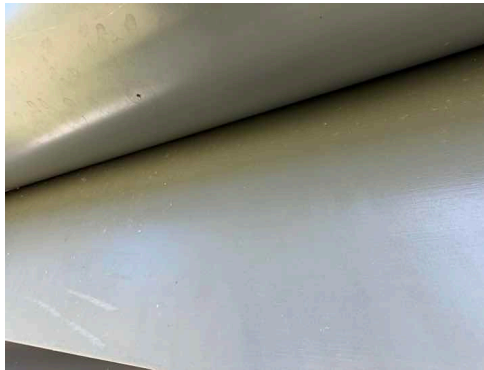
On visual inspection, the general condition of the fascia/barge boards is serviceable.

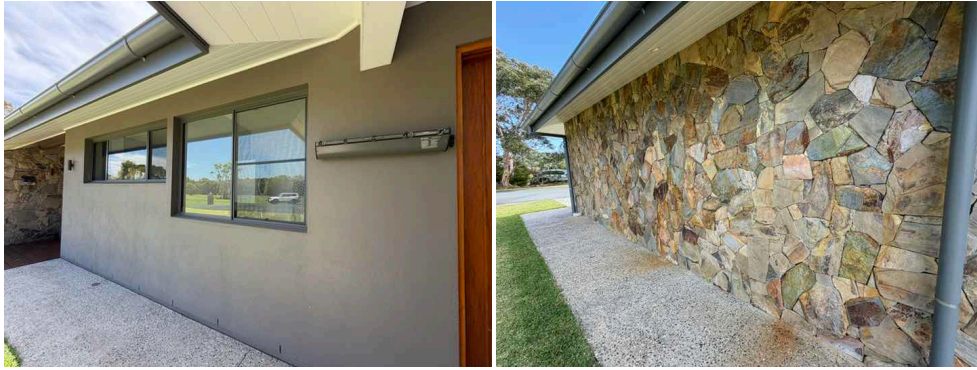
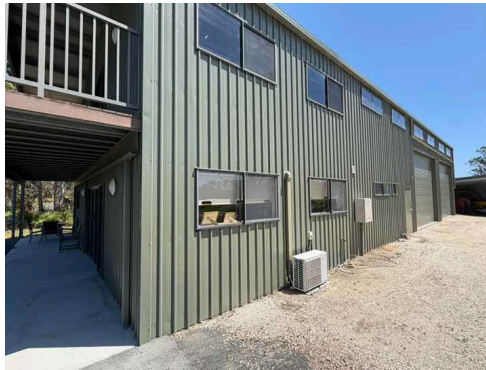
On visual inspection, the general condition of the exterior walls is serviceable for the age.

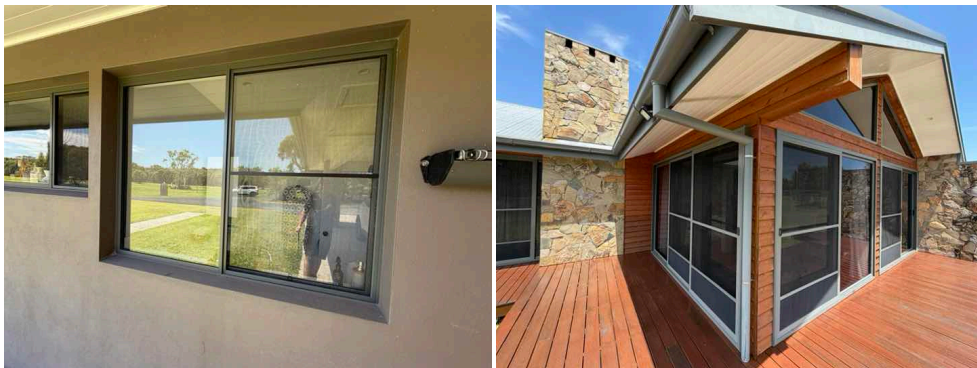
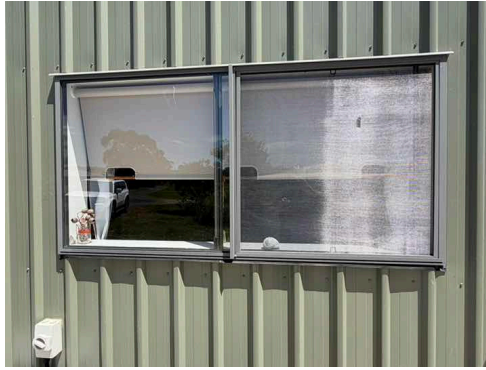
On visual inspection, the general condition of the windows is serviceable for the age.

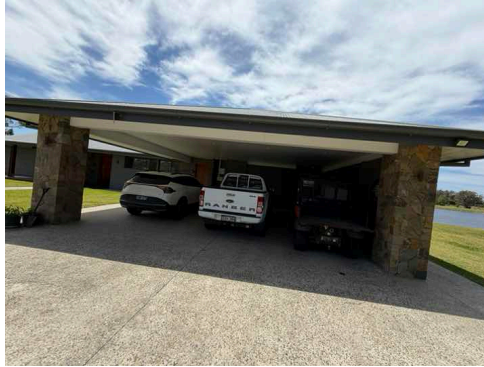
The overall condition of the carport is serviceable for the age.

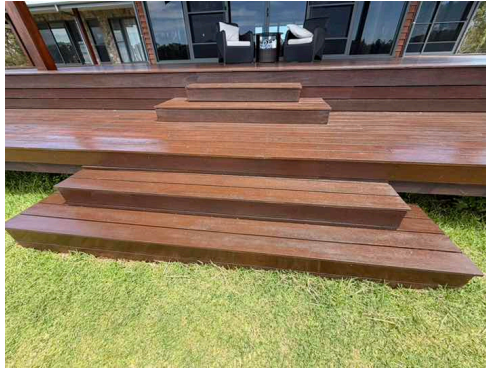
The stairs/steps appear to be serviceable with no notable defects.

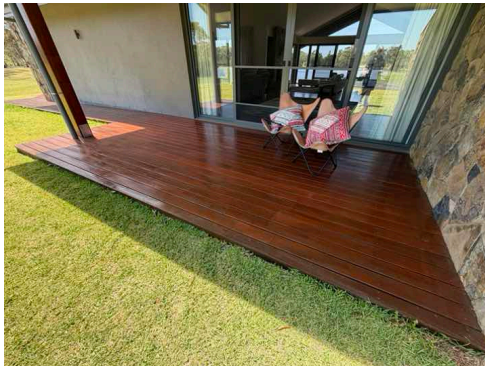
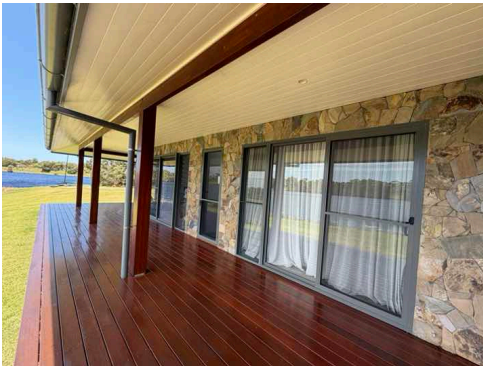
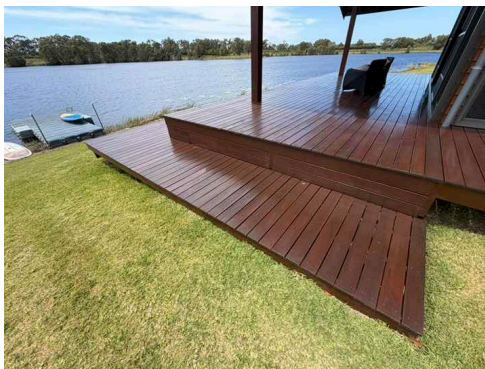
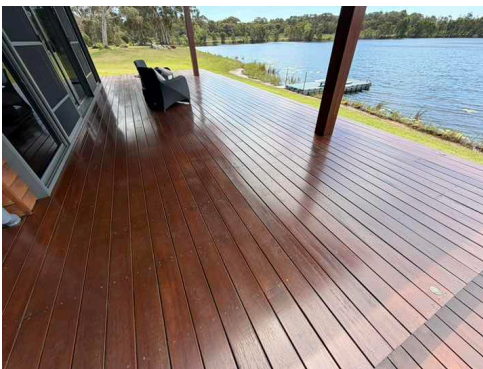
Of areas visible, the decking appears to be in a serviceable condition.

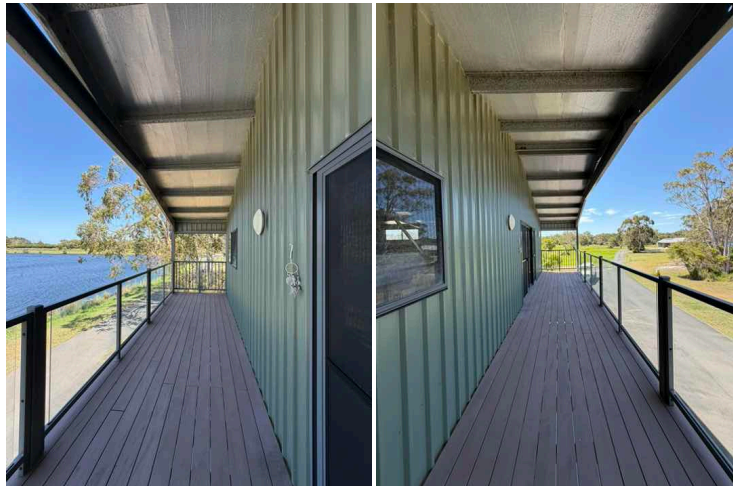
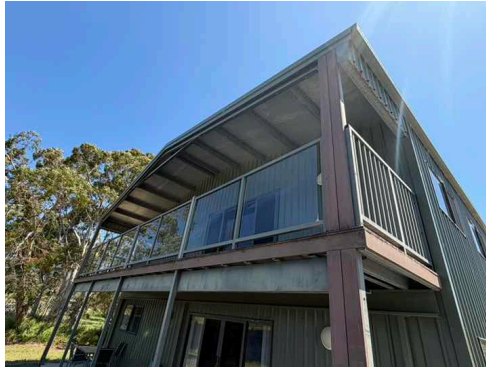
Though we are not structural engineers the balcony/s appear to be in a serviceable condition.

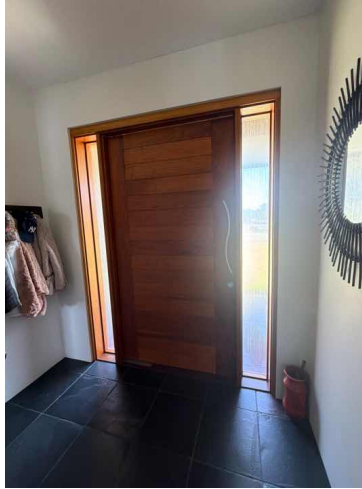
The doors are in serviceable condition with no notable defects observed.

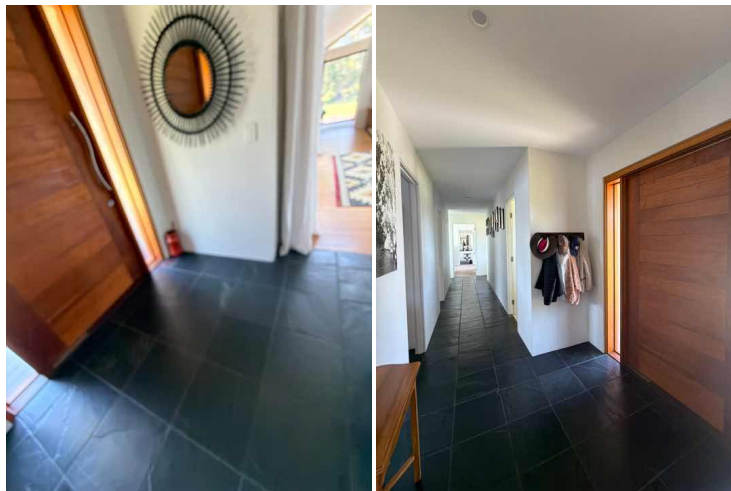
From the visible and accessible areas, this area appears to be in a serviceable condition for the age of the property with no notable structural defects sighted.

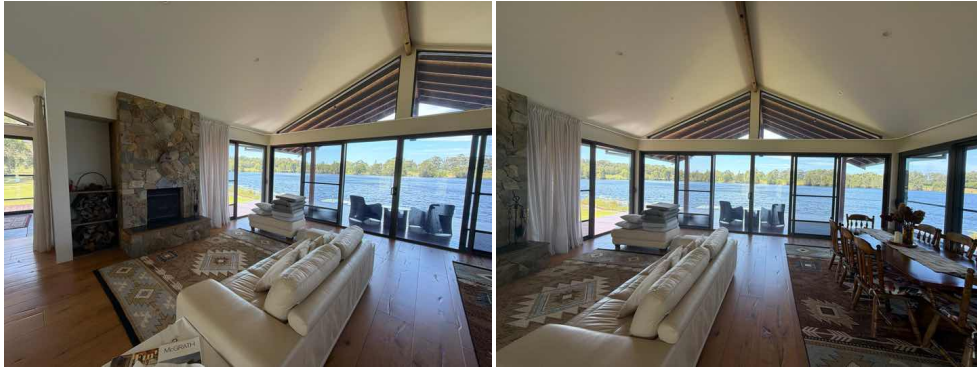
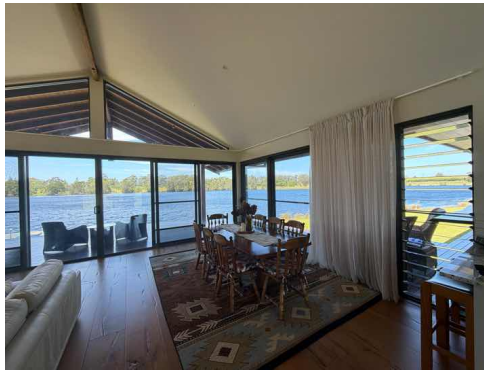
From the visible and accessible areas, this room appears to be in a serviceable condition for the age of the property with no notable structural defects sighted.

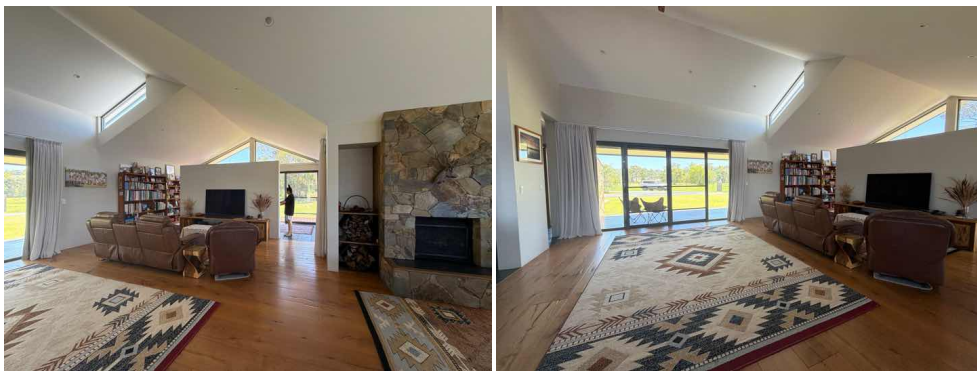
From the visible and accessible areas, this room appears to be in a serviceable condition for the age of the property with no notable structural defects sighted.

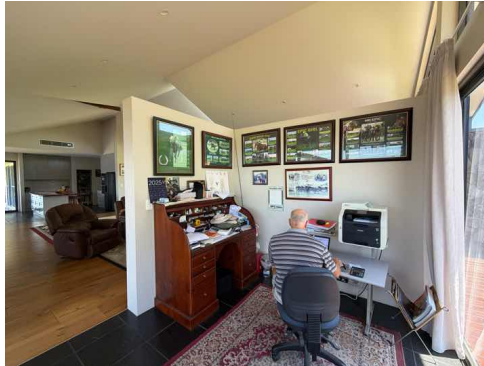
From the visible and accessible areas, this room appears to be in a serviceable condition for the age of the property with no notable structural defects sighted.

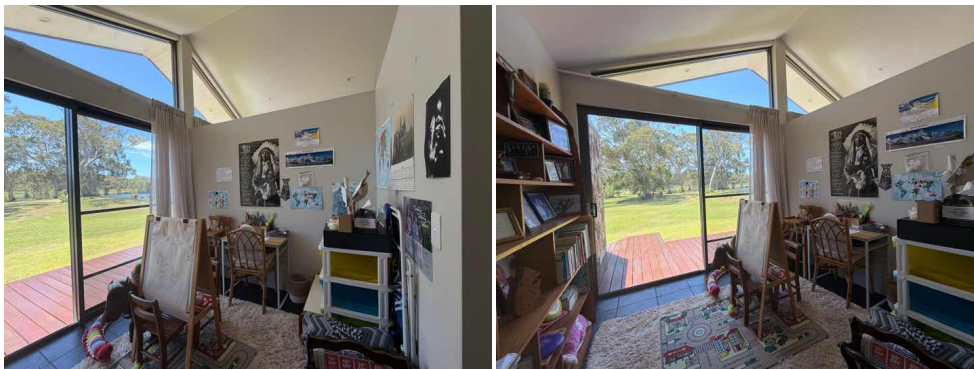
From the visible and accessible areas, this room appears to be in a serviceable condition for the age of the property with no notable structural defects sighted.

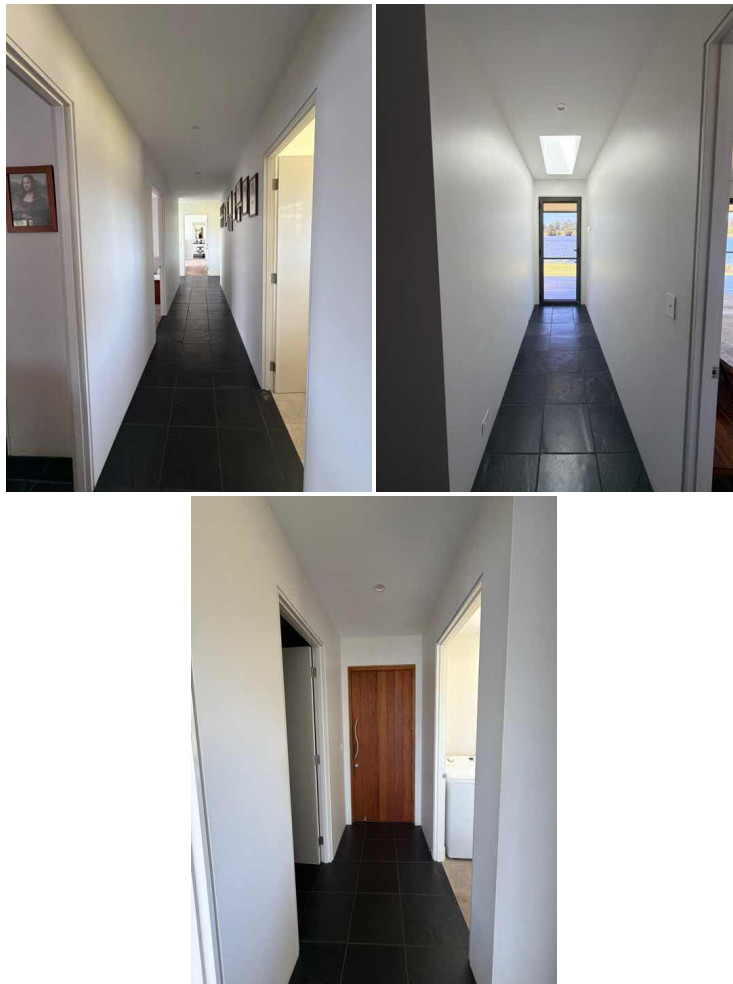
From the visible and accessible areas, the hallway/s appears to be in a serviceable condition for the age of the property with no notable structural defects sighted.

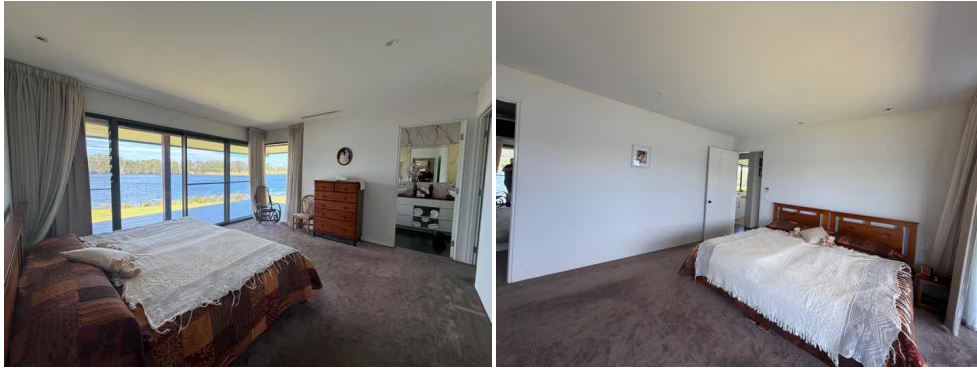
From the visible and accessible areas, this bedroom appears to be in a serviceable condition for the age of the property with no notable structural defects sighted.

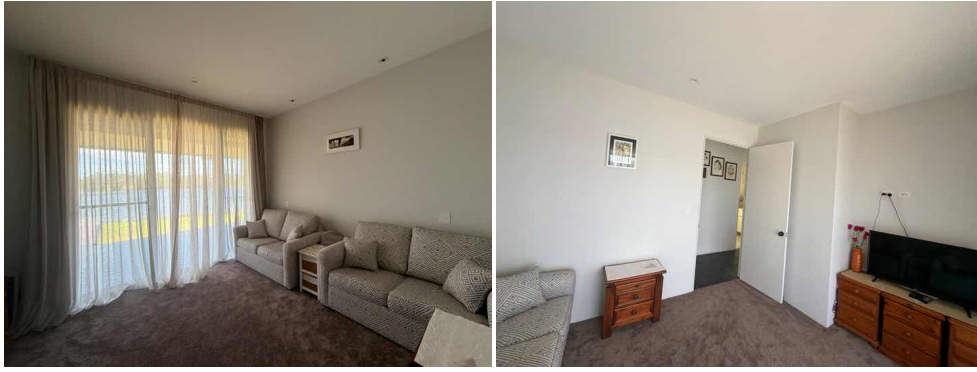
From the visible and accessible areas, this bedroom appears to be in a serviceable condition for the age of the property with no notable structural defects sighted.

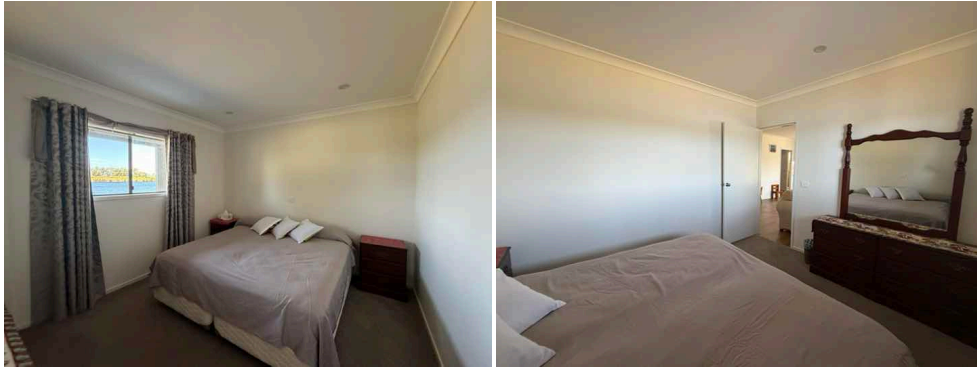
From the visible and accessible areas, this bedroom appears to be in a serviceable condition for the age of the property with no notable structural defects sighted.

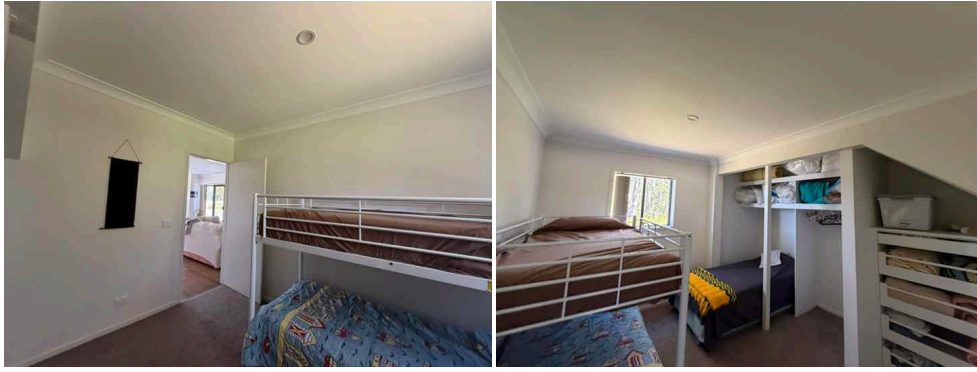
From the visible and accessible areas, this bedroom appears to be in a serviceable condition for the age of the property with no notable structural defects sighted.

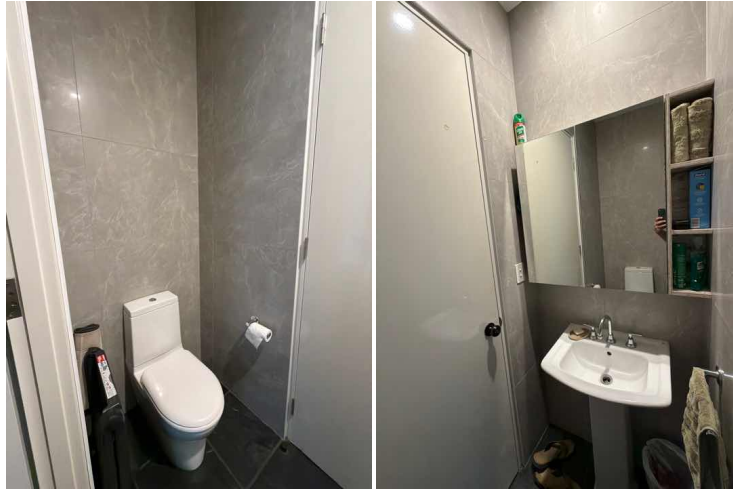
Of the visible areas, the general condition of this bathroom is serviceable or in reasonable condition for age of dwelling.

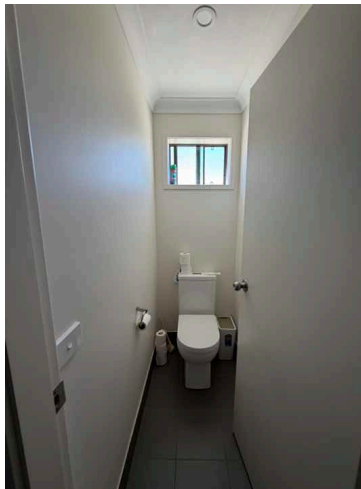
Of the visible areas, the general condition of this bathroom is serviceable or in reasonable condition for age of dwelling.

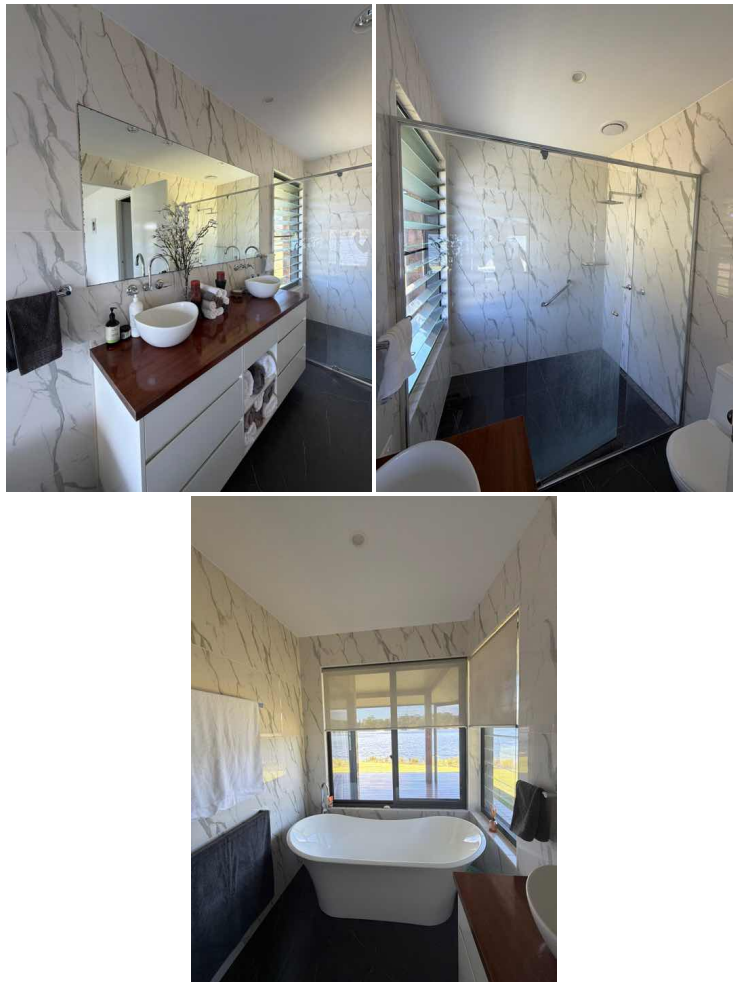
Of the visible areas, the general condition of this bathroom is serviceable or in reasonable condition for age of dwelling.

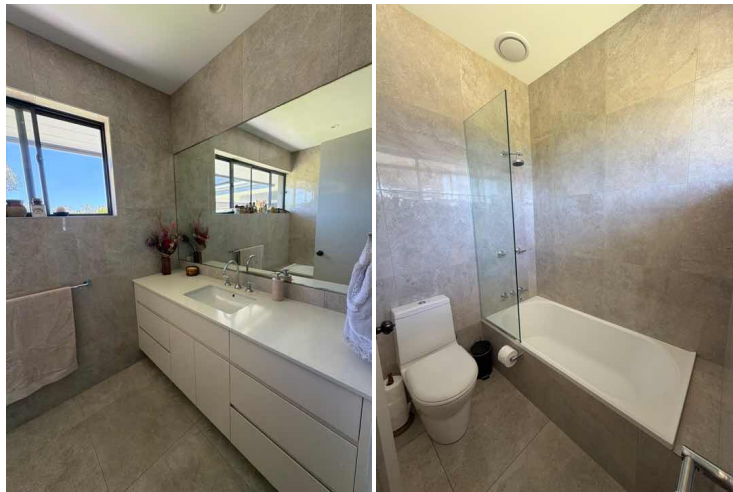
Of the visible areas, the general condition of this bathroom is serviceable or in reasonable condition for age of dwelling.

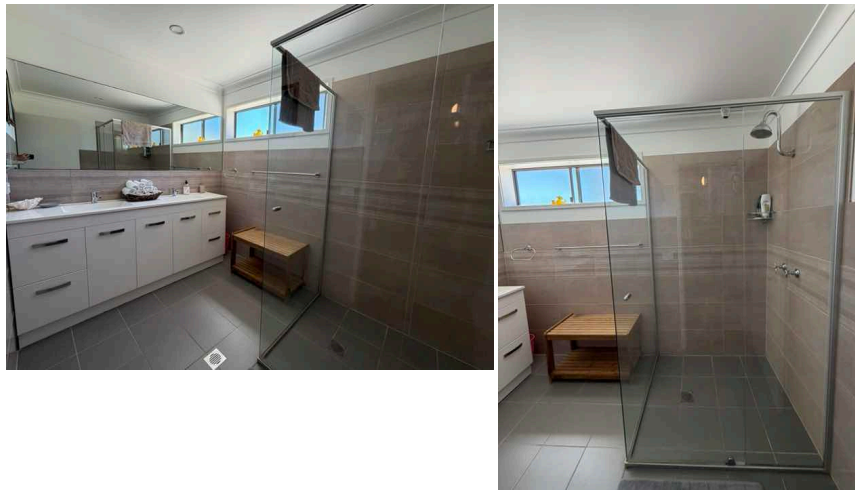
### **Bathroom 3**

Of the visible areas, the general condition of this bathroom is serviceable or in reasonable condition for age of dwelling.

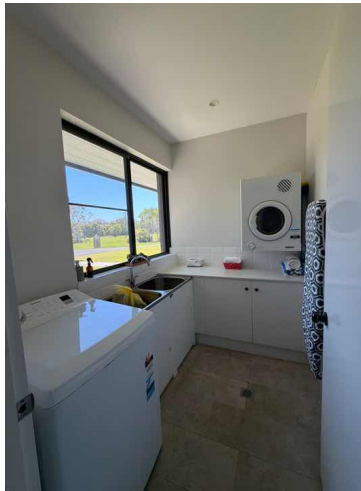
Of the visible areas, the general condition of the laundry is serviceable or in reasonable condition for age of dwelling.

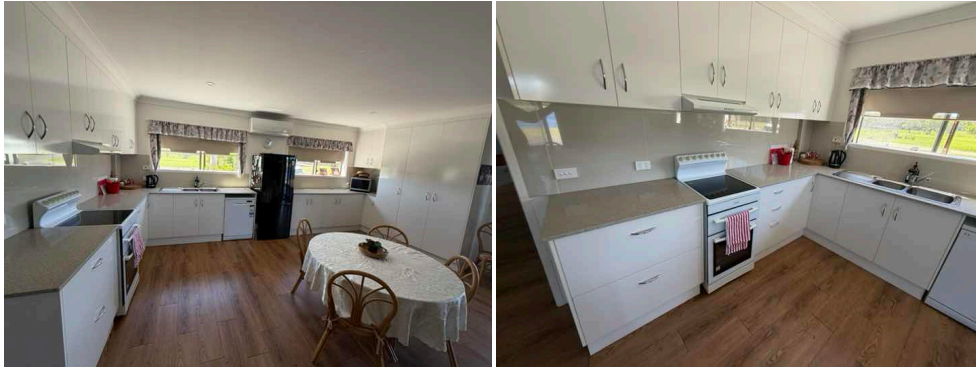
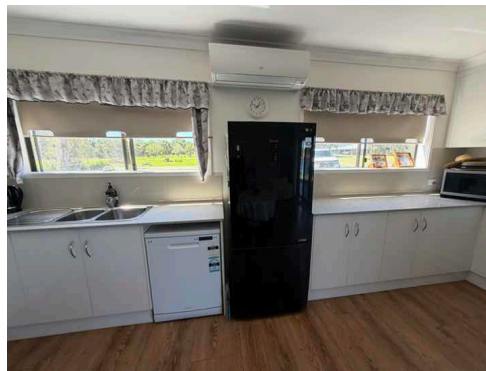
Of the visible areas, the general condition of the kitchen and pantry is serviceable or in reasonable condition for age of dwelling.

Adjustment to cabinet doors required, in some instance hinges may need to be replaced.

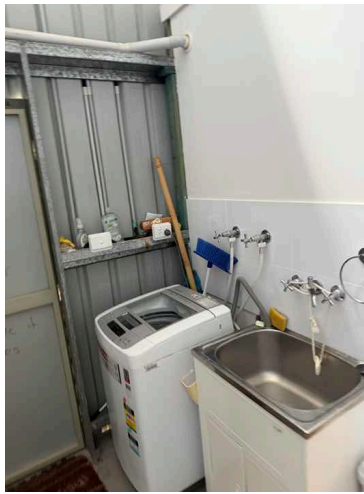
Of the visible areas, the general condition of the laundry is serviceable or in reasonable condition for age of dwelling.

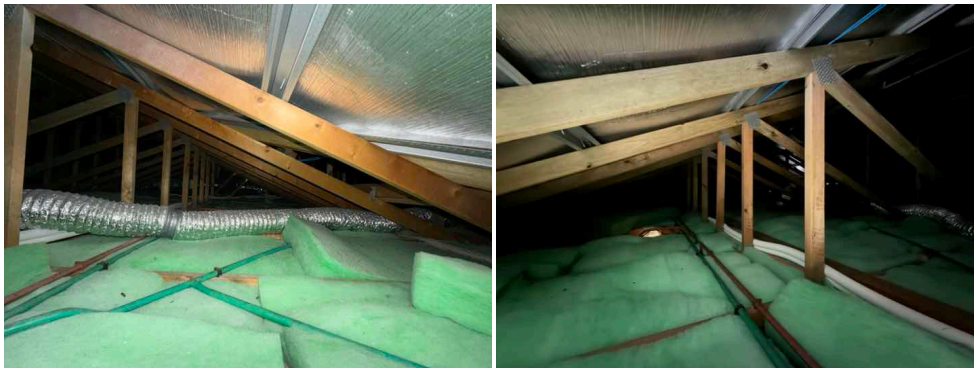
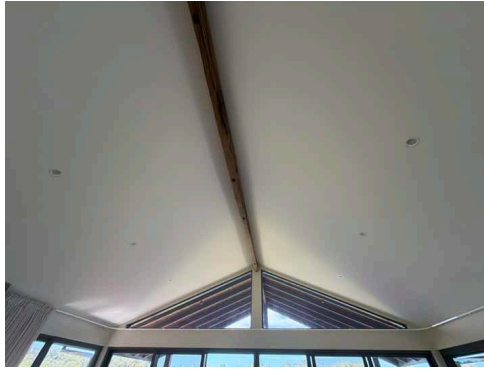
Cathedral/Raked ceiling design - No crawl space. It is strongly recommended that full access be gained as it could be harbouring timber pest activity, damage or defects.

There is insulation present in the roof space/void. This is preventing a full inspection of ceiling joists from being undertaken. It is strongly recommended that full access be gained as it could be harbouring timber pest activity, damage or defects.

There is sarking present in the roof space/void. This is preventing a full inspection from being undertaken. It is strongly recommended that full access be gained as it could be harbouring timber pest activity, damage or defects.

Visible sections of the roof void is in a serviceable condition for age of this dwelling.
