Inspection Report

Naraic Building & Pest Inspections Pty Ltd

36 Gibbon St, Lennox Head, NSW, 2478

Pest And Building Inspection

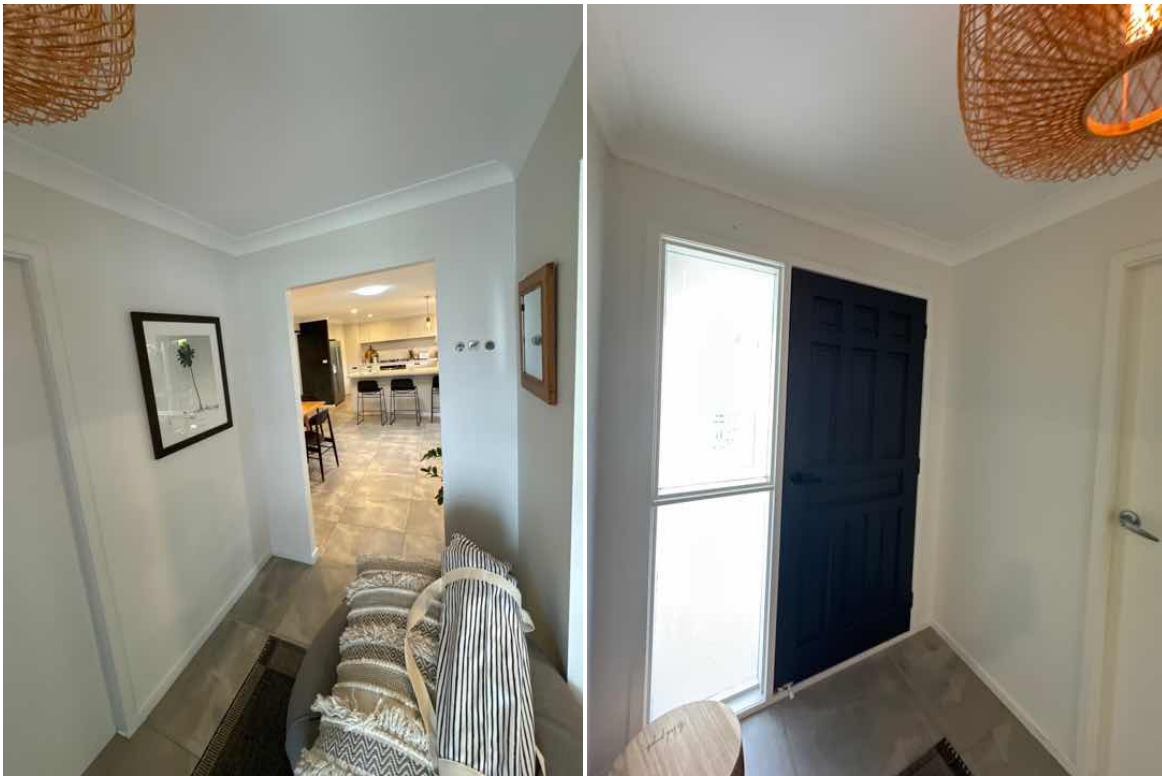
From the visible and accessible areas, this area appears to be in a serviceable condition for the age of the property with no notable structural defects sighted.

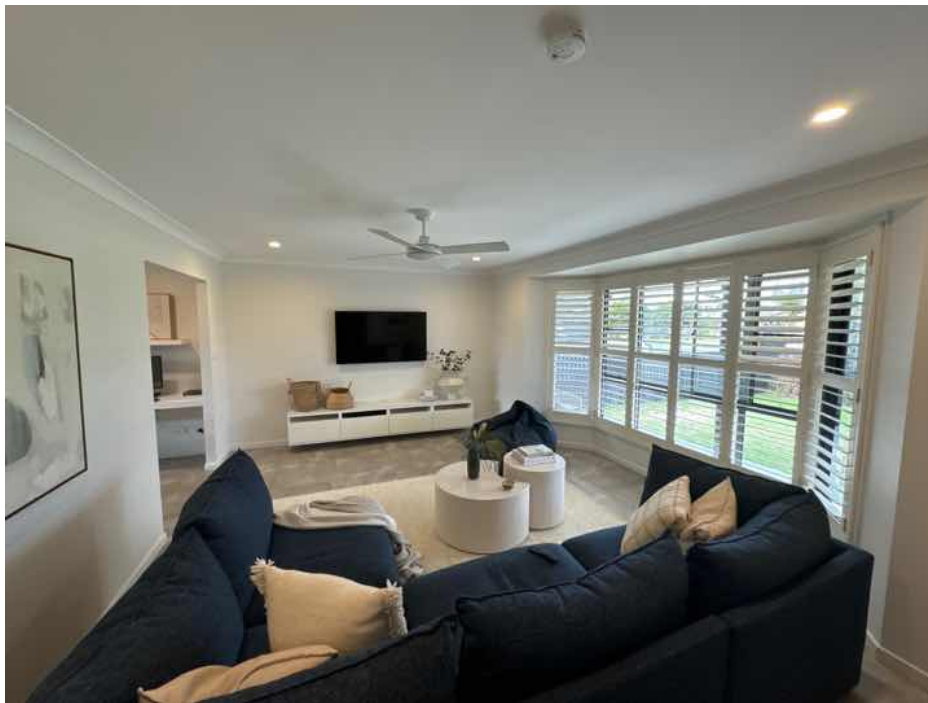
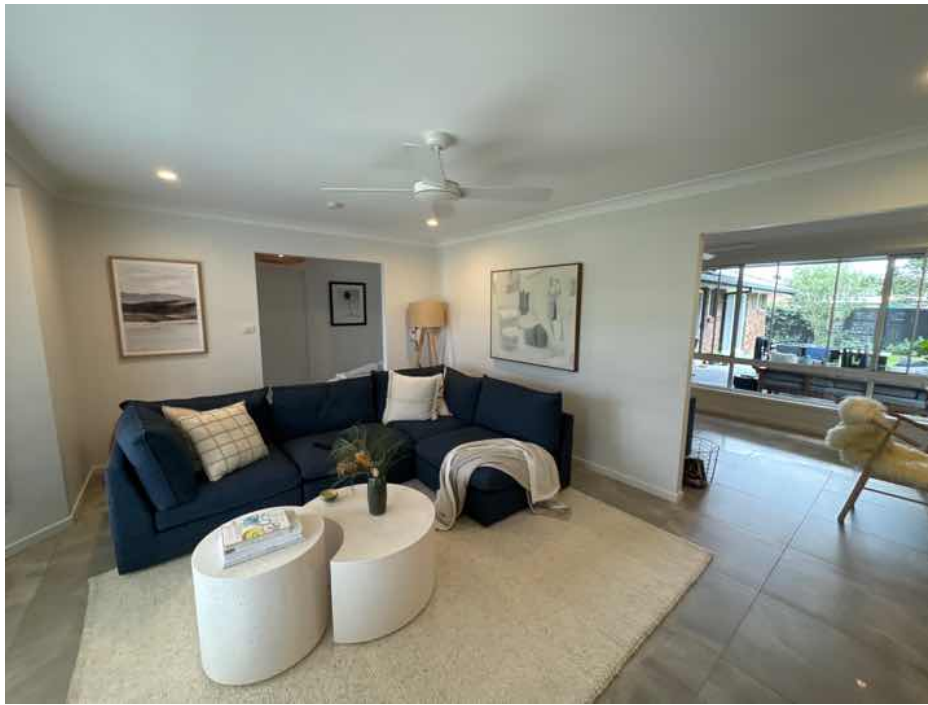
Living Room

From the visible and accessible areas, this room appears to be in a serviceable condition for the age of the property with no notable structural defects sighted.

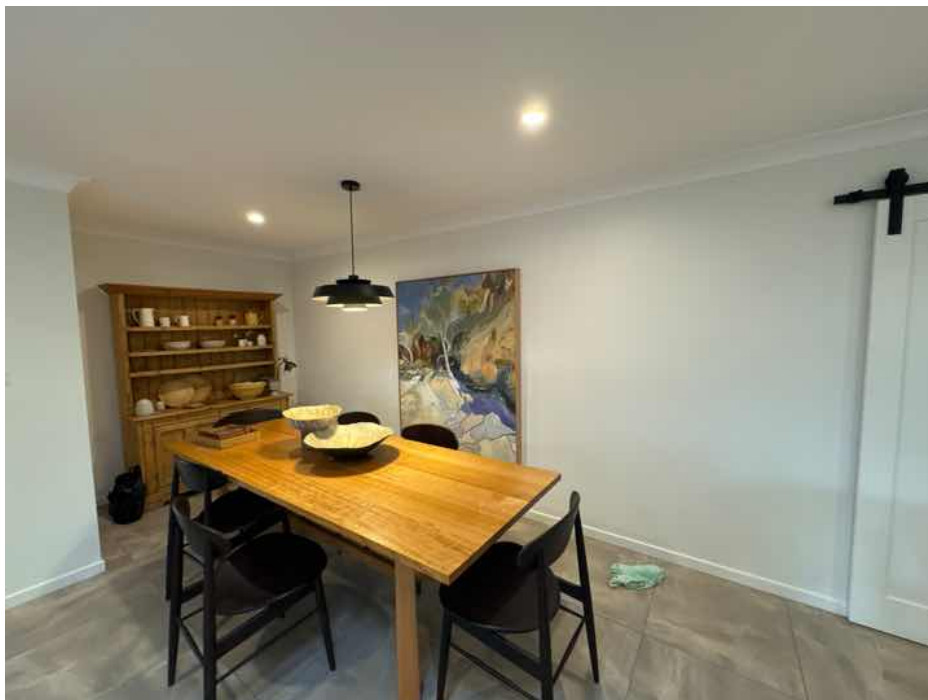
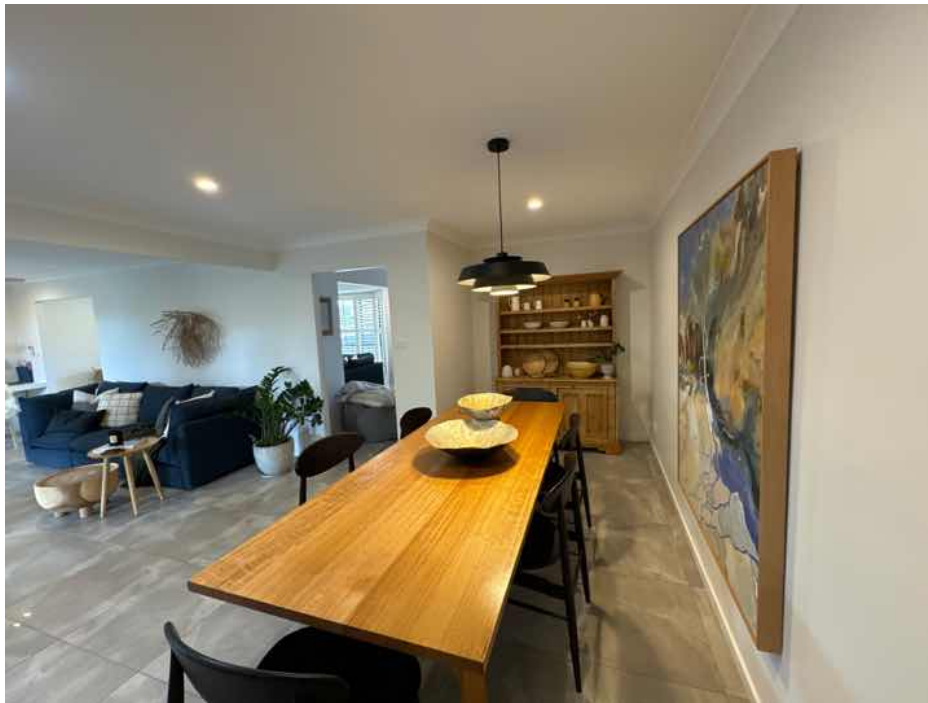
Dining Room

From the visible and accessible areas, this room appears to be in a serviceable condition for the age of the property with no notable structural defects sighted.

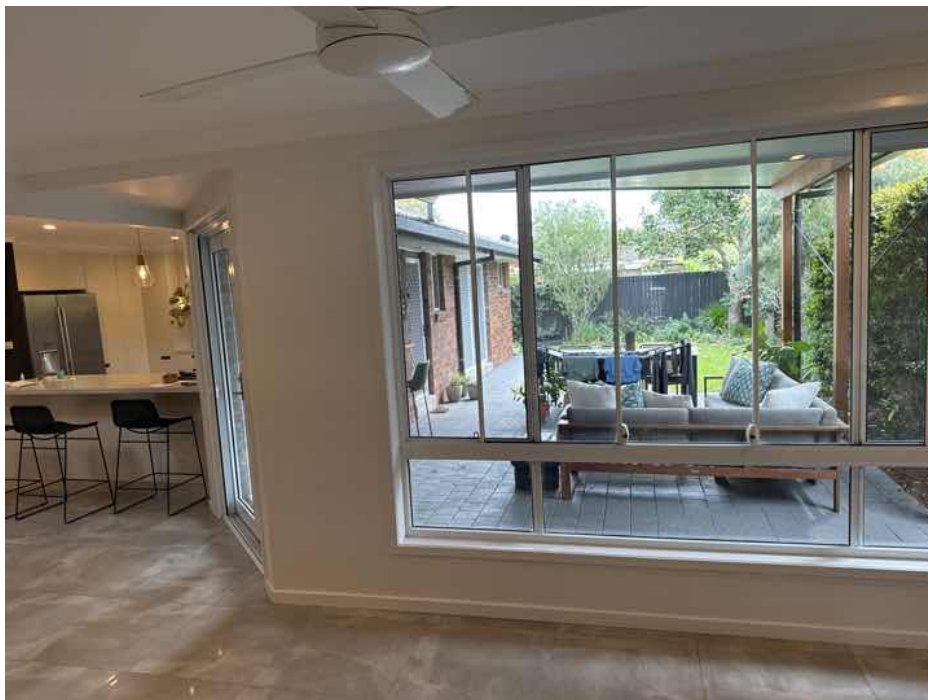
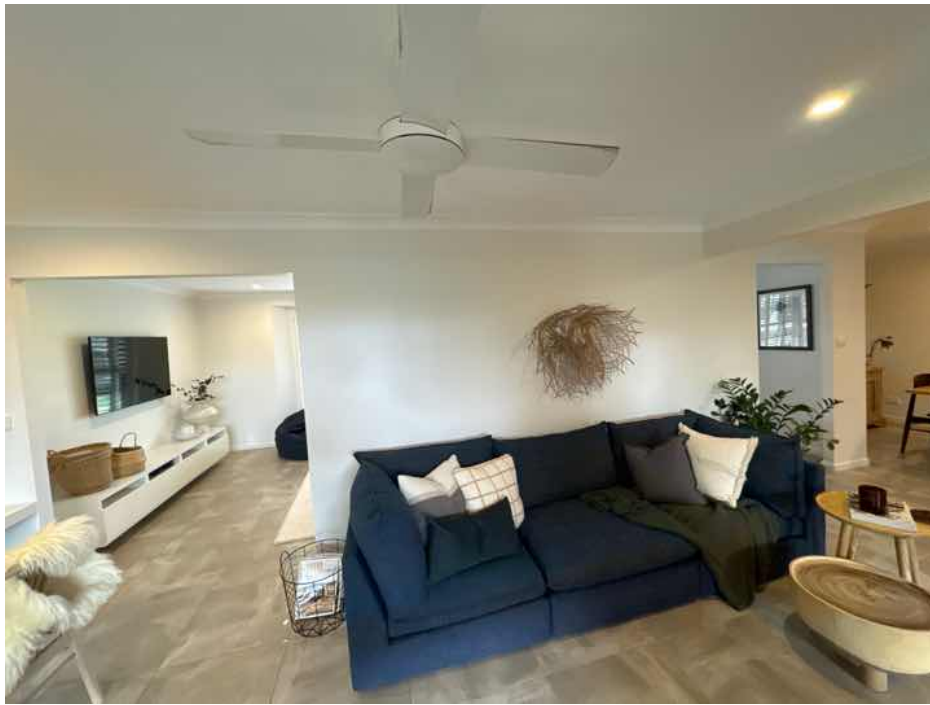
Family Room

From the visible and accessible areas, this room appears to be in a serviceable condition for the age of the property with no notable structural defects sighted.

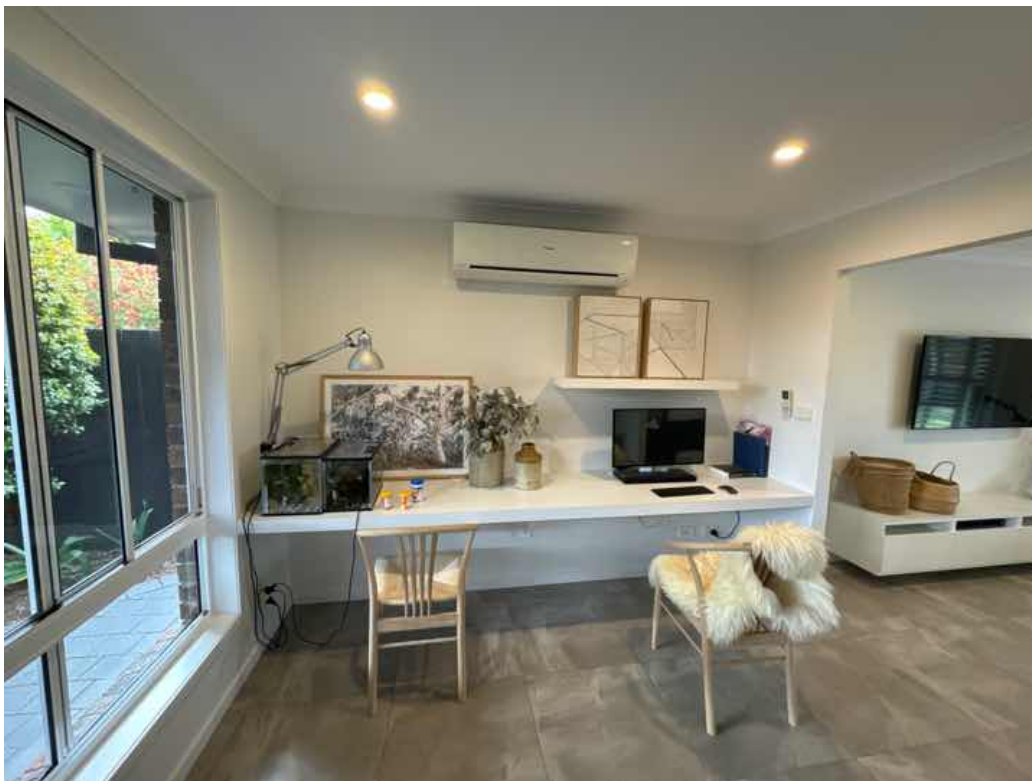
Study

From the visible and accessible areas, this room appears to be in a serviceable condition for the age of the property with no notable structural defects sighted.

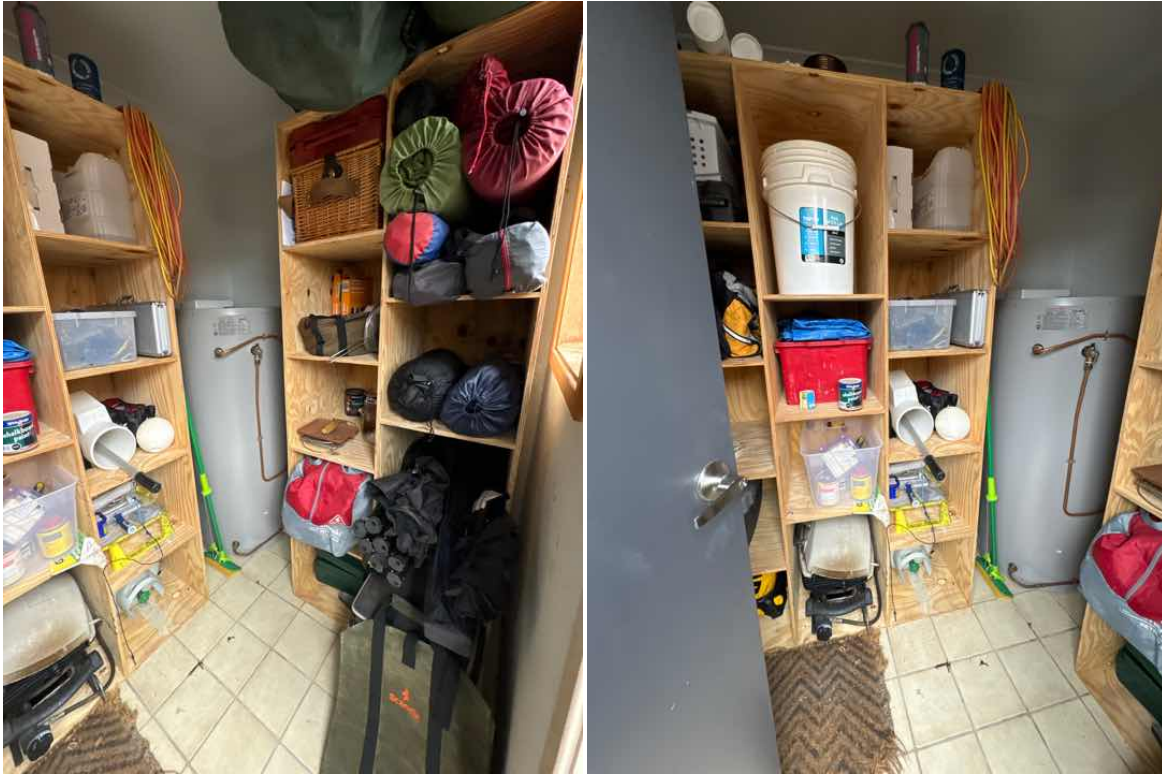
Storage

From the visible and accessible areas, this room appears to be in a serviceable condition for the age of the property with no notable structural defects sighted.

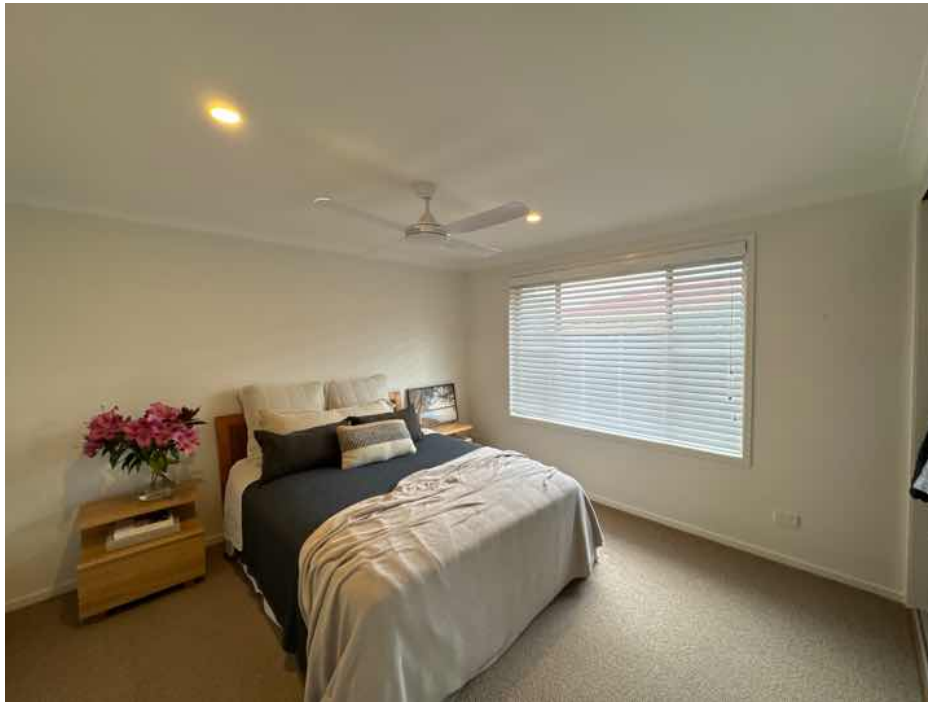
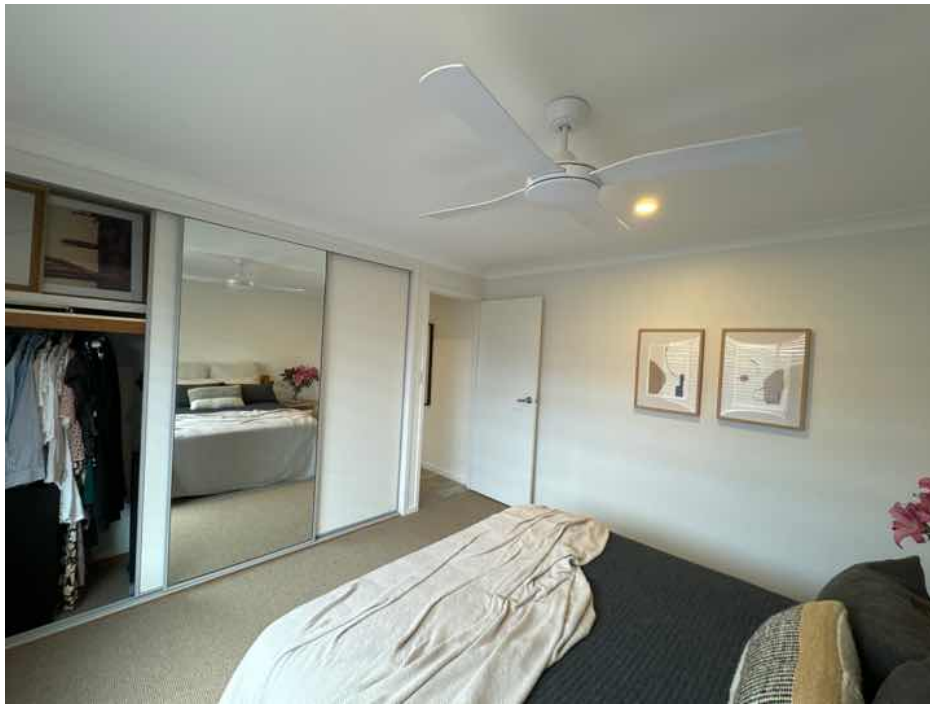
From the visible and accessible areas, this bedroom appears to be in a serviceable condition for the age of the property with no notable structural defects sighted.

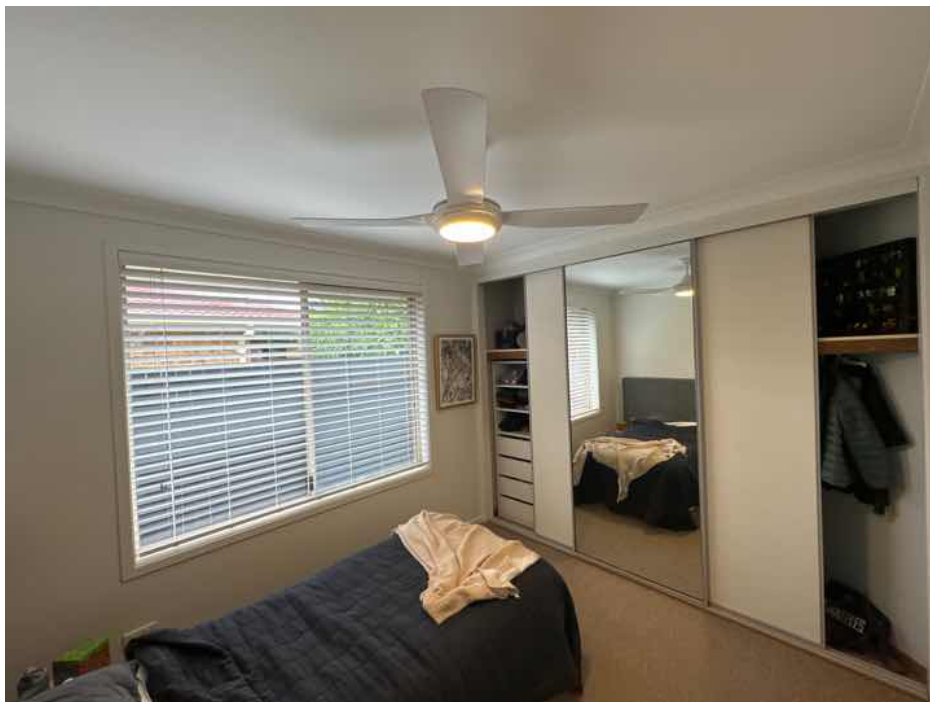
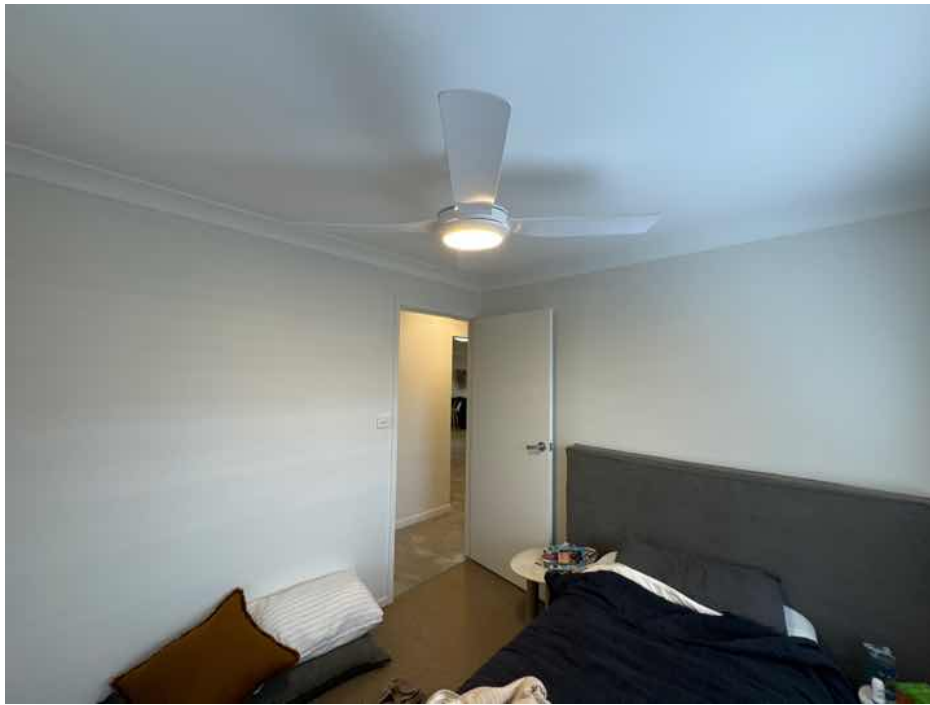
Bedroom 2

From the visible and accessible areas, this bedroom appears to be in a serviceable condition for the age of the property with no notable structural defects sighted.

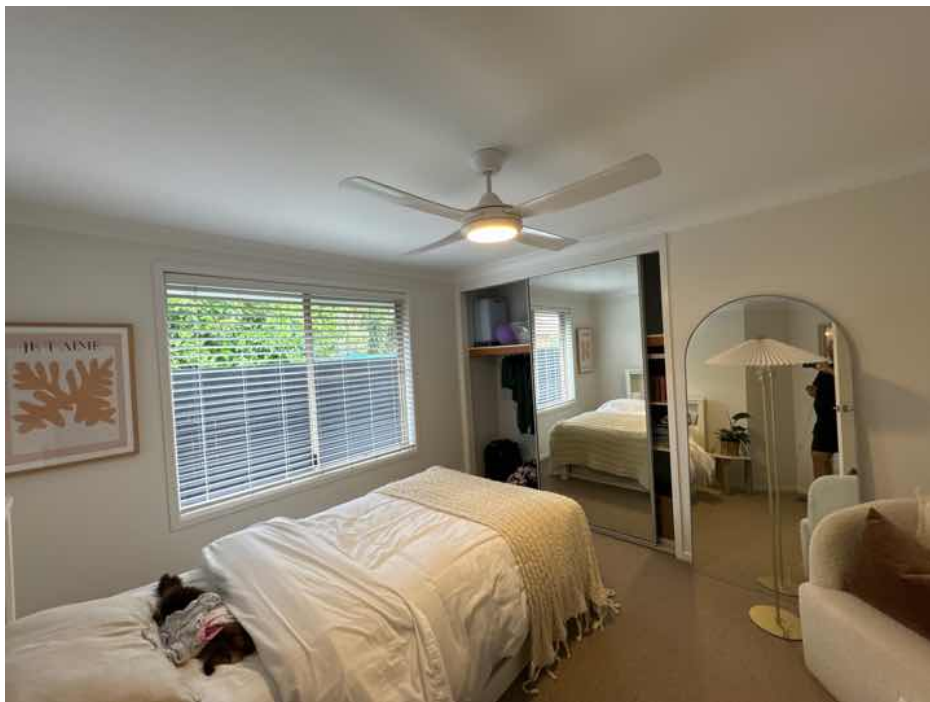
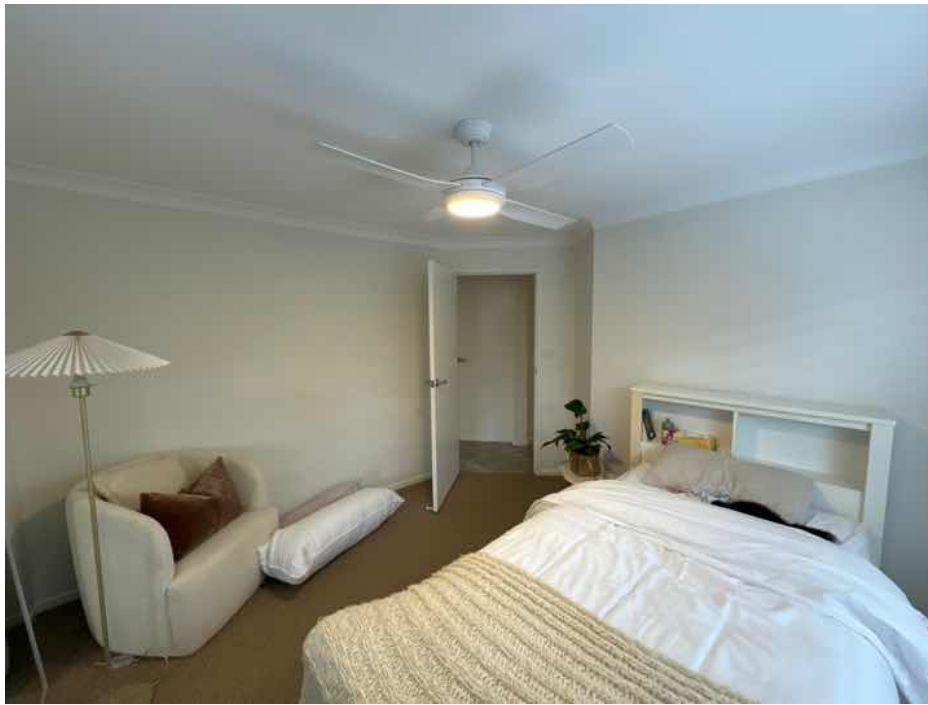
Bedroom 3

From the visible and accessible areas, this bedroom appears to be in a serviceable condition for the age of the property with no notable structural defects sighted.

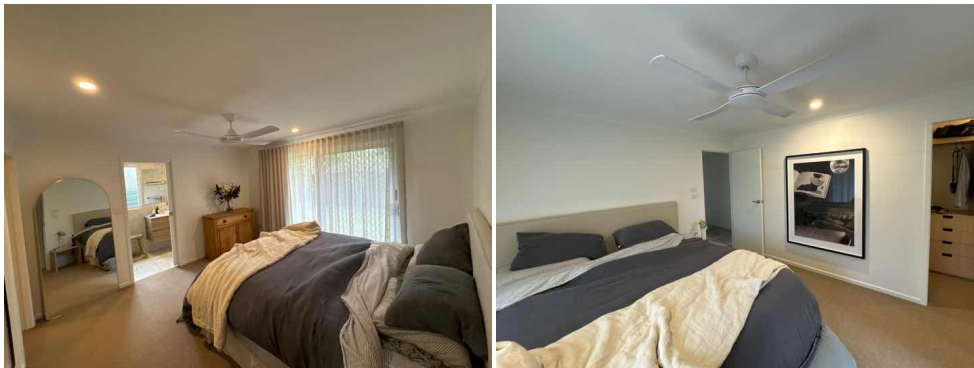
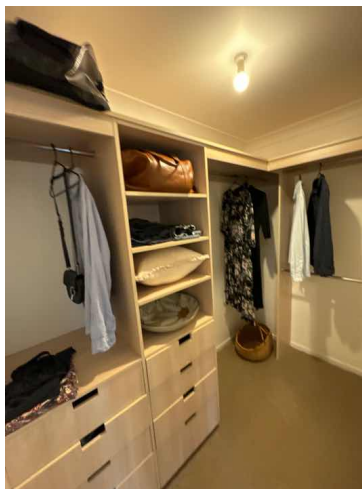
Bedroom 4

From the visible and accessible areas, this bedroom appears to be in a serviceable condition for the age of the property with no notable structural defects sighted.

Stains observed - Steam cleaning may rectify stained areas but they appear entrenched.

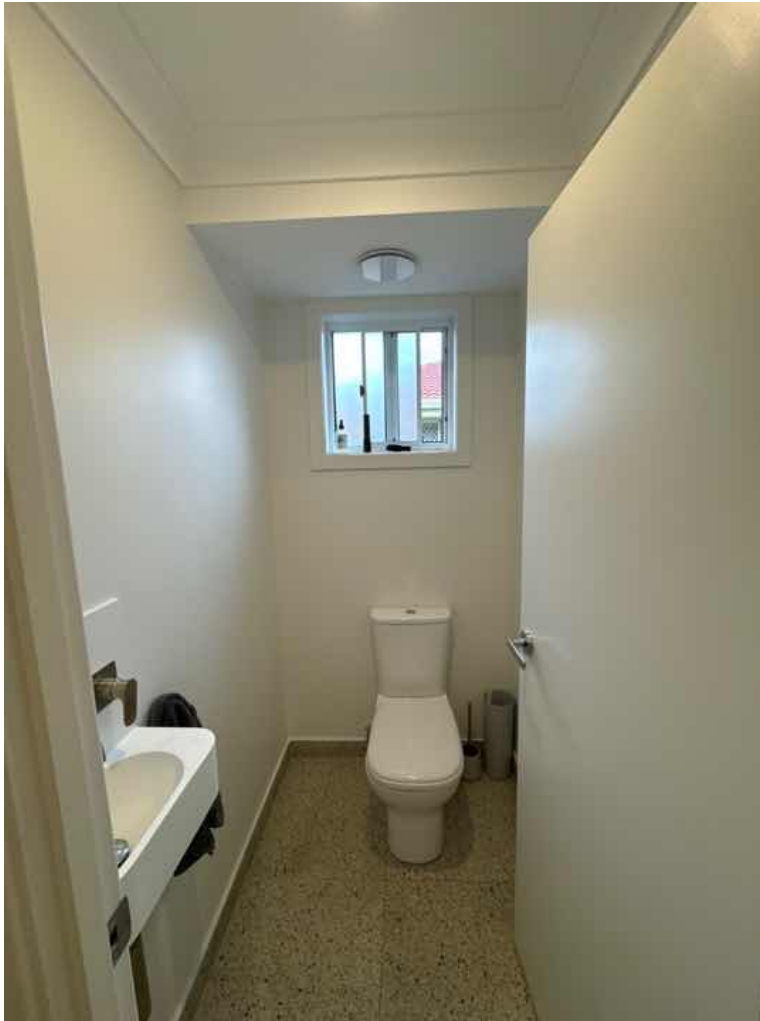
Of the visible areas, the general condition of this bathroom is serviceable or in reasonable condition for age of dwelling.

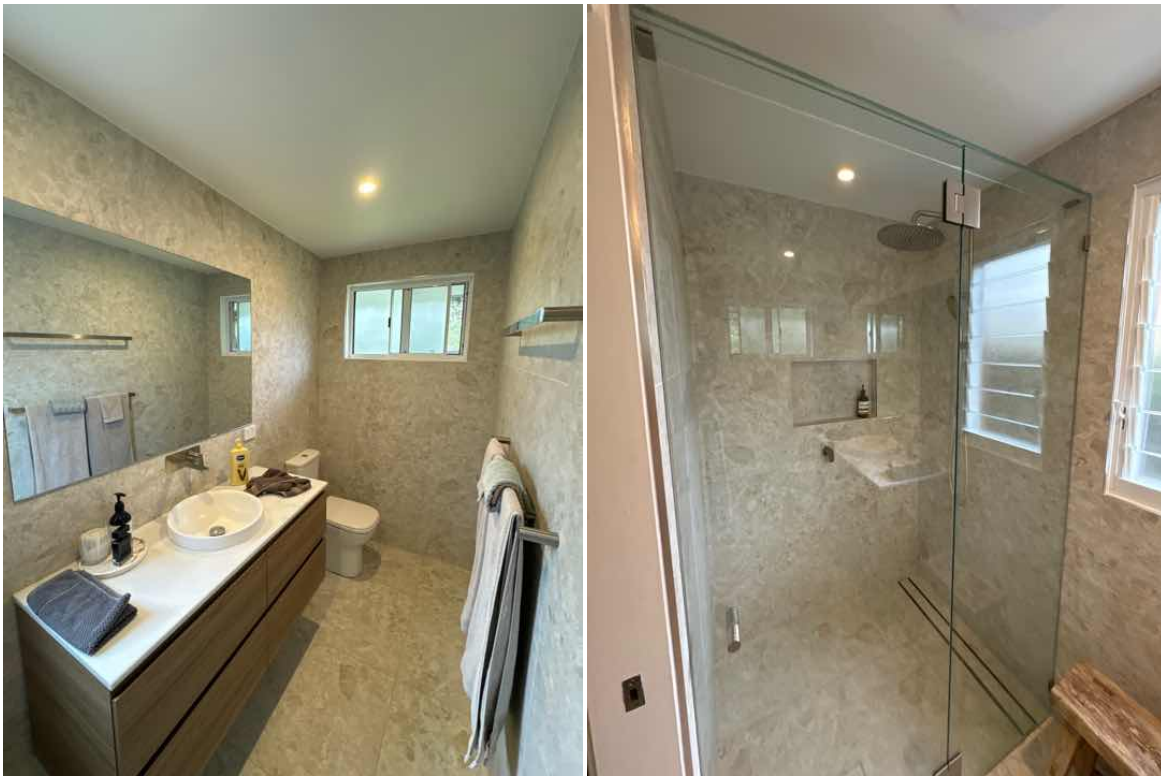
Bathroom 1

Of the visible areas, the general condition of this bathroom is serviceable or in reasonable condition for age of dwelling.

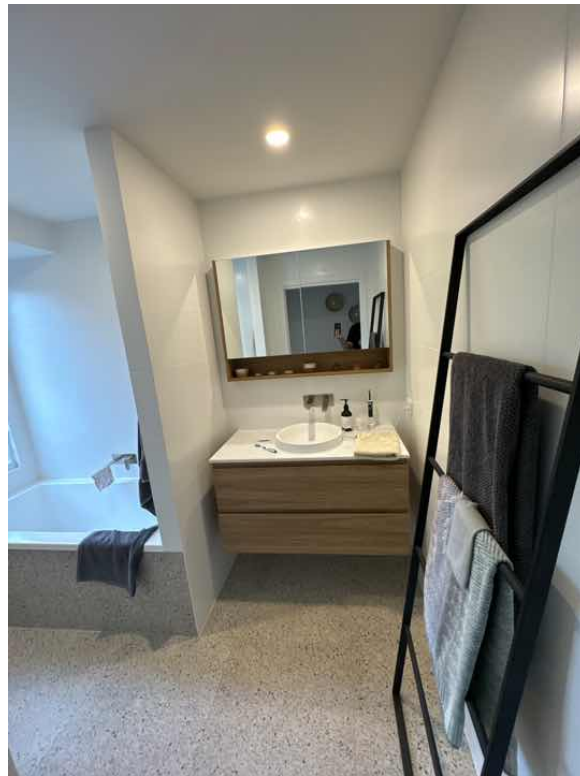
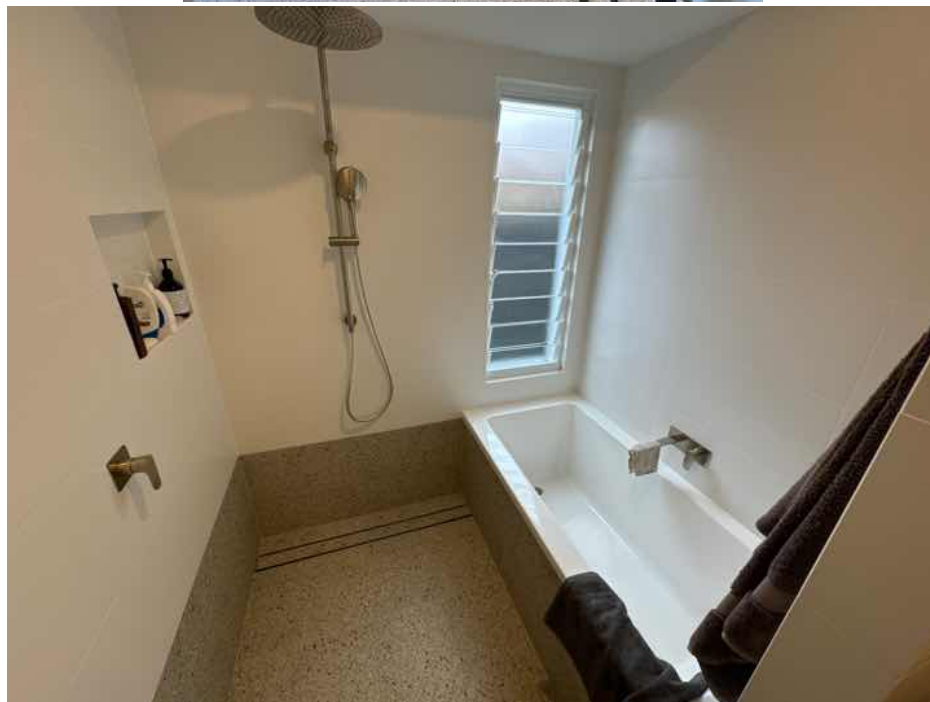
Of the visible areas, the general condition of this bathroom is serviceable or in reasonable condition for age of dwelling.

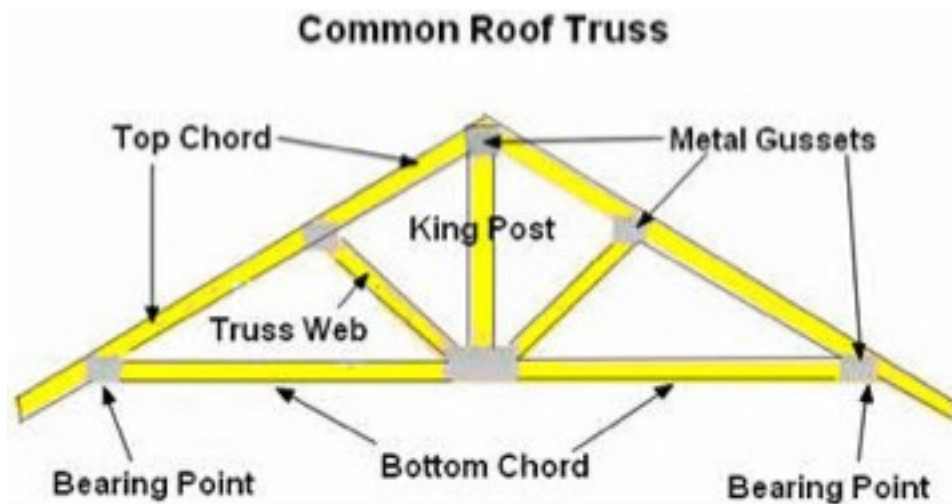
The roof frame is a truss timber frame.

Visible sections of the roof void is in a serviceable condition for age of this dwelling.
