PEST AND BUILDING PRE-PURCHASE REPORTS

Inspection Report

28 Tamar St, Ballina, NSW, 2478

Pest And Building Inspection

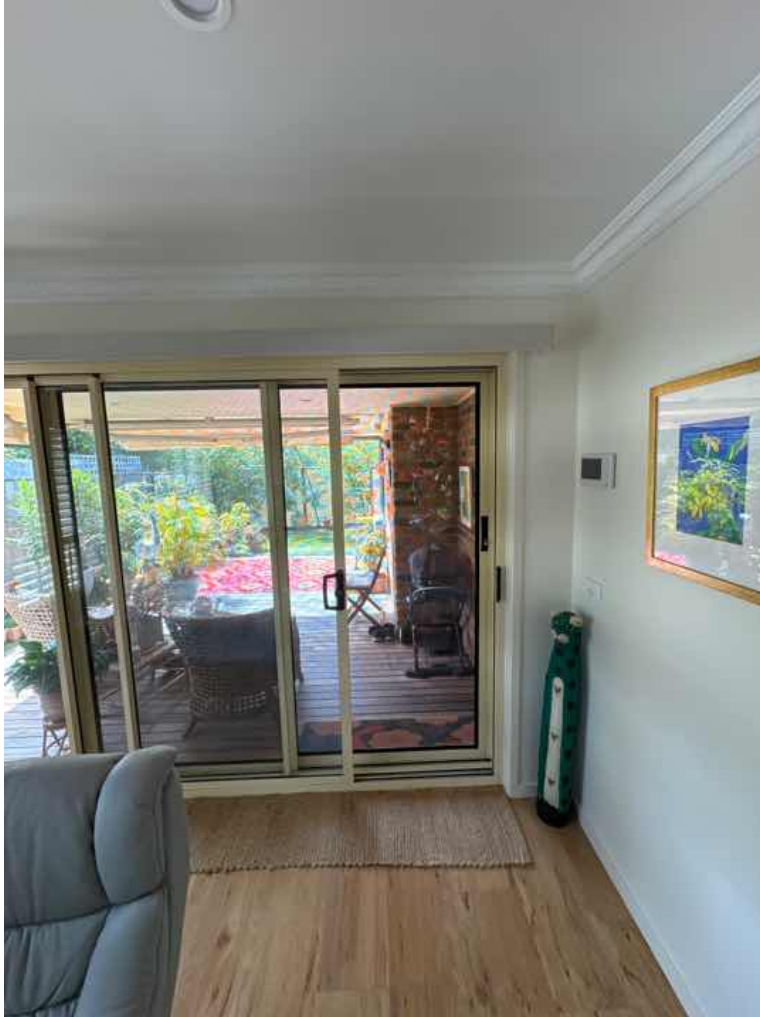
From the visible and accessible areas, this area appears to be in a serviceable condition for the age of the property with no notable structural defects sighted.

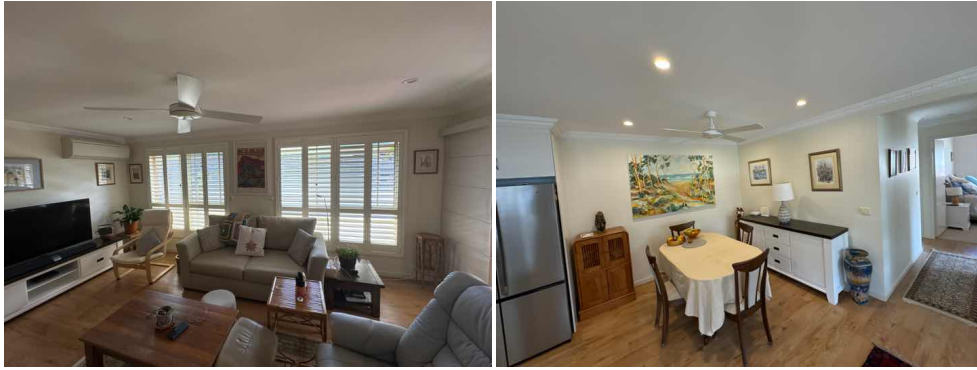
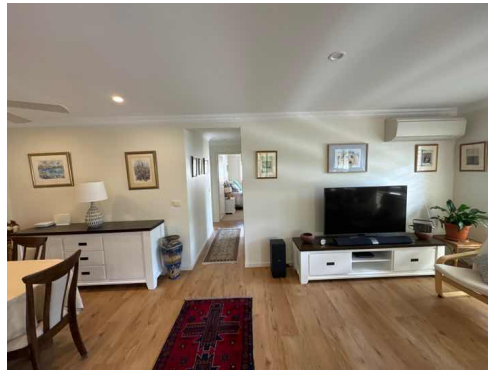
Combined Living & Dining

From the visible and accessible areas, this room appears to be in a serviceable condition for the age of the property with no notable structural defects sighted.

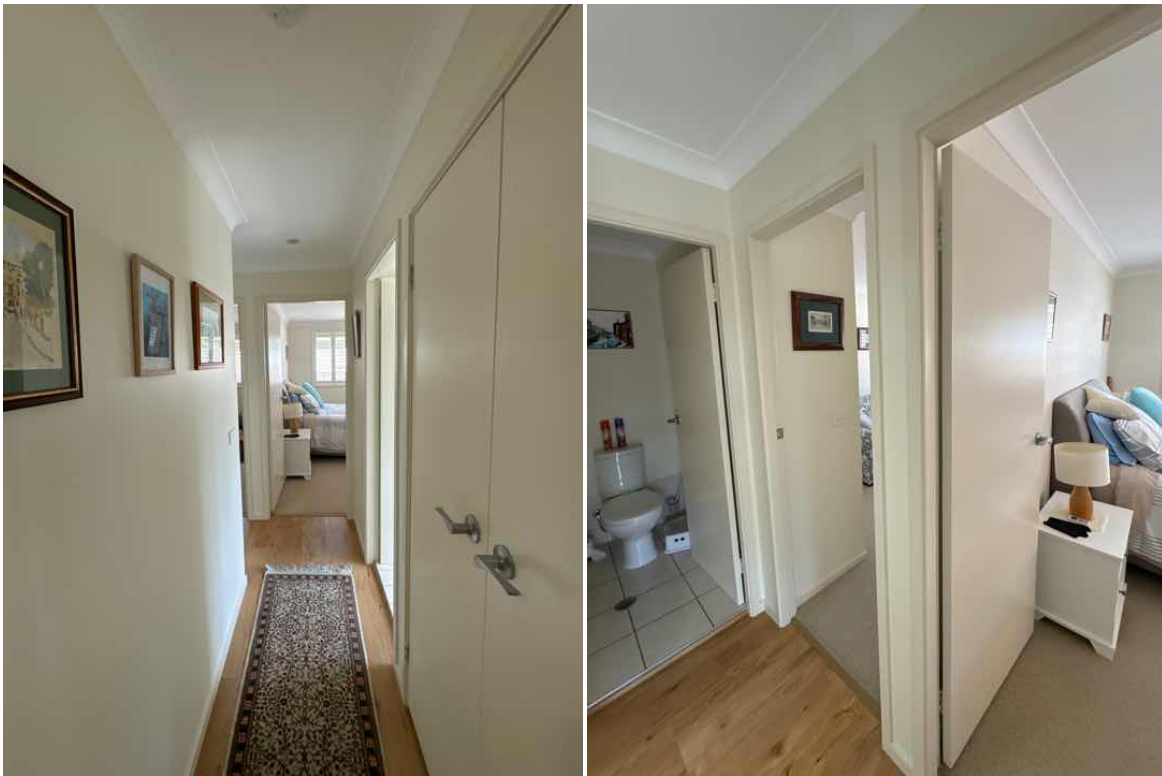
Hallway/s

From the visible and accessible areas, the hallway/s/ appears to be in a serviceable condition for the age of the property with no notable structural defects sighted.

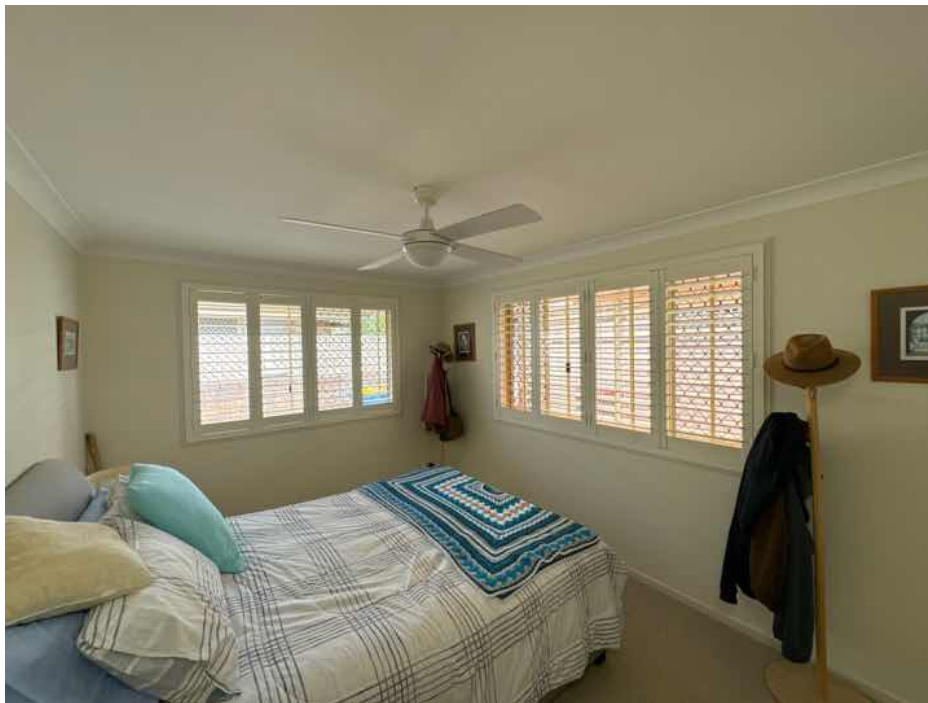
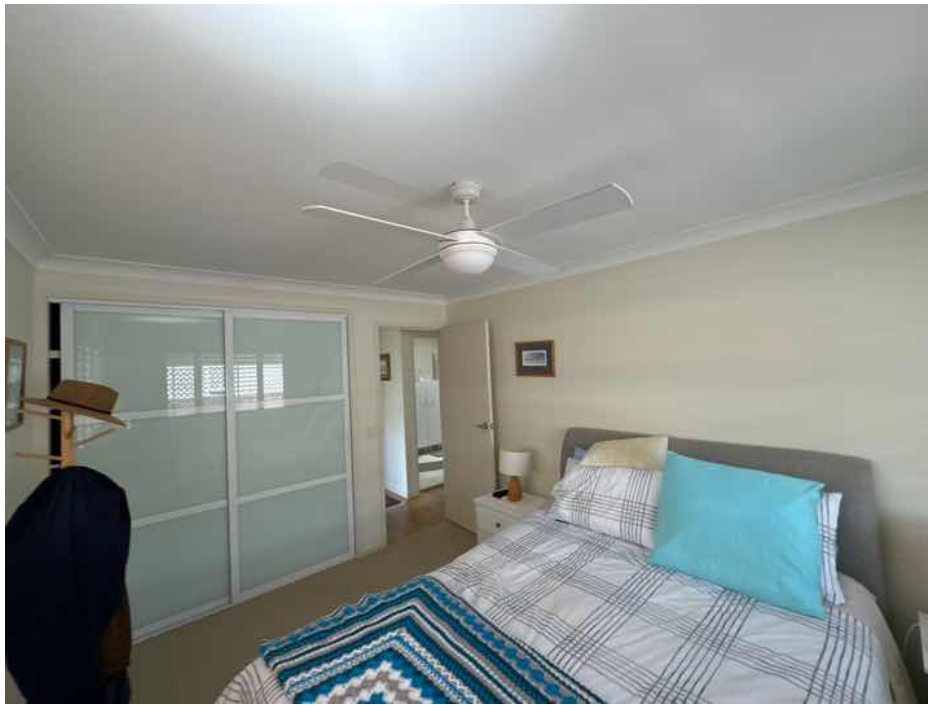
Bedroom 1

From the visible and accessible areas, this bedroom appears to be in a serviceable condition for the age of the property with no notable structural defects sighted.

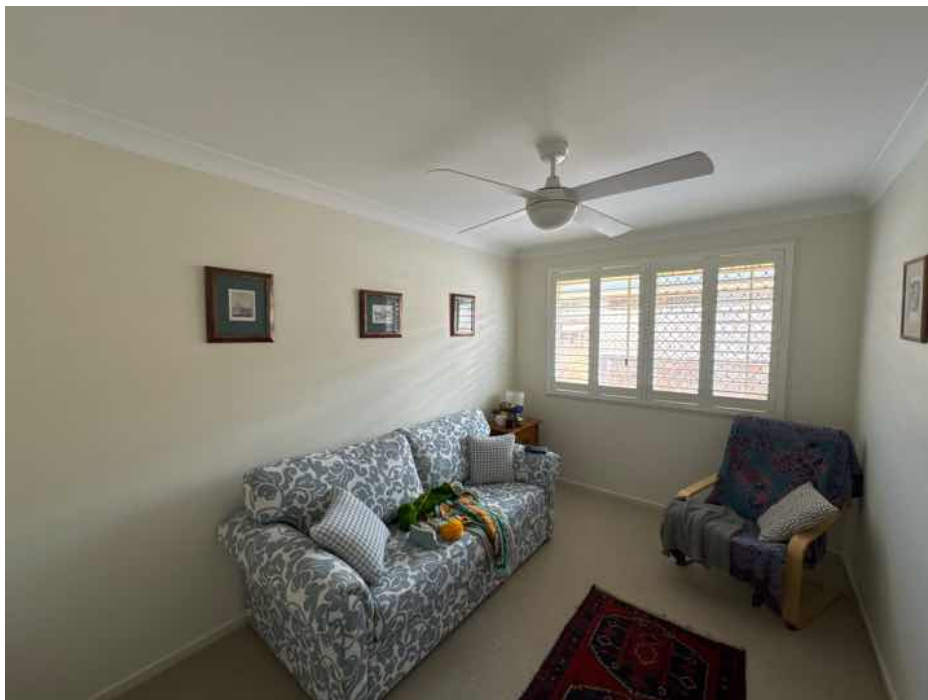
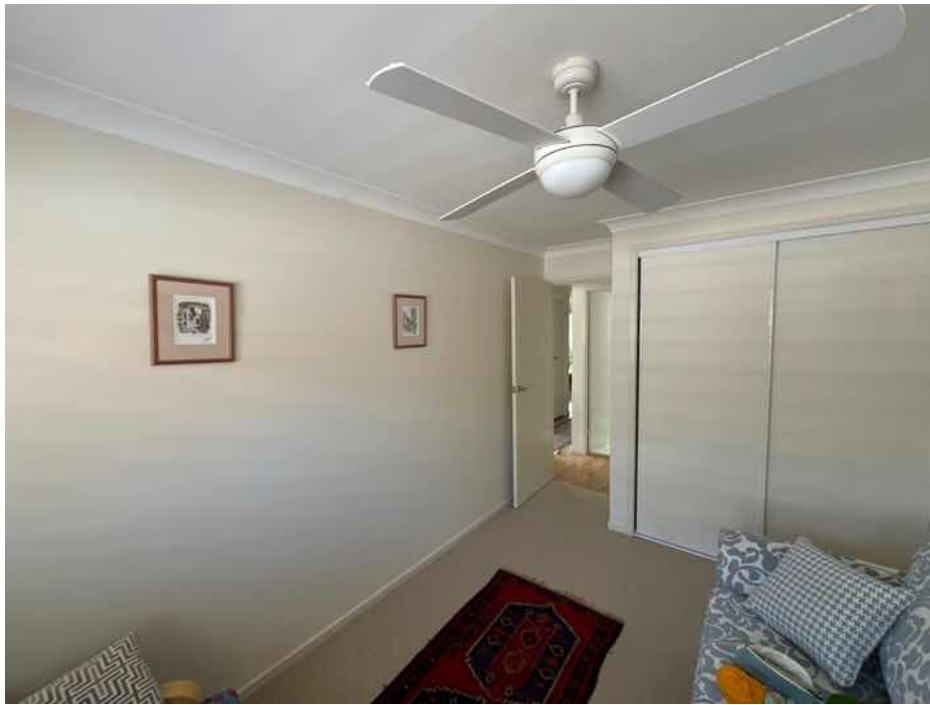
Bedroom 2

From the visible and accessible areas, this bedroom appears to be in a serviceable condition for the age of the property with no notable structural defects sighted.

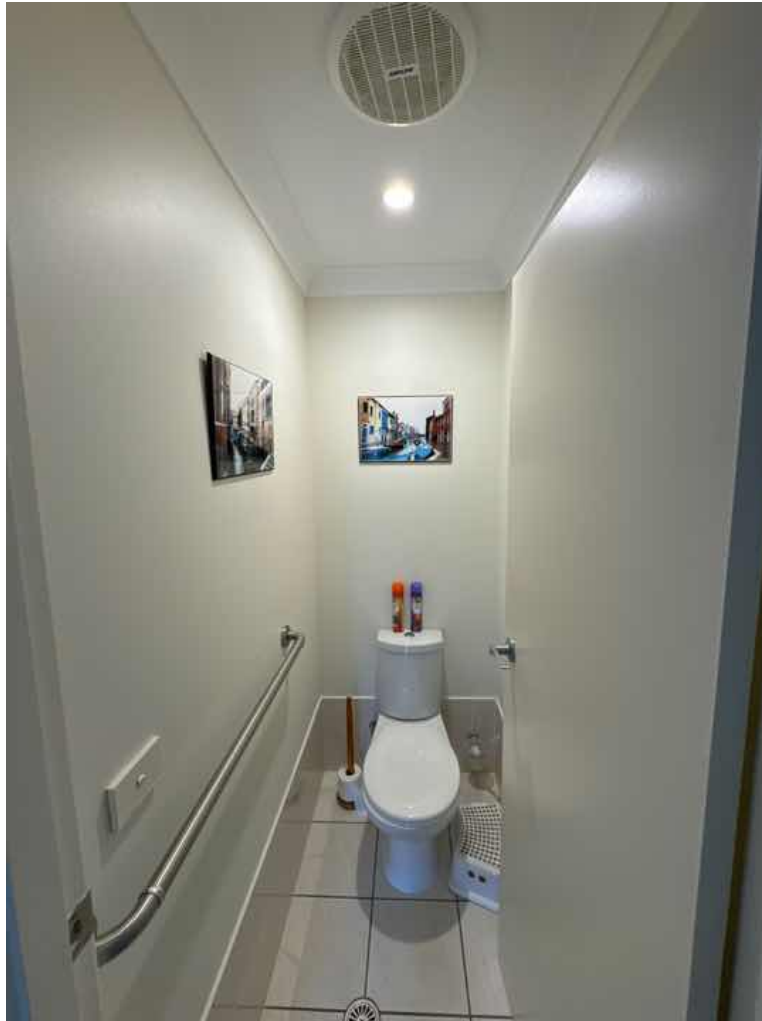
Of the visible areas, the general condition of this bathroom is serviceable or in reasonable condition for age of dwelling.

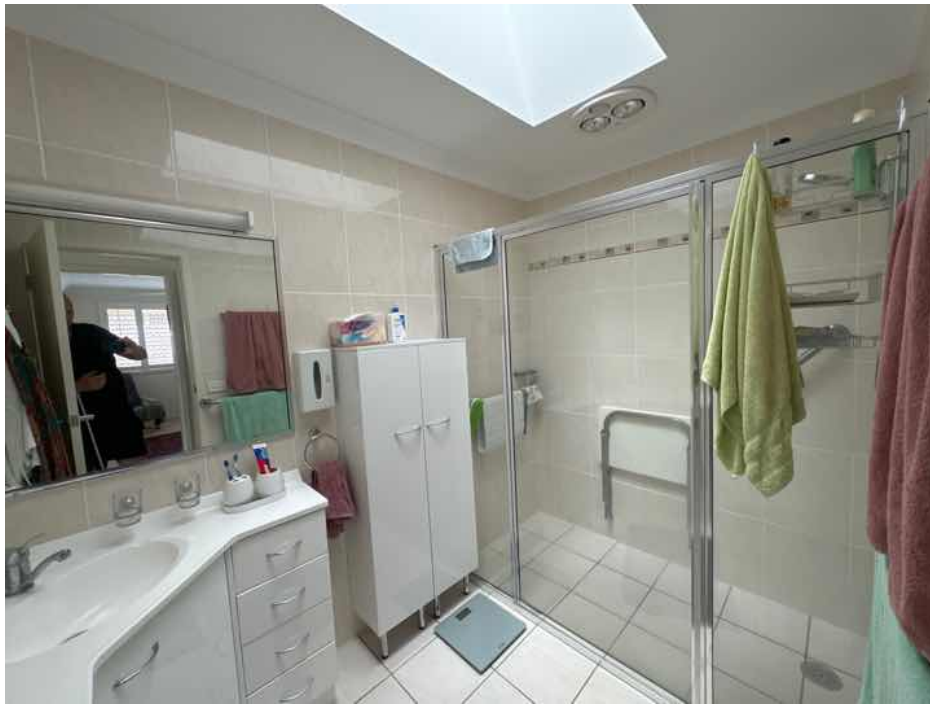
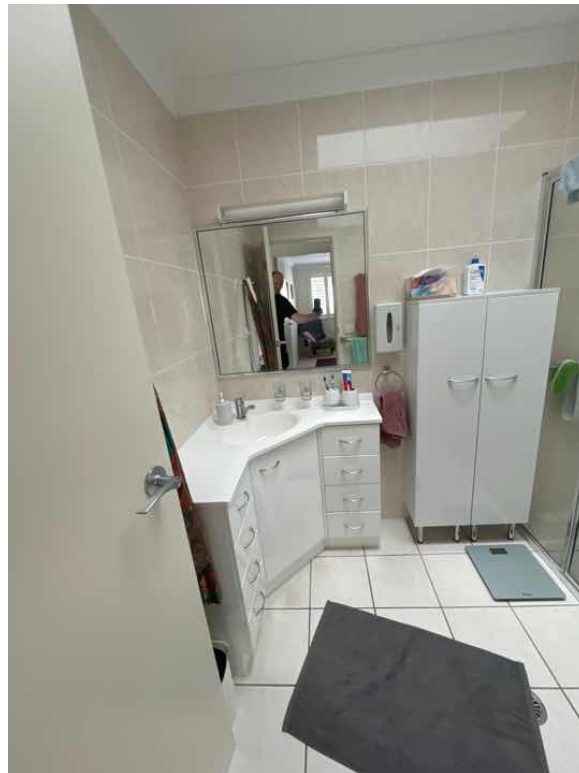
Bathroom 1

Of the visible areas, the general condition of this bathroom is serviceable or in reasonable condition for age of dwelling.

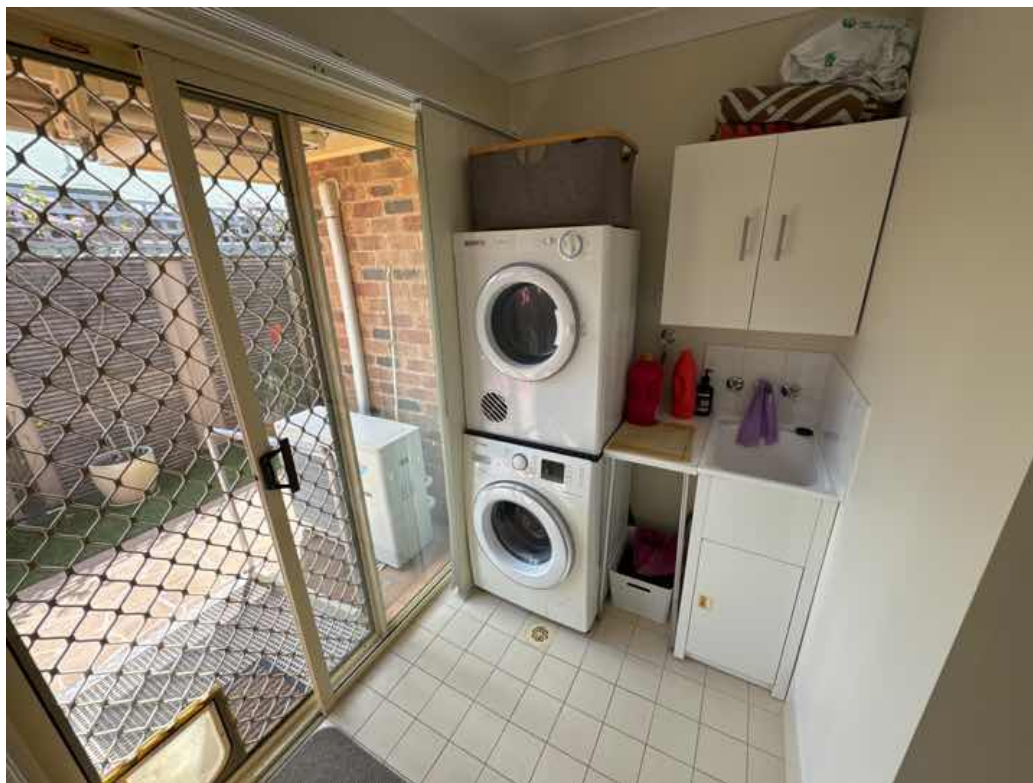
Of the visible areas, the general condition of the laundry is serviceable or in reasonable condition for age of dwelling.
