PEST AND BUILDING PRE-PURCHASE REPORTS

Visual Timber Pest Inspection and Report in Accordance with AS 4349.3-2010

Property Address: 4-6 George Street Bangalow 2479

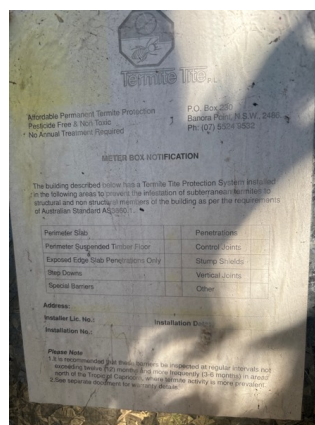
Image of Termite Management Sticker

Type of Treatment:

Pre-Construction

A termite management system has been installed by another company. It is recommended you consult that company for full details of the system installed.
