Scout.
HOME INSPECTIONS

Pre-Purchase Building & Timber Pest Inspection Report

50 Shirley Street Byron Bay 2481 New South Wales Australia

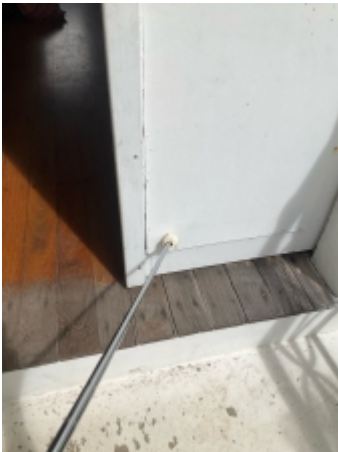
Defect Severity	Minor Defect
Defective Item	Doors and frames
Defect	Defective door hardware
Comment	Deterioration observed to the door. Contact a licensed carpenter for repair.

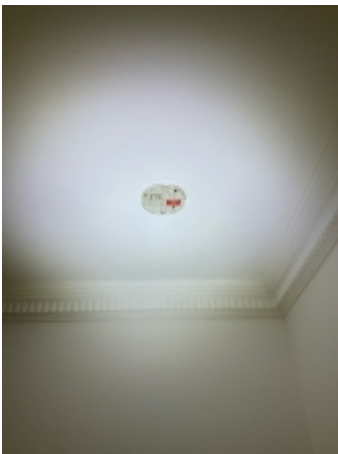
Defect Severity	Safety Hazard
Defective Item	Electrical
Defect	Smoke alarm removed
Comment	Although this inspection does not include the checking of smoke alarms, it is worth noting that a smoke alarm has been removed. Contact a licensed electrician for assessment and recommendations to prevent unsafe conditions.

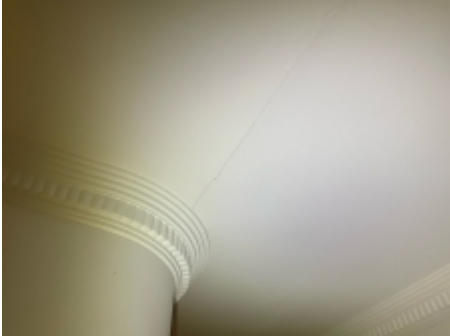
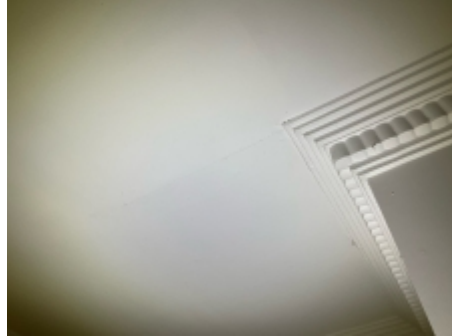
Defect Severity	Minor Defect
Defective Item	Ceilings
Defect	Joint cracking
Comment	Common joint cracking observed to areas of the ceiling linings. Contact a licensed plasterer for repair.

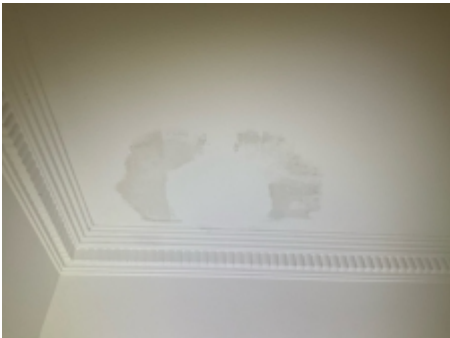
Defect Severity	Minor Defect
Defective Item	Ceilings
Defect	Moisture staining/damage - dry
Comment	Moisture staining/damage observed, no high moisture readings taken at time of inspection. The cause of the staining/leak may have been repaired, however, this area must be monitored and if further evidence of leaking becomes evident a licensed roof plumber must be engaged for assessment.

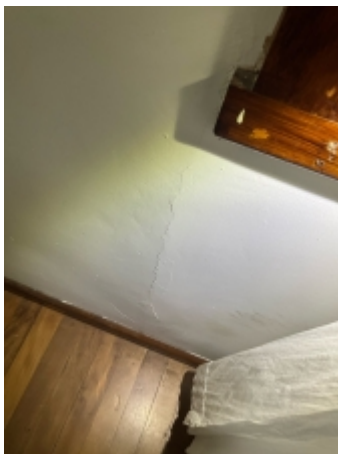
Defect Severity	Minor Defect
Defective Item	Walls
Defect	Settlement cracking - minor
Comment	Settlement cracking observed (minor). Generally, patch and paint will suffice, however, monitoring these cracks is advised and if worsening occurs a qualified builder must be engaged for assessment.

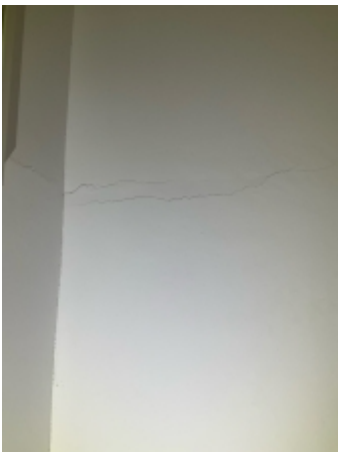
Defect Severity	Minor Defect
Defective Item	Walls
Defect	Settlement cracking - minor
Comment	Settlement cracking observed (minor). Generally, patch and paint will suffice, however, monitoring these cracks is advised and if worsening occurs a qualified builder must be engaged for assessment.

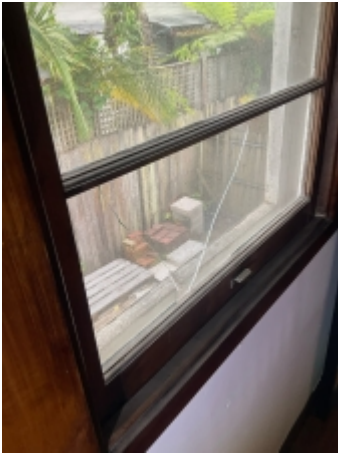
Cracked Glass Pane

Cracked/damaged glass pane observed. Contact a licensed glazier for repair.

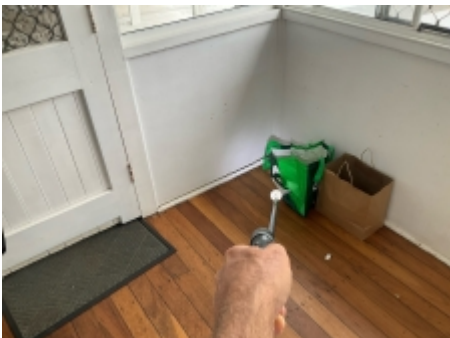
Defect Severity	Minor Defect
Defective Item	Flooring
Defect	Uneven/Out of level Flooring
Comment	Unevenness observed in flooring. Contact a licensed carpenter for further assessment and repair.

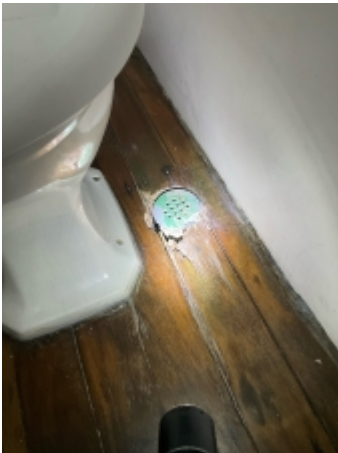
Defect Severity	Minor Defect
Defective Item	Flooring
Defect	Timber Fungal Decay
Comment	Timber fungal decay/rot observed to areas of the timber flooring. Contact a licensed carpenter for repair.

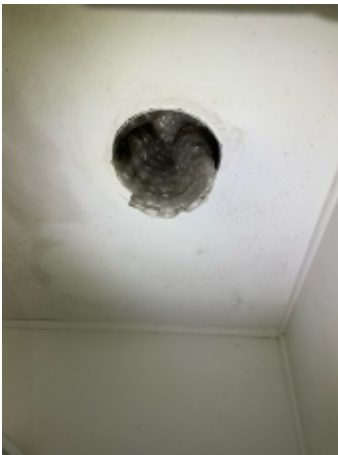
Defect Severity	Minor Defect
Defective Item	Ceilings
Defect	Vent removed
Comment	A vent/flue has been removed. Contact a licensed carpenter for full removal and patching.

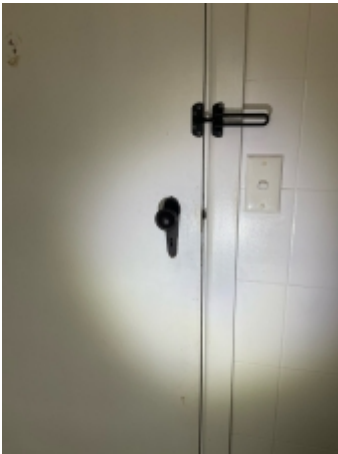
Defect Severity	Minor Defect
Defective Item	Doors and frames
Defect	Defective door hardware
Comment	Damaged door hardware observed. Contact a licensed carpenter for repair.

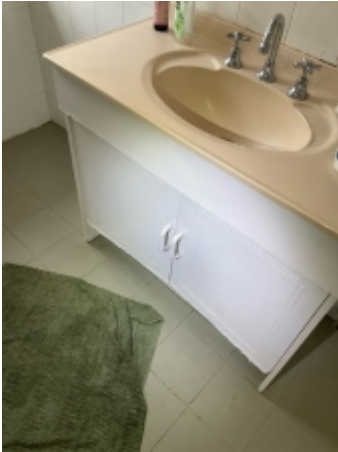
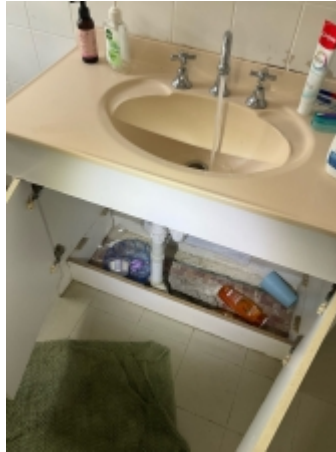
Defect Severity	Minor Defect
Defective Item	Vanity basin/cabinet
Defect	General age/deterioration
Comment	General age/deterioration observed to the vanity cabinet. Contact a licensed plumber for replacement.

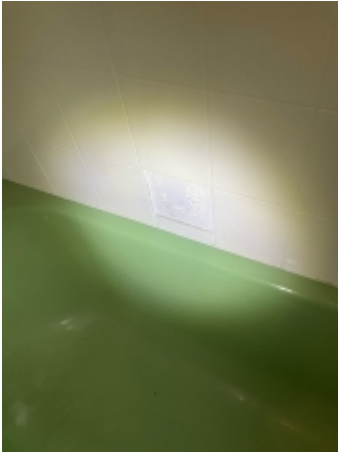
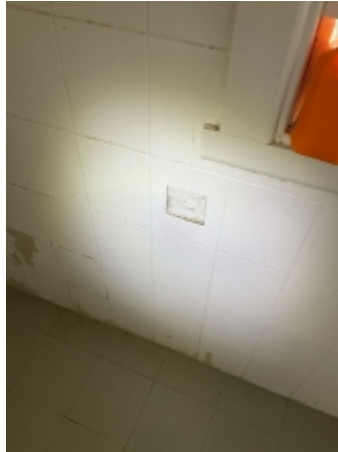
Defect Severity	Minor Defect
Defective Item	Tiled walls
Defect	Missing tiles
Comment	Wall tiles are missing in areas, including the shower recess. Contact a licensed tiler for immediate repair.

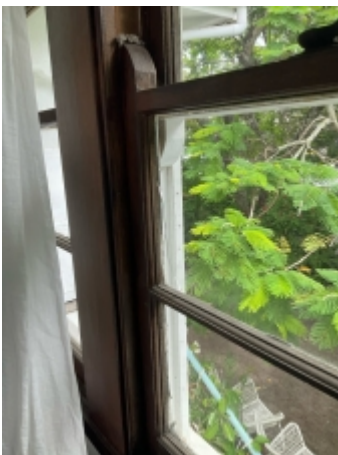
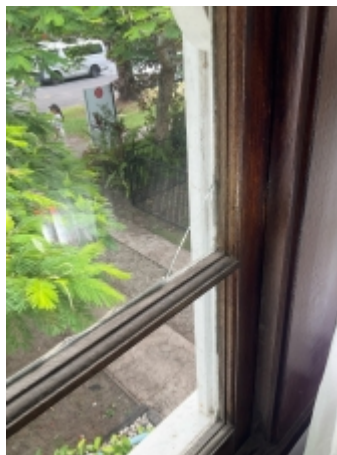
Defect Severity	Minor Defect
Defective Item	Windows
Defect	Cracked Glass Pane
Comment	Cracked/damaged glass panes observed. Contact a licensed glazier for repair.

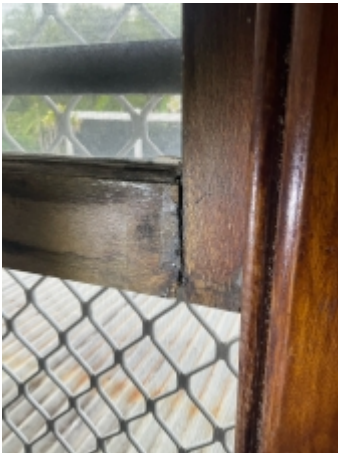
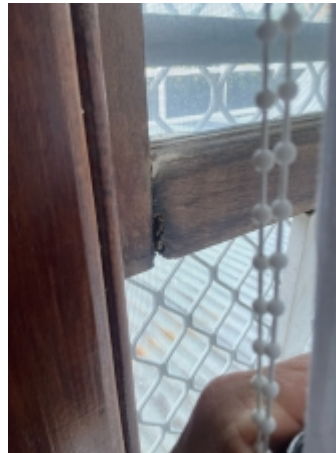
Defect Severity	Minor Defect
Defective Item	Windows
Defect	Fungal decay/rot to window
Comment	Timber fungal decay/rot observed to window sashes (minor). Contact a licensed carpenter for repair.

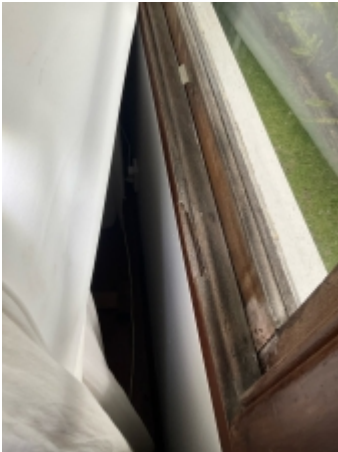
Defect Severity	Major Defect
Defective Item	Windows
Defect	Termite Damage/workings
Comment	Termite damage was observed to areas of the timber windows. Contact a licensed carpenter for further assessment, and please refer to the visual timber pest inspection section of the report for further details.

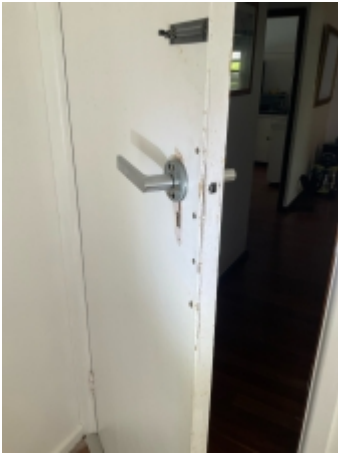
Defect Severity	Minor Defect
Defective Item	Doors and frames
Defect	Damage
Comment	Damage observed to the door. Contact a licensed carpenter for repairs.

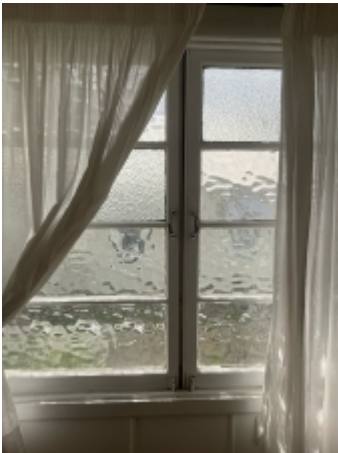
Defect Severity	Minor Defect
Defective Item	Windows
Defect	Binding sash
Comment	The window sashes are binding. Contact a licensed carpenter for adjustment.

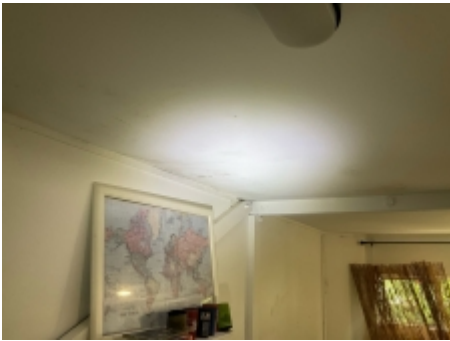
Defect Severity	Minor Defect
Defective Item	Ceilings
Defect	Moisture staining/damage - dry
Comment	Moisture damaged linings observed, no high moisture readings taken at time of inspection. The cause of the staining/leak may have been repaired, however, this area must be monitored and if further evidence of leaking becomes evident a licensed plumber must be engaged for assessment. Contact a licensed plasterer for repairs to damaged linings.

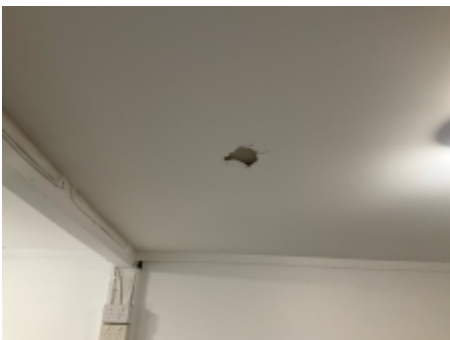
Defect Severity	Minor Defect
Defective Item	Ceilings
Defect	Lining damage
Comment	Damage observed to the ceiling linings. Contact a licensed plasterer for repair.

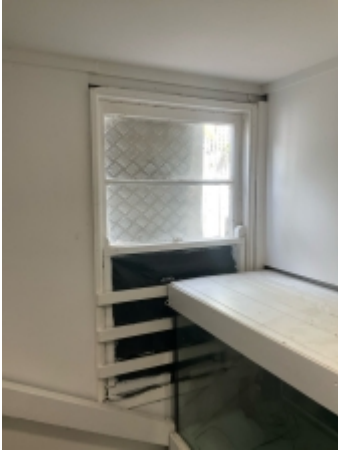
Defective Item	Windows
Defect	Cracked Glass Pane
Comment	Cracked/damaged glass pane observed. Contact a licensed glazier for repair.

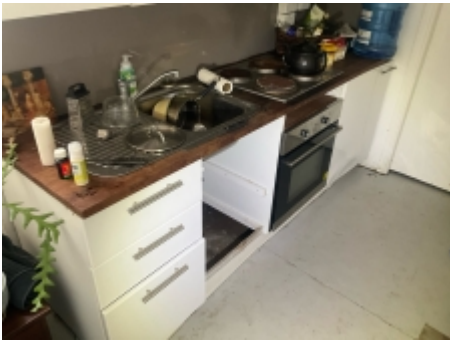
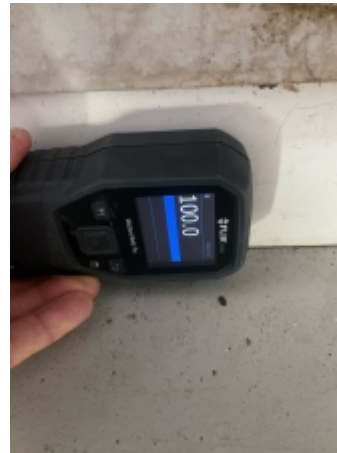
Defect Severity	Minor Defect
Defective Item	Kitchen cabinets
Defect	Moisture damage
Comment	Water/moisture damage observed to areas of the cabinets, high moisture readings were obtained at the time of inspection which would indicate an active leak/source of moisture in this area. Contact a licensed plumber for further assessment. Contact a licensed cabinetmaker for repairs to damaged cabinetry.

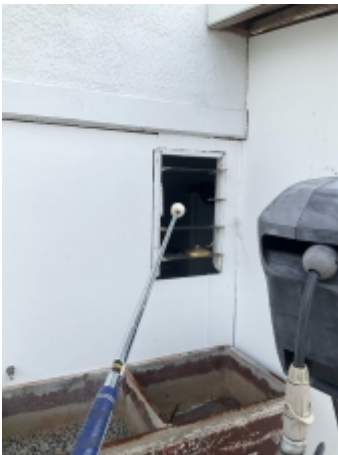
Defect Severity	Minor Defect
Defective Item	Windows
Defect	Missing glazing
Comment	Sections of glazing are missing. Contact a licensed glazier for repair.

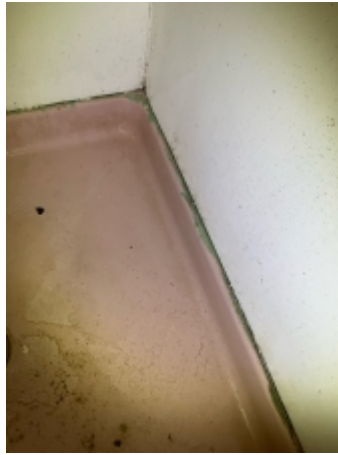
Defective Item	Shower
Defect	Reseal internal corners
Comment	The internal corners of the floor/wall panels require re-sealing to prevent water ingress/egress which can lead to leaking, gaps were also visible behind the taps which require sealing. Contact a licensed plumber for repairs.

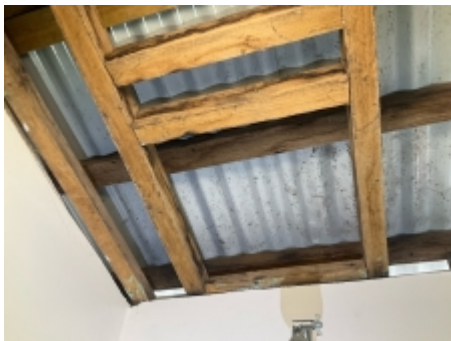
Defect Severity	Major Defect
Defective Item	Ceilings
Defect	Termite Damage/workings
Comment	Termite damage was observed to areas of the ceiling framing. Contact a licensed carpenter for further assessment, and please refer to the visual timber pest inspection section of the report for further details.

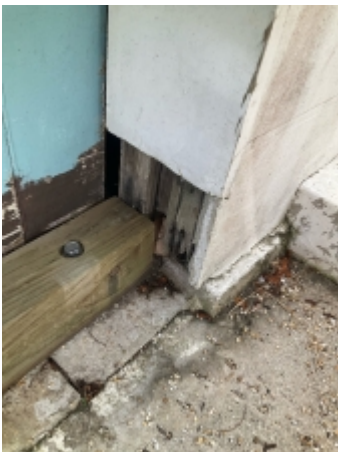
Defect Severity	Major Defect
Defective Item	Garage door/s
Defect	Termite Damage/workings
Comment	Termite damage was observed to areas of the garage door framing. Contact a licensed carpenter for further assessment, and please refer to the visual timber pest inspection section of the report for further details.

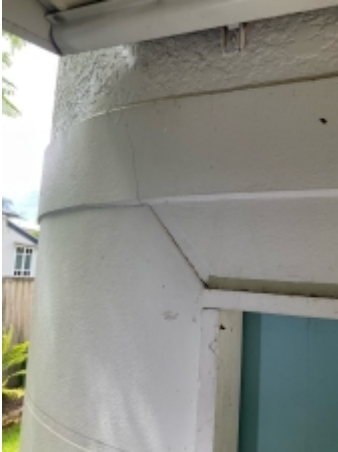
Defect Severity	Minor Defect
Defective Item	External Walls
Defect	Settlement cracking - minor
Comment	Settlement cracking observed to areas of the external walls. These cracks were considered to be in the minor category at the time of the inspection, however, these areas must be closely monitored, and if worsening or widening occurs a structural engineer must be engaged for assessment.

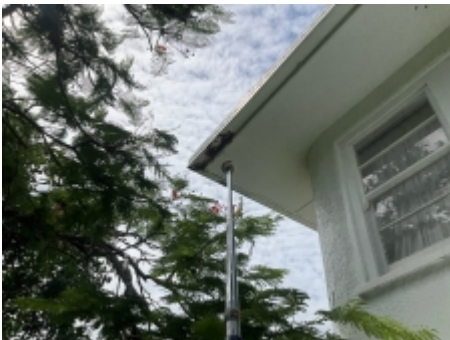
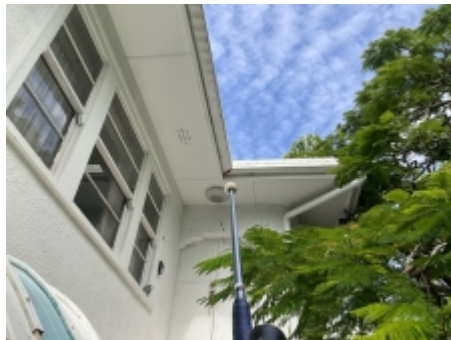
Defect Severity	Minor Defect
Defective Item	Guttering
Defect	Gutter rust
Comment	Rust was observed in areas of the guttering around the home. Contact a licensed plumber for assessment and repairs, full replacement is likely to be required.

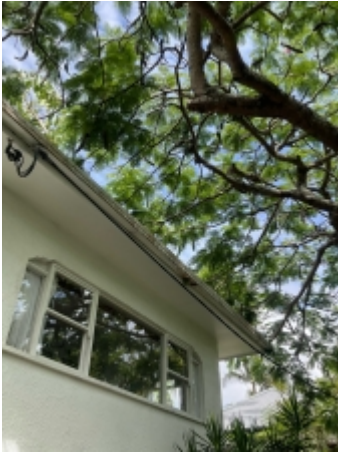
Defect Severity	Minor Defect
Defective Item	Trees
Defect	Roof overhang
Comment	Trees are overhanging areas of the roof. I recommend cutting back to prevent debris and damage.

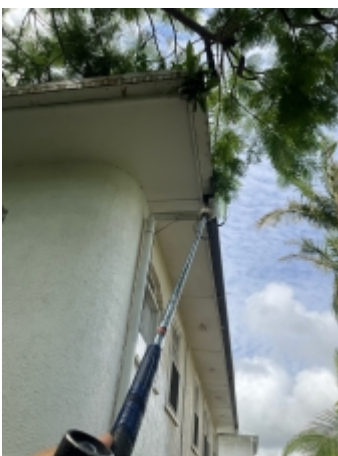
Downpipe not connected to stormwater discharge. Contact a licensed plumber for rectification.

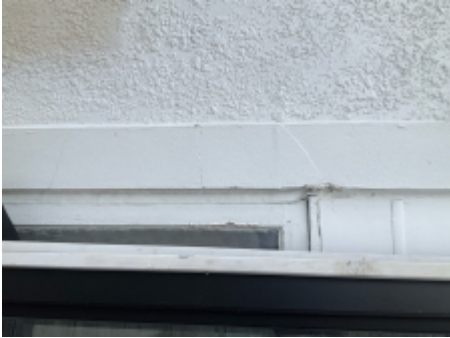
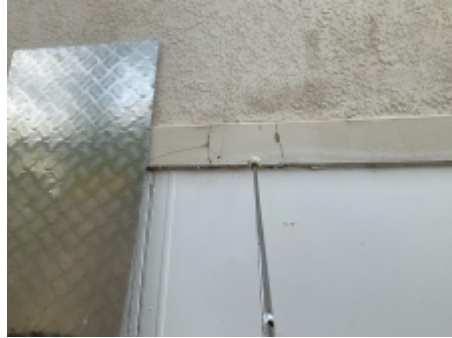
Defect Severity	Minor Defect
Defective Item	External Walls
Defect	Settlement cracking - minor
Comment	Settlement cracking observed to areas of the external walls. These cracks were considered to be in the minor category at the time of the inspection, however, these areas must be closely monitored, and if worsening or widening occurs a structural engineer must be engaged for assessment.

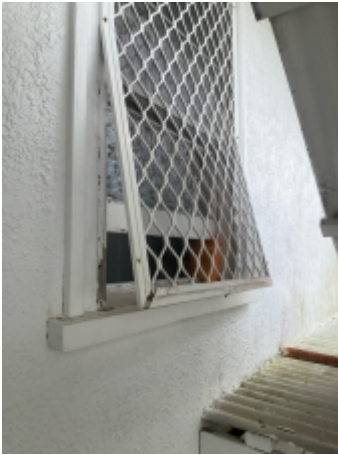
Defect Severity	Minor Defect
Defective Item	External windows
Defect	Screen damage
Comment	The security screen is damaged. Contact a licensed carpenter for repair.

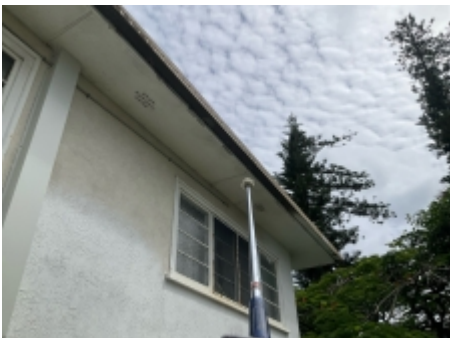
Defect Severity	Minor Defect
Defective Item	Fascia/barge boards
Defect	Paint deterioration
Comment	Paint deterioration observed to areas of the fascia/barge boards around the home. Contact a licensed painter for repair.

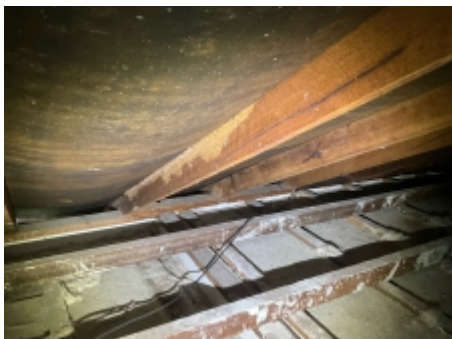
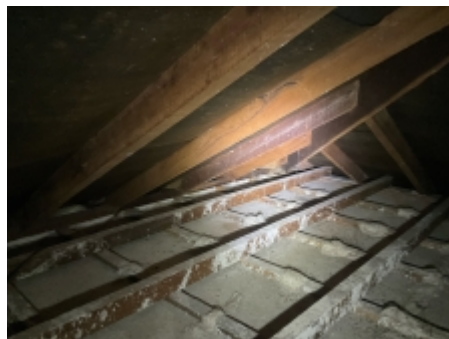
Defect Severity	Major Defect
Defective Item	Roof framing
Defect	Termite Damage/workings
Comment	Termite damage was observed in areas of the roof framing. Contact a licensed carpenter for further assessment. Please refer to the visual timber pest inspection section of the report for further details.

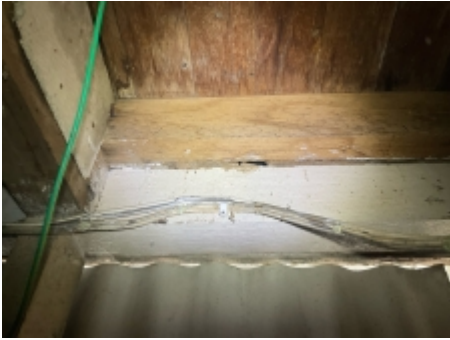
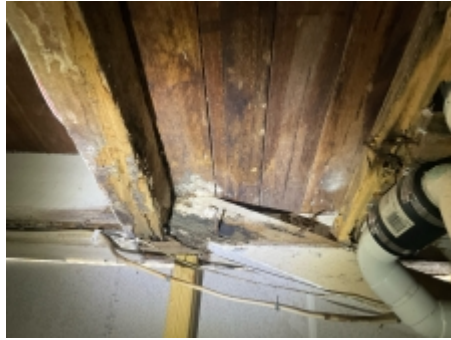
Defect Severity	Major Defect
Defective Item	Subfloor framing
Defect	Termite Damage/workings
Comment	Termite damage and workings were observed in areas of the timber floor framing, and wall framing. Contact a licensed carpenter for full further assessment, and please refer to the visual timber pest inspection section of the report for further details.

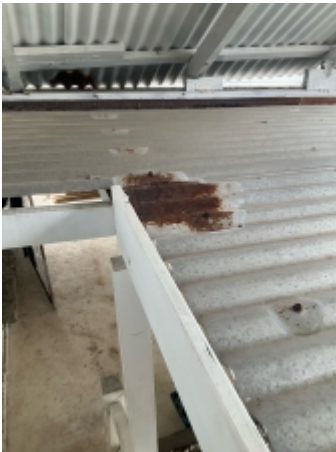
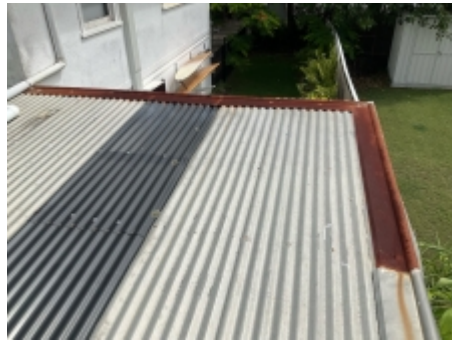
Defect Severity	Minor Defect
Defective Item	Roof cladding
Defect	Rust to cladding
Comment	Rust was observed in areas of the roof cladding to the rear pergola area. Contact a licensed roof plumber for further assessment and repairs where required.

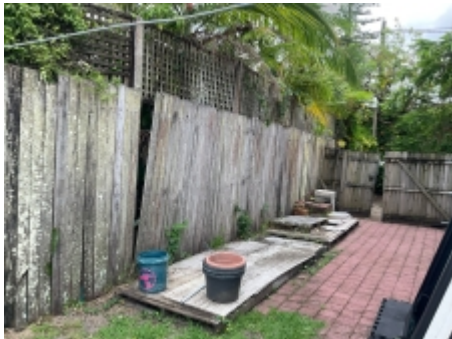
Defect Severity	Minor Defect
Defective Item	Fencing
Defect	General ageing/deterioration
Comment	General ageing/deterioration was observed to the timber fencing and gates. Contact a licensed fencing contractor for repair.

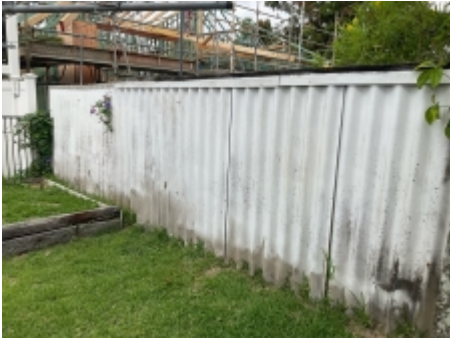
Defect Severity	Safety Hazard
Defective Item	Fencing
Defect	Asbestos
Comment	Although this inspection does not include checking for the presence of asbestos, it must be noted that sections of the fencing appear to be constructed from asbestos sheeting. Contact a licensed asbestos contractor for further assessment.

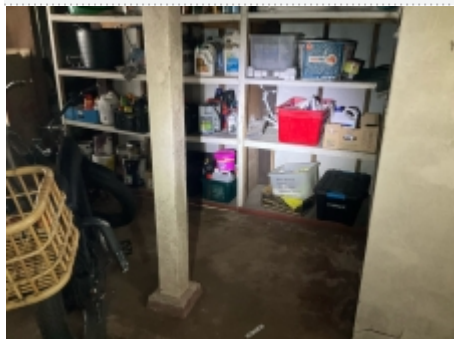
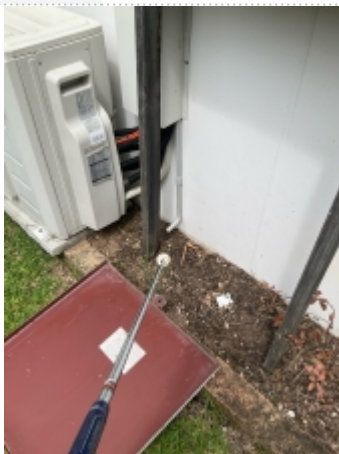
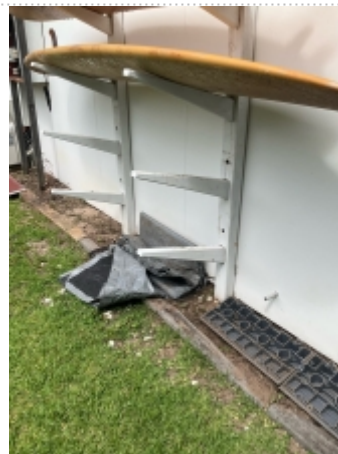
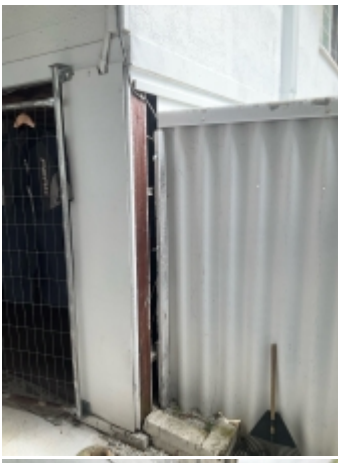
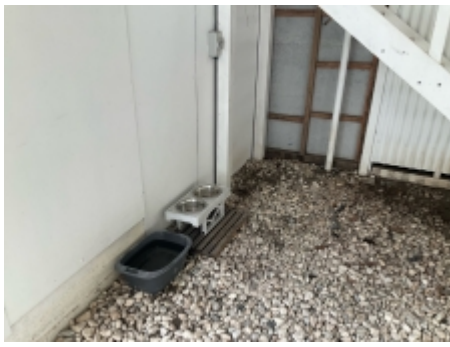
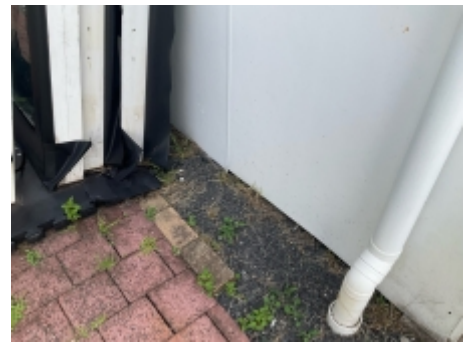
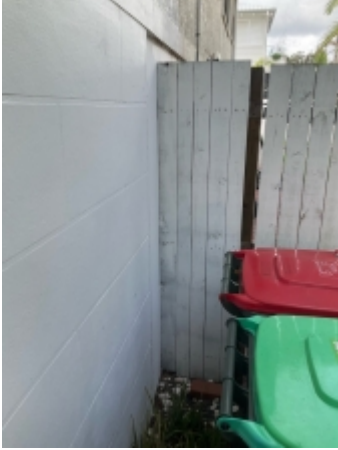
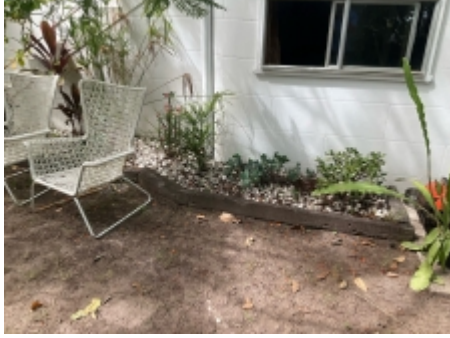
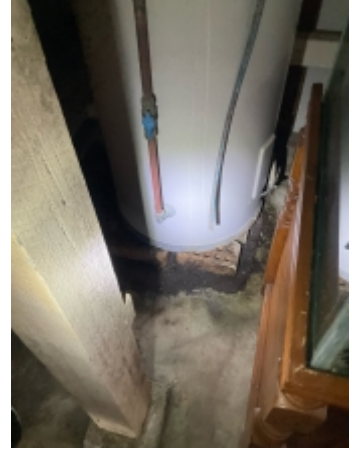
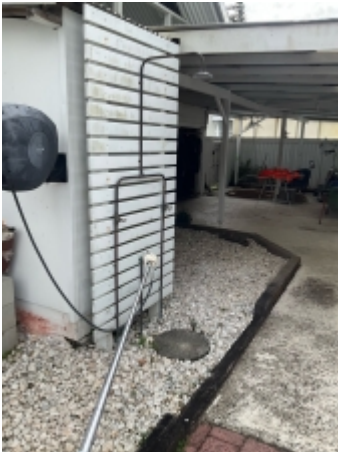
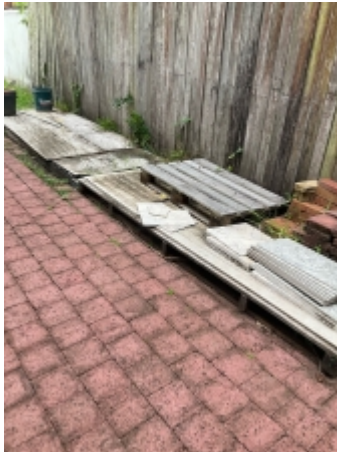
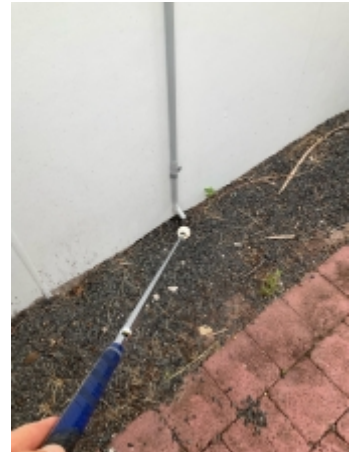
Conducive Condition Photos

These provide conducive conditions and/or concealed entry for termite infestation and must be rectified to reduce risk.
