## Building and Timber Pest Inspection Report VR

Inspection Date: Thu, 22 Jan 2026

Property Address: 4 Riverside Crescent, Brunswick Heads NSW,  
Australia

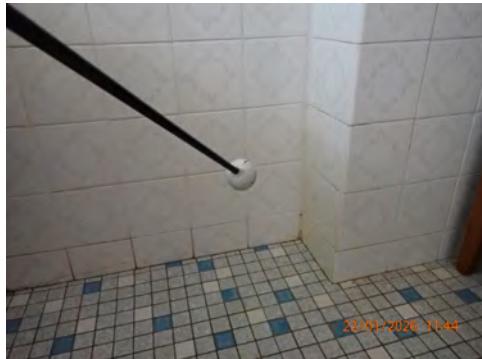
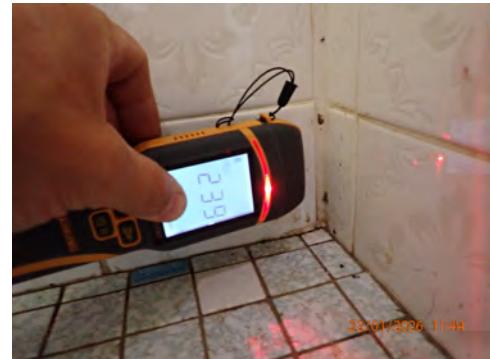
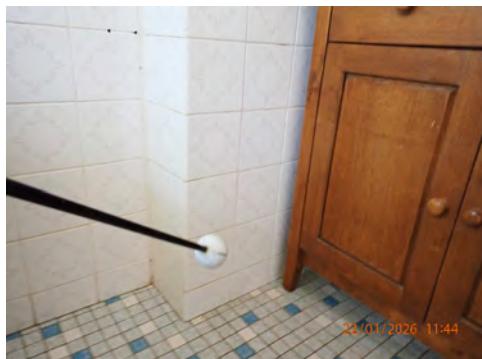
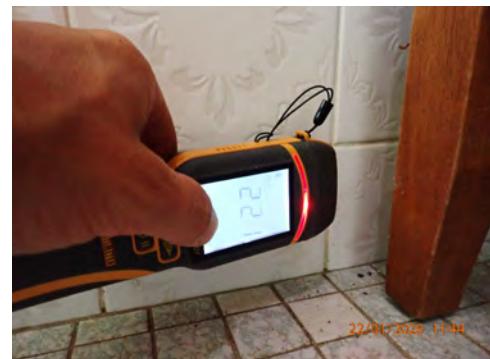
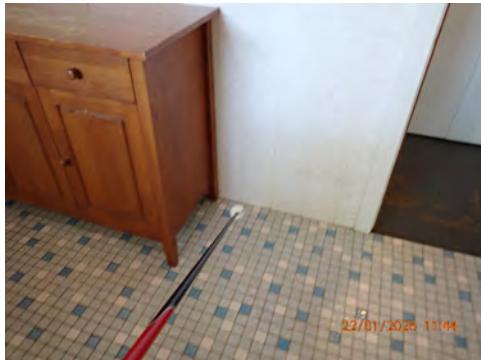
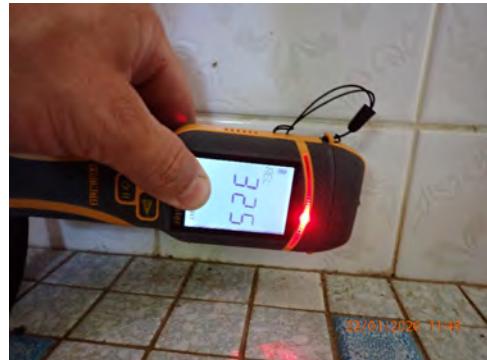
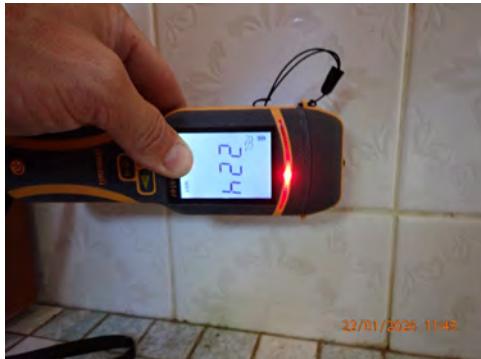
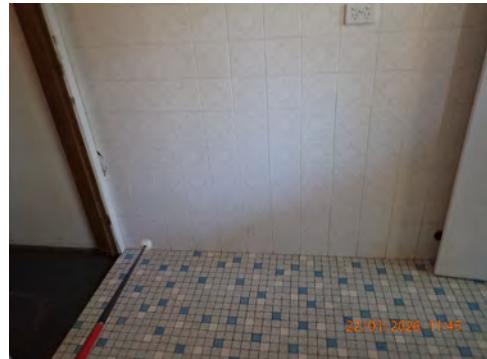
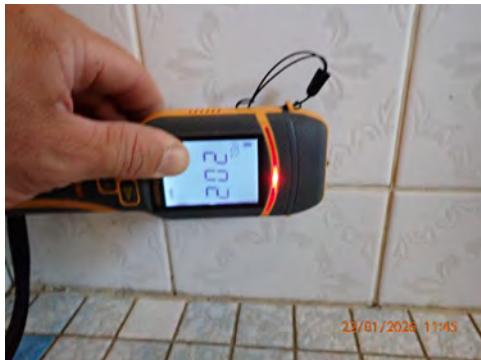
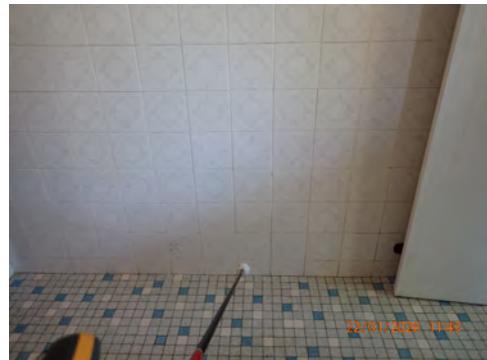
#### Finding 2.01

B | EMR | Moisture readings detected in laundry

During the inspection, elevated moisture readings were detected in the laundry area. The source of the moisture could not be confirmed at the time of inspection.

Moisture in laundry areas is commonly associated with plumbing leaks, failed seals, drainage issues, or moisture migration from adjoining building elements. If left unmanaged, ongoing moisture exposure may lead to deterioration of wall linings, cabinetry, skirtings, and other concealed building components.

The moisture meter used operates on a scale from 0 to 999. Readings above 200 are considered elevated. Concealed damage could not be ruled out, and further invasive inspection may be required to determine the full extent of any concealed moisture-related issues.

A licensed plumber or licensed builder, depending on the suspected source, can be engaged to investigate and rectify the cause of moisture ingress. This should be addressed as soon as practicable.

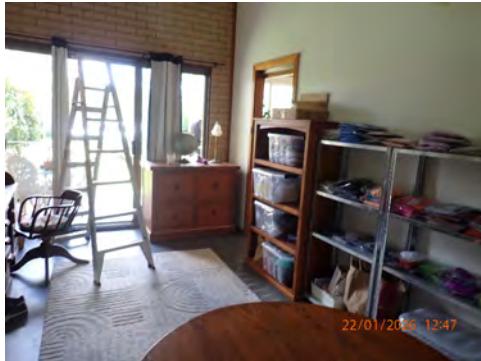
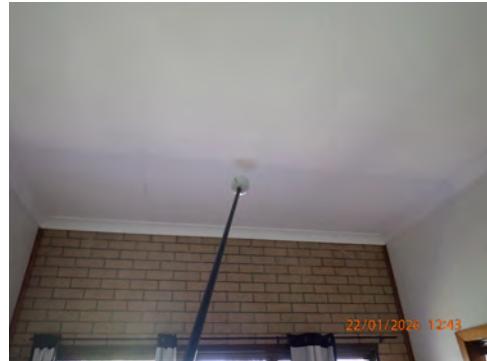
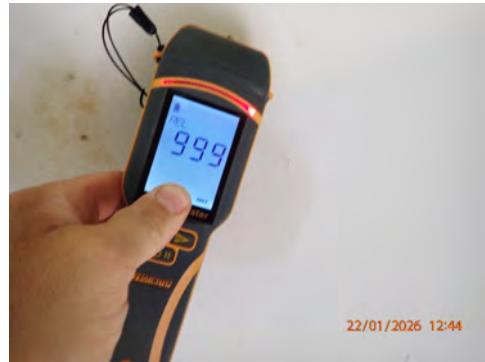
## Finding 2.02

Building: Main Building  
Location: Downstairs rumps  
Finding: B | EMR | Moisture observed to ceiling

During the inspection, moisture was observed to the ceiling in this area. The presence of moisture may be associated with issues such as roof leaks, plumbing defects, condensation, or moisture migration from adjoining building elements. Continued moisture exposure can lead to deterioration of ceiling linings, staining, mould growth, and potential concealed damage if left unmanaged.

The moisture meter used operates on a scale from 0 to 999. Readings above 200 are considered elevated. Concealed damage could not be ruled out. More invasive inspection is recommended to determine the full extent of any concealed moisture-related damage.

The source of moisture was not confirmed at the time of inspection. A licensed builder or qualified plumber, depending on the suspected source, should be engaged to investigate, identify the cause of moisture ingress, and carry out appropriate rectification works. This should be addressed as soon as practicable to prevent further deterioration.

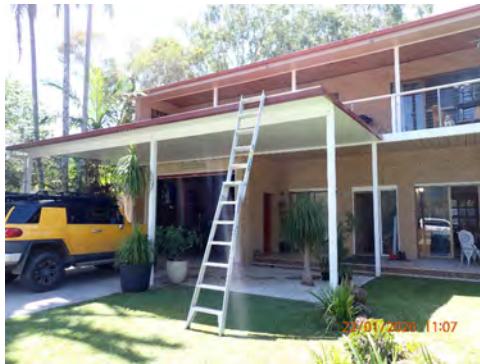
## Finding 3.01

Information: All gutters and roof areas should be kept clear of debris to ensure proper water flow and to prevent blockages, overflow, and premature deterioration of roofing and drainage components. Debris build-up can also create moisture-retention points that may become conducive to timber decay and termite activity if left unmanaged.

It was also observed that the gap between the roof sheeting and the gutter is insufficient, which can restrict effective water discharge into the gutter, increase the likelihood of overflow, and accelerate deterioration of the guttering and adjacent building elements.

Regular cleaning, maintenance, and adjustment of gutter positioning or roof edge detailing should be carried out as part of routine property upkeep to improve drainage performance and reduce the risk of moisture-related damage.

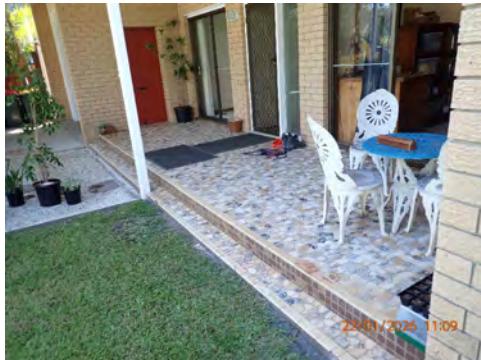
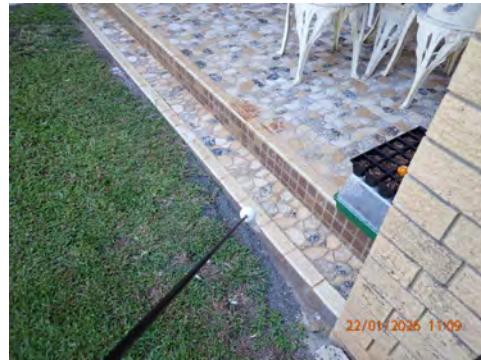
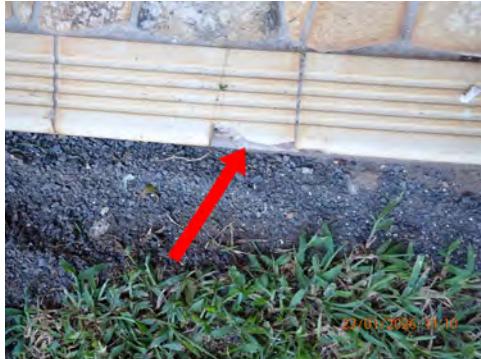
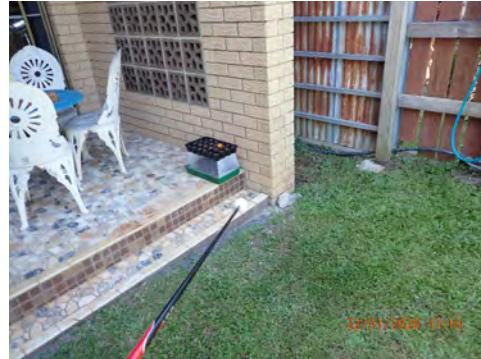
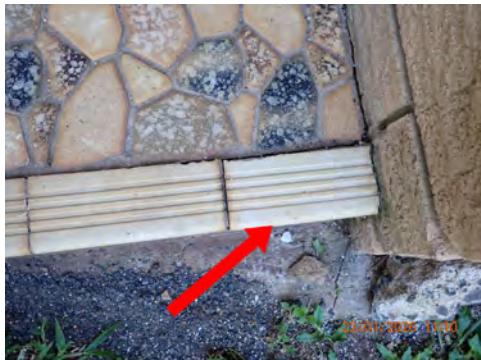
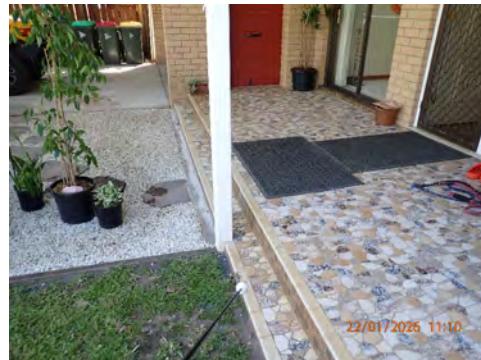
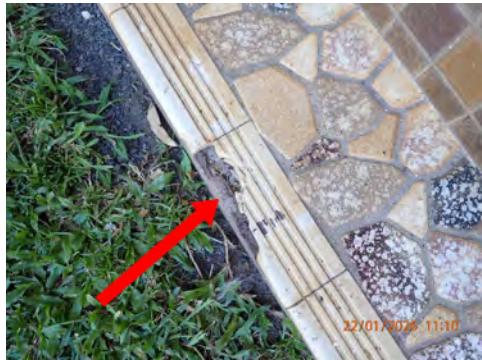
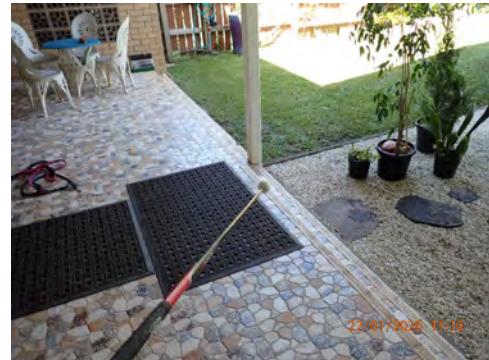
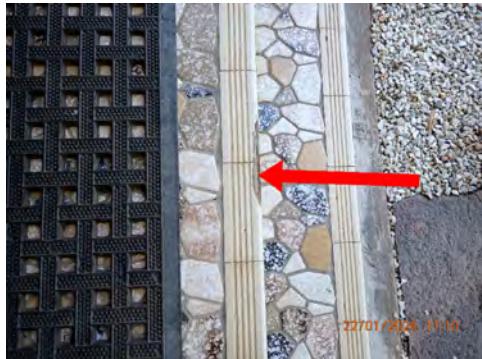
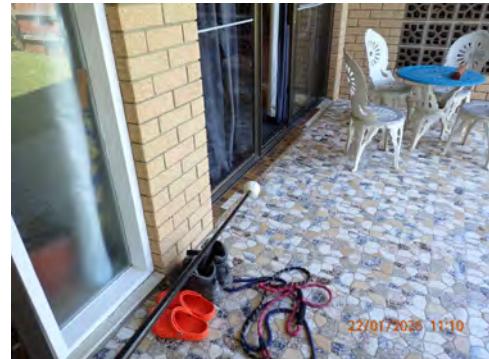
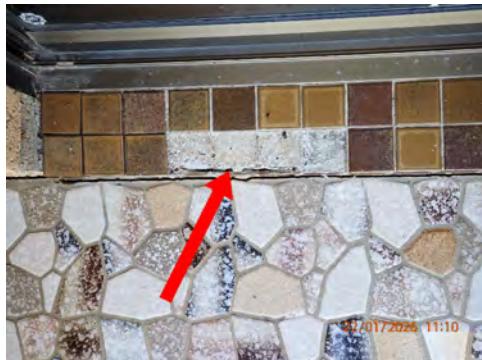
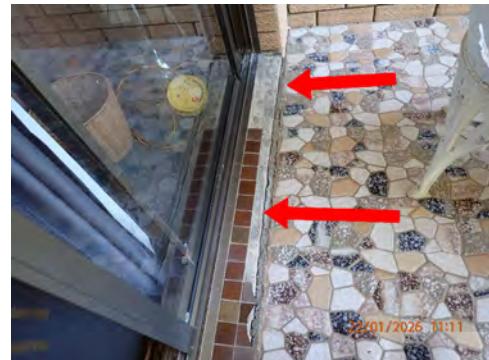
### Finding 3.02

Building:	Main Building
Location:	Porch Front
Finding:	B   Tiles   Damaged and loose tiles to external areas
Information:	During the inspection, tiles to the external areas were observed to be chipped, missing, and in some sections starting to come away from the substrate.

Damage and loss of adhesion to external tiles commonly occurs due to weather exposure, moisture ingress beneath tiles, thermal movement, age-related deterioration, or inadequate fixing methods. If left unmanaged, loose or missing tiles may worsen over time and allow further moisture penetration into the underlying substrate.

A licensed builder or qualified tiler should be engaged to assess the affected areas, remove loose tiles, and repair or replace damaged sections as required. These works can be carried out at the clients discretion this will prevent further deterioration.

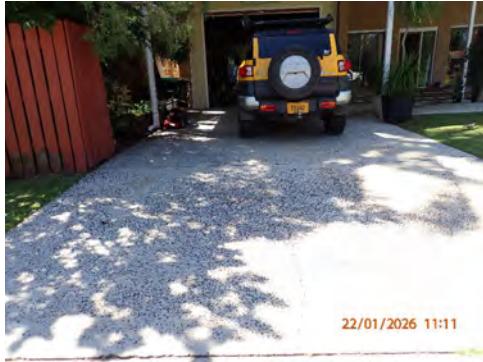
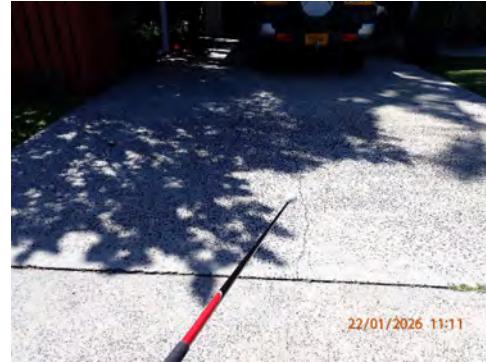
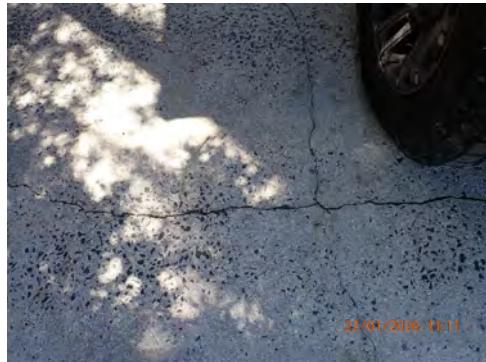
### Finding 3.03

B | Crack | Driveway cracking observed

At the time of inspection, noticeable cracking was observed to sections of the concrete driveway. This type of cracking is common in residential driveways and is generally associated with normal ageing of the concrete, thermal movement, and minor ground settlement over time.

The cracking did not appear to affect the immediate usability of the driveway at the time of inspection. Maintenance or repair options, such as crack sealing or localised patching, can be considered to improve presentation and limit future deterioration. Any remedial works may be undertaken at the clients discretion, with periodic monitoring recommended as part of routine property maintenance

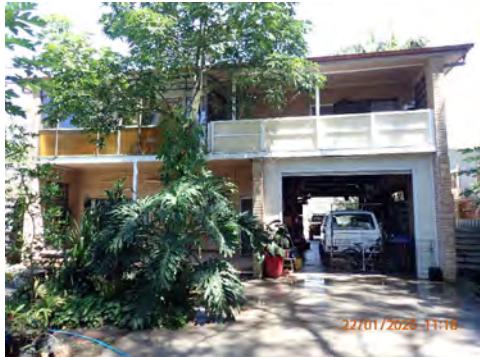
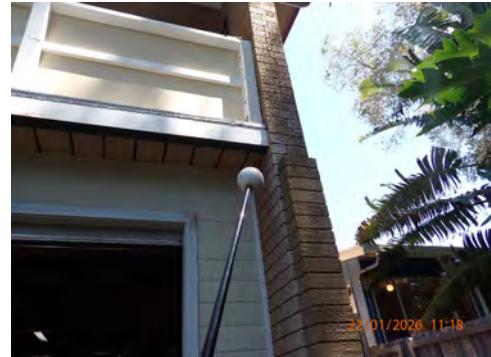
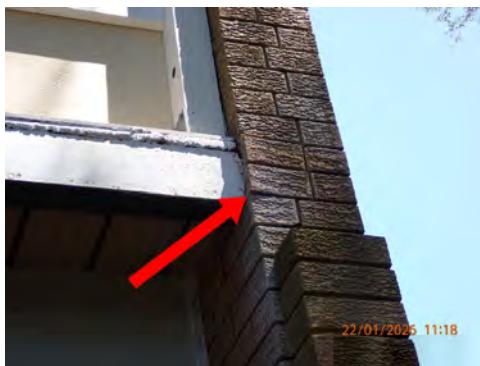
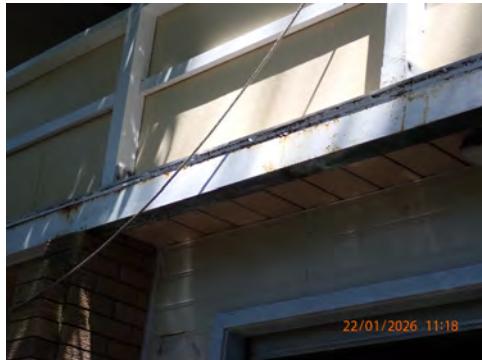
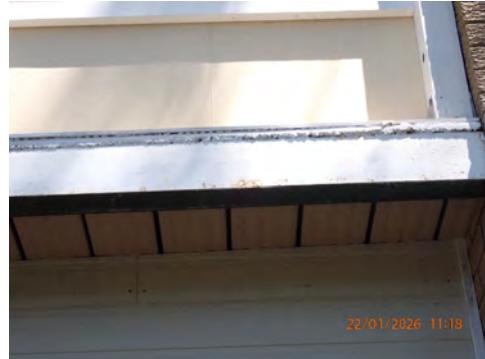
Finding: B | Corrosion | External steel beam – rusting observed

Information: At the time of inspection, the external steel beam was observed to show signs of surface rusting. Minor cracking and displacement to the adjacent brickwork was also noted, which is commonly associated with the natural expansion of steel as it corrodes over time.

This condition is relatively common in properties where steel elements are exposed to weather and moisture. Maintenance works such as rust treatment, application of protective coatings, and localised brickwork repairs may be considered to limit further deterioration and improve presentation. Depending on the extent of corrosion and masonry movement, consultation with a licensed builder and/or a structural engineer may be required to provide further advice on appropriate remedial measures. Any works may be undertaken at the owner's discretion, with periodic monitoring recommended as part of routine property maintenance.

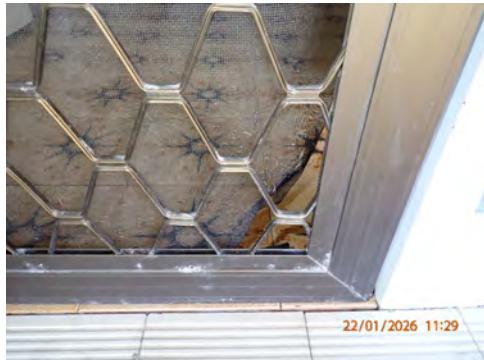
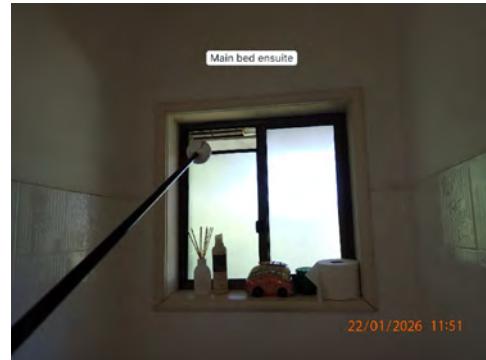
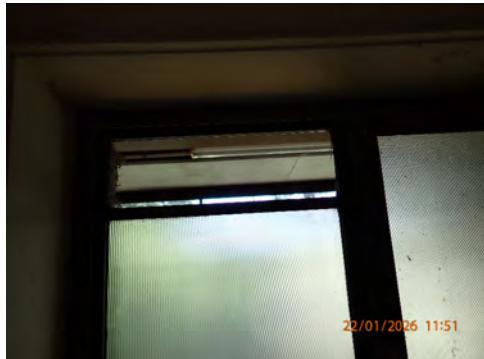
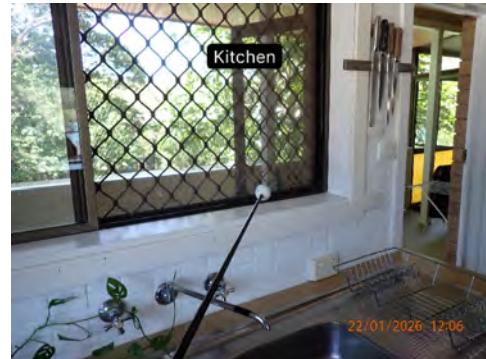
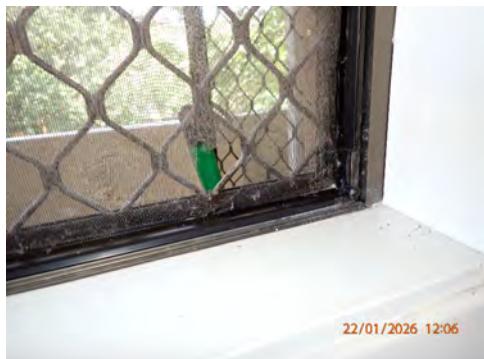
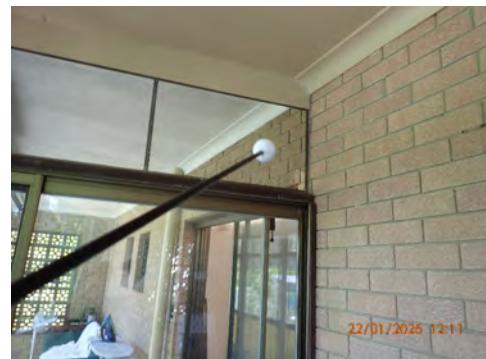
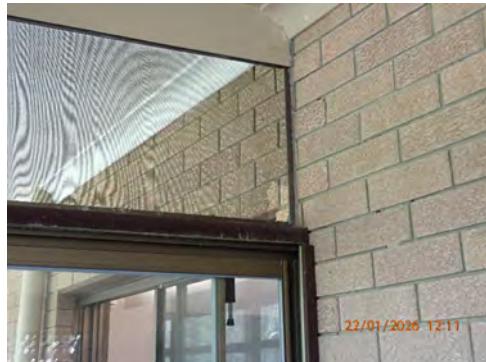
Building:	Main Building
Location:	All Areas, Rear
Finding:	Flyscreens - Damaged
Information:	<p>It was observed that the window flyscreens is damaged, with tears and holes present in the mesh. This damage is likely due to general wear and tear, accidental impact, or prolonged exposure to weather. A damaged flyscreen can reduce ventilation effectiveness, allow insects to enter the building, and may also detract from the overall appearance of the window. Additionally, gaps in the flyscreen can provide easy access for pests, which could lead to further maintenance issues. It is recommended that a qualified handyman or window contractor be engaged to repair or replace the damaged flyscreen. This work should be carried out at the client's earliest convenience to restore the function of the window and maintain a pest-free environment.</p>

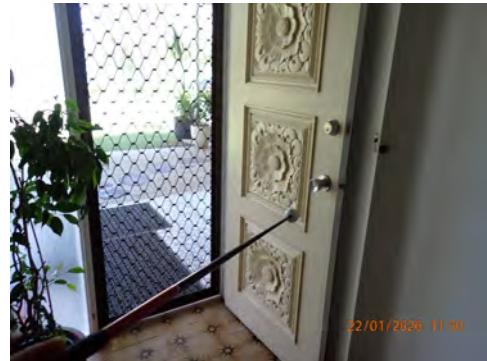
### Finding 3.12

Building:	Main Building
Location:	All Areas, Rear
Finding:	WD   Door   Damage to door noted
Information:	<p>During the inspection, damage was observed to the front door. The damage was noted in accessible areas and may include surface deterioration, impact marks, wear to edges, or damage to door components.</p> <p>Damage of this nature commonly occurs due to general use, impact, moisture exposure, or age-related wear. While the condition may primarily affect presentation and functionality, further deterioration can occur if left unaddressed.</p> <p>A licensed carpenter or door specialist can be engaged to assess the extent of damage and carry out repair or replacement as required. These works can be undertaken at the owner's discretion, with monitoring recommended as part of routine maintenance</p>

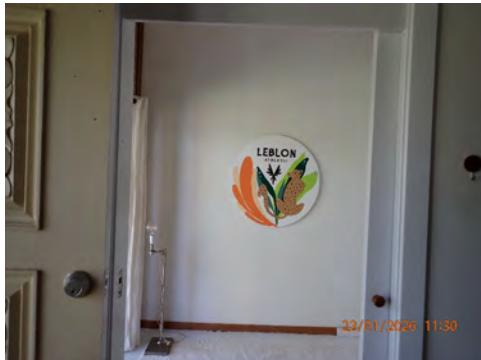
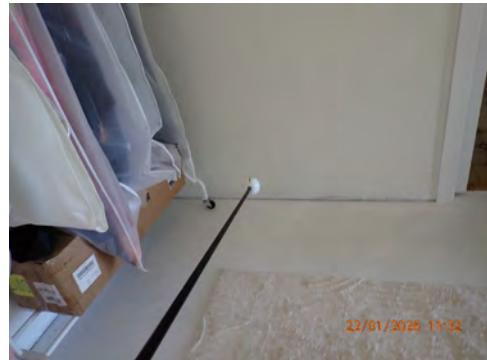
### Finding 3.13

Finding: B | Skirting | Section of skirting missing or incomplete

Information: During the inspection, sections of skirting were observed to be missing, incomplete, or not securely fixed. Missing or poorly fitted skirting leaves gaps at wall and floor junctions, detracting from presentation and allowing dust and debris to accumulate. Prolonged exposure of unprotected wall edges may also result in minor damage or moisture absorption.  
A licensed carpenter should be engaged to install, refix, or complete the skirting to match adjoining finishes and ensure a neat, consistent appearance. These works can be carried out at the owner's discretion

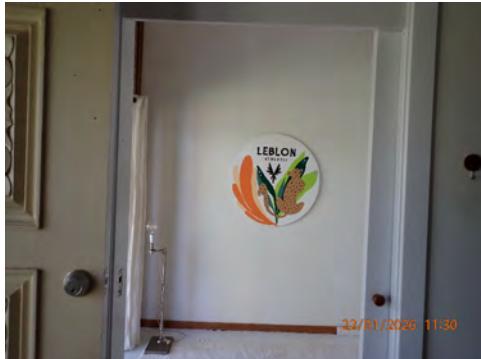
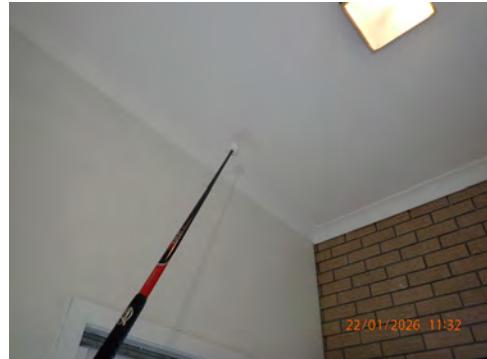
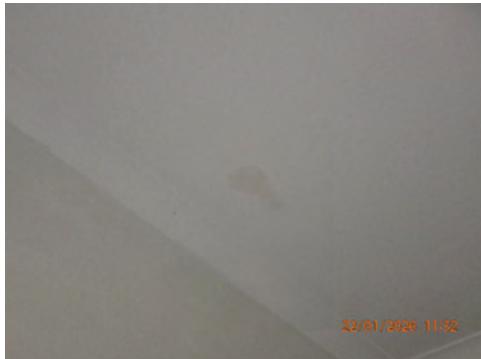
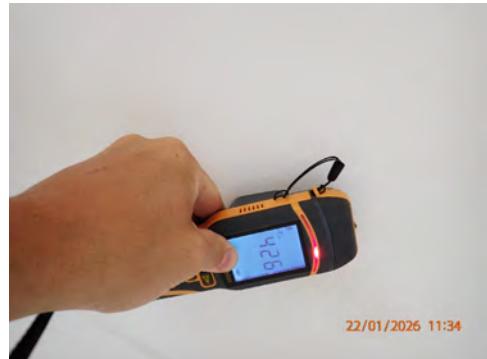
### Finding 3.14

Building: Main Building  
Location: Bedroom 3 Ground Level  
Finding: B | EMR | Moisture observed to ceiling

During the inspection, moisture was observed to the ceiling in this area. The presence of moisture may be associated with issues such as roof leaks, plumbing defects, condensation, or moisture migration from adjoining building elements. Continued moisture exposure can lead to deterioration of ceiling linings, staining, mould growth, and potential concealed damage if left unmanaged.

The moisture meter used operates on a scale from 0 to 999. Readings above 200 are considered elevated. Concealed damage could not be ruled out. More invasive inspection is recommended to determine the full extent of any concealed moisture-related damage.

The source of moisture was not confirmed at the time of inspection. A licensed builder or qualified plumber, depending on the suspected source, should be engaged to investigate, identify the cause of moisture ingress, and carry out appropriate rectification works. This should be addressed as soon as practicable to prevent further deterioration.

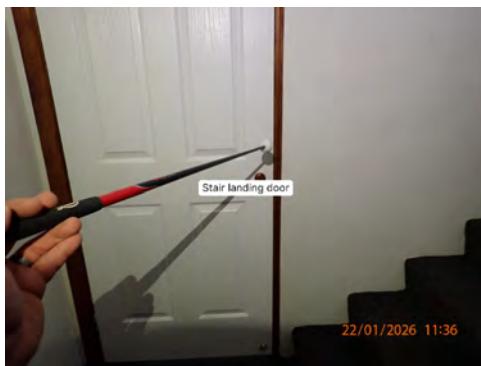
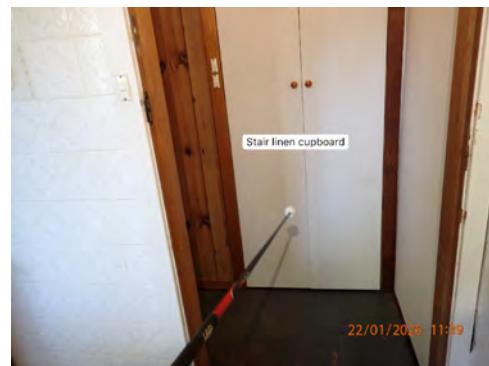
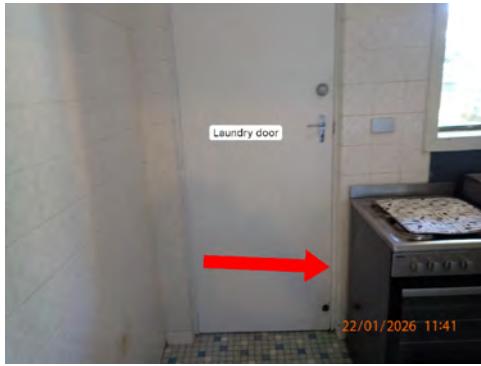
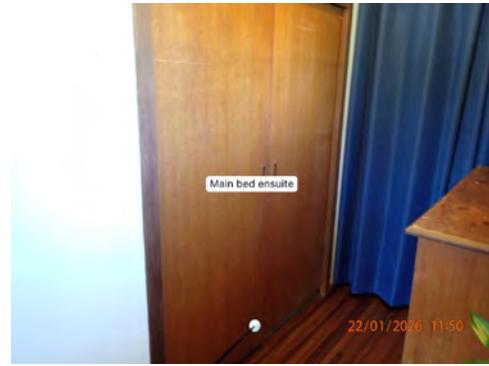
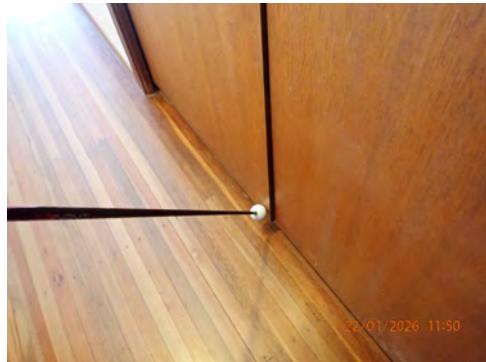
**Finding 3.15**

Information: Several doors throughout the property were either binding during operation or displayed uneven gaps within their frames. Such defects reduce functionality and presentation and may worsen over time if not addressed. Common causes include minor frame movement, wear to hinges, or general age-related settlement.

A licensed carpenter or builder should adjust or realign the affected doors and hardware as required. Works may be carried out at the owner's discretion.

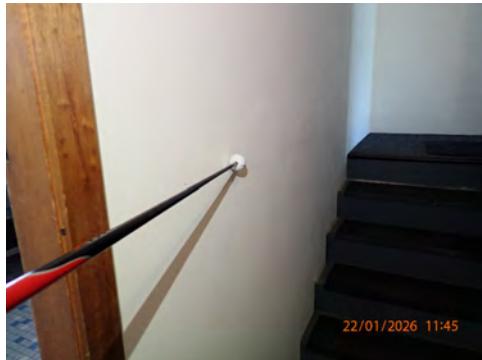
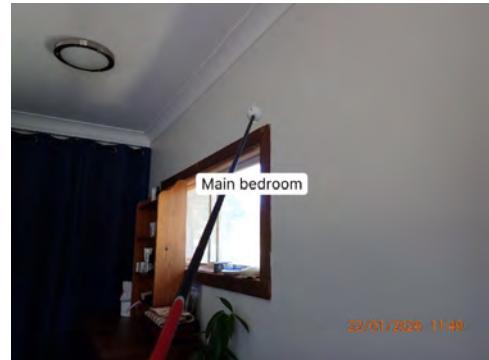
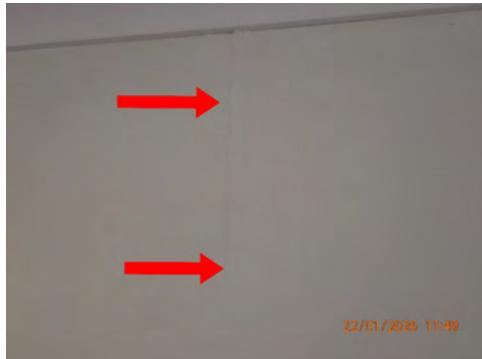
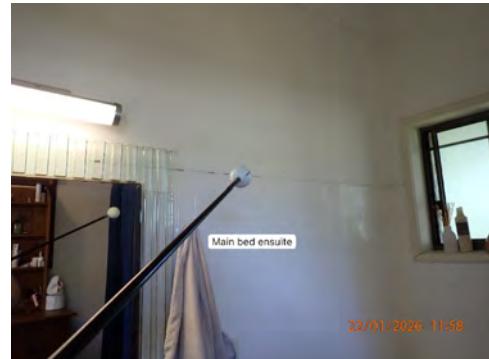
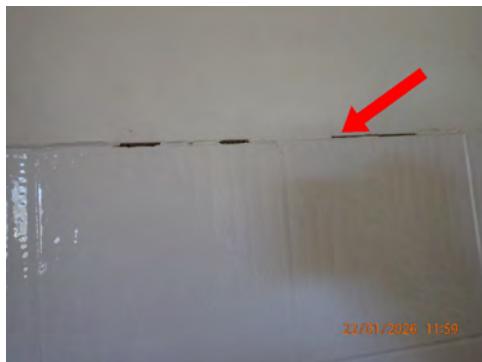
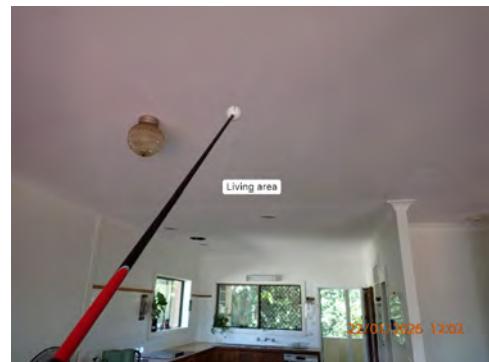
During the inspection, minor paint finish inconsistencies were observed throughout the property. These included scuff marks, patchy or uneven touch-ups, minor surface blemishes, and areas where previous patch repairs remain visible. Such conditions are common in lived-in properties and are generally associated with normal wear, past maintenance works, and variations in surface preparation over time.

The observed paint finishes primarily affect presentation rather than performance. If an improved or more uniform appearance is desired, repainting of selected areas or the dwelling as a whole may be considered. A licensed painter can be engaged at the owner's discretion to carry out surface preparation and repainting works as required.

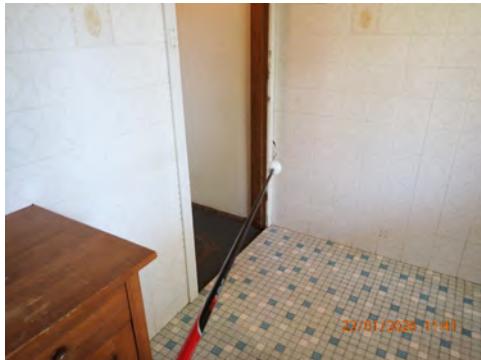
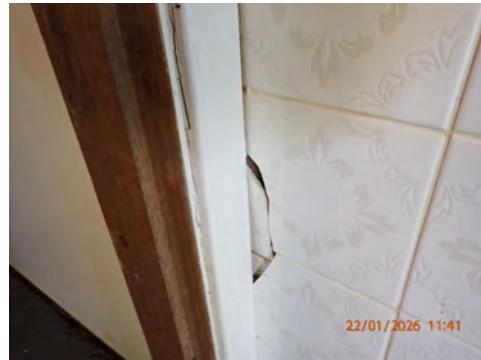
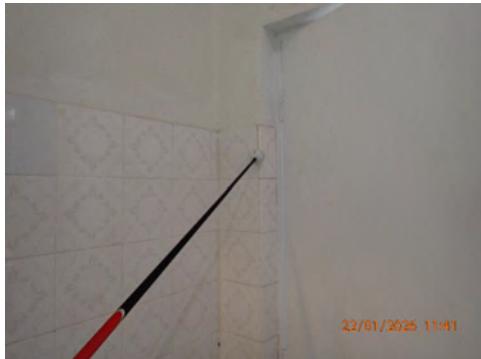
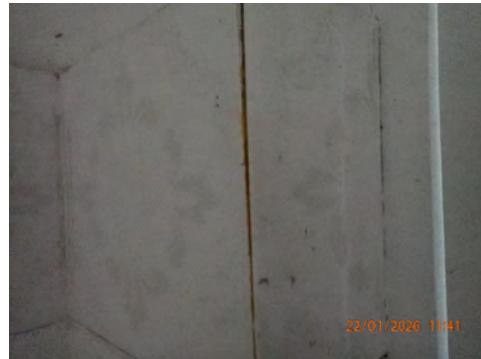
### Finding 3.18

Building:	Main Building
Location:	All Internal Areas
Finding:	B   Tiles   Wall tile damage observed
Information:	<p>At the time of inspection, minor damage was observed to wall tiles in the laundry. This may include small chips, surface wear, or isolated cracking, which is commonly associated with normal use, age-related wear, or minor impact.</p>

The condition primarily affects presentation and does not appear unusual for a property of this age and type. If improved appearance is desired, localised tile repair or replacement may be considered. A licensed tiler can be engaged at the owner's discretion, with ongoing monitoring recommended as part of routine maintenance.

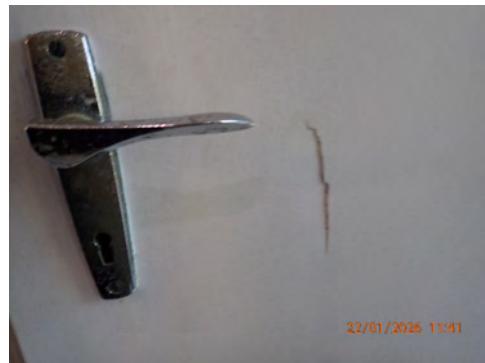
### Finding 3.19

Finding: WD | Door | Dent/crack to door

Information: At the time of inspection, a dent and/or crack was observed to the door. This type of damage is commonly associated with general use, minor impact, or age-related wear.

While not uncommon, damage of this nature may affect presentation and could worsen over time if left unmanaged. A licensed carpenter or door specialist should be engaged to repair or replace the affected door as required. These works can be carried out at the owner's discretion.

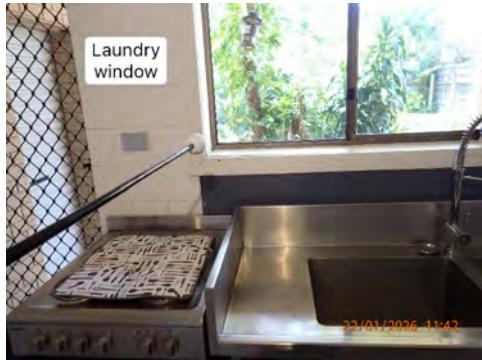
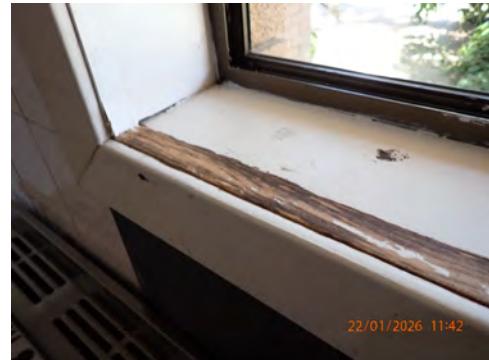
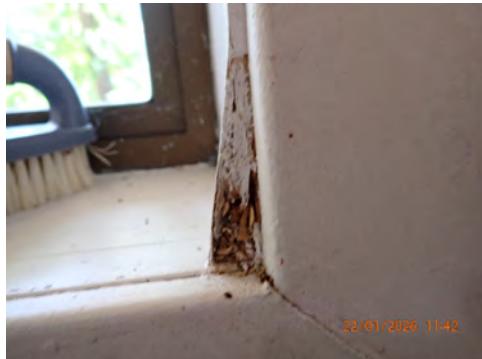
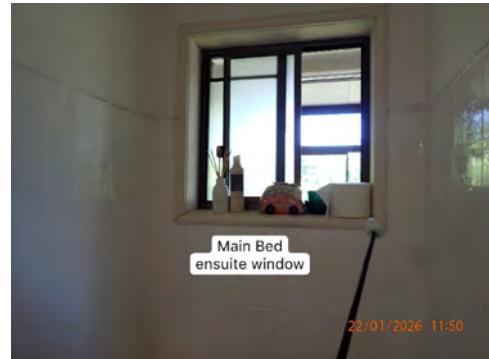
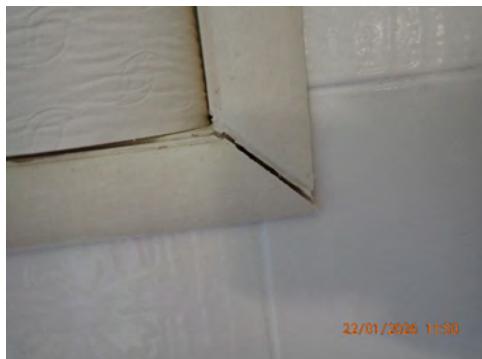
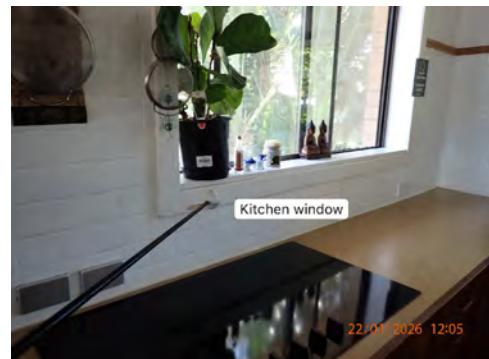
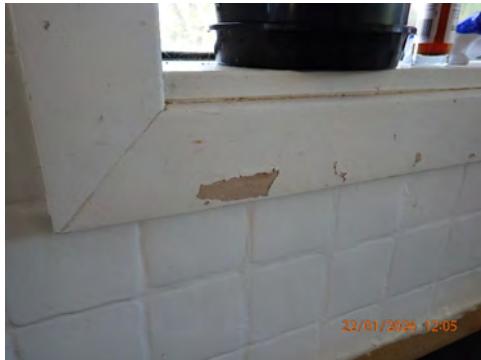
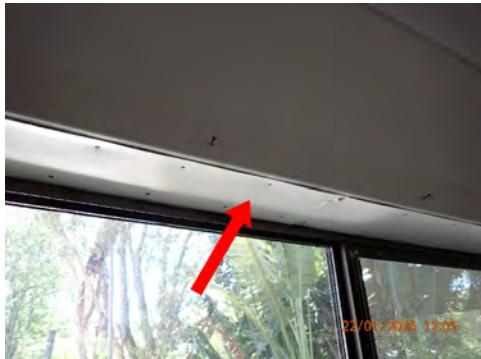
Finding: WD | Window | Damage noted to multiple windows

Information: Damage was observed to several windows throughout the property, including evidence of past water staining, cracking to window architraves, and previous repair works.

A licensed builder or qualified carpenter should be engaged to assess the affected windows and carry out further repairs or maintenance as required. These works should be attended to as soon as practicable.

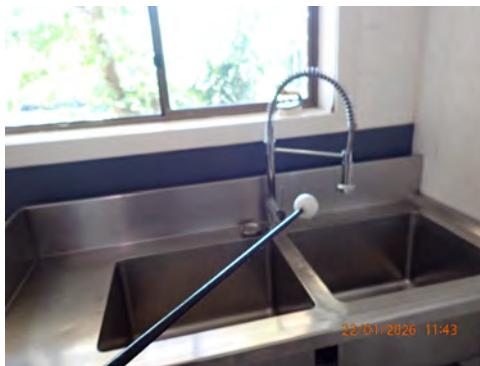
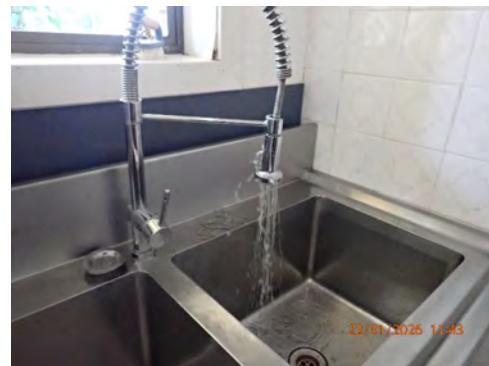
### Finding 3.21

Finding: Tap - Leaking

Information: The tap in this area was found to be leaking at the time of inspection. This is a common defect that is consistent with general ageing of the building element. However, it may be indicative of substandard plumbing workmanship if the tap is relatively new.

While this defect only seems minor, if left unmanaged, it is likely to result in the development of rust, water damage and/or extensive water usage.

It is advised that a handyman or licensed plumber be appointed to perform remedial works on the affected tap. Such works should be performed prior to the development of secondary defects to ensure adequate functionality of all associated building elements.

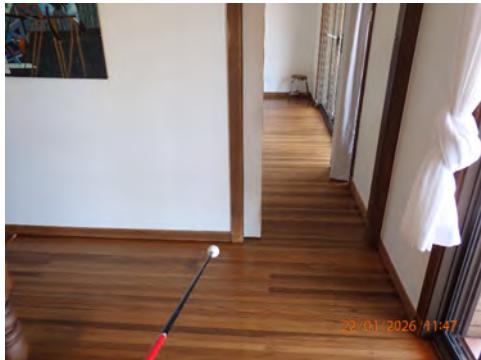
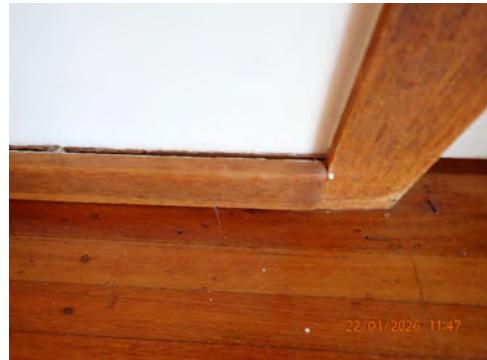
### Finding 3.22

Finding: Skirting - Loosely fitted

Information: The skirting in this area was observed to be loosely fitted at the time of inspection. If not addressed it may result in further loosening, visible gaps, or potential damage to the skirting and adjoining surfaces. Re-securing the skirting with suitable fixings or adhesive is recommended to restore a neat and stable finish. This work can be carried out by a carpenter or handyman at the client's discretion.

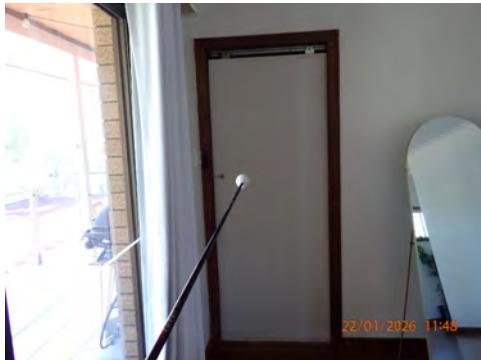
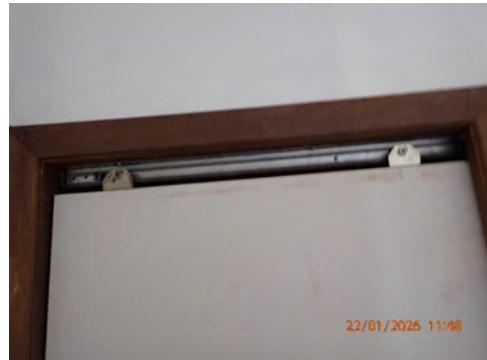
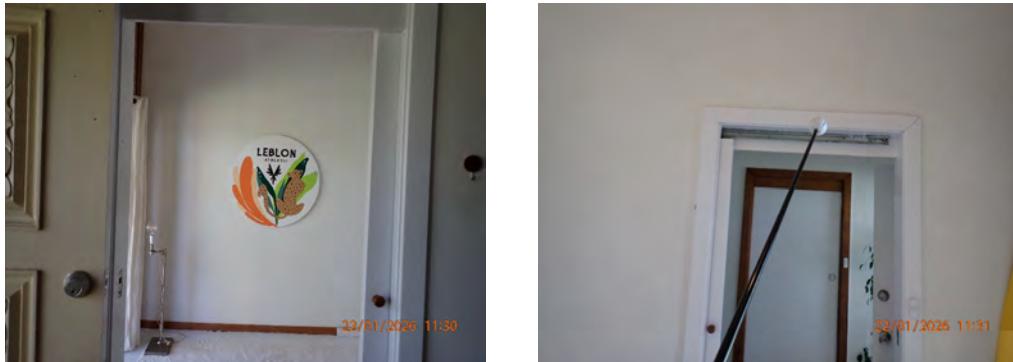
### Finding 3.23

Finding: WD | Door | Sliding door pelmet missing

Information: During the inspection, the top pelmet to the sliding door was observed to be missing. This condition does not affect the operation or function of the sliding door at the time of inspection.

The missing pelmet primarily affects presentation and finish. If a complete or uniform appearance is desired, replacement of the pelmet may be considered. A licensed carpenter or suitably qualified tradesperson can be engaged to carry out reinstatement at the owner's discretion.

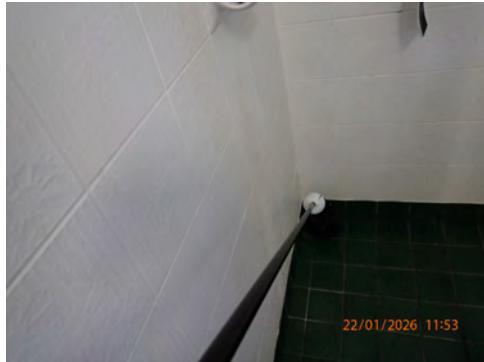
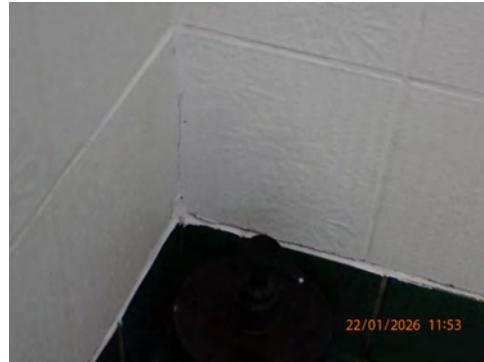
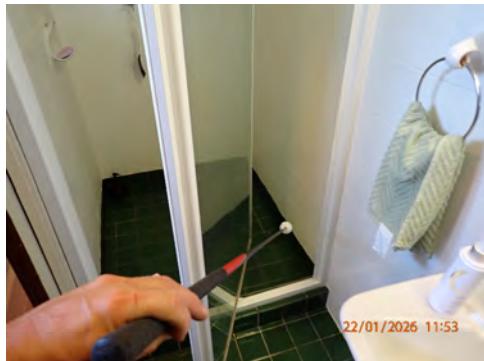
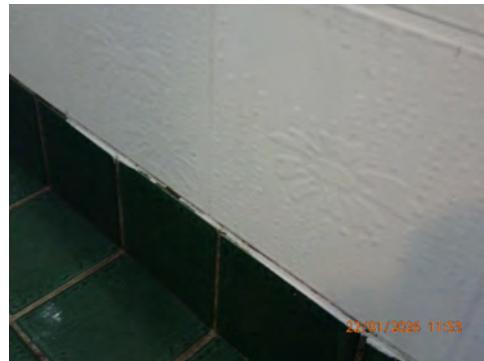
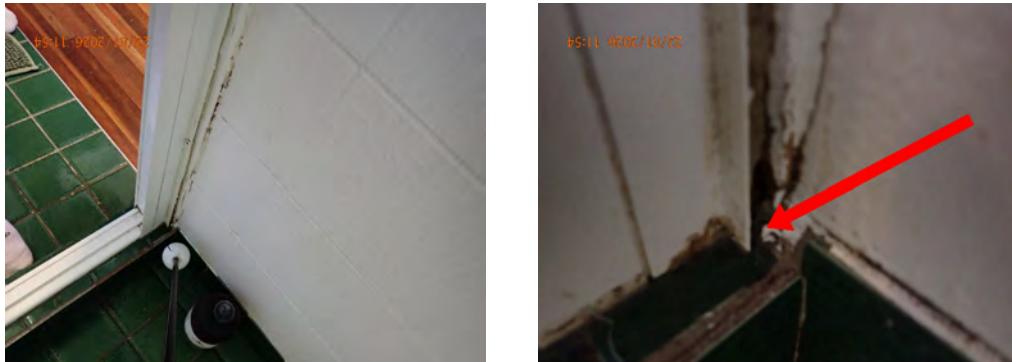
Building: Main Building  
Location: Ensuite - Master  
Finding: Sealant and grouting - Missing or damaged

It was noted on inspection that sealant or grout is degraded to the tiled shower alcove and or other areas of the bathroom.

Different materials and floor areas move at different rates, generally causing cracking to grout or sealant at this point. A flexible sealant is required to allow for expected expansion and contraction, while keeping the joint water tight and protective of all associated building materials.

There appears to be excessive mould to the sealant and grout which will likely require scraping out and replacement.

Flexible and mould resistant materials should be applied to affected areas to prevent any subsequent water damage that is likely to occur. Regular maintenance and replacement of damage or missing or damaged sealant and grout is highly recommended to the wet areas, as this is a regular wear and tear defect. Sealant and grouting in areas that come into regular contact with water should be maintained for the long term care of your property.

A sealant specialist or tiling contractor should be appointed to complete these works as soon as possible

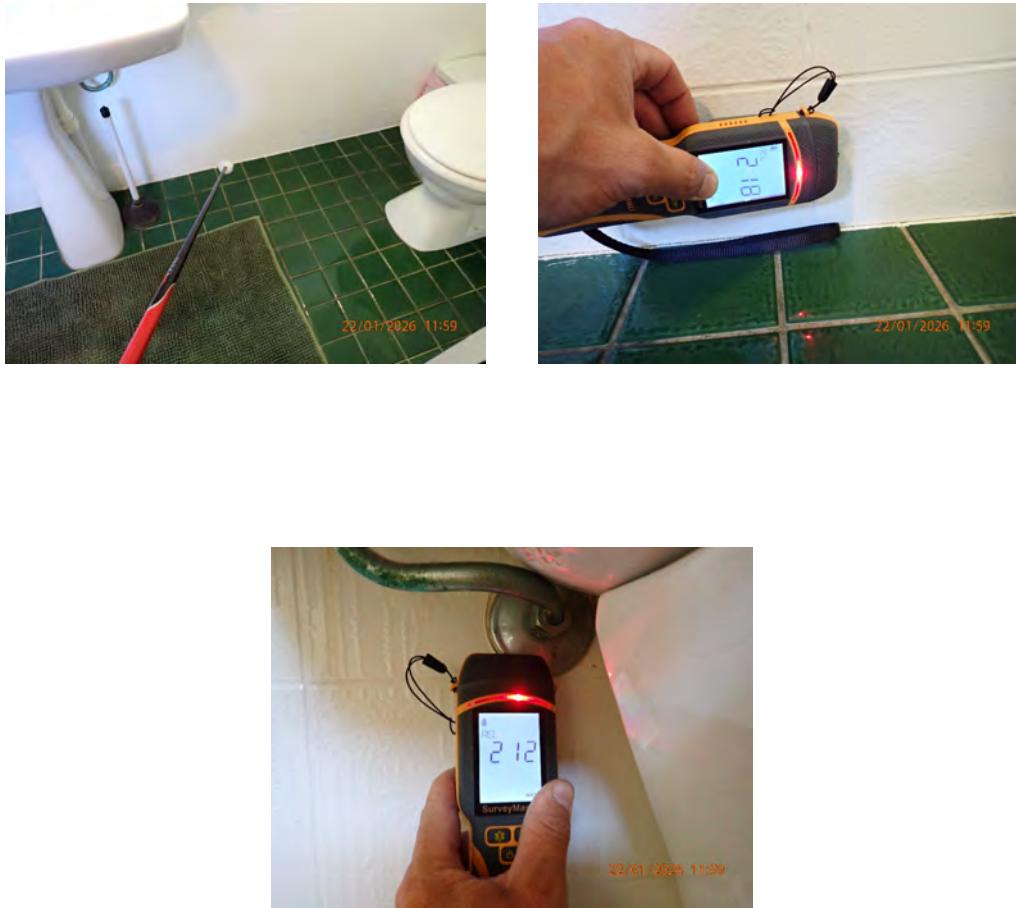
### Finding 3.26

Finding: B | EMR | Moisture observed at ensuite basin junction

Information: During the inspection, elevated moisture readings were observed to the right-hand side of the ensuite basin at both the water point and the floor and wall junction. The source of the moisture could not be confirmed at the time of inspection.

Moisture in this location is commonly associated with plumbing leaks, failed or deteriorated sealant, or water splash-back during regular use. If left unmanaged, ongoing moisture exposure may lead to deterioration of wall linings, floor finishes, and concealed building components.

The moisture meter used operates on a scale from 0 to 999. Readings above 200 are considered elevated. Concealed damage could not be ruled out, and further invasive inspection may be required to determine the full extent of any concealed moisture-related issues.

A licensed plumber or licensed builder, depending on the suspected source, should be engaged to investigate and rectify the cause of moisture ingress. This should be attended to as soon as practicable.

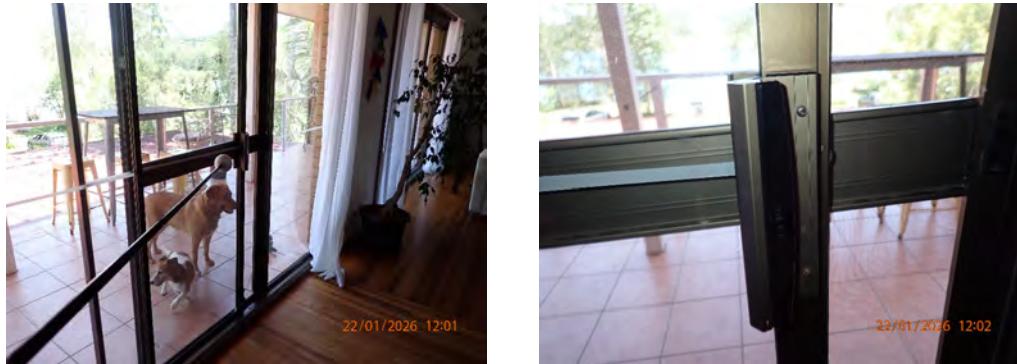
### Finding 3.27

Information: During the inspection, it was noted that the external sliding door lock was not engaging correctly and requires adjustment to ensure proper locking and smooth operation. This type of defect commonly occurs due to general wear, building movement, or misalignment of the striker plate.

It is recommended that a licensed carpenter adjust and service the lock and striker plate to restore correct function. This work can be undertaken at the owner's discretion.

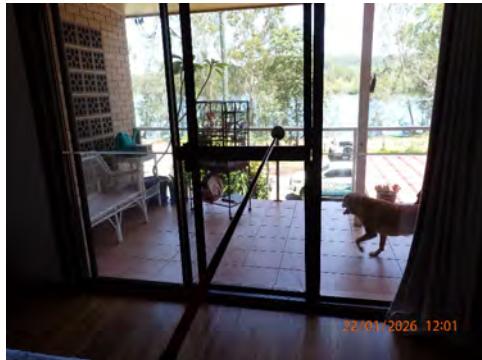
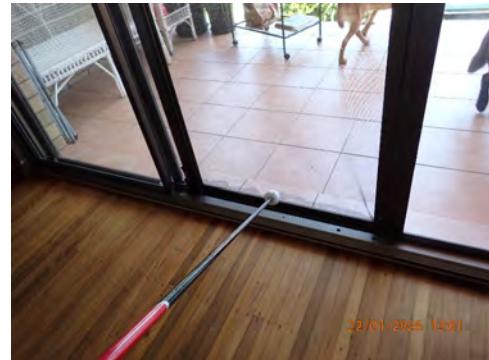
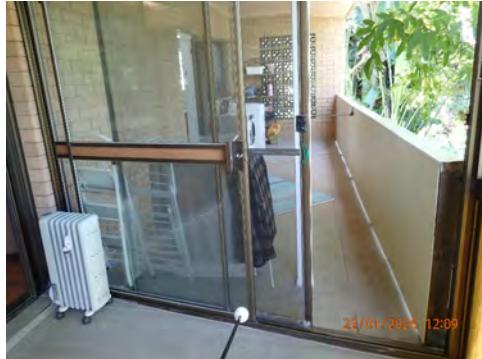
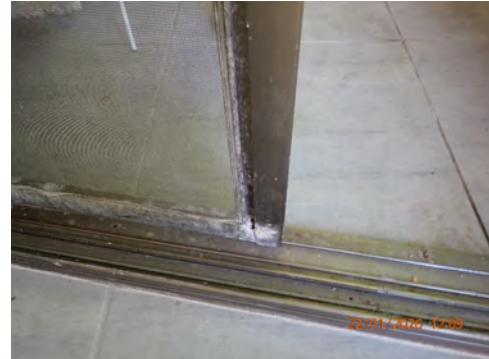
### Finding 3.28

Information: During the inspection, it was noted that the flyscreen sliding door was stiff and difficult to operate. Restricted movement of the flyscreen track may result from a build-up of dirt or debris in the tracks, lack of lubrication, or deterioration of hardware components. If not addressed, this condition can lead to further damage to door and compromise their functionality.

A licensed carpenter should be engaged to clean, service, and adjust the affected windows to restore smooth operation. Where components are found to be corroded or damaged beyond repair, replacement may be required. These works should be carried out as soon as practicable.

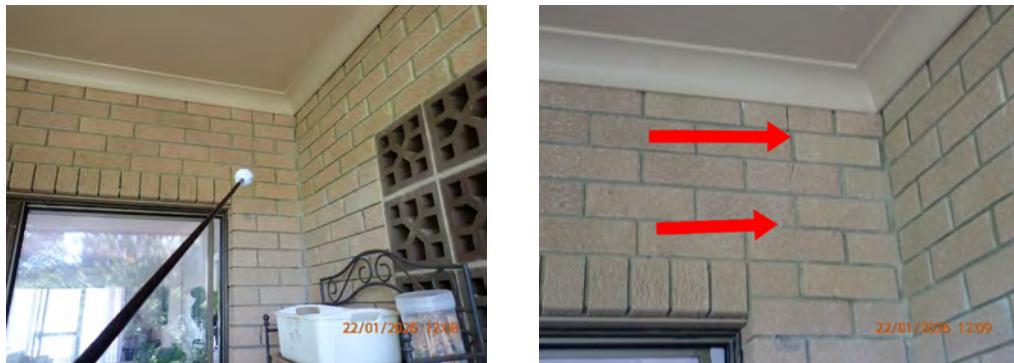
### Finding 3.29

Building: Main Building  
Location: Balcony Rear  
Finding: B | Crack | Brickwork cracking above sliding door

At the time of inspection, cracking was observed to the brickwork above the kitchen window. Cracking in this location is commonly associated with normal building movement, thermal expansion and contraction, or minor settlement around openings such as doors and windows.

The cracking did not appear unusual for a property of this age and construction and is a common occurrence where masonry is supported over openings. While primarily a maintenance and presentation-related matter, periodic monitoring is recommended to ensure the cracking does not worsen over time.

If improvement to appearance or reassurance is desired, consultation with a licensed builder may be undertaken at the owner's discretion to assess the cracking and carry out localised repairs or sealing as required.
