## Building and Timber Pest Inspection Report VR

Inspection Date: Thu, 22 Jan 2026

Property Address: 4 Riverside Crescent, Brunswick Heads NSW,  
Australia

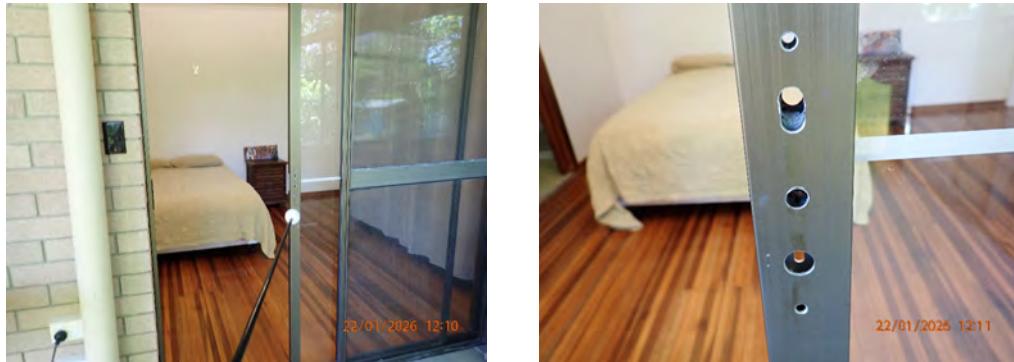
**Finding 3.30**

Finding: Sliding door - Missing handle

Information: The handle to the sliding door was missing at the time of the inspection. Absence of the handle limits the operation of the door and may pose as a safety risk.

Replacement of the handle should be conducted as soon as possible. A general handy person or qualified carpenter should be appointed to perform these works to improve the operational state of the affected window and improve the safety of the internal area.

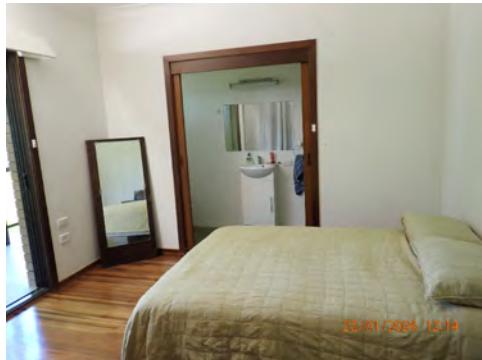
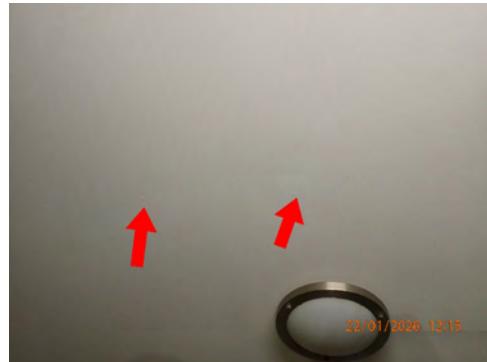
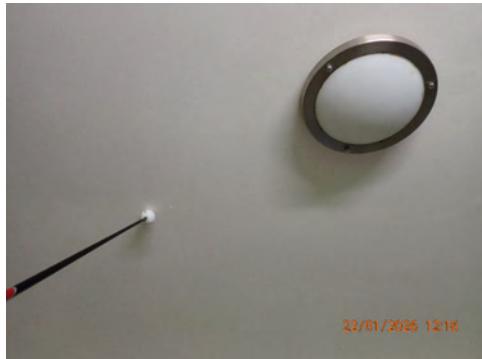
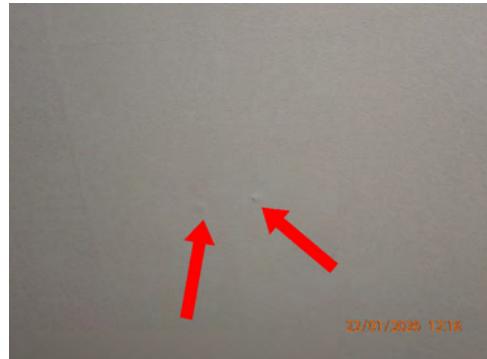
### Finding 3.31

Information: At the time of inspection, numerous popped nails were noted within the internal ceiling. This occurs when ceiling fixings gradually lose their grip on the sheet material, often due to natural ageing, timber shrinkage, or minor structural movement. If left unmanaged, the ceiling sheets may loosen further, potentially leading to instability, sagging, or secondary damage to the ceiling structure.

A qualified carpenter or plasterer should be engaged to resecure the ceiling sheets and refinish the affected areas. This work should be carried out at the owner's discretion to maintain stability and improve overall presentation.

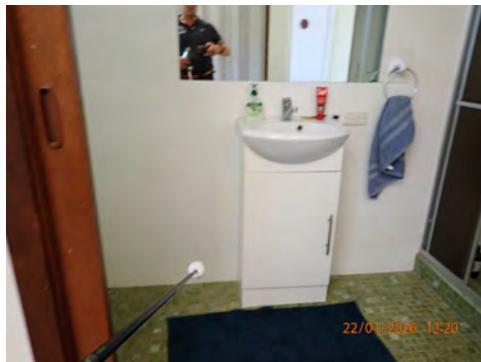
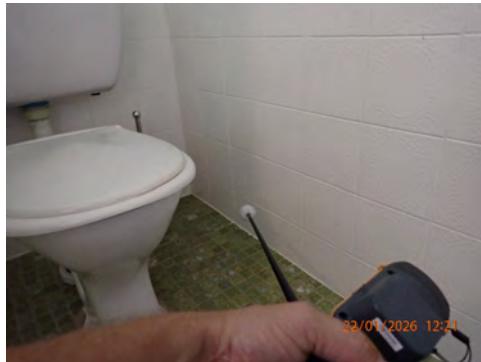
### Finding 3.32

Building: Main Building  
Location: Bedroom 2 ensuite  
Finding: B | EMR | Moisture observed at ensuite basin junction

During the inspection, elevated moisture readings were observed to the left-hand side of the ensuite basin at the floor and wall junction. The source of the moisture could not be confirmed at the time of inspection.

Moisture in this location is commonly associated with plumbing leaks, failed or deteriorated sealant, or water splash-back during regular use. If left unmanaged, ongoing moisture exposure may lead to deterioration of wall linings, floor finishes, and concealed building components.

The moisture meter used operates on a scale from 0 to 999. Readings above 200 are considered elevated. Concealed damage could not be ruled out, and further invasive inspection may be required to determine the full extent of any concealed moisture-related issues.

A licensed plumber or licensed builder, depending on the suspected source, should be engaged to investigate and rectify the cause of moisture ingress. This should be attended to as soon as practicable.

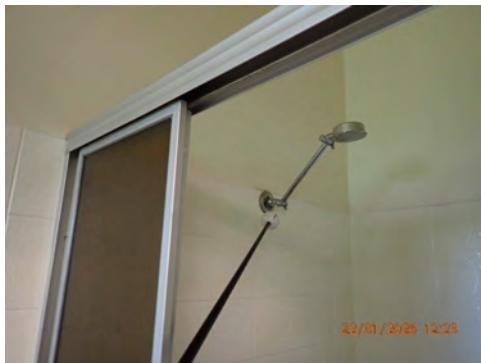
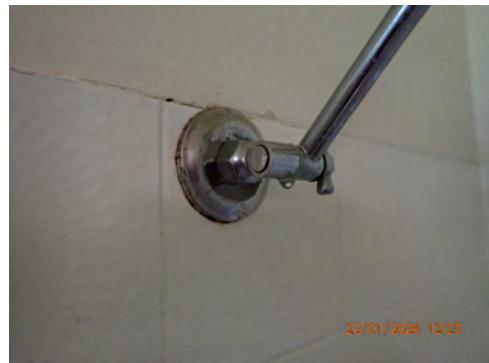
**Finding 3.33**

Finding: B | Plumbing | Leaking shower head

Information: During inspection, the shower head was found to be leaking within the shower area. This defect is commonly associated with the ageing of plumbing fixtures, but may also indicate substandard installation if the fitting is relatively new. If left unmanaged, the leak may contribute to unnecessary water usage, rusting of components, and potential water damage to adjoining materials.

A licensed plumber should be engaged to repair or replace the affected fitting as necessary. This work should be carried out as soon as practicable to restore proper function and prevent secondary defects.

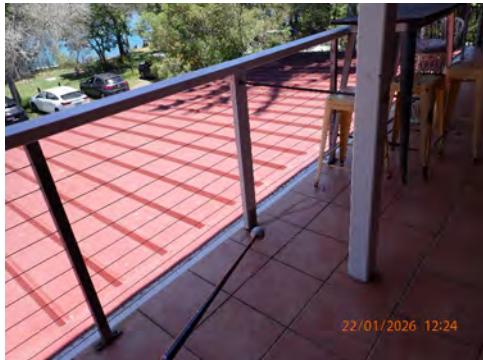
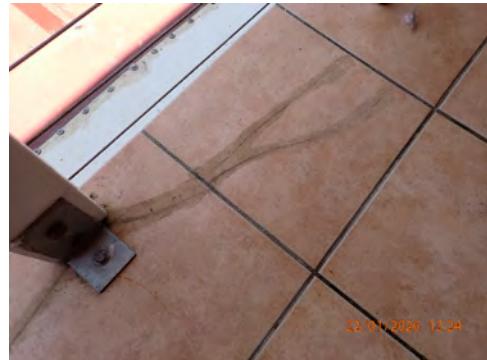
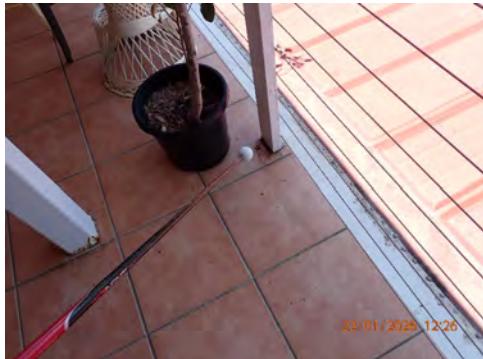
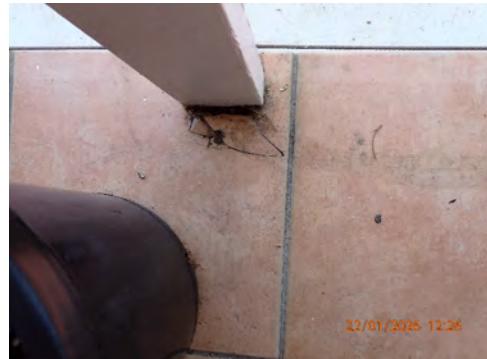
### Finding 3.34

Finding: B | Tiles | Cracked tiles observed

Information: Cracked tiles were observed in this area at the time of inspection. Tile cracking commonly occurs due to impact, building movement, substrate movement, or age-related deterioration.

If left unmanaged, cracked tiles may worsen over time and can allow moisture to penetrate beneath the tiled surface, potentially leading to deterioration of underlying materials. A licensed tiler or builder should be engaged to assess and repair or replace the affected tiles as required. These works should be attended to as soon as practicable.

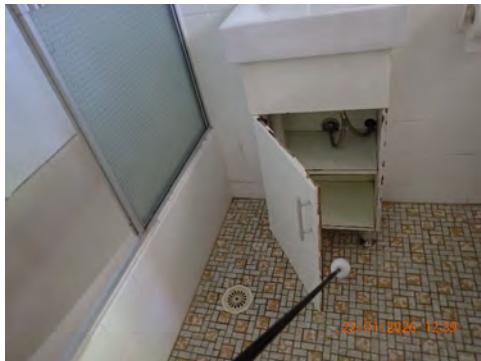
B | Joinery | Water damage to bathroom vanity

At the time of inspection, it was observed that the bathroom vanity displayed signs of past water damage, including swelling and deterioration of cabinetry surfaces. This condition is commonly associated with previous exposure to moisture or inadequate sealing of cabinet edges and junctions. Importantly, no active moisture was observed at the time of inspection.

If left untreated, such damage can worsen over time, reducing the vanity's overall appearance.

Rectification should include identifying and repairing any potential source of moisture, replacing or repairing affected vanity panels, and ensuring all edges and junctions are properly sealed to prevent recurrence. These works can be undertaken by a cabinetmaker, with plumbing input if leaks are identified.

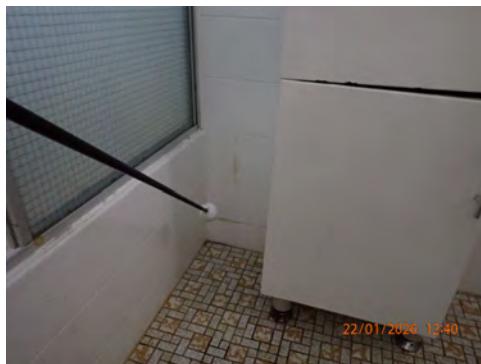
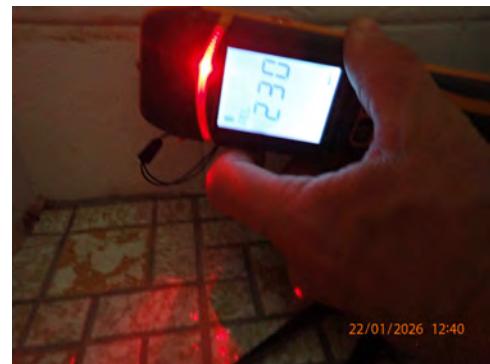
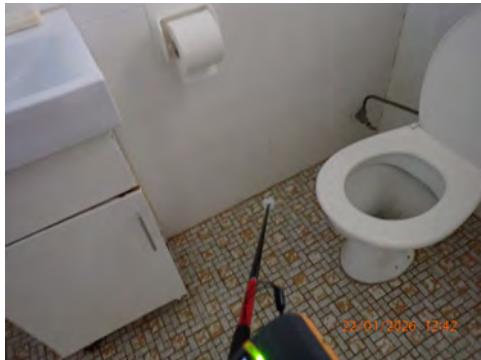
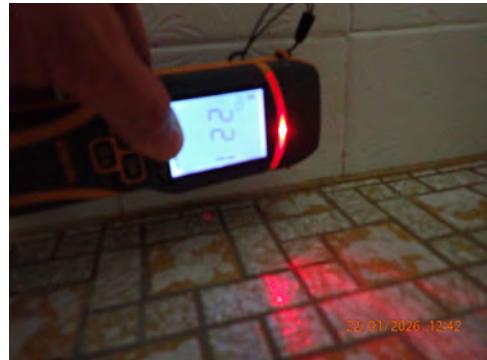
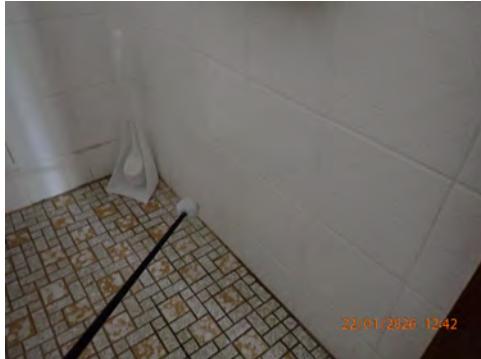
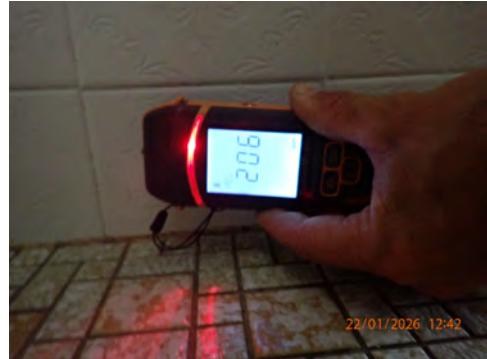
### Finding 3.36

Finding: B | EMR | Elevated moisture in bathroom

Information: Elevated moisture levels were detected within the bathroom during inspection. The moisture meter operates on a scale from 0 to 999, with readings above 200 considered elevated. Staining was also observed in adjoining areas, indicating possible past or ongoing water ingress. Excessive moisture in wet areas can result from deteriorated or missing sealant, cracked grout, leaking plumbing fixtures, or compromised waterproofing membranes. If left unmanaged, these conditions may lead to concealed damage behind linings, deterioration of structural elements, and mould development.

The moisture meter used operates on a scale from 0 to 999. Readings above 200 are considered elevated. Concealed damage could not be ruled out. Photographs included are indicative only and do not constitute an exhaustive record of all instances of the defec

A licensed plumber or bathroom specialist should be engaged without delay to investigate and rectify the source of the moisture. More invasive inspection may be required to determine the full extent of damage concealed behind finishes.

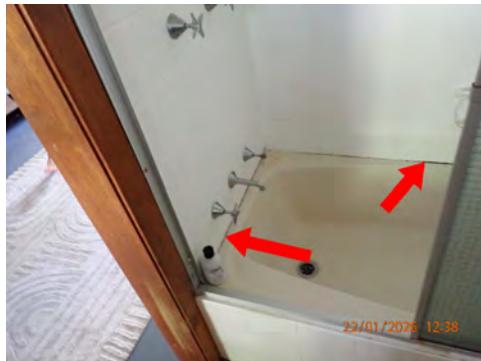
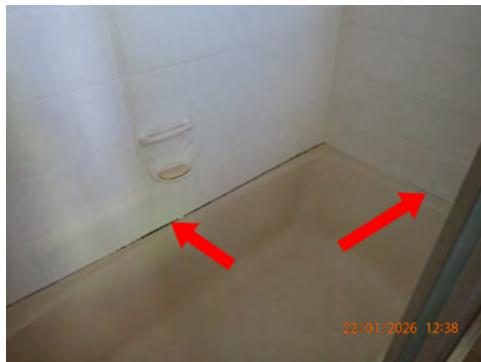
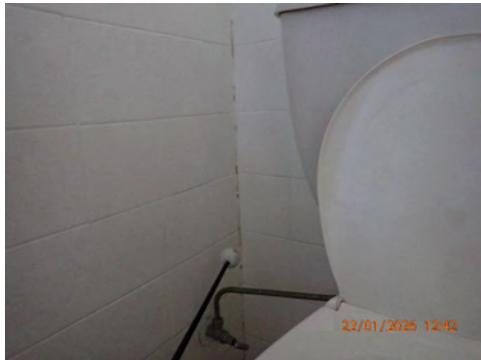
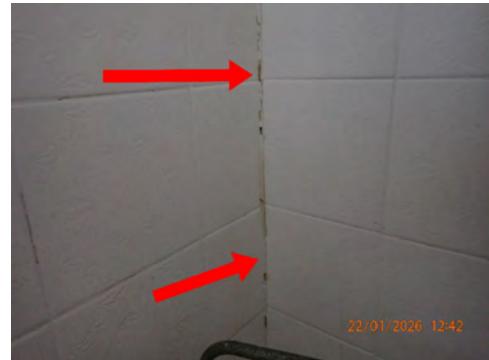
### Finding 3.37

B | Sealant | Deteriorated silicone and cracked grout to bathroom

During the inspection, sections of silicone sealant were observed to have mould and grime build-up. In addition, cracking to grout was noted at internal corners within the bathroom.

Deteriorated sealant and cracked grout are common in wet areas due to regular water exposure, movement between adjoining surfaces, and age-related wear. If left unmanaged, these conditions may allow moisture penetration behind finishes, increasing the risk of further deterioration.

A licensed tiler or sealant specialist should be engaged to remove the affected sealant and grout and replace with suitable mould-resistant materials. These works should be attended to as soon as practicable to maintain water resistance and hygiene.

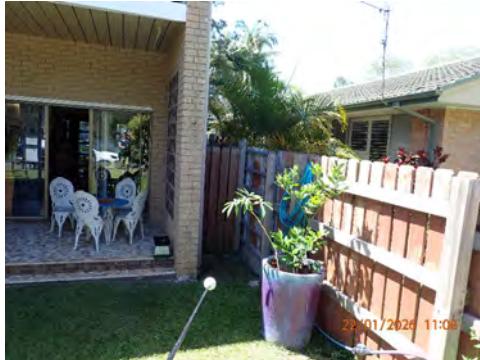
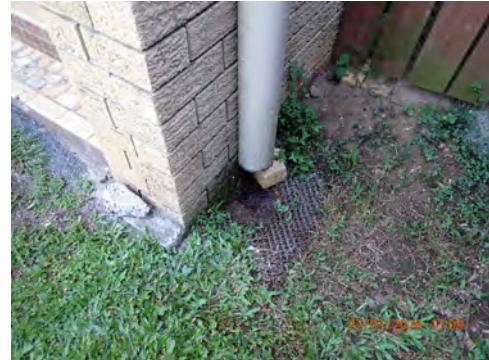
Building: Main Building  
Location: Carport Front  
Finding: TP | EMR | Elevated moisture at downpipe footing connection

During the inspection, the downpipe connection at the base of the building was observed to be not connected to the stormwater and is discharging in to a stormwater pit, resulting in active water leakage and uncontrolled discharge at the footing and adjoining ground. This condition was noted where the downpipe connects to the ground drainage system.

Uncontrolled water discharge at the base of the building can lead to persistently damp conditions at footing and wall junctions. Elevated moisture in these areas is considered conducive to timber pest activity, including subterranean termites, and may also contribute to deterioration of adjoining building materials over time.

A qualified plumber or licensed builder should repair or replace the damaged downpipe connection and ensure stormwater is effectively discharged away from the building as soon as practicable.

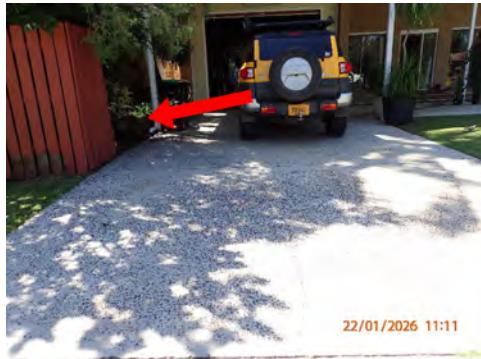
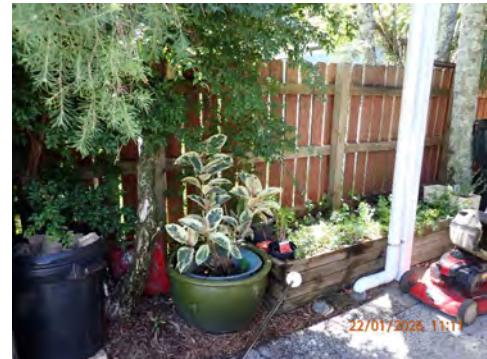
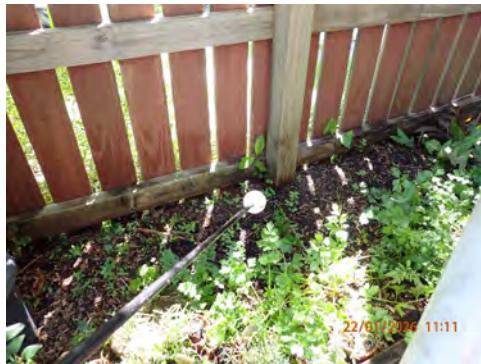
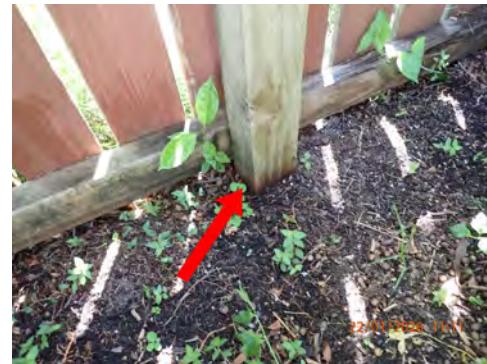
## Finding 6.02

During inspection, timber elements were observed to be in direct contact with the ground and consequently exposed to ongoing moisture. Such conditions are conducive to termite activity and can lead to fungal decay or wood rot over time. Timber in ground contact—whether part of a structure, fencing, or stored materials—creates an ideal environment for subterranean termites to establish concealed entry points into building elements.

All timbers in direct contact with the ground should be removed or isolated from soil as soon as possible to reduce the risk of termite attack and decay. Replacement timbers, if required, should be of a durable or treated species suitable for external use.

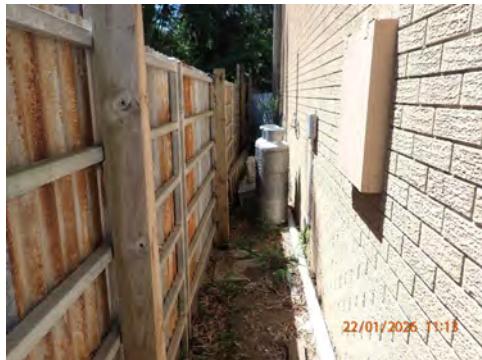
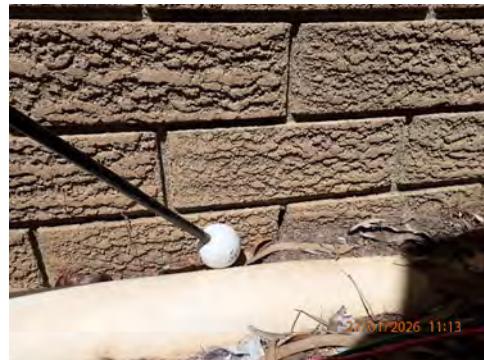
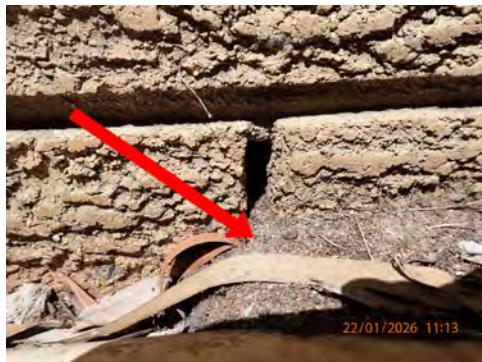
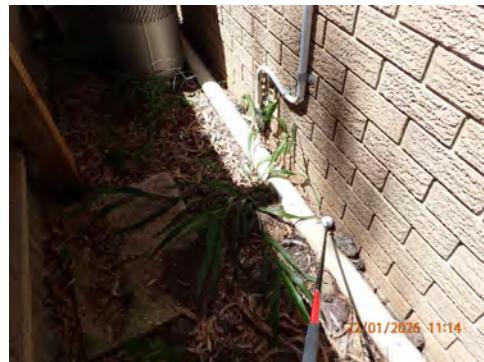
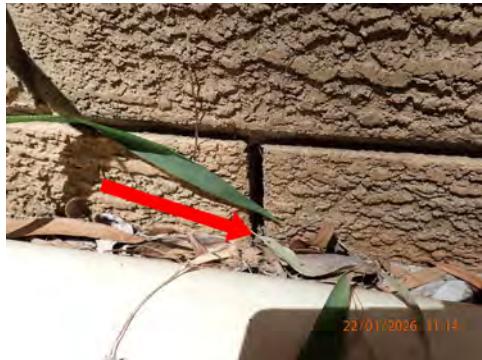
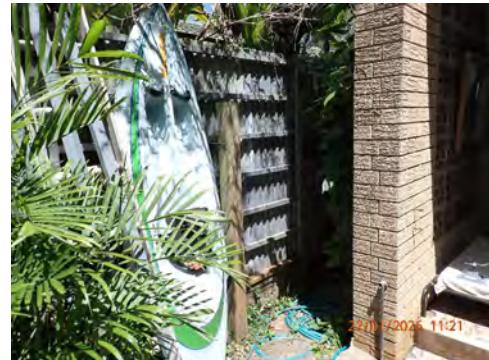
**Finding 6.03**

Information: Weep holes to the external brickwork were observed to be partially or fully covered by external ground levels such as paving and garden beds. This condition results in bridging or breaching of the termite management system, providing subterranean termites with concealed access into the brickwork or adjoining wall materials. It also creates areas where moisture can accumulate, increasing the risk of attracting termite activity. This situation is inconsistent with the requirements of AS 3660.1 Termite Management regarding maintenance of inspection zones and barrier integrity.

A licensed builder or carpenter should lower adjacent ground levels or modify external surfaces as soon as practicable to ensure all weep holes remain fully exposed and clear of obstruction, reinstating a compliant inspection zone.

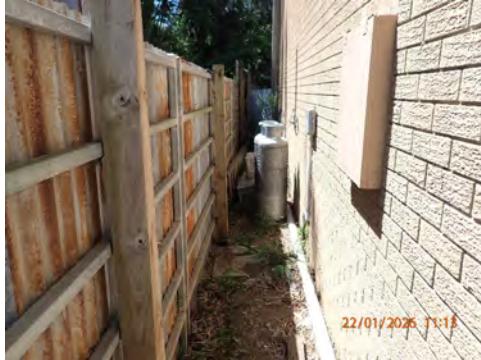
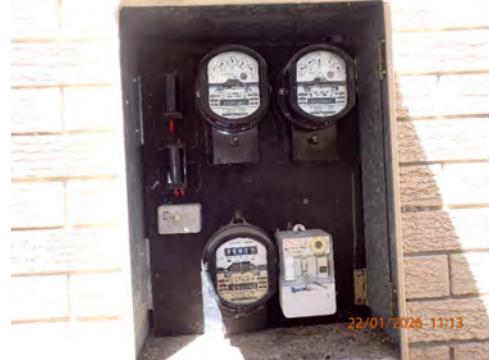
## Finding 6.04

TP | Durable | Missing or illegible termite durable notice

During inspection, the termite durable notice was either missing or illegible. In accordance with AS 3660.1 and AS 3660.2, a durable notice must be installed where a termite management system (such as a physical or chemical barrier) has been applied. Without this notice, it is not possible to confirm whether a system exists or remains effective.

A licensed pest controller should be engaged without delay to inspect the property and, if a termite management system is present, install a compliant durable notice. It is also strongly recommended that an ongoing termite management plan be established to maintain long-term protection of the property.

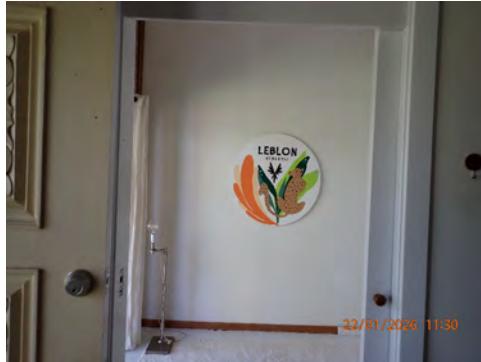
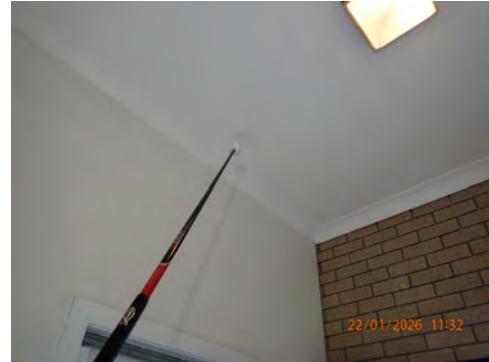
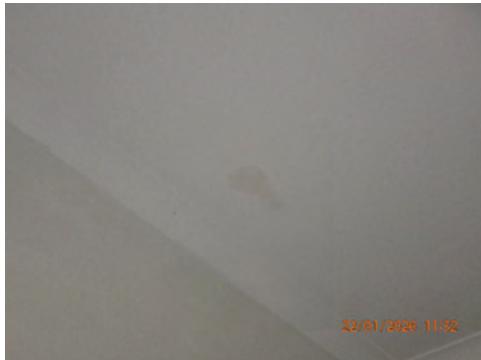
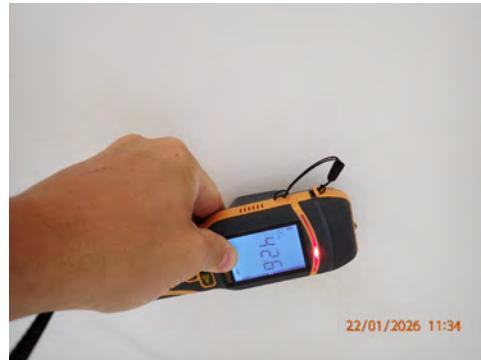
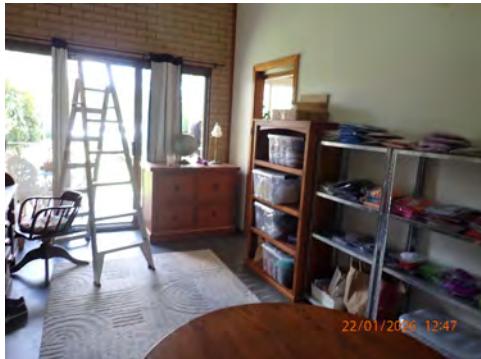
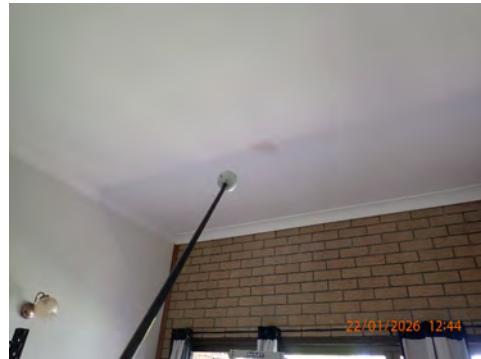
## Finding 6.05

B | EMR | Moisture conditions conducive to deterioration

During the inspection, moisture was observed to the ceiling in this area. Although the exact source of moisture could not be confirmed at the time of inspection, the presence of moisture indicates conditions that are conducive to material deterioration and may also increase the risk of concealed damage if the issue persists.

Moisture at ceiling level is commonly associated with roof leaks, plumbing defects, condensation, or moisture migration from adjoining building elements. If left unmanaged, these conditions may lead to staining, mould growth, degradation of ceiling linings, and deterioration of concealed structural components.

A licensed builder or qualified plumber, depending on the suspected source, should be engaged to investigate and rectify the cause of moisture ingress. This should be attended to as soon as practicable to reduce the risk of ongoing deterioration.

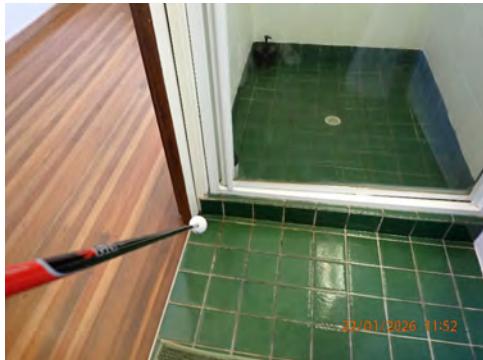
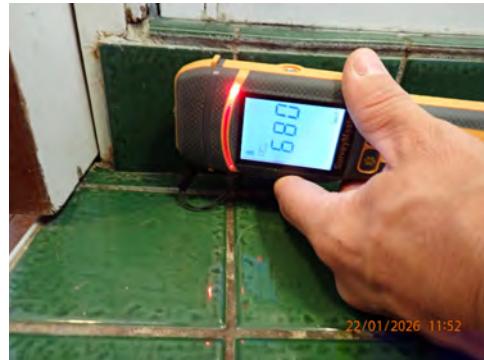
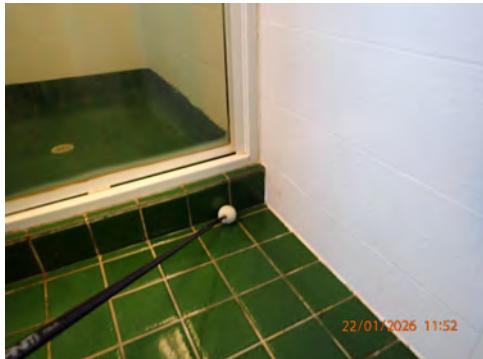
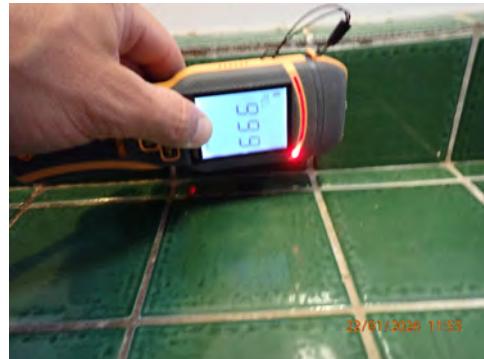
B | EMR | Moisture conditions conducive to deterioration – shower hob

Moisture was detected to the shower hob at the time of inspection. While the source could not be confirmed, the presence of moisture indicates conditions that are conducive to deterioration if left unmanaged.

Moisture in this area is commonly associated with regular water exposure, deteriorated grout or sealant, or compromised waterproofing. A licensed builder or waterproofing specialist should be engaged to investigate and address the cause as soon as practicable.

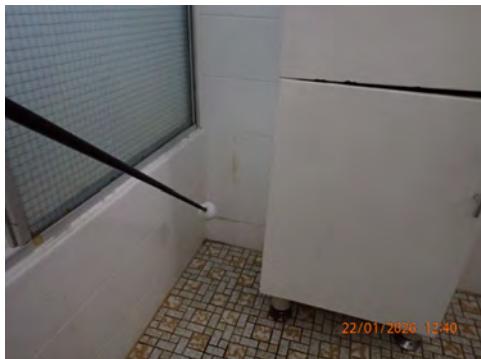
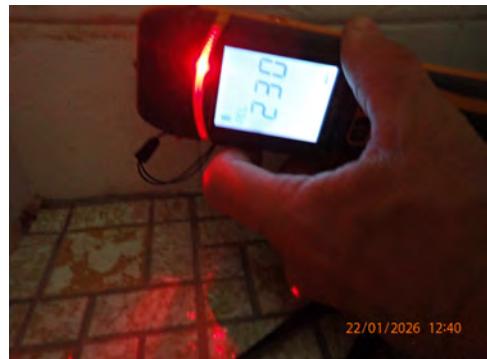
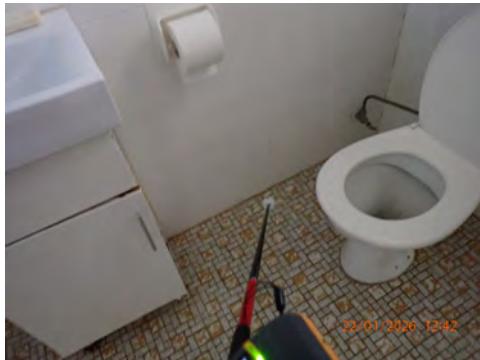
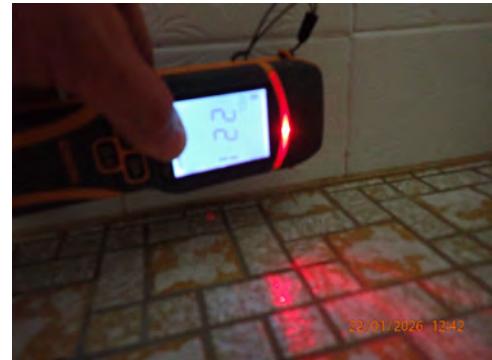
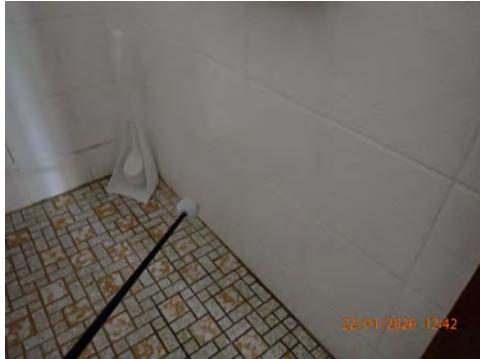
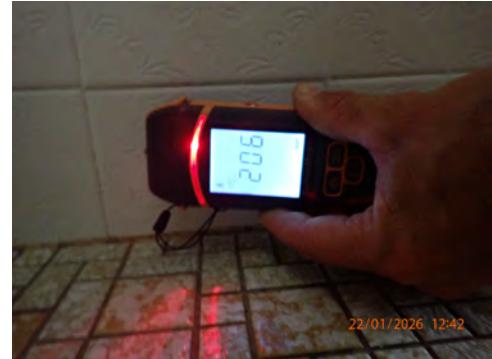
Building: Main Building  
Location: Bathroom 2 Ground Level  
Finding: TP | Conducive | Elevated moisture – bathroom

Elevated moisture levels were detected within the bathroom at the time of inspection. The moisture meter used operates on a scale from 0 to 999, with readings above 200 considered elevated. Elevated moisture in wet areas may be associated with factors such as deteriorated or missing sealant, cracked grout, plumbing fixtures, or waterproofing performance.

The presence of elevated moisture in this location creates conditions conducive to timber pest activity, including subterranean termites, as well as an increased risk of fungal decay if left unmanaged. Moisture was also detected to areas outside the shower recess, which may indicate moisture migration beyond the intended wet area; however, this observation does not, in isolation, confirm a waterproofing failure.

At the client's discretion, a qualified plumber or licensed builder may be engaged to further assess the area, including leak detection or moisture investigations if conditions persist or worsen. More invasive inspection may be required to determine whether any concealed moisture-related deterioration is present behind finishes.

Ongoing monitoring of this area is recommended as part of routine timber pest management, with regular timber pest inspections at intervals of 6–12 months advised.

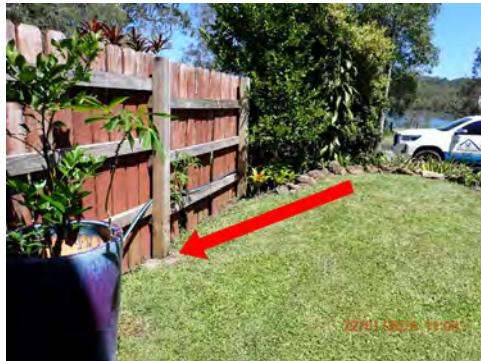
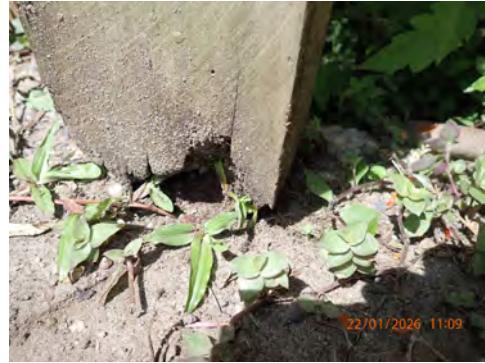
### **Finding 7.01**

Finding: B | Timber | Wood rot noted to external timber fence posts

At the time of inspection, wood rot was noted to sections of the external timber boundary fence posts. The deterioration was observed in accessible areas, particularly at or near ground contact points.

Timber boundary fences are commonly constructed with posts embedded directly into the ground. Due to ongoing exposure to soil moisture and weather conditions, timber decay in these locations is a common occurrence and generally consistent with the typical construction method used for timber boundary fencing. If left unmanaged, deterioration may progress and reduce the structural stability of the fence over time.

A fencing contractor or licensed carpenter should be engaged to assess the extent of deterioration and repair or replace affected posts as required. These works can be carried out at the owner's discretion, with ongoing monitoring recommended as part of routine maintenance.

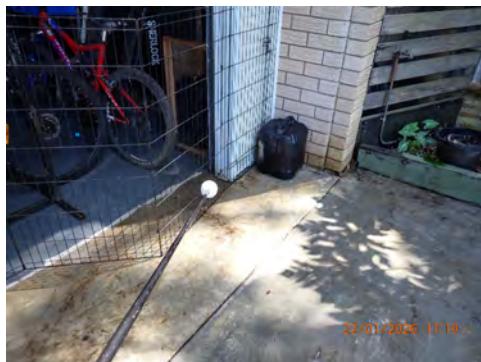
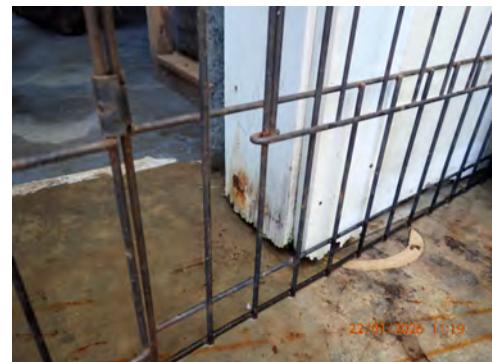
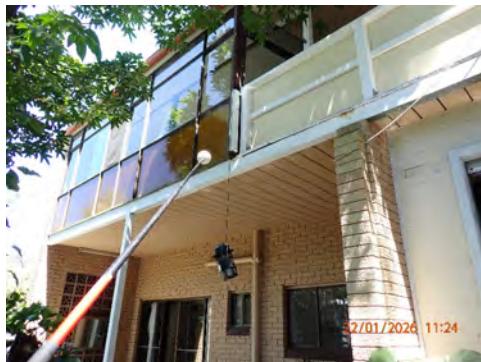
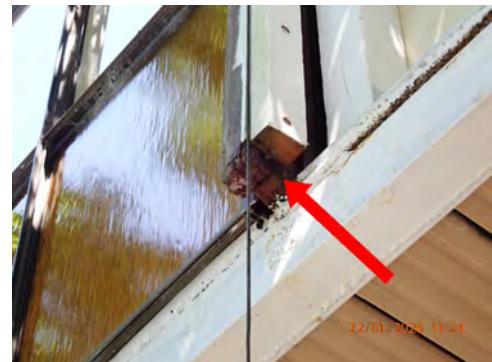
## Finding 7.02

Finding: B | Timber | Localised wood rot observed

Information: During the inspection, evidence of localised wood rot (fungal decay) was observed to sections of timber building elements. Timber decay of this nature commonly develops where materials are exposed to moisture over time and is often associated with general weathering, drainage conditions, or age-related deterioration.

Wood rot is a relatively common condition in external timber elements and does not necessarily indicate a current structural failure. Routine maintenance and management of moisture exposure will assist in slowing further deterioration and extending the service life of the affected timbers.

Depending on presentation and future use, maintenance works such as improved drainage, sealing, or replacement of affected sections may be considered. Consultation with a licensed builder or suitably qualified tradesperson may be undertaken at the owner's discretion to obtain advice on appropriate remedial options and timing.

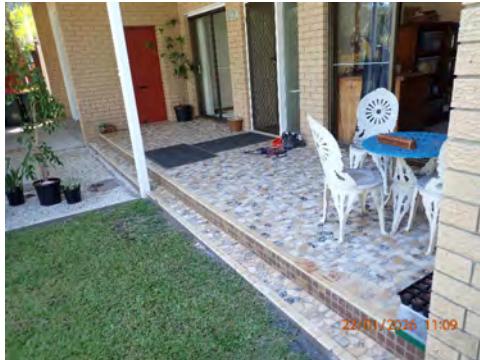
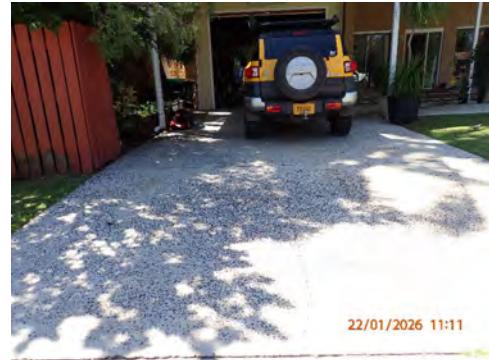
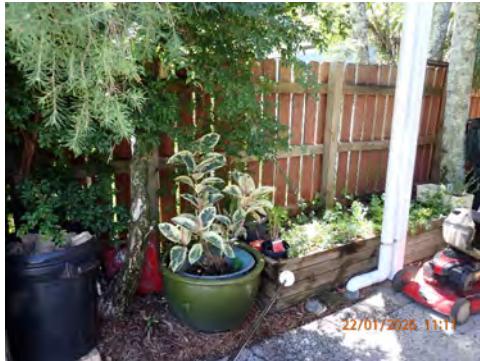
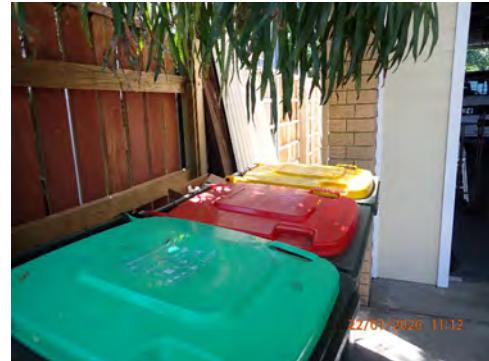
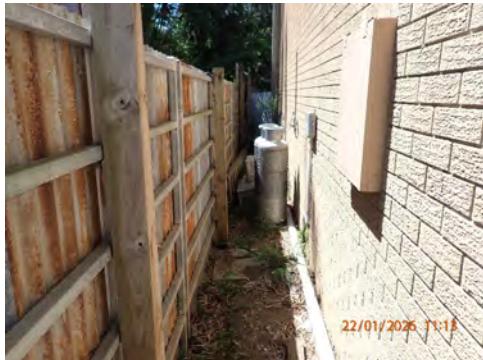
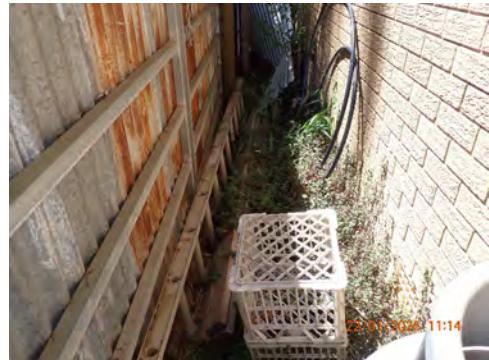
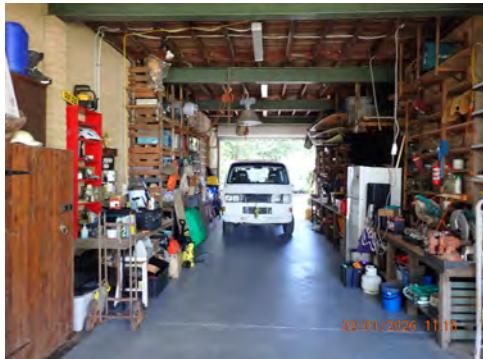
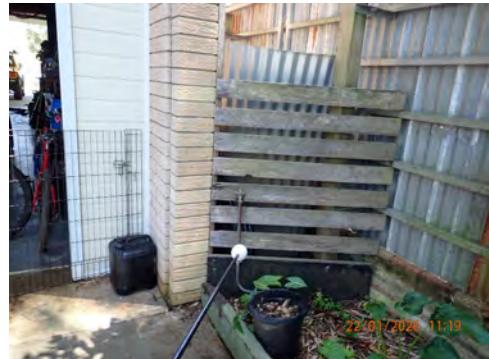
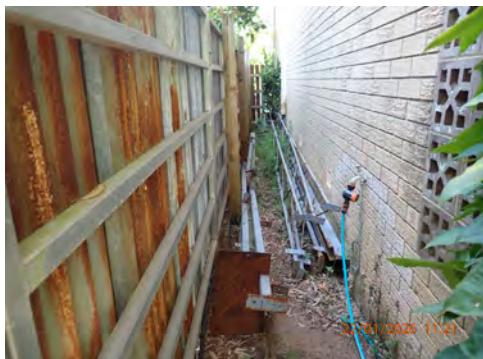
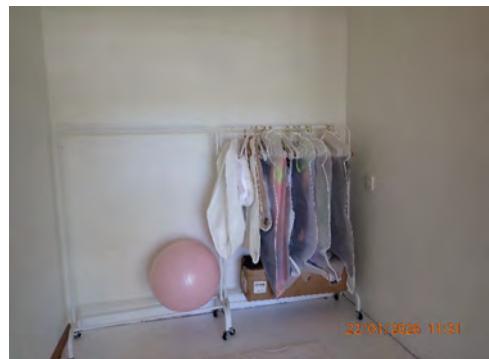
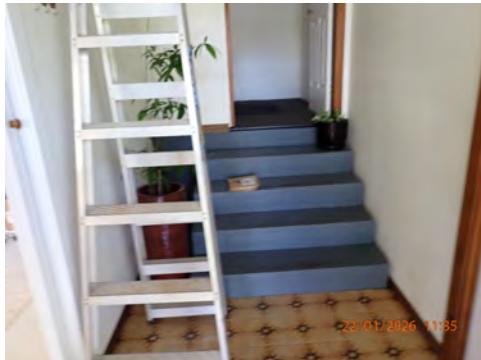
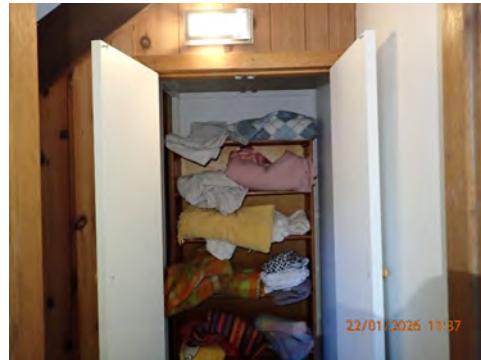
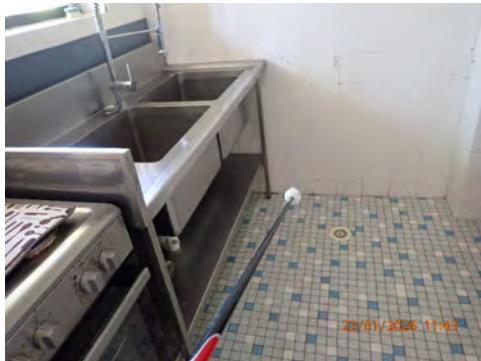
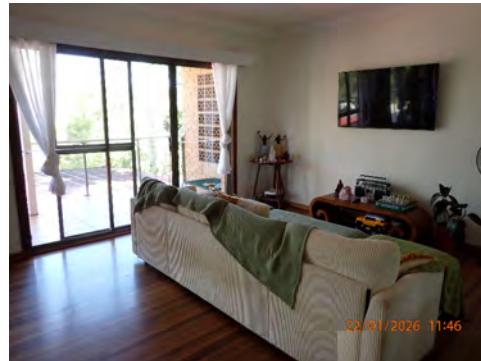
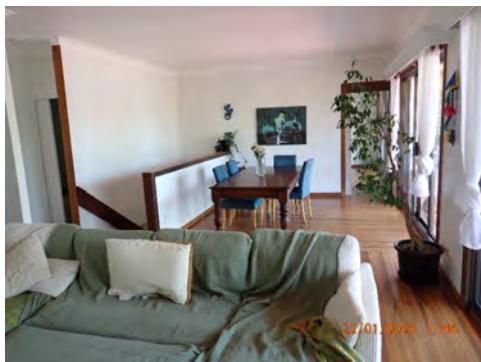
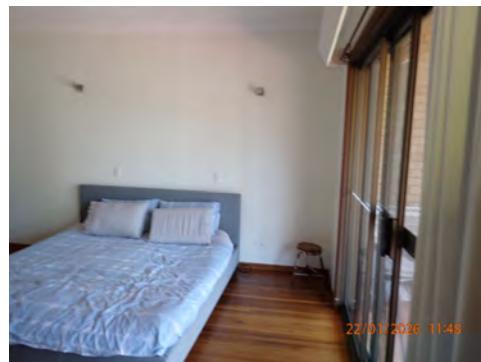
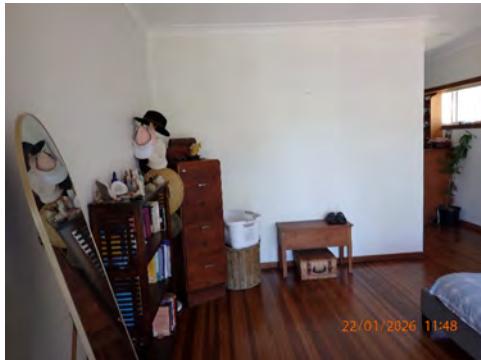
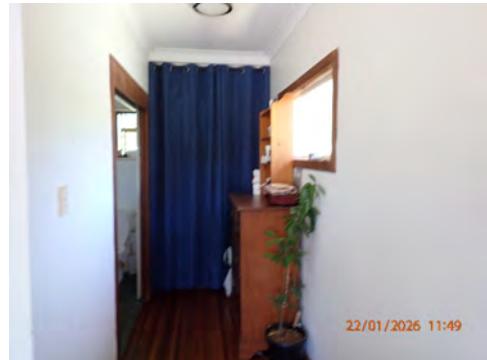
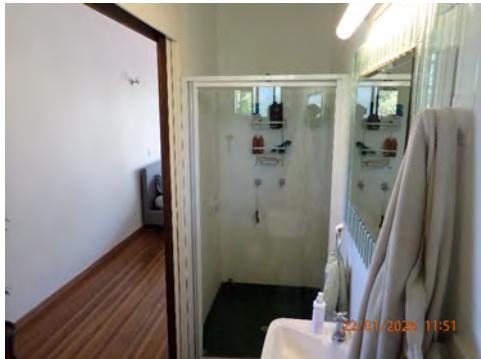
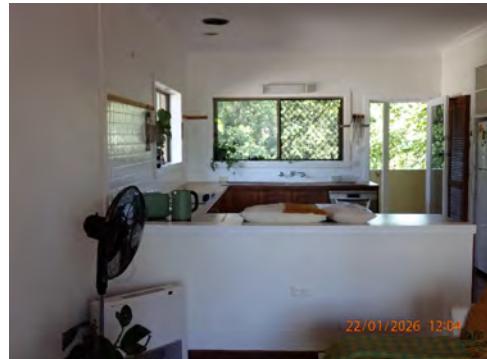
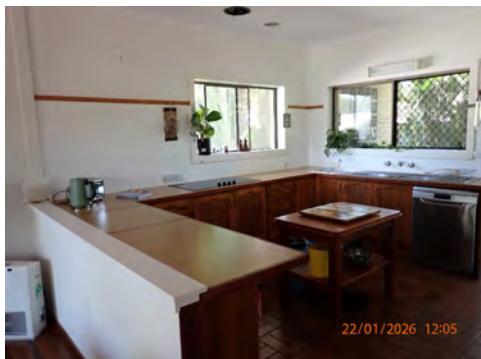
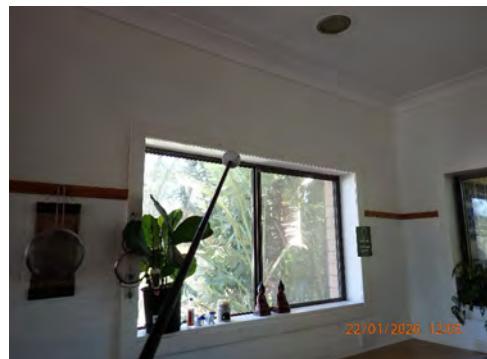
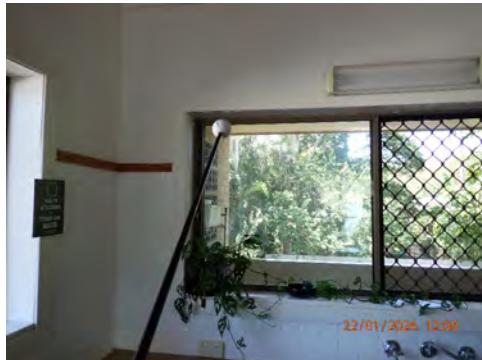
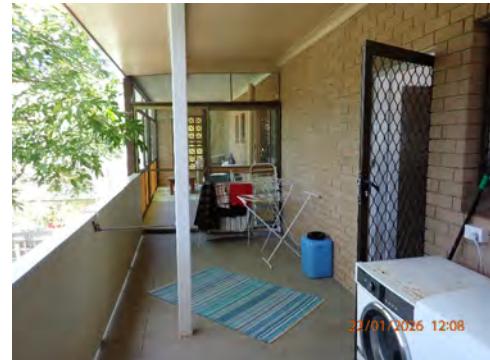
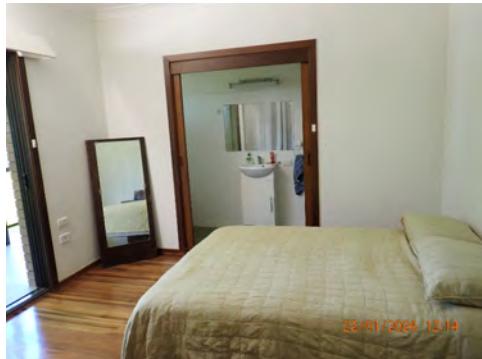
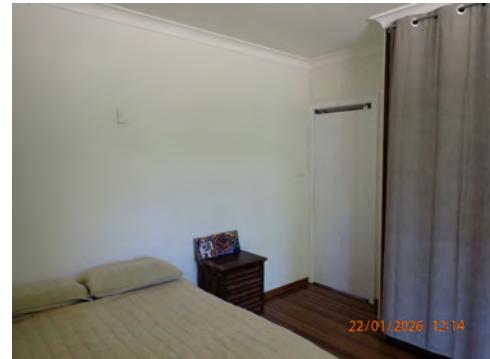
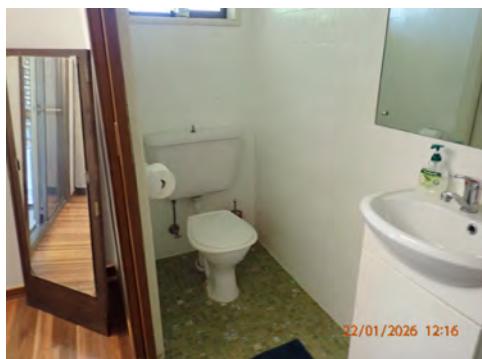
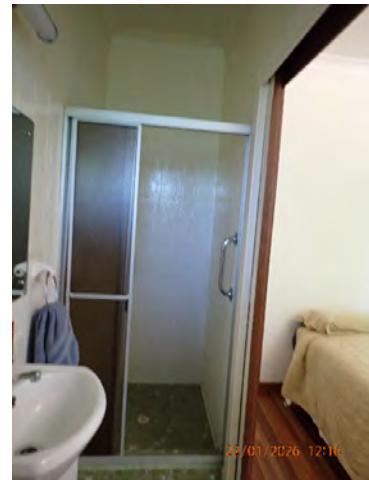
Finding: Additional Photos - Obstructions and Limitations

Information: These photographs are an indication of the obstructions and limitations which impeded full inspection of the property at the time of inspection. These obstructions can hide an array of defects and should be removed to allow full inspection to be carried out. A re-inspection is recommended once the areas are made accessible.

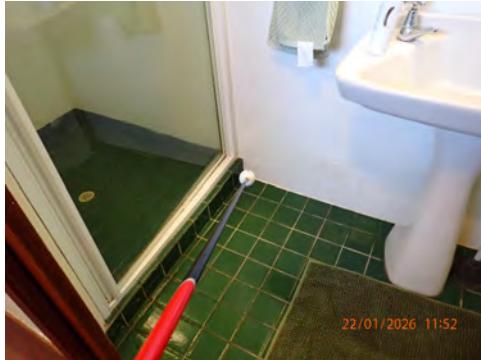
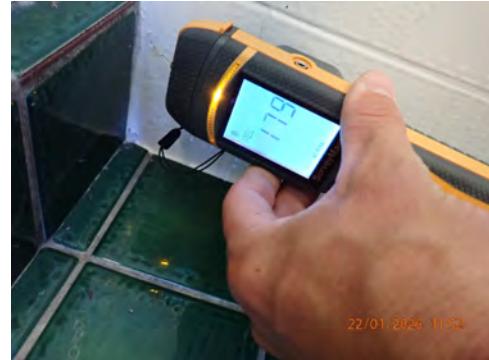
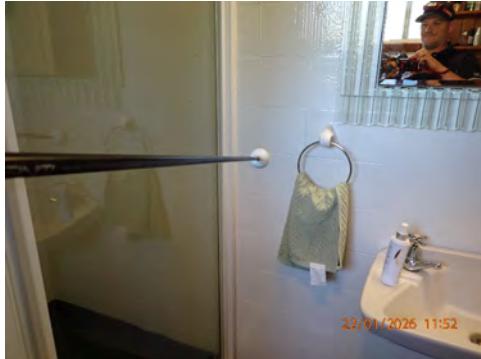
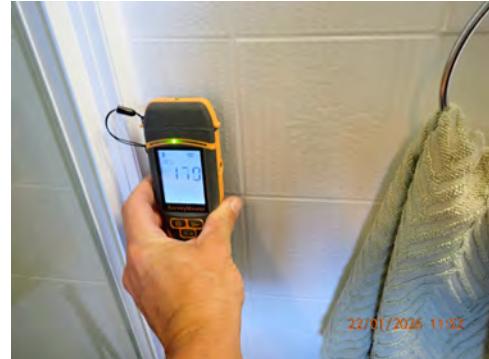
Finding: B | EMR | Dry moisture readings around both shower recesses

Information: During the inspection, dry moisture readings were recorded around both shower recesses. No active moisture was detected at the time of inspection. The observations indicate that the surrounding areas are currently dry and not showing signs of active leakage.

It is important to note that the moisture detection device registers "wet" from readings of 200 and above on a scale of 0–999. Regular monitoring of these areas is recommended as part of routine maintenance to identify any future changes that may indicate moisture ingress

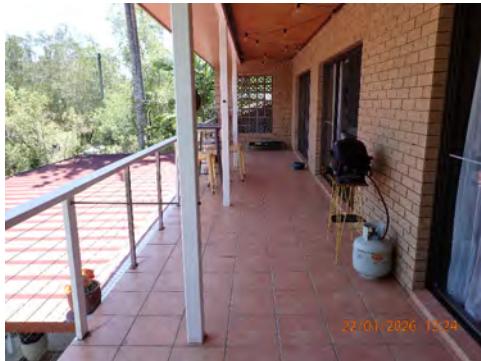
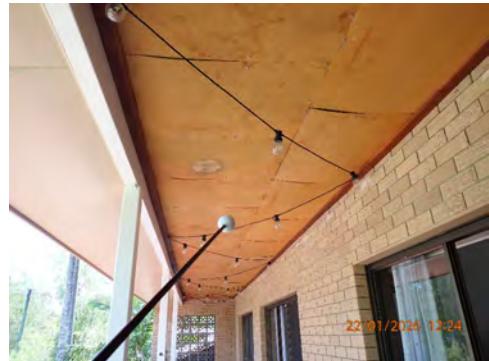
Building: Main Building  
Location: Balcony Front  
Finding: B | Cladding | Unsuitable ceiling lining to front balcony

During the inspection, the ceiling lining material used to the front balcony was observed to be unsuitable for external exposure and not intended for use in this location. The material appears inconsistent with products designed for outdoor or weather-exposed environments.

Ceiling linings installed externally are required to be moisture-resistant and suitable for ongoing exposure to weather, humidity, and temperature fluctuations. Use of an inappropriate material may lead to premature deterioration, sagging, staining, or failure of fixings over time, and may also increase maintenance requirements.

A licensed builder should be engaged to assess the ceiling lining and replace it with a suitable external-grade material designed for balcony or soffit applications. This should be attended to as soon as practicable to prevent further deterioration and ongoing maintenance issues.

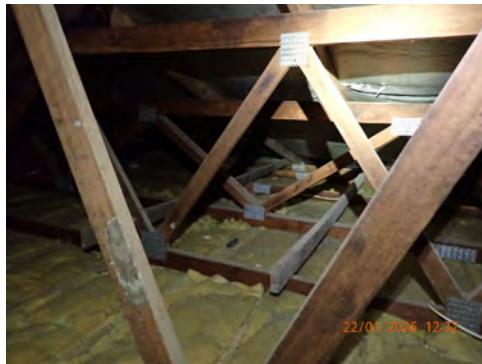
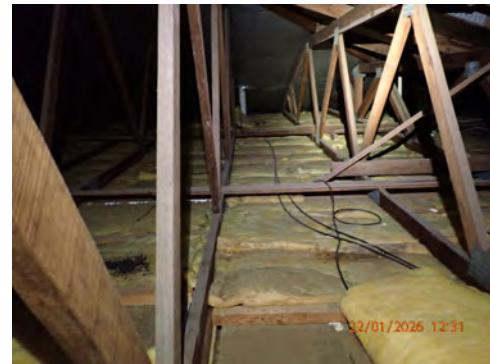
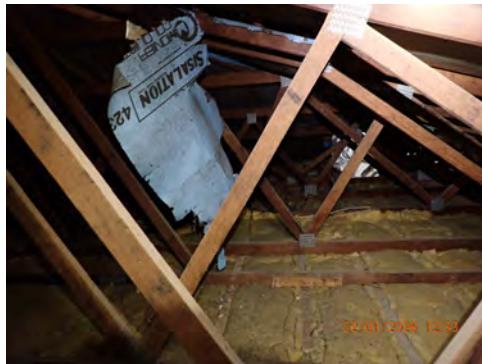
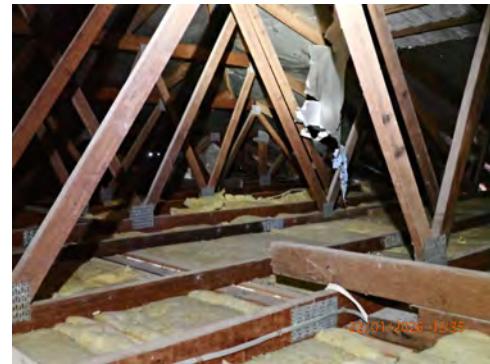
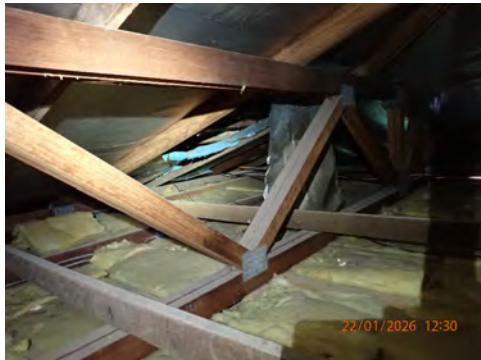
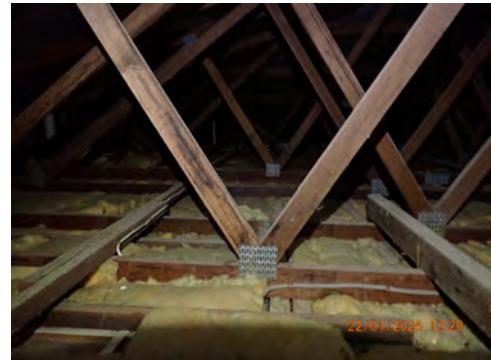
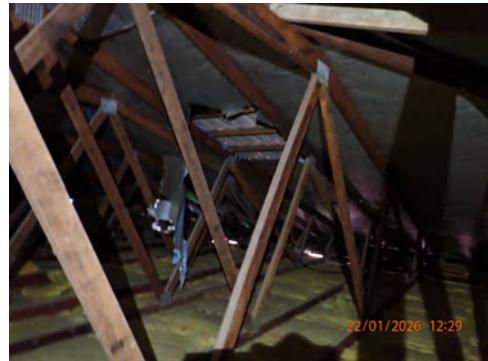
R | Roof Space | Restricted access and damaged sarking

Inspection of the roof space was carried out where safe and accessible at the time of inspection. Access to several areas was restricted due to the low roof pitch, insulation coverage, and sarking installation, which collectively obstructed visibility and limited inspection of framing timbers, ceiling linings, and potential moisture entry points.

It was also noted that some sections of roof sarking were observed to be loose and damaged, which can reduce its effectiveness as a secondary moisture barrier and contribute to minor condensation or water ingress issues if left unmanaged.

These obstructions and conditions are common in roof voids and limit the ability to identify concealed defects or areas of deterioration. It is recommended that damaged sarking be repaired or replaced, and improved access be provided where practicable. A licensed builder or pest inspector should be engaged to re-inspect the roof void once access and visibility have been improved.
