## Building and Timber Pest Inspection Report VR

Inspection Date: Thu, 22 Jan 2026

Property Address: 4 Riverside Crescent, Brunswick Heads NSW,  
Australia

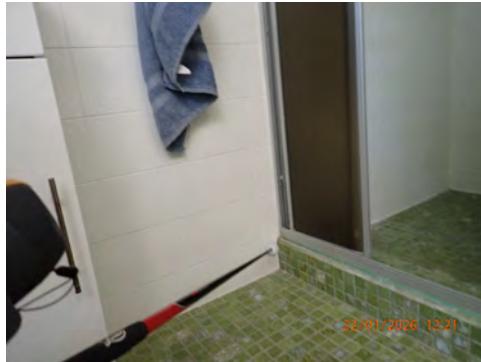
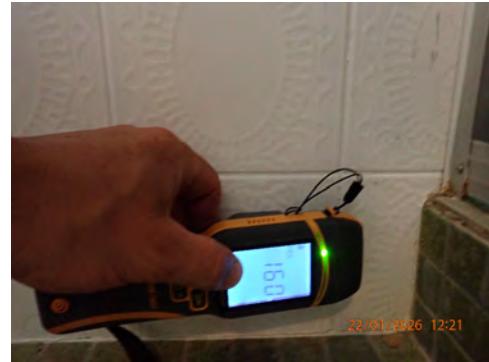
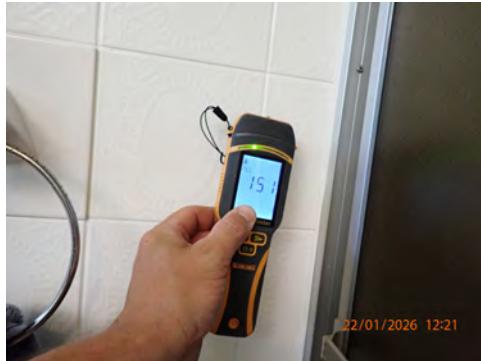
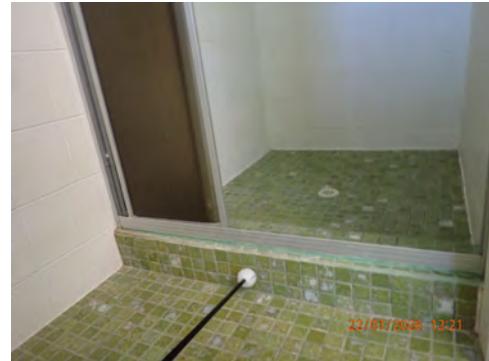
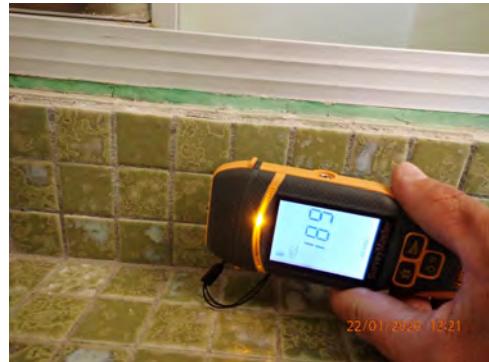
Finding: B | EMR | Dry moisture readings recorded to shower recess and adjoining wall

During the inspection, dry moisture readings were recorded to the middle and upper sections of the shower recess, as well as to the wall adjoining the rear of the shower. These observations indicate that the surrounding wall areas are currently dry and that any potential moisture is confined within the shower recess itself. The condition should be monitored over time for any signs of water egress or deterioration around the shower screen junctions, as movement or failed sealant can allow leaks to develop.

The moisture-meter device used operates on a scale from 0 to 999, with readings above 200 considered elevated. Regular monitoring of these areas is recommended as part of routine maintenance to identify any future changes that may indicate moisture ingress.
