Building and Pest Report

37 Sandstone Cres Lennox Head

Pest And Building Inspection

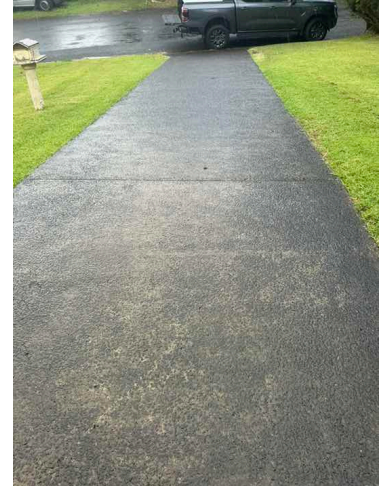
Driveway Condition

On visual inspection, the general condition of the driveway is serviceable.

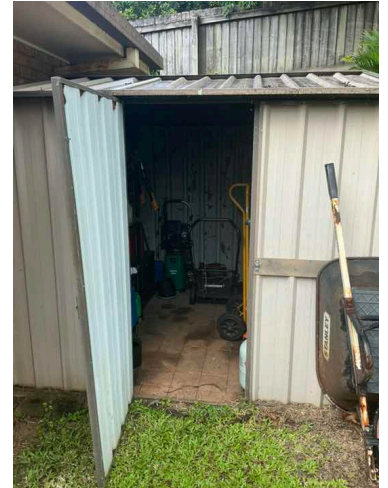
Shed Condition

The shed is in fair usable condition.

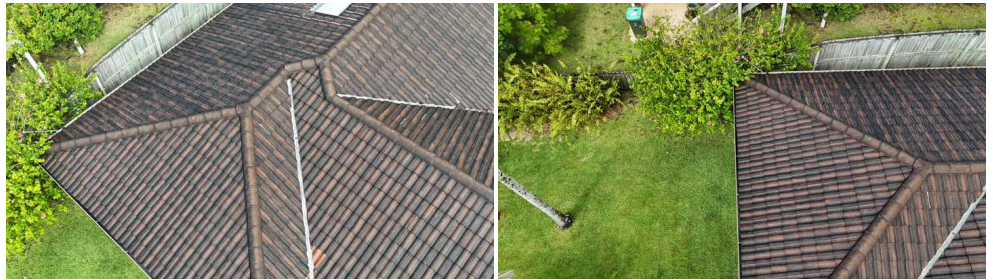
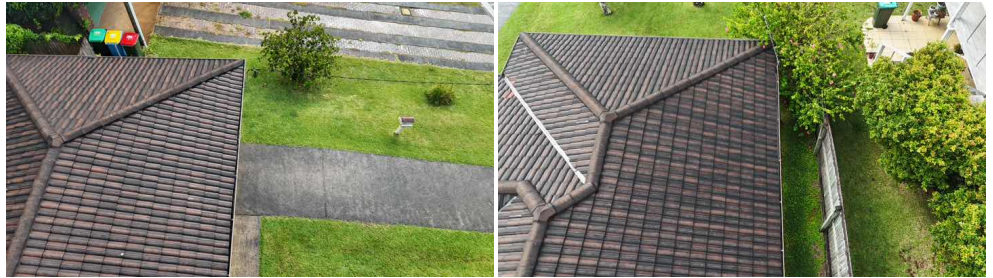
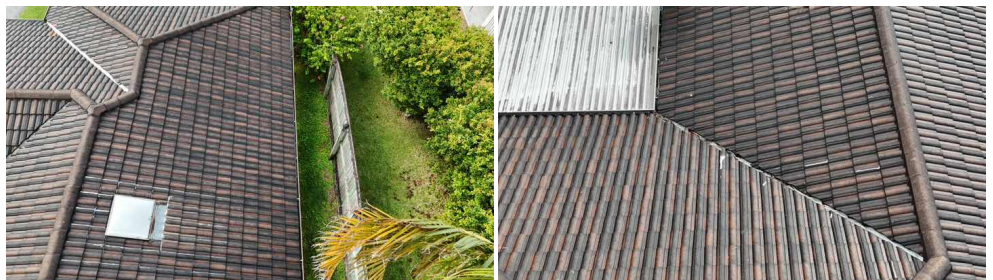
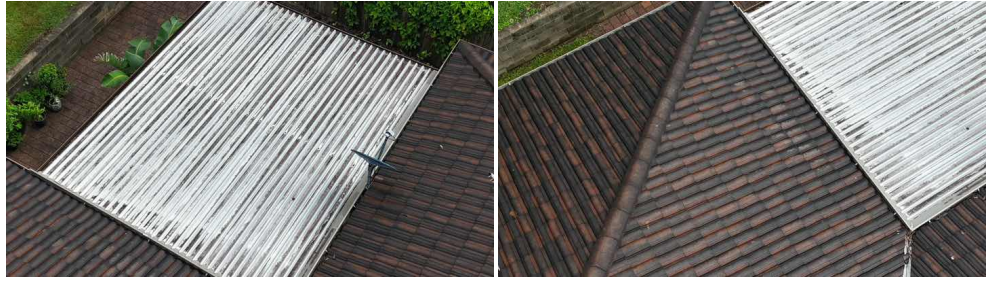
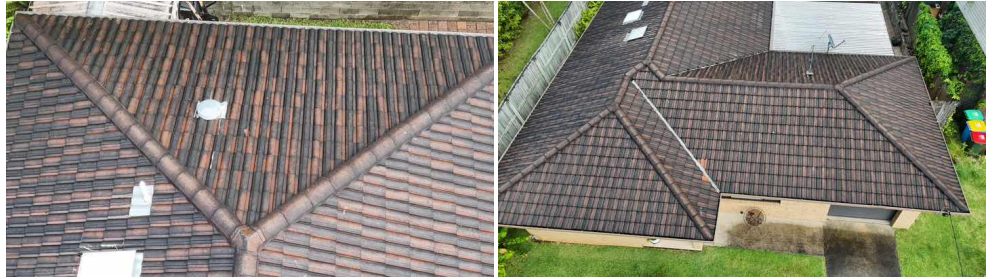
Overall Condition

Of the visible areas, the general condition of the roof is in serviceable condition for the age.

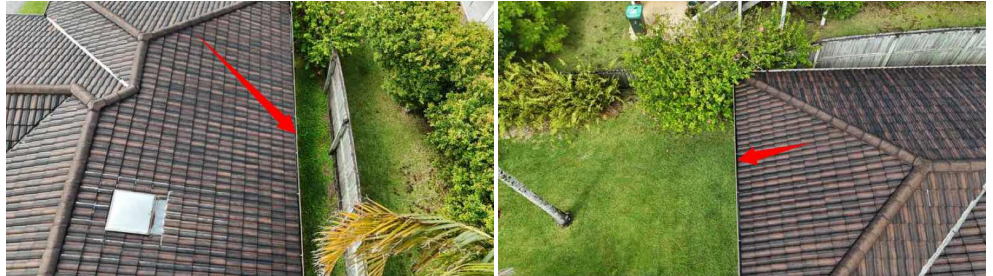
Guttering

All visible and accessible of the physical nature of the guttering system appears to be in a serviceable condition with no apparent defects at the time of inspection. In the absence of prolonged rain fall efficiency of the guttering can not be assessed and you may find that further investigation or repairs maybe required. Note: Periodic maintenance checks should be carried out for rust penetrations and leaks.

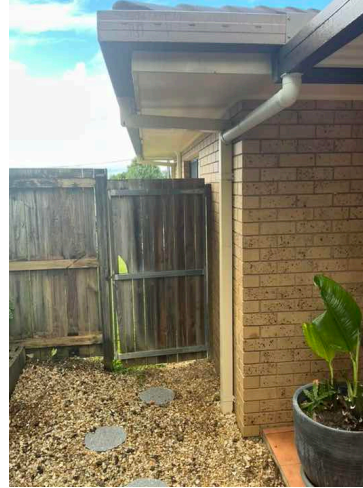
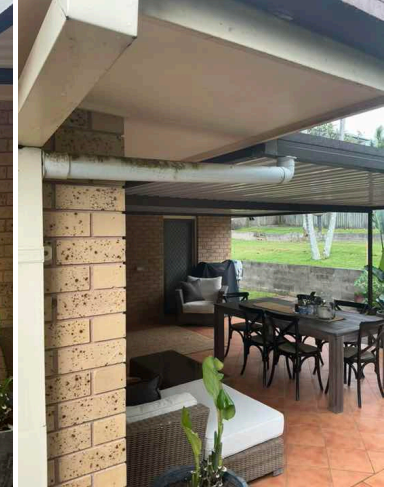
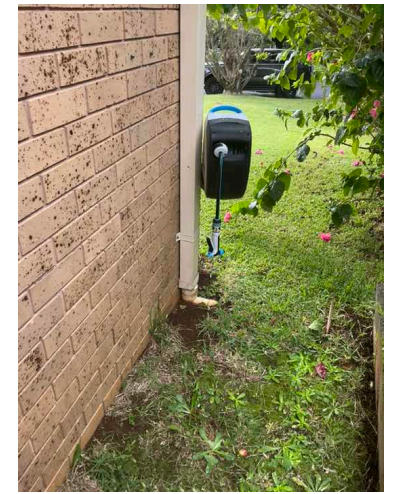
Downpipes

On visual inspection no apparent defects were noted to the down pipes and are considered serviceable, however no comment can be made with regard to blockages or connections to stormwater or functionality in the absence of rain. Note: Periodic maintenance checks should be carried out for rust penetrations and leaks.

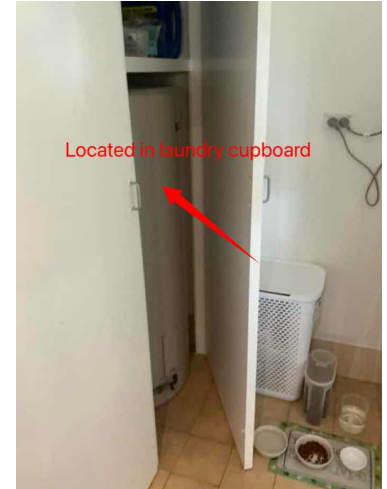
Hot Water Unit Findings

The hot water system appears to be in a serviceable condition. No specific tests other than running the hot water from a tap was carried out. No determination has been made as to the suitability or adequacy of the hot water system in relation to capacity or otherwise.

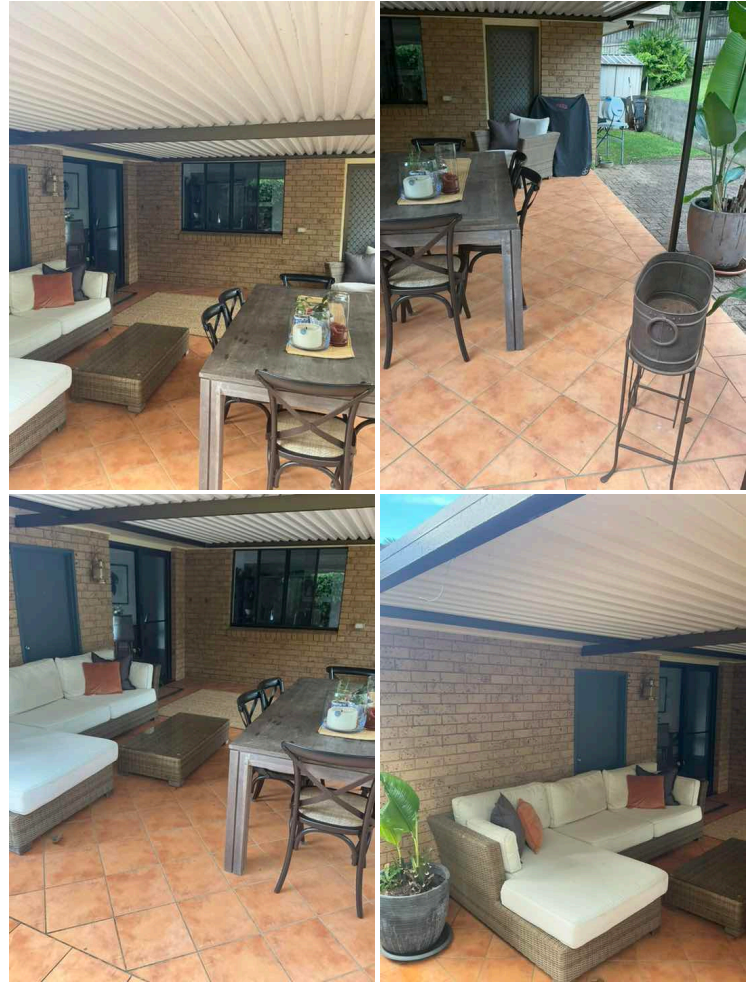
Overall Condition

Visible sections of the Alfresco area are serviceable or in reasonable or condition for the age of this dwelling.

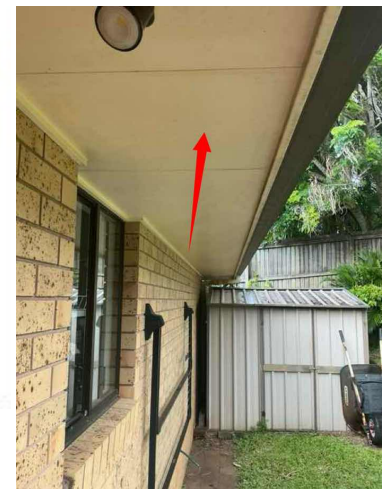
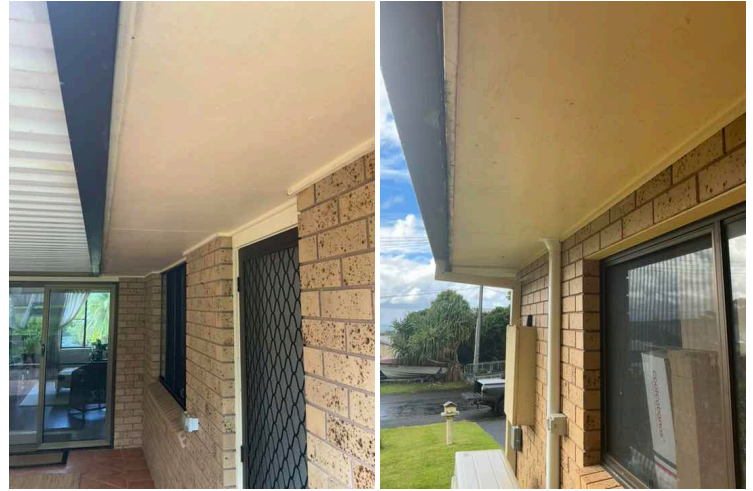
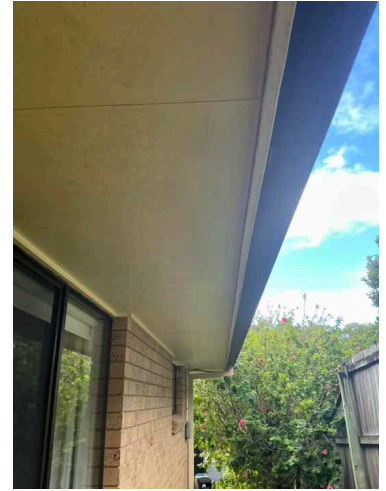
Eaves

The soffit lining (eaves) are in a serviceable condition with no notable defects.

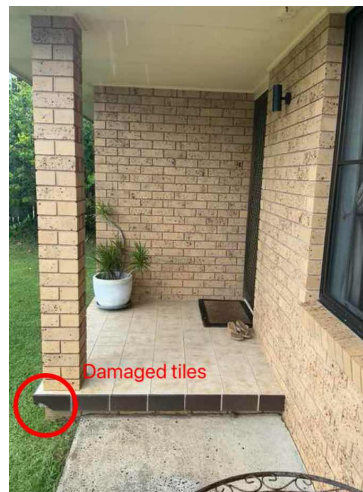
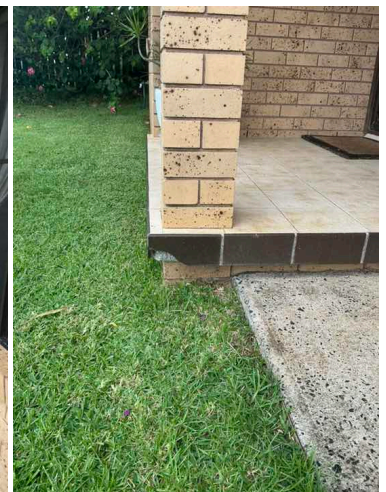
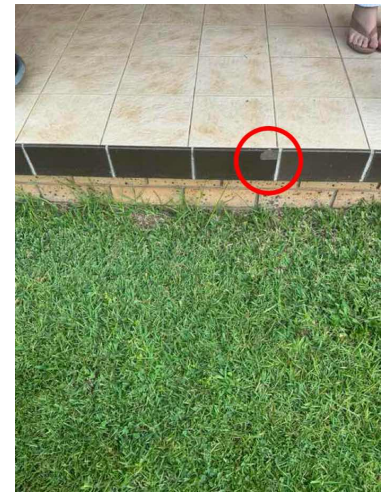
Entry Porch Area

The entry porch serviceable or in reasonable or condition for the age of this dwelling.
Defects exist to an area or component/s requiring assessment by a specialised field. Please read below for details.

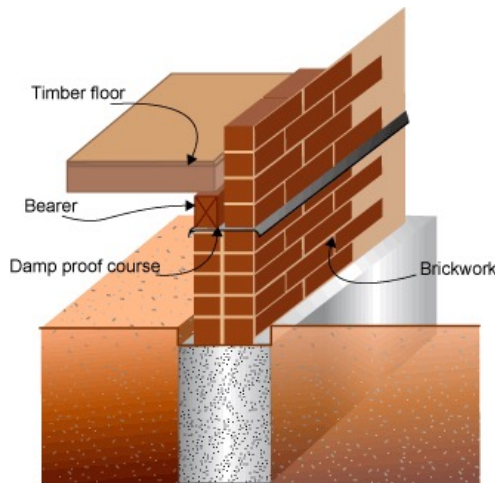
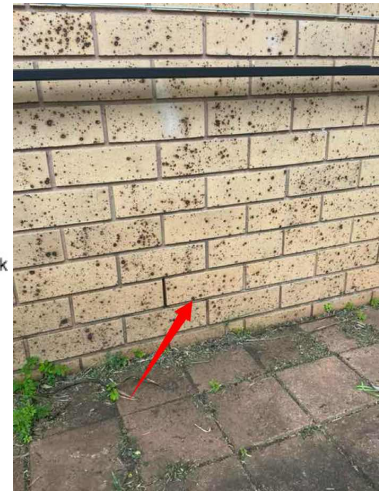
Damp Proof Course

A damp proof course (DPC) was noted.

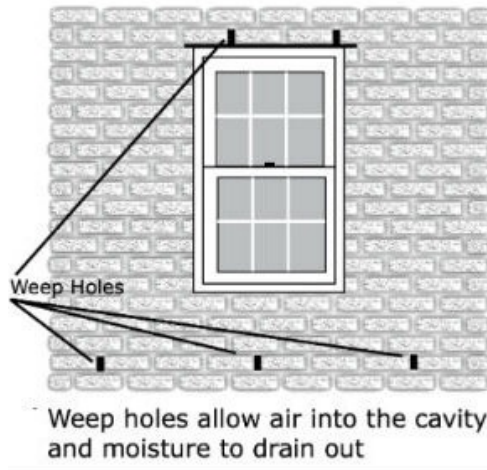
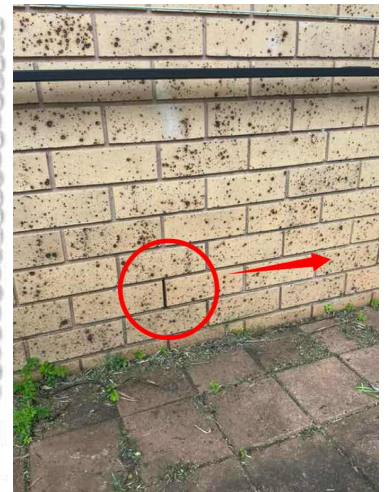
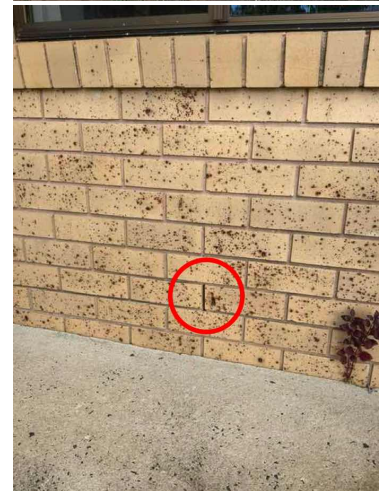
Findings

The weep holes are unobstructed .

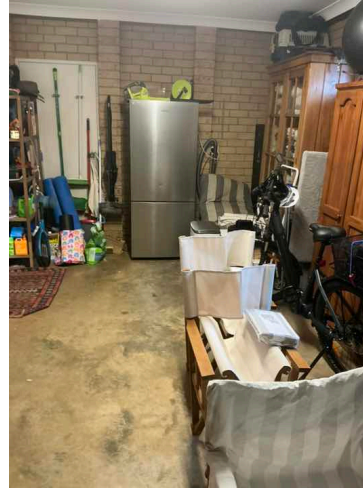
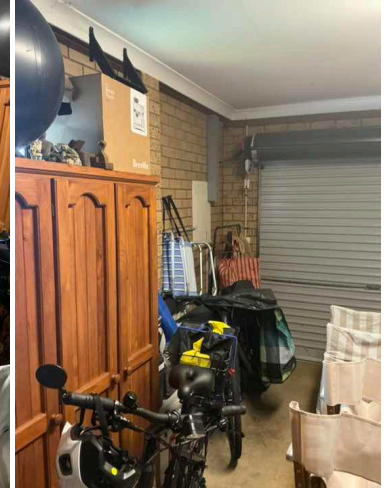
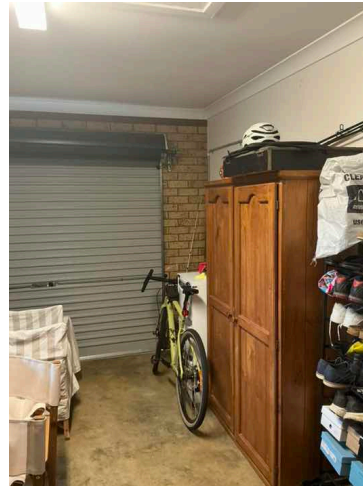
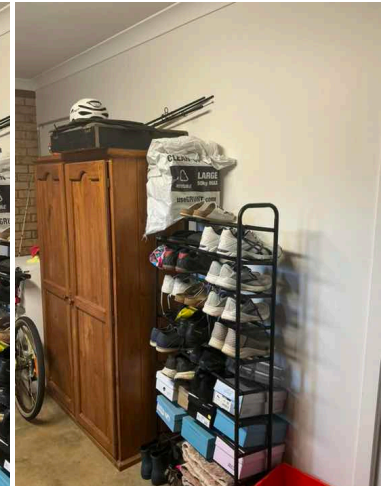
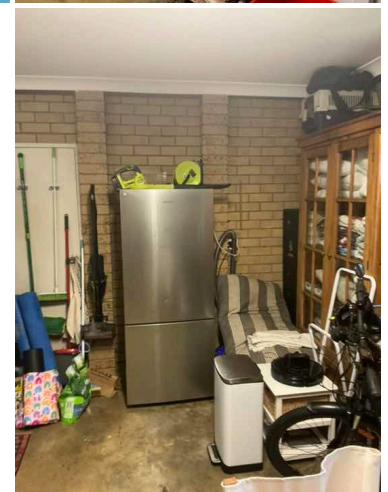
Areas Restricted

Stored items restricted a full and thorough inspection of this area. Defects may exist in the obstructed and inaccessible areas. It is strongly recommended that full access be granted to enable a thorough inspection as there may be timber pest activity, damage or defects. Note: Where vehicles and storage has restricted a full inspection it is advised that this area be cleared so a full and unobstructed inspection can be carried out.

From the visible and accessible areas, the garage appears to be in a serviceable condition for the age of the property with no notable structural defects sighted.

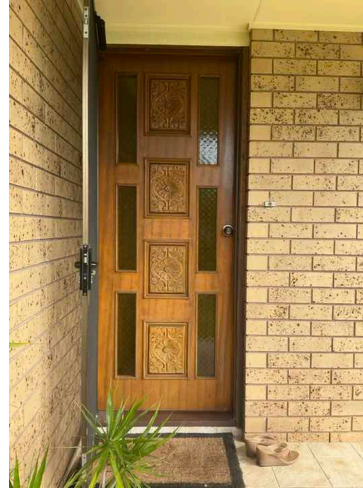
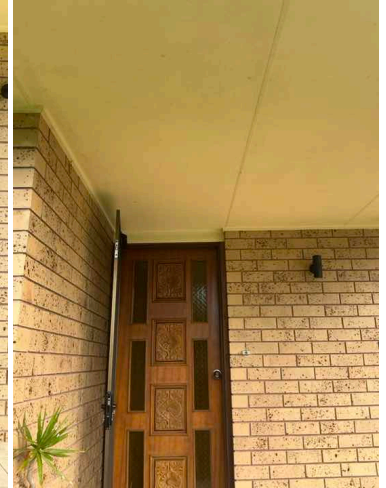
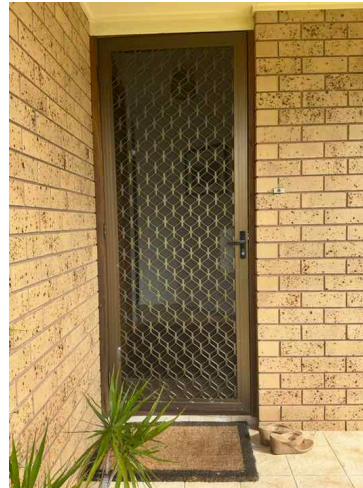
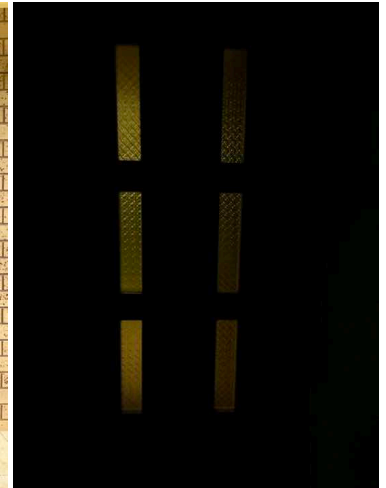
Front Entry Doors

The doors are in serviceable condition with no notable defects observed.

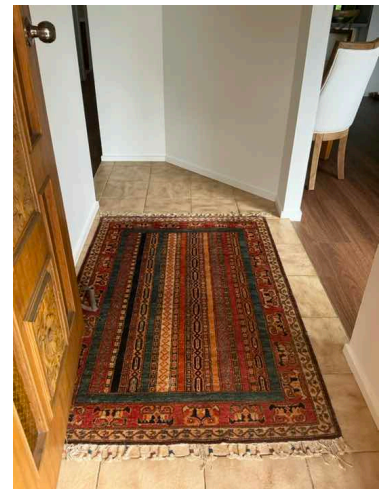
Entry Foyer

From the visible and accessible areas, this area appears to be in a serviceable condition for the age of the property with no notable structural defects sighted.

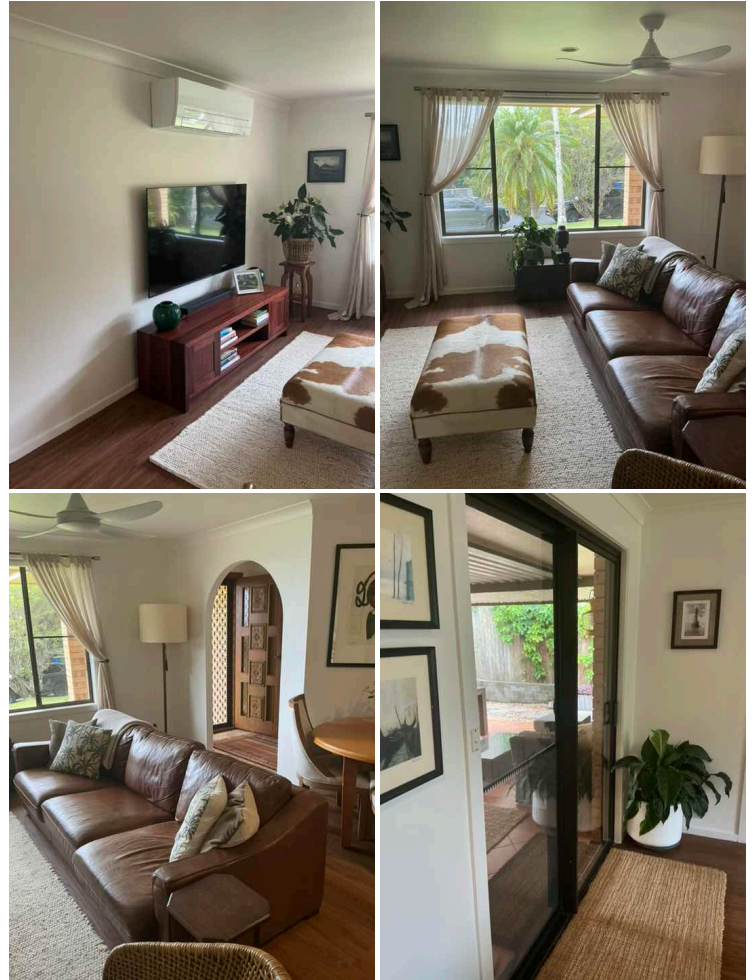
Combined Living & Dining

From the visible and accessible areas, this room appears to be in a serviceable condition for the age of the property with no notable structural defects sighted.

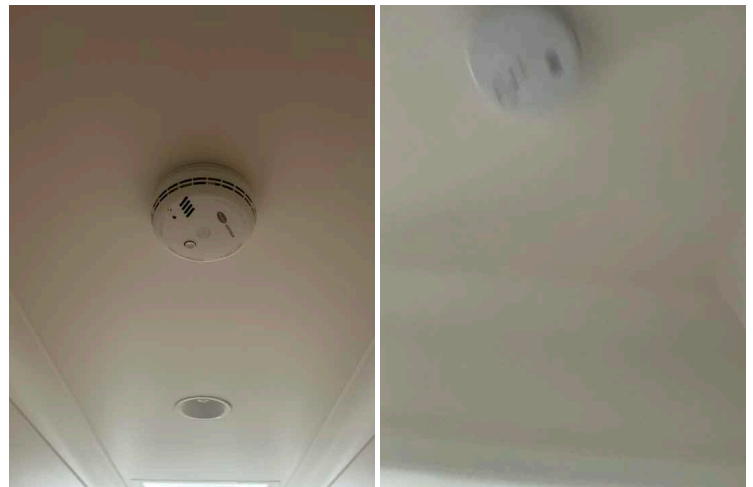
Hallway/s

From the visible and accessible areas, the hallway/s/ appears to be in a serviceable condition for the age of the property with no notable structural defects sighted.

Yes 2 smoke alarms were sighted but not tested.

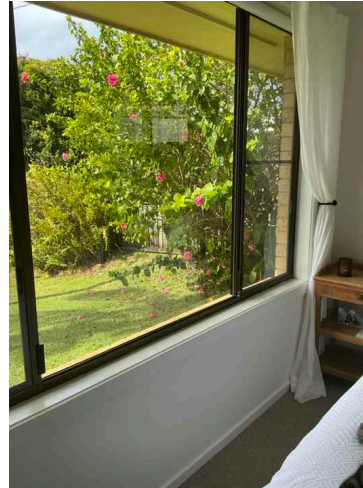
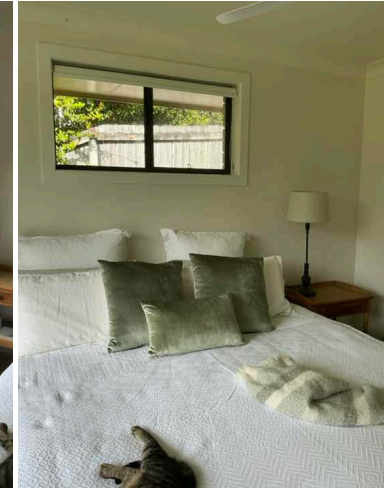
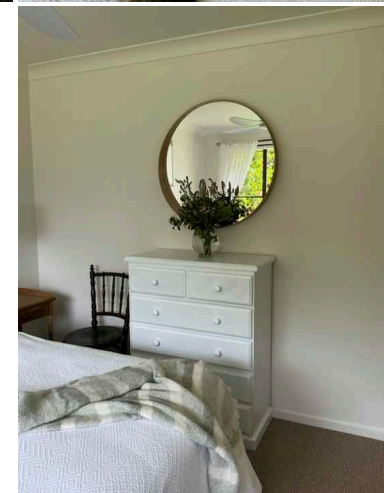
Bedroom 1

From the visible and accessible areas, this bedroom appears to be in a serviceable condition for the age of the property with no notable structural defects sighted.

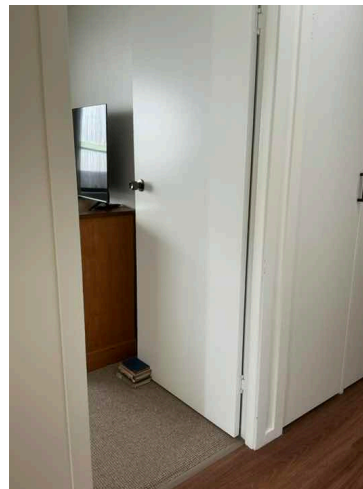
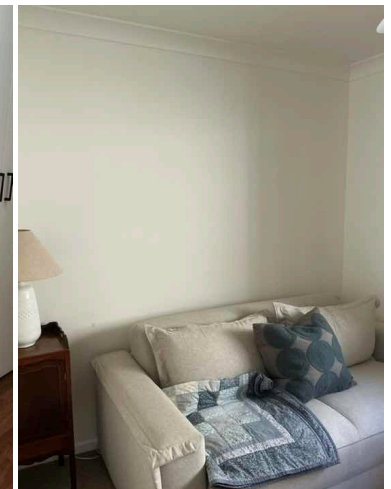
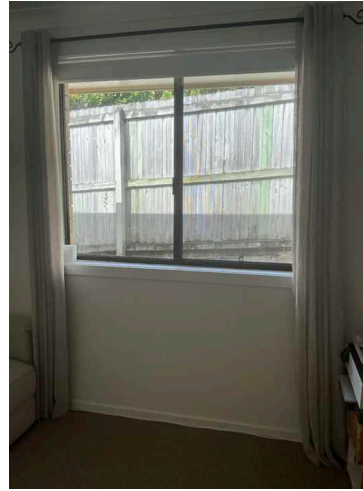
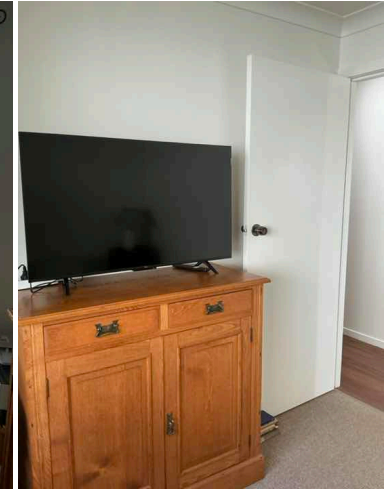
From the visible and accessible areas, this bedroom appears to be in a serviceable condition for the age of the property with no notable structural defects sighted.

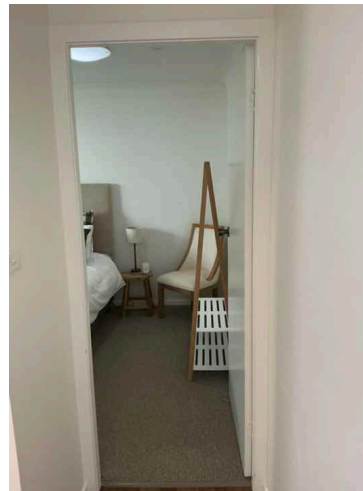
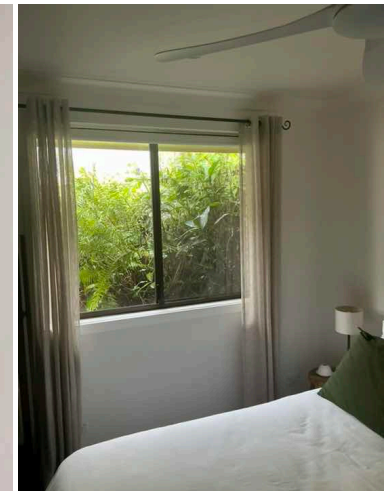
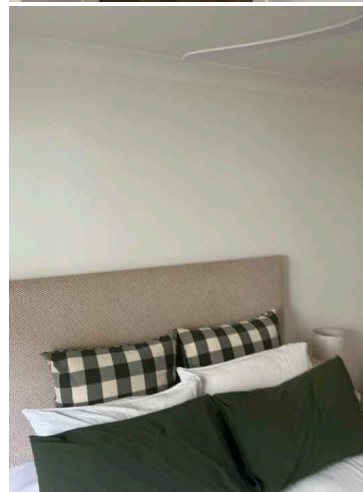
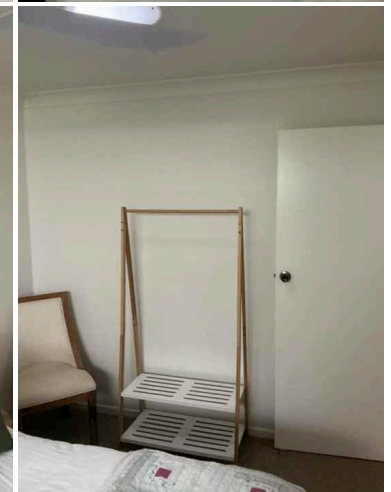
Bedroom 3

From the visible and accessible areas, this bedroom appears to be in a serviceable condition for the age of the property with no notable structural defects sighted.

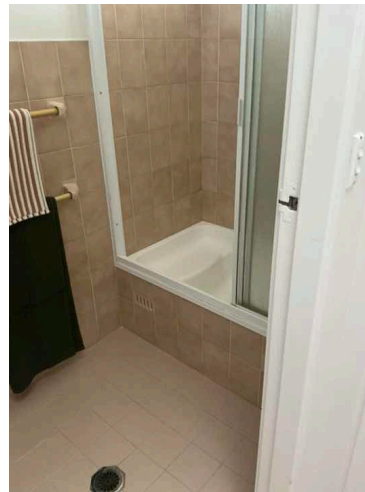
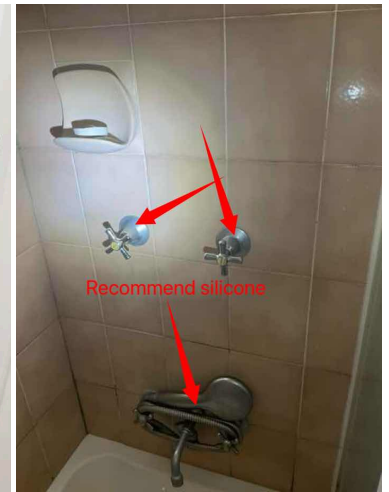
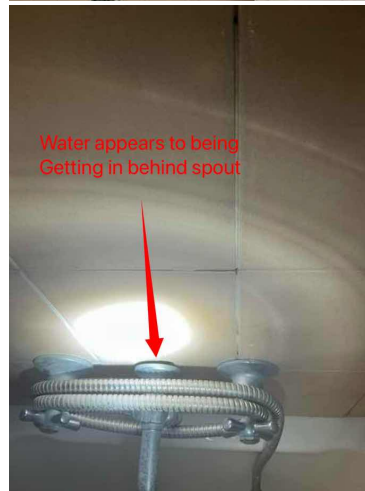
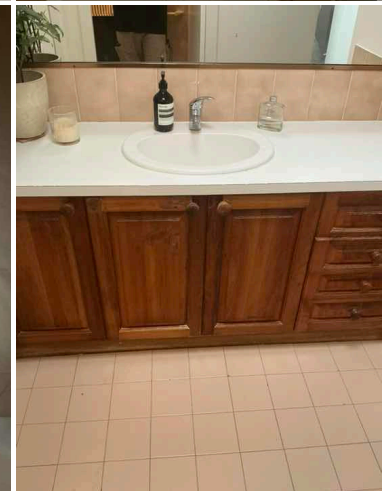
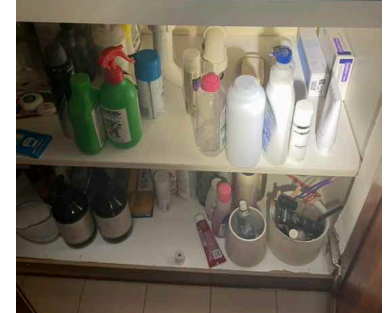
BATHROOM(S)

On inspection, defects were present that will require further assessing and recommendations by licensed and qualified trades persons, please read below for details.

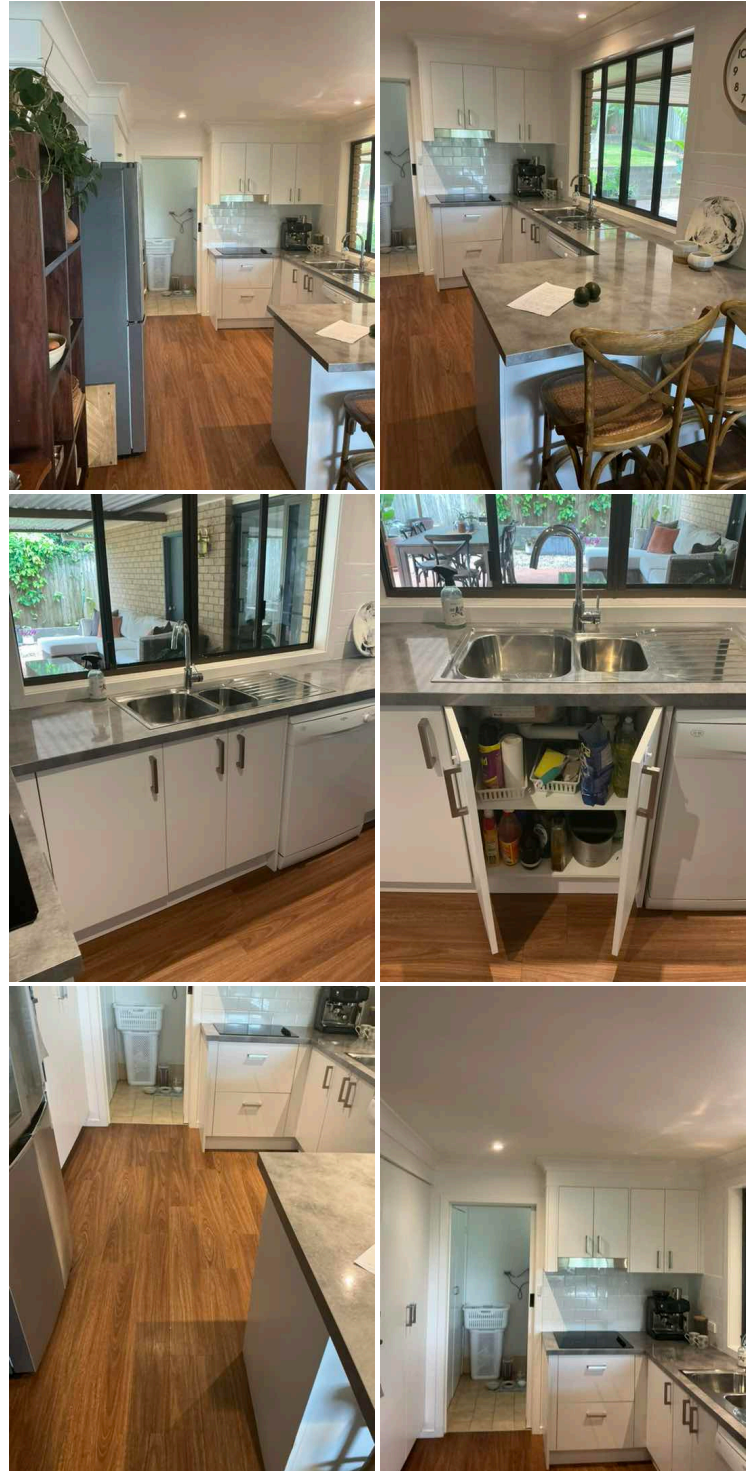
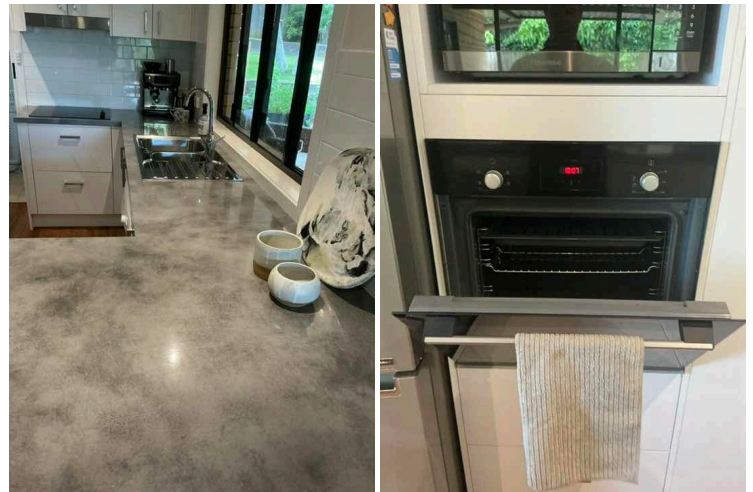
Of the visible areas, the general condition of the kitchen and pantry is serviceable or in reasonable condition for age of dwelling.

These components appear to be in a serviceable condition

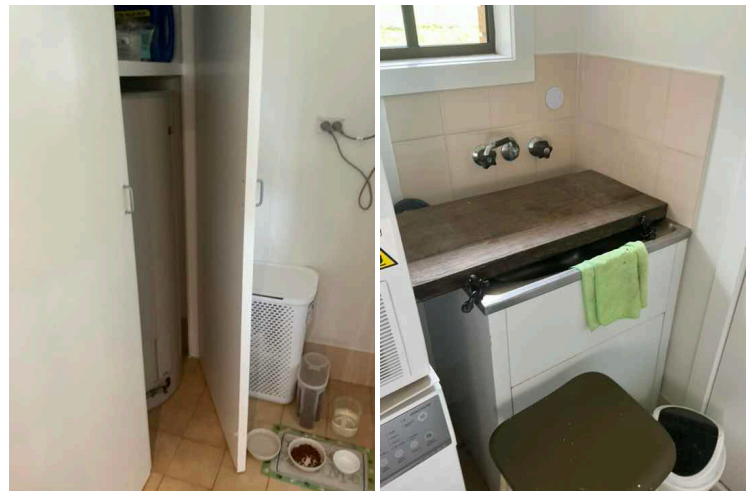
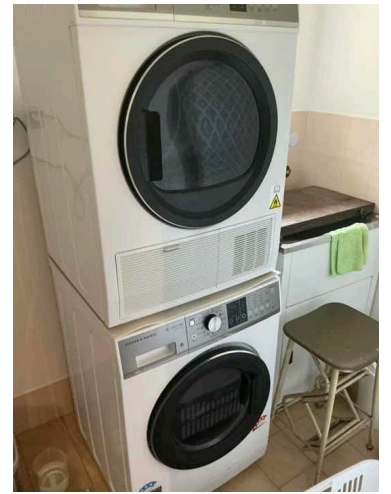
Of the visible areas, the general condition of the laundry is serviceable or in reasonable condition for age of dwelling.

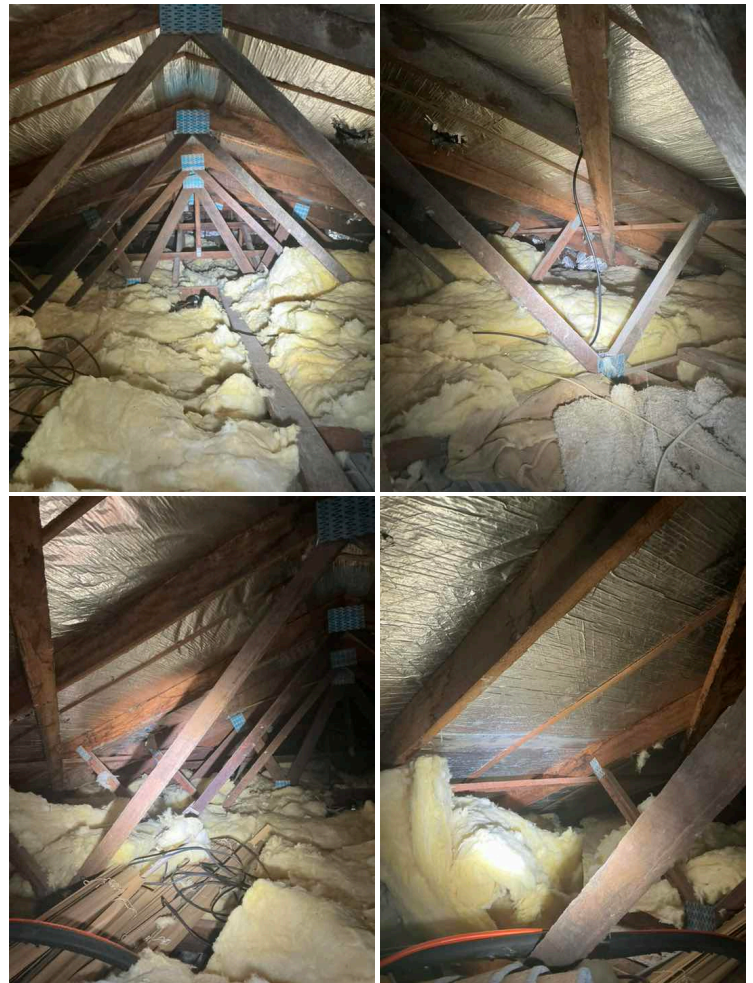
ROOF VOID

Visible sections of the roof void is in a serviceable condition for age of this dwelling.

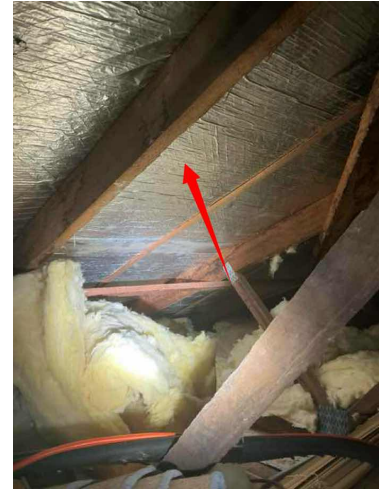
Where visible and accessible, the insulation appears to be in a serviceable condition.

The sarking generally is in a serviceable condition.
