BUILDING & PEST INSPECTIONS

17 Avocado Crescent
Ewingsdale

BPI - INSPECTION REPORT

Special Purpose building report of subfloor area.

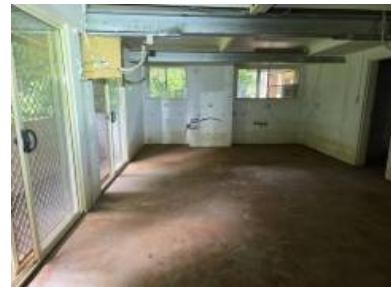
Although I'm not a plumber or structural engineer, the work shop area subject to water ingress should not affect the structural integrity of the building as long as the pump is kept clean, maintained and gets used when water starts pooling.

There are no signs of mould or damp issues to the house above at the time of the inspection.
