# BUILDING AND PEST REPORT

1/4 Durroon Court Ocean Shores NSW 2483

## Part 1: Purpose and Scope of Inspection

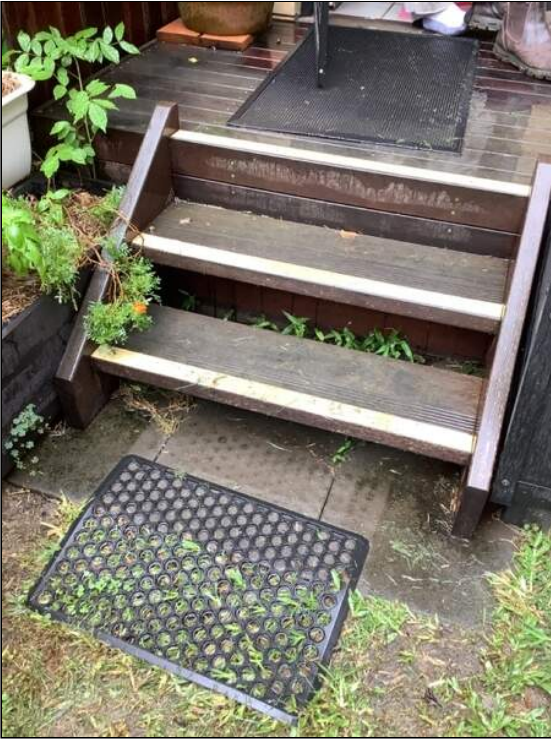
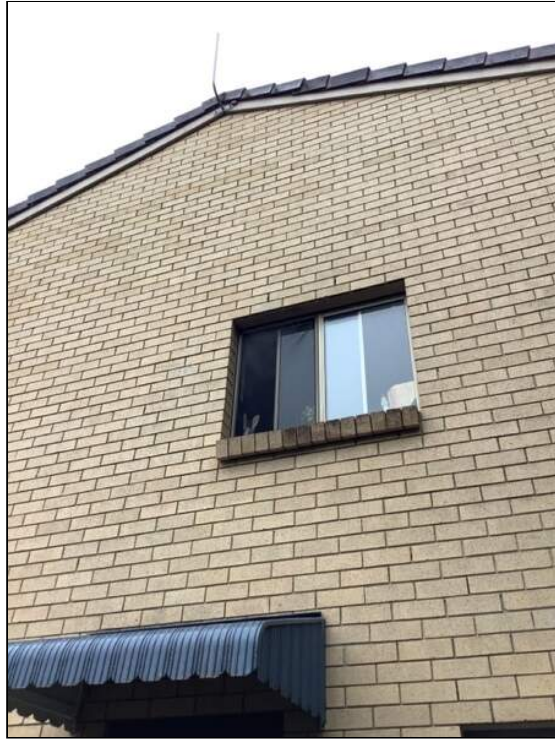
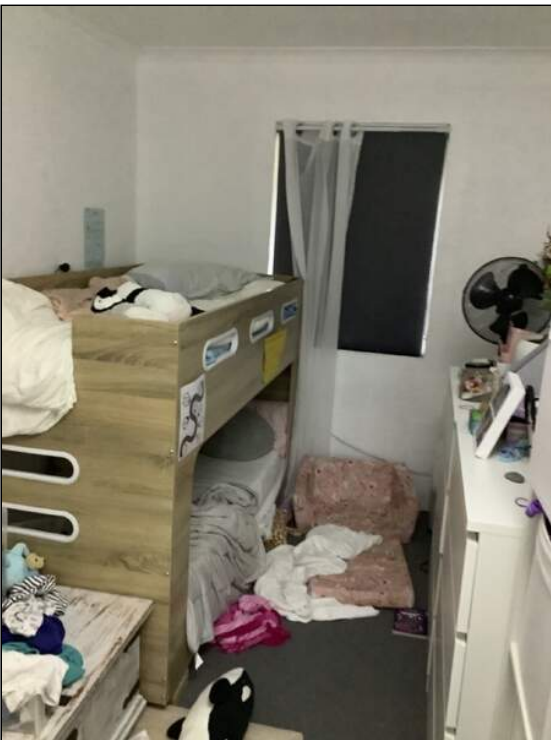
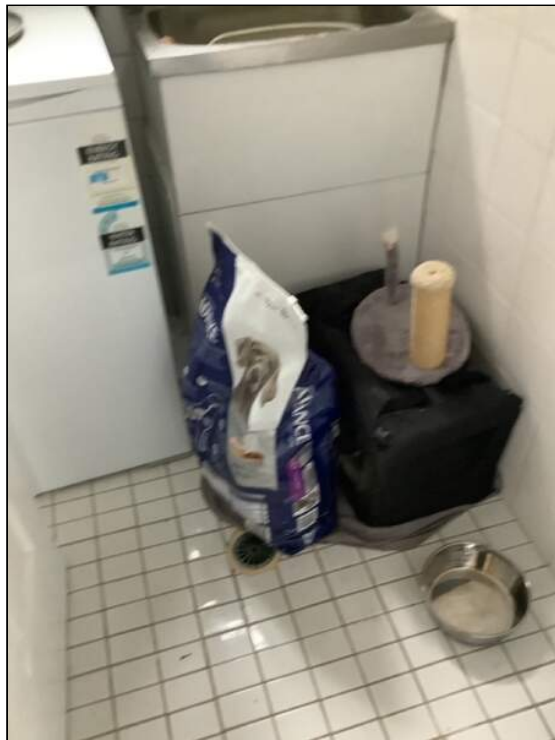
Were there Areas not inspected and, if so, the reasons were: **Yes**  
**Reasons: Roof exterior due to wet weather**  
**Underside of timber deck due to no access**  
**Storage**

**Internally, some walls, skirting board, floor linings and the like were not visible due to storage/ furniture., Internally, Cupboards also had storage items that restricted full visibility of areas., Upper two storey roof cladding was not accessed or walked on due to safe and reasonable access.**

Areas to which access should be gained, or fully gained, are:
