12/17 MAHOGANY DRIVE, BYRON BAY

BUILDING & PEST REPORT

Inspection Report

12/17 Mahogany Drive, Byron Bay, NSW, 2482

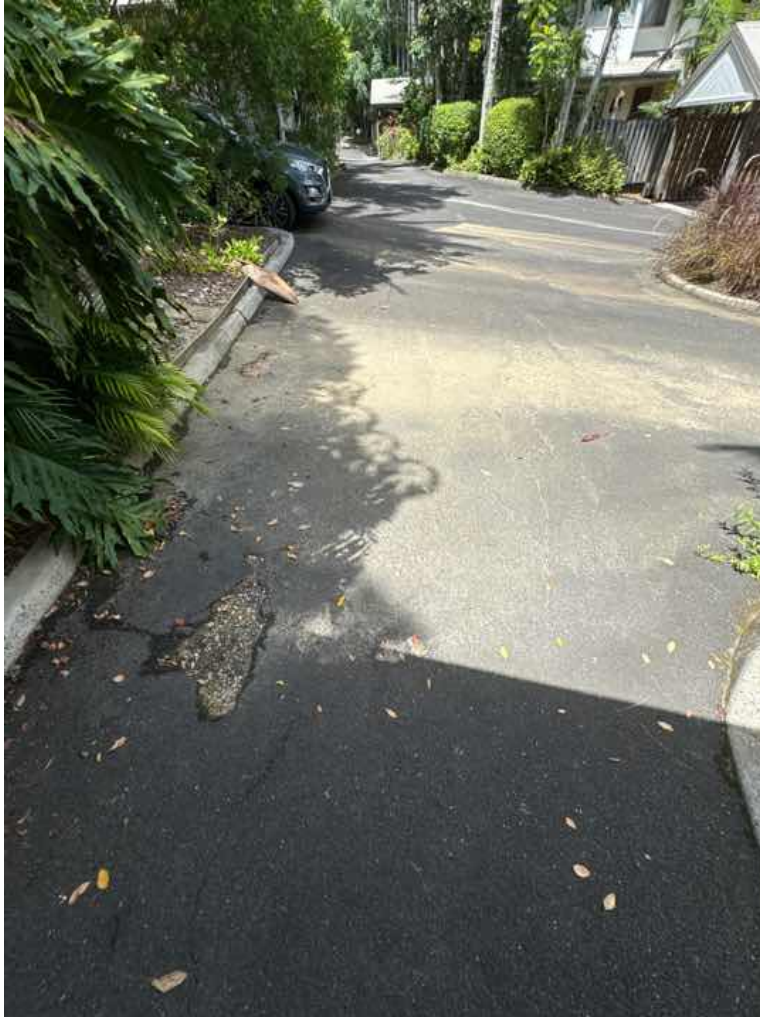
Driveway Condition

On visual inspection, the general condition of the driveway is serviceable.

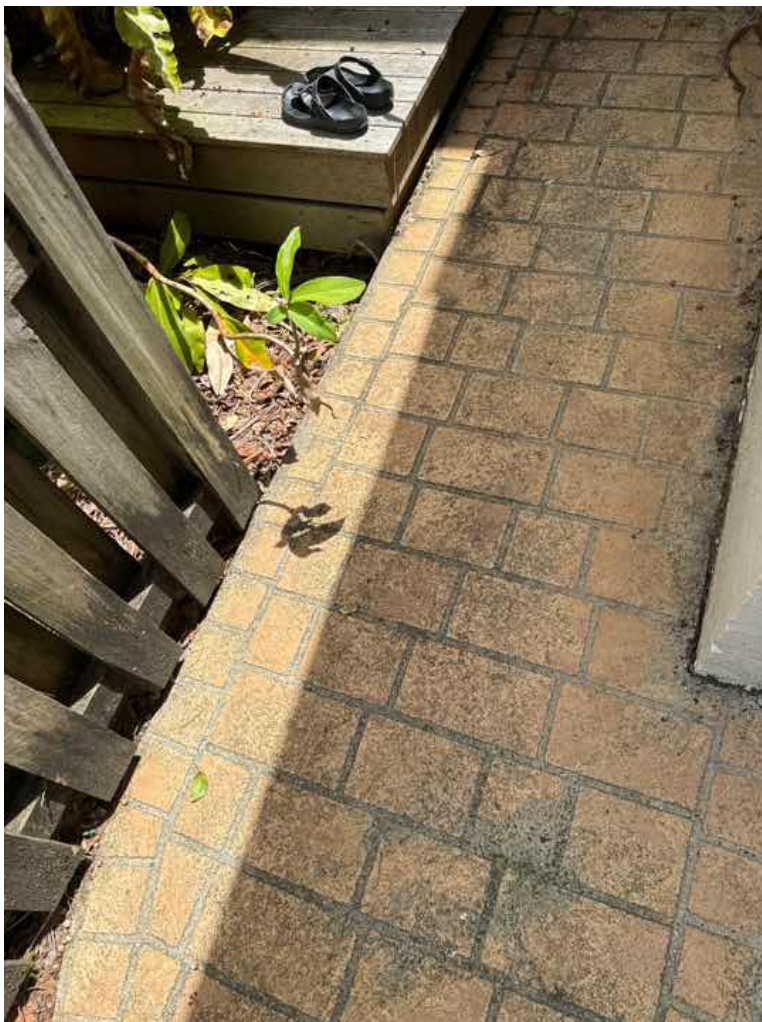
Pathways Condition

The paths around the home are in a serviceable condition for the age of this dwelling with no major defects visible.

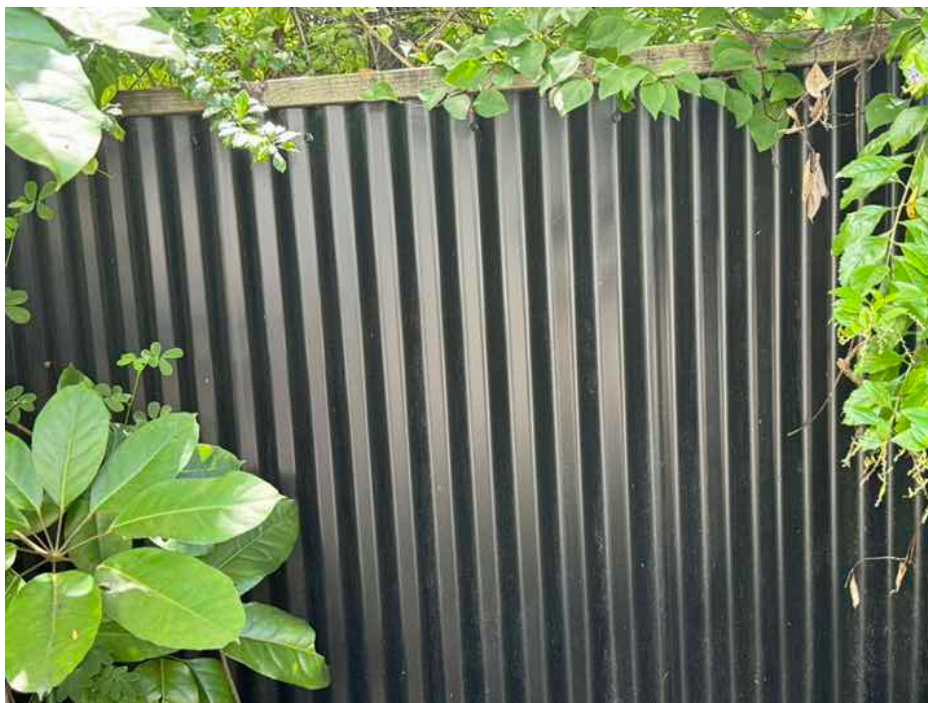
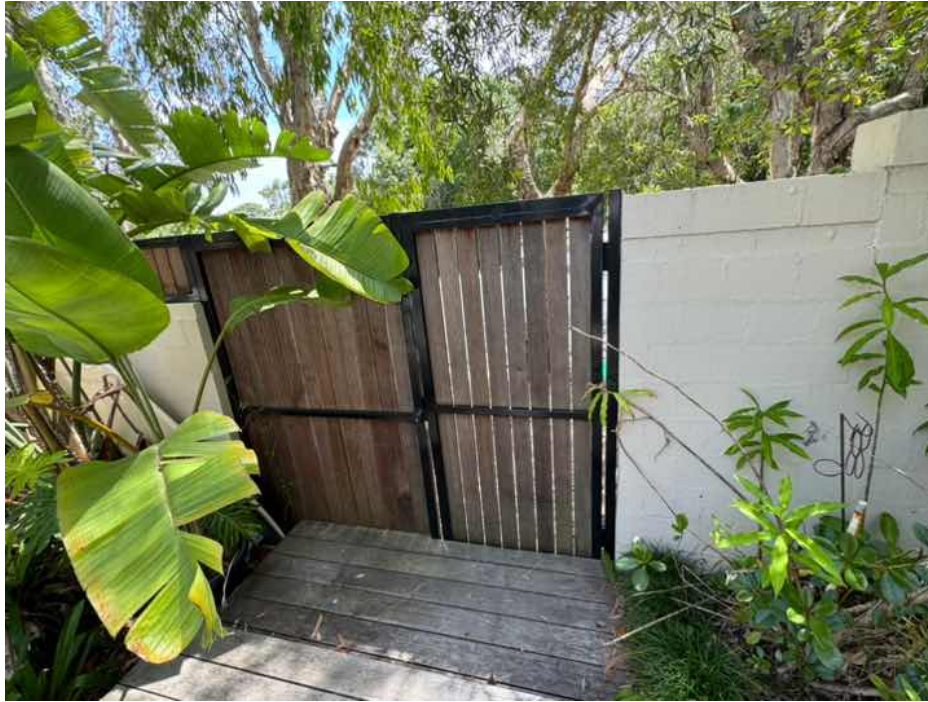
Overall Condition

Of the visible areas, the general condition of the fences and gates is serviceable for the age of dwelling.

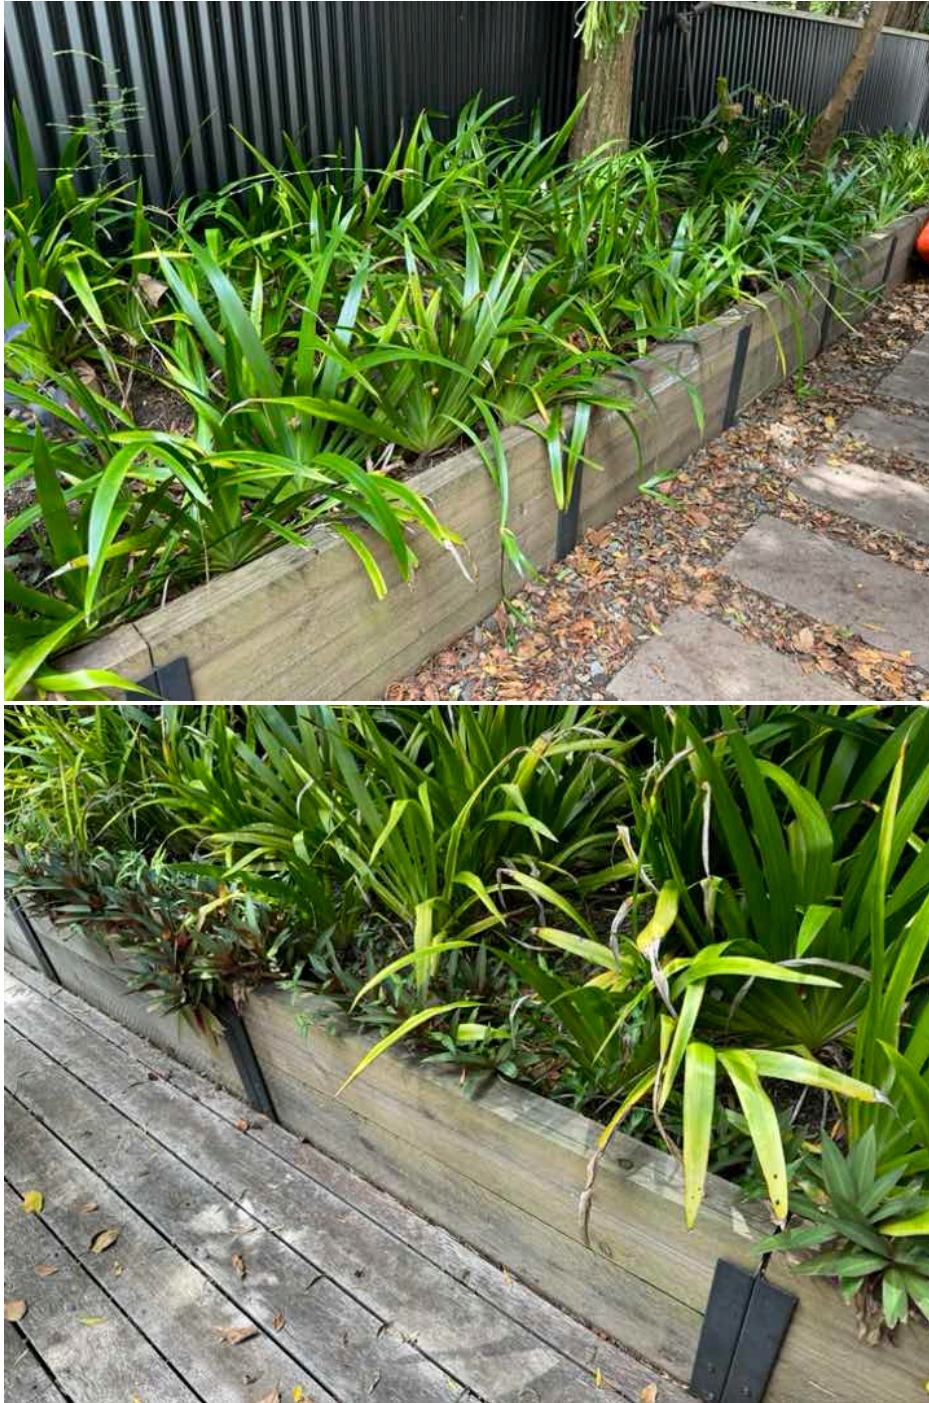
Retaining Walls

Of the visible areas, the general condition is serviceable or in reasonable condition for age of dwelling.

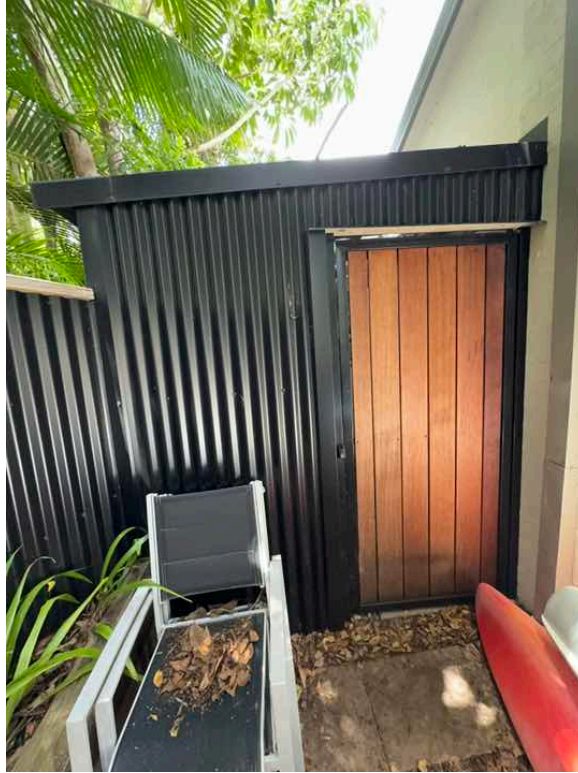
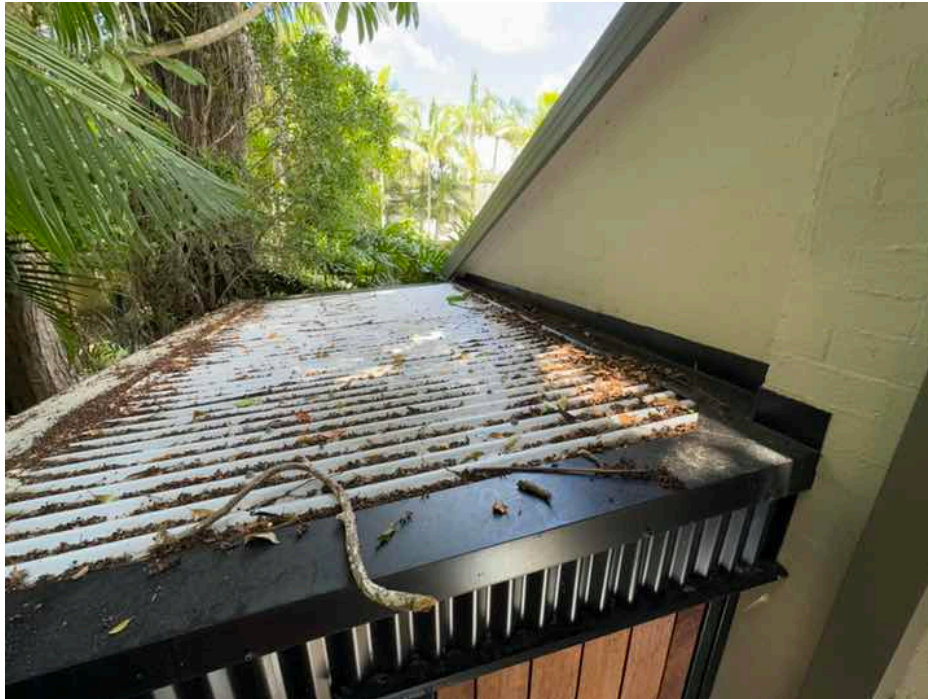
Shed Condition

The shed is in fair usable condition.

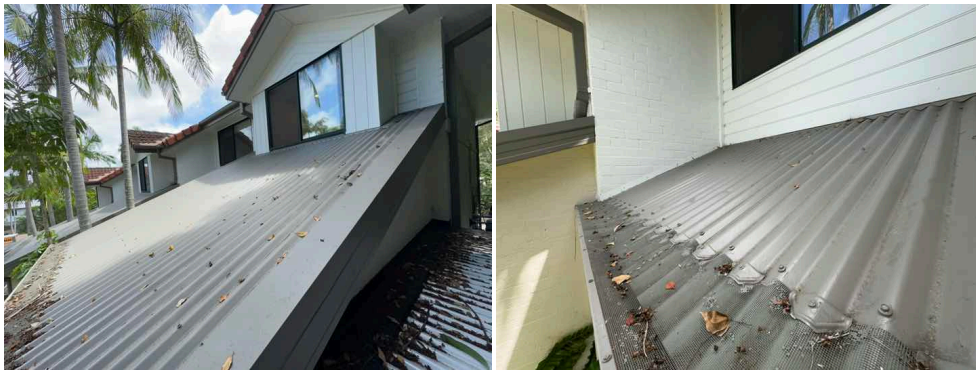
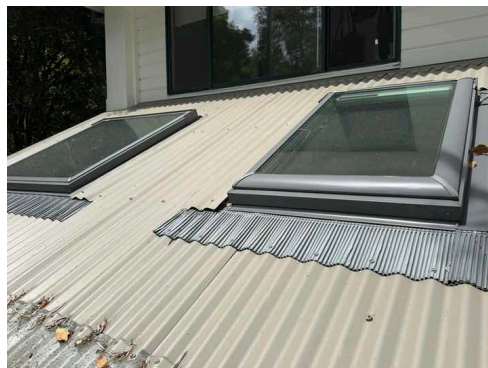
Due to height restrictions only the lower roof only was inspected and of the visible and accessible areas, the general condition of the roof is in serviceable condition for the age.

Note: In the absence of rainfall there is no guarantee that the roof won't leak.

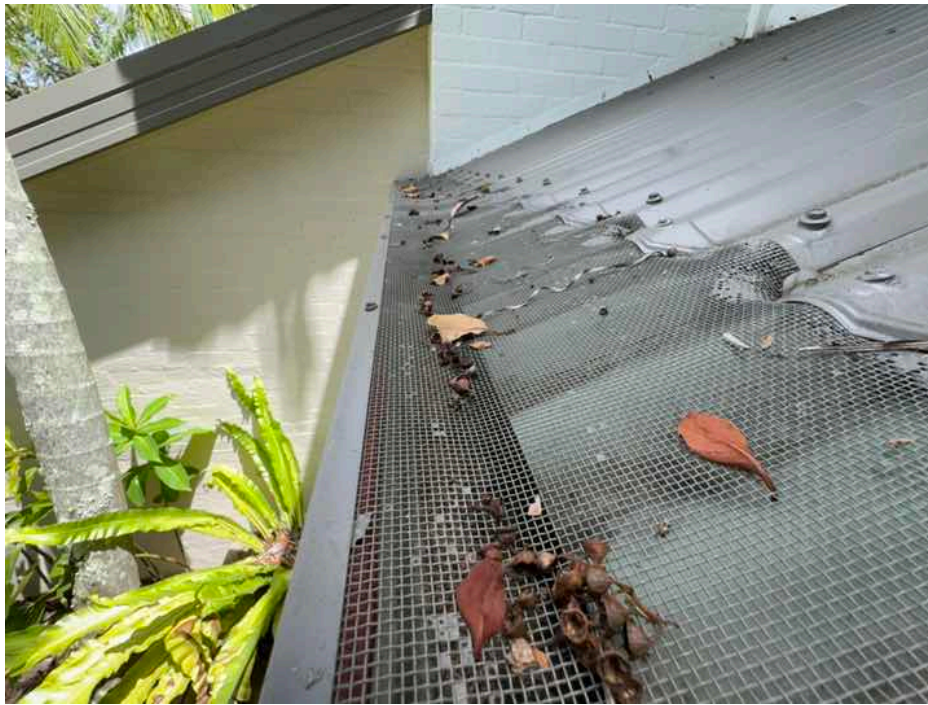
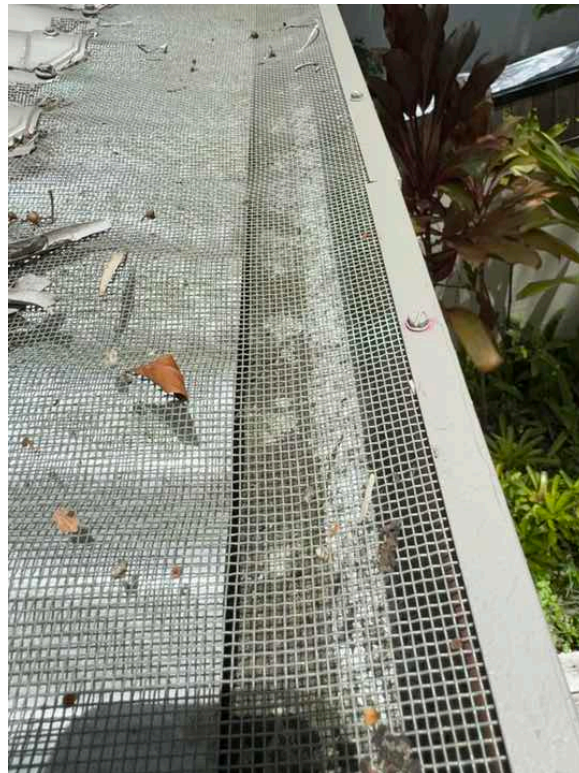
Guttering

All visible and accessible of the physical nature of the guttering system appears to be in a serviceable condition with no apparent defects at the time of inspection. In the absence of prolonged rain fall efficiency of the guttering can not be assessed and you may find that further investigation or repairs maybe required. Note: Periodic maintenance checks should be carried out for rust penetrations and leaks.

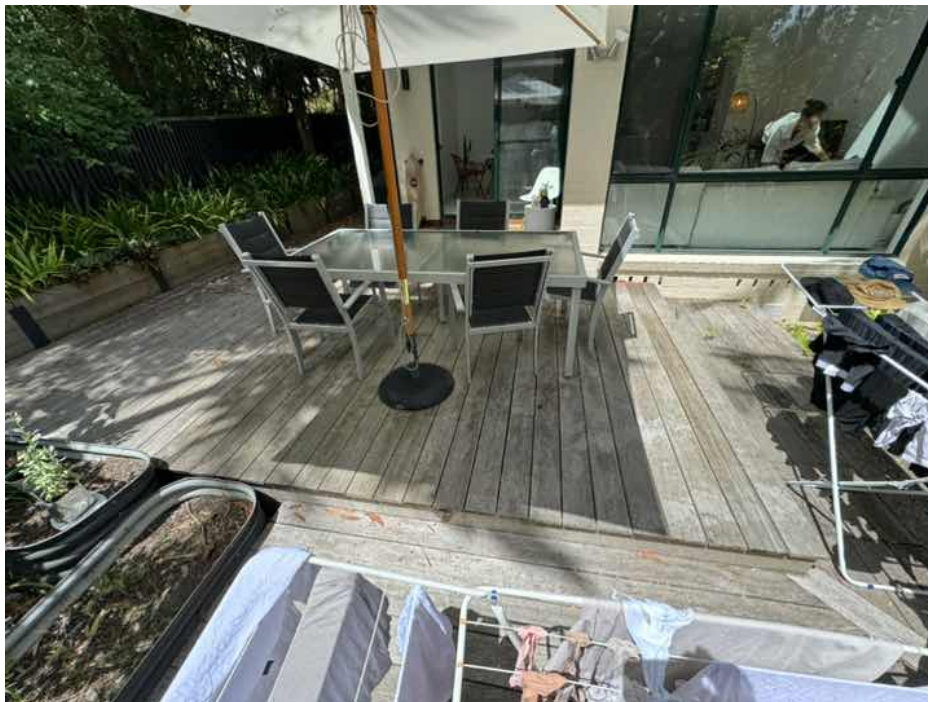
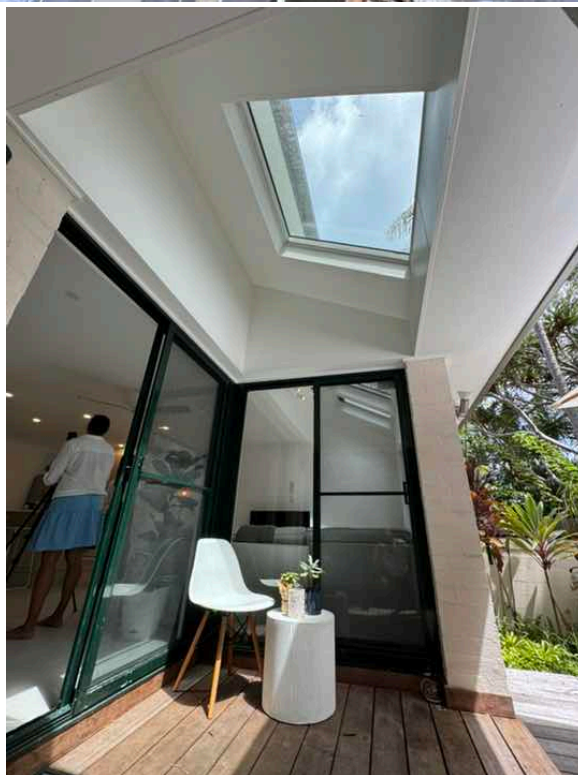
Visible sections of the Alfresco area are serviceable or in reasonable or condition for the age of this dwelling.

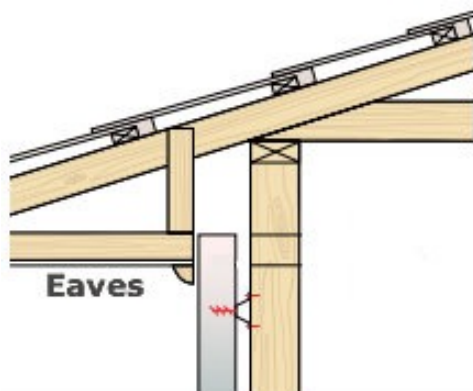
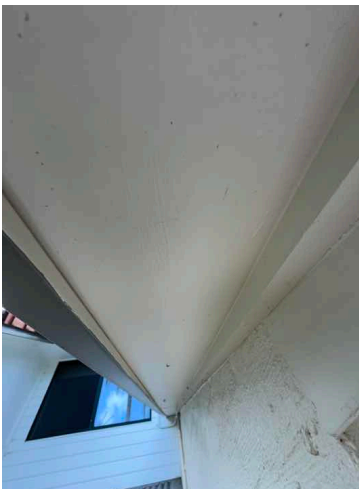
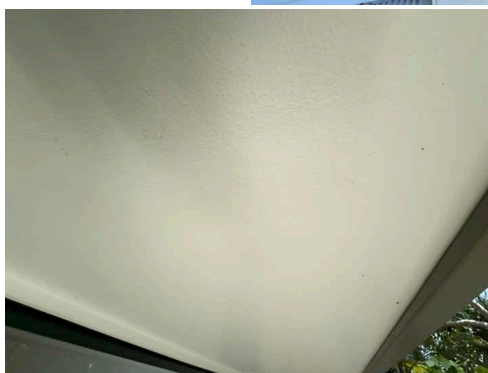
Eaves

The soffit lining (eaves) are in a serviceable condition with no notable defects.

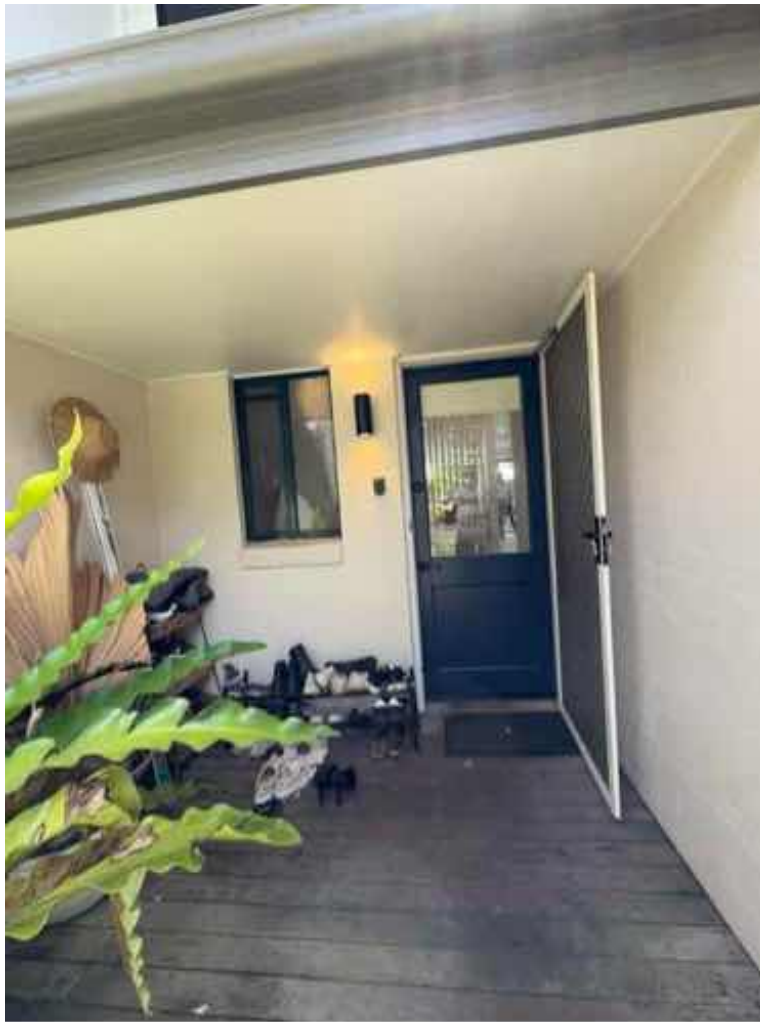
Entry Porch Area

The entry porch serviceable or in reasonable or condition for the age of this dwelling.

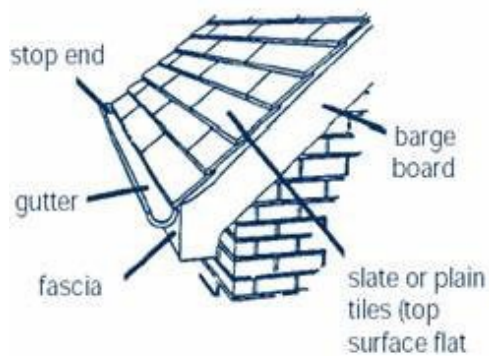
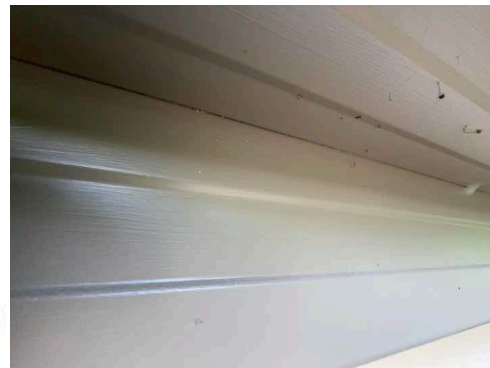
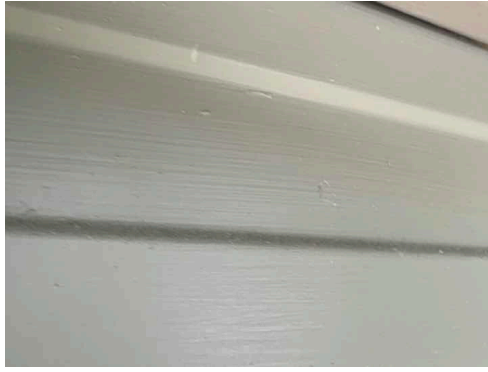
On visual inspection, the general condition of the fascia/barge boards is serviceable.

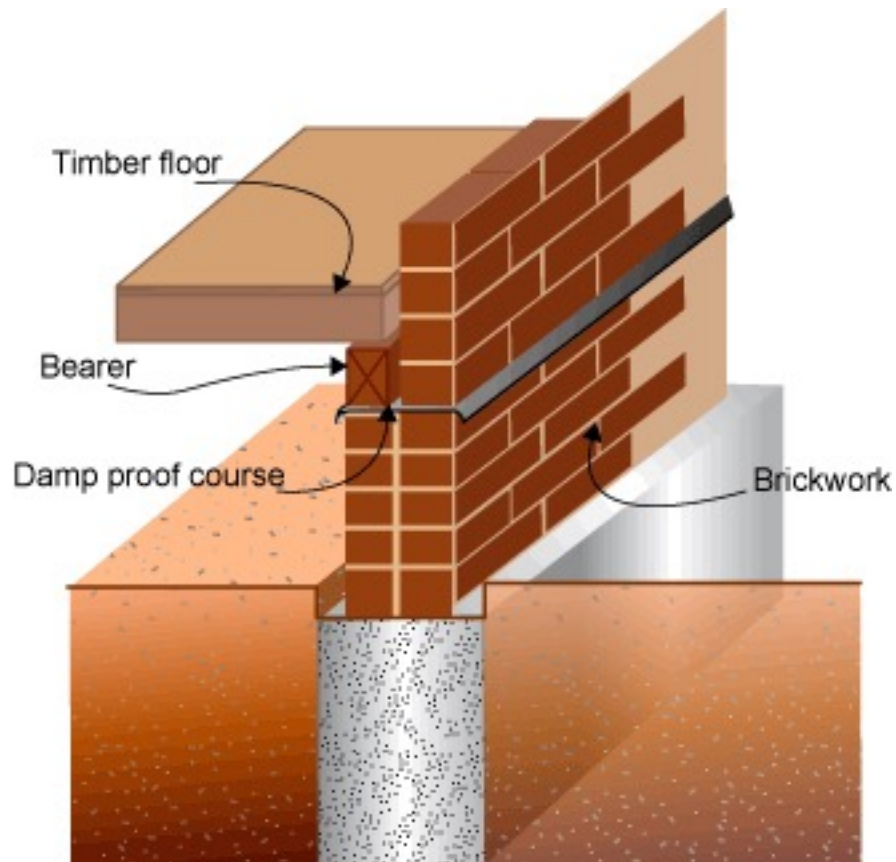
Damp Proof Course

A damp proof course (DPC) was noted.

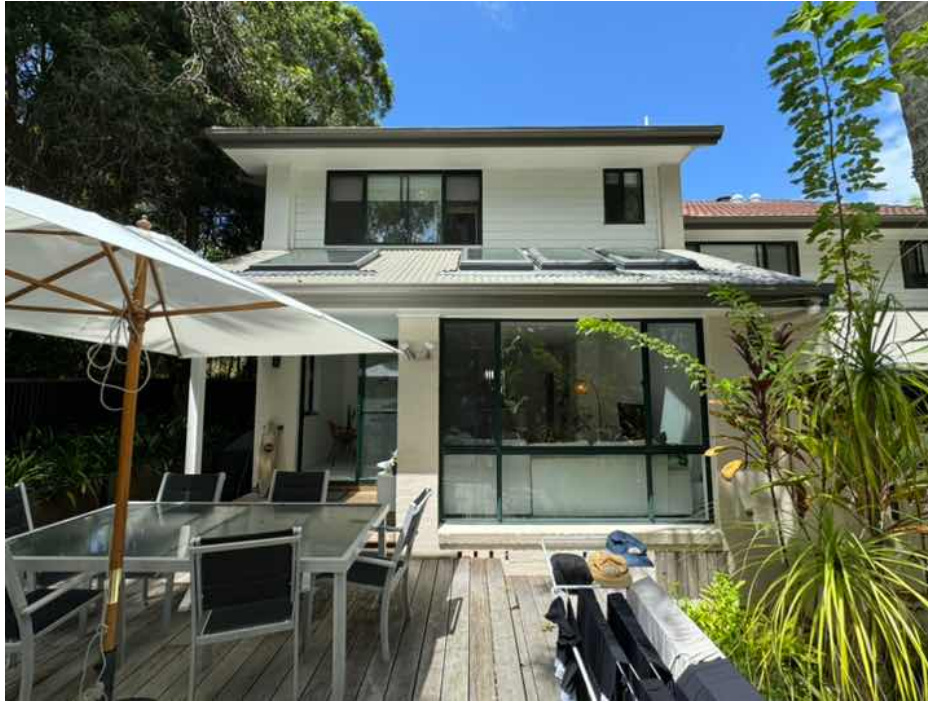
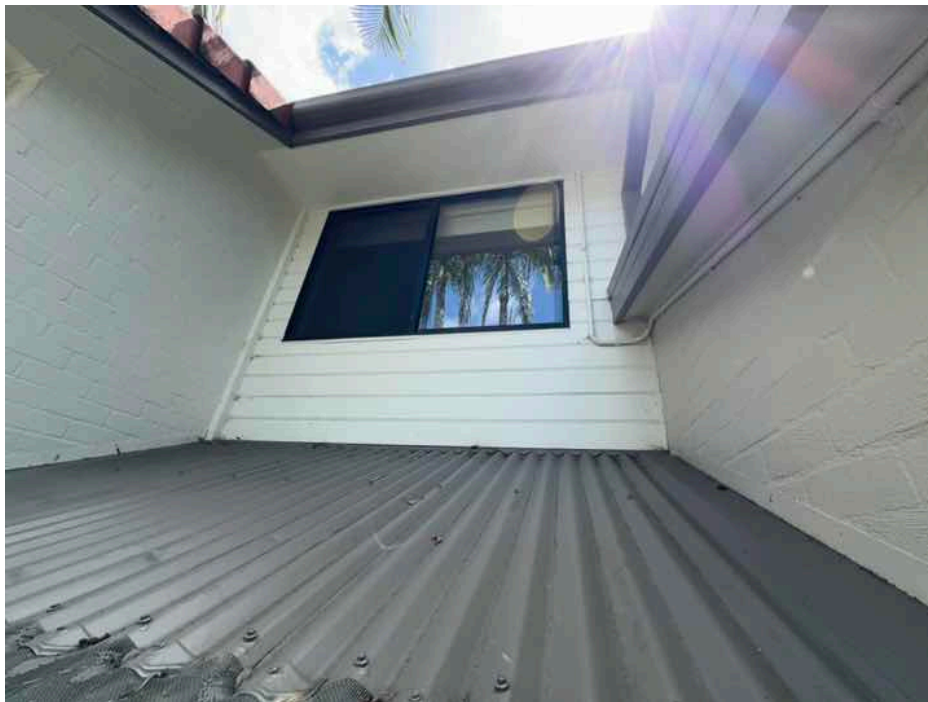
Walls

On visual inspection, the general condition of the exterior walls is serviceable for the age.

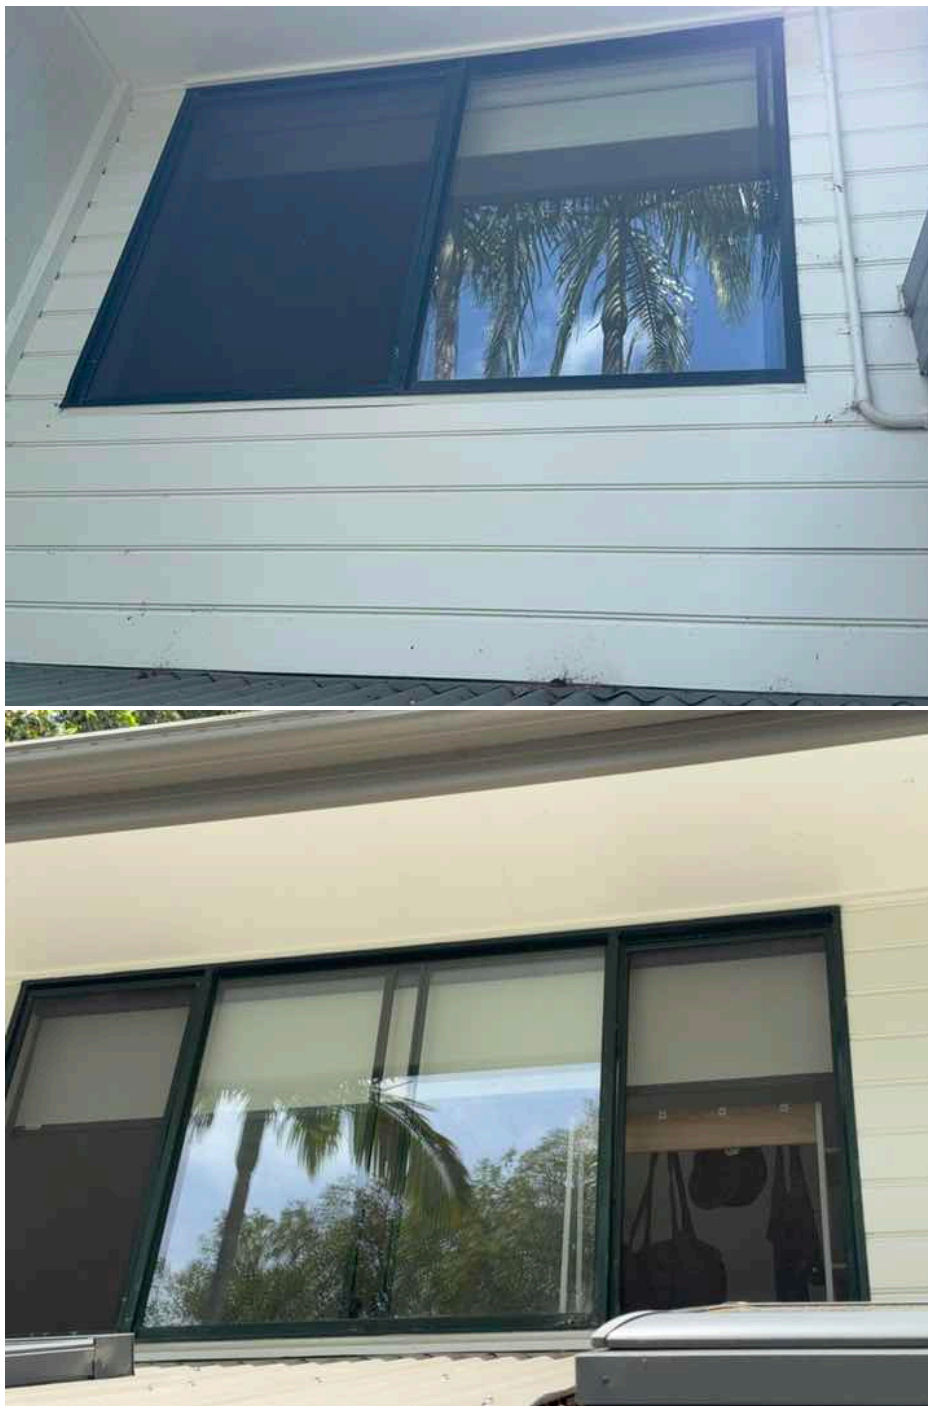
Windows

On visual inspection, the general condition of the windows is serviceable for the age.

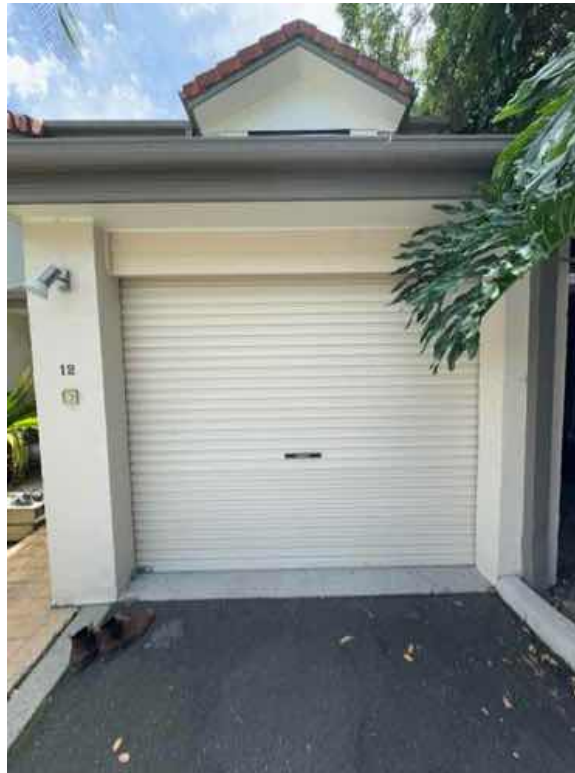
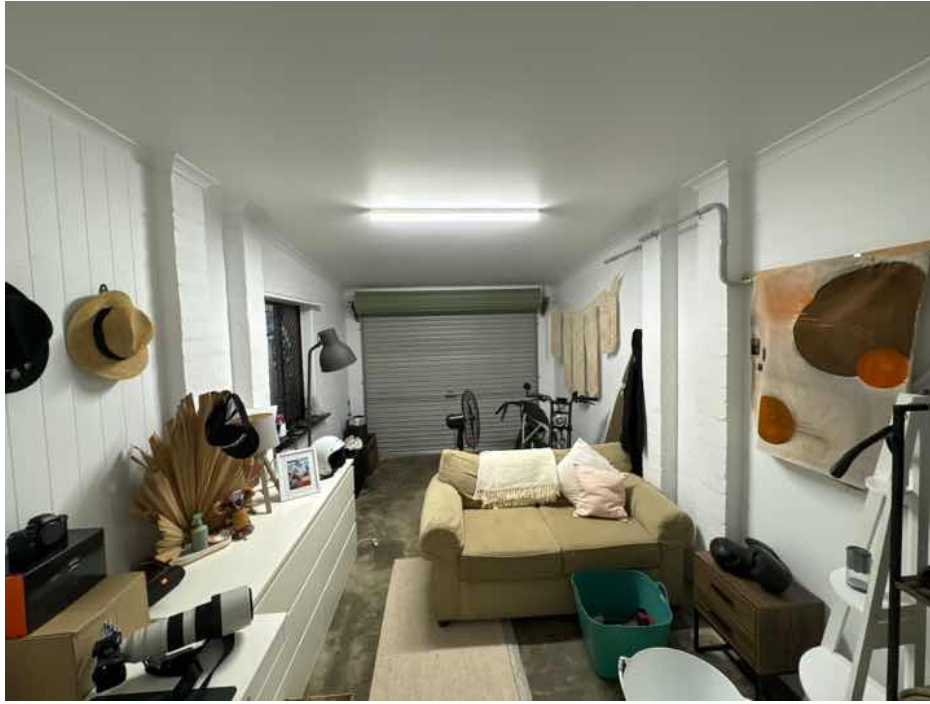
Stored items restricted a full and thorough inspection of this area. Defects may exist in the obstructed and inaccessible areas. It is strongly recommended that full access be granted to enable a thorough inspection as there may be timber pest activity, damage or defects. Note: Where vehicles and storage has restricted a full inspection it is advised that this area be cleared so a full and unobstructed inspection can be carried out.

From the visible and accessible areas, the garage appears to be in a serviceable condition for the age of the property with no notable structural defects sighted.

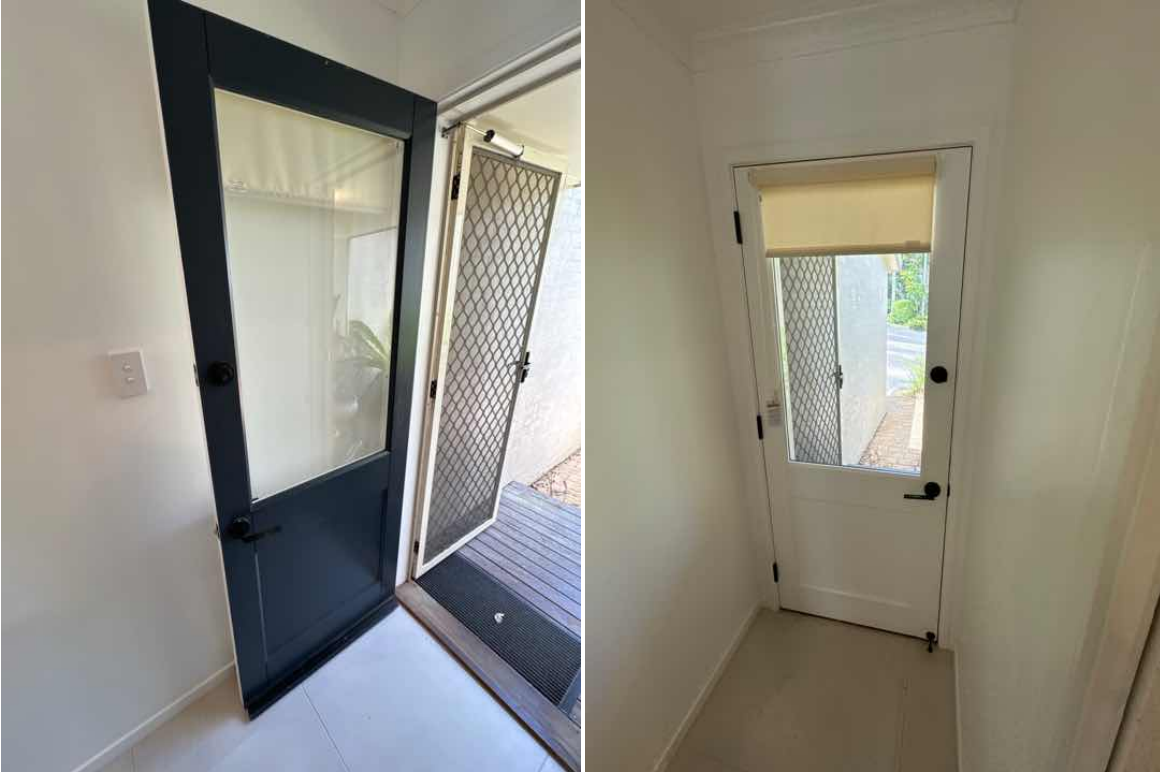
Front Entry Doors

The doors are in serviceable condition with no notable defects observed.

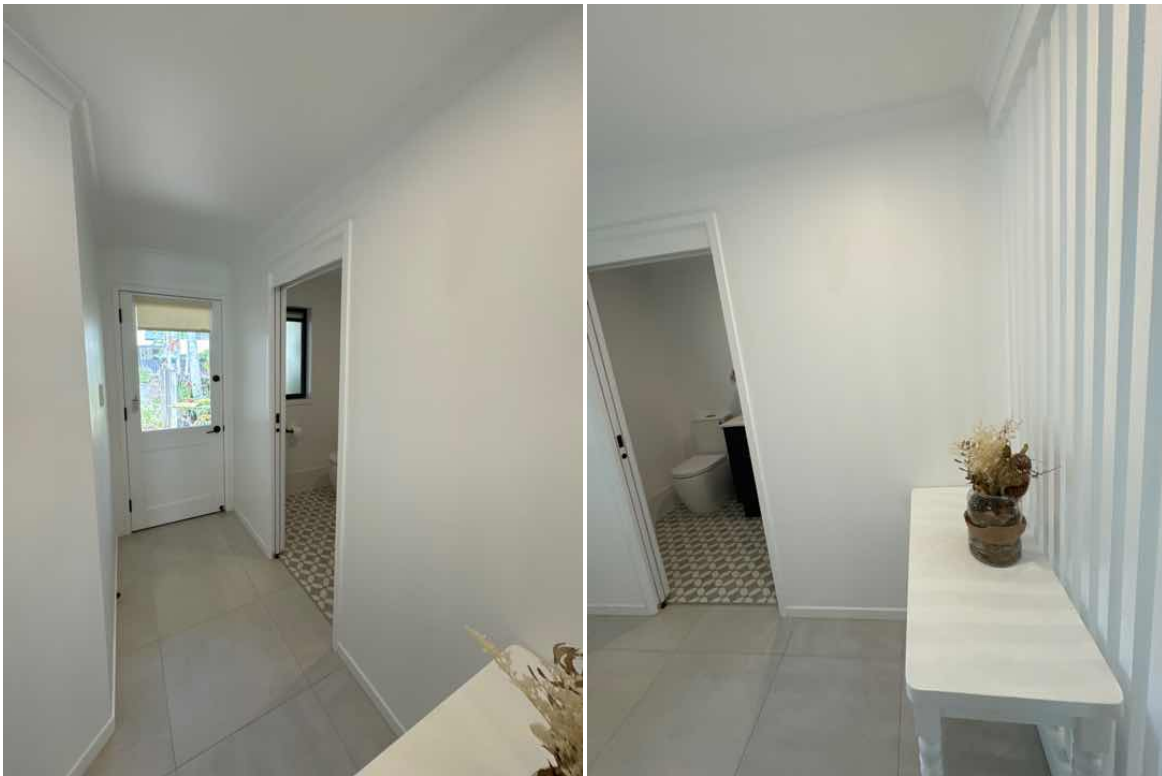
From the visible and accessible areas, this area appears to be in a serviceable condition for the age of the property with no notable structural defects sighted.

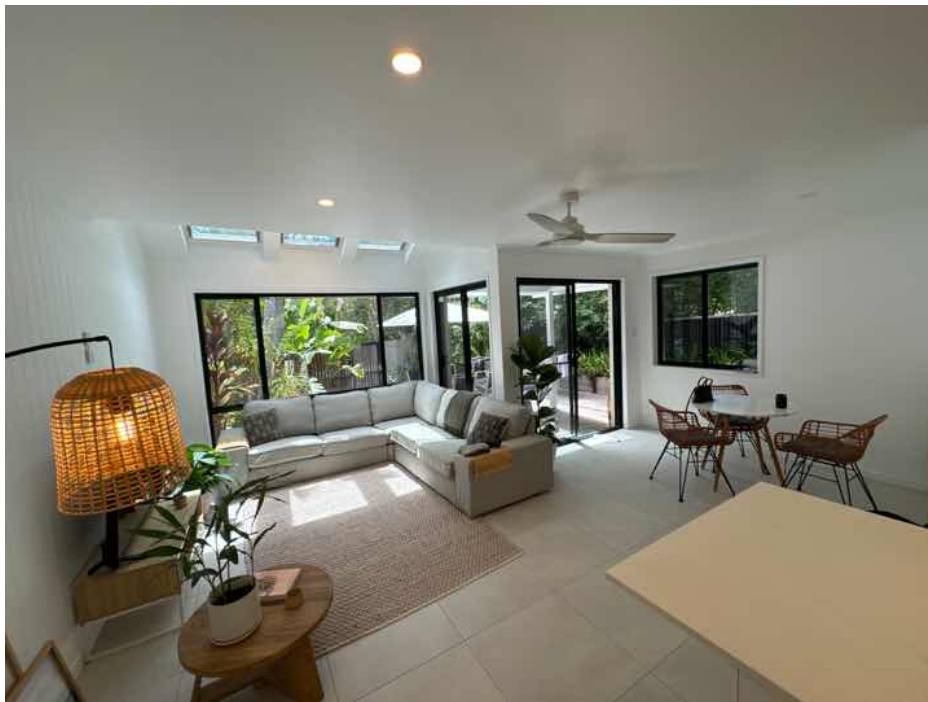
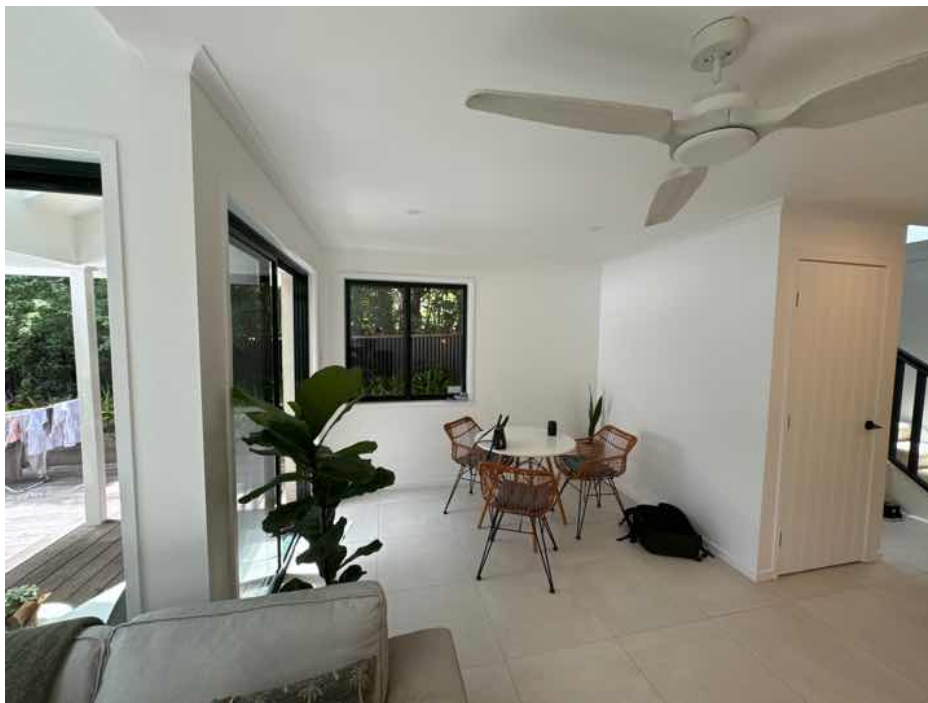
Combined Living & Dining

From the visible and accessible areas, this room appears to be in a serviceable condition for the age of the property with no notable structural defects sighted.

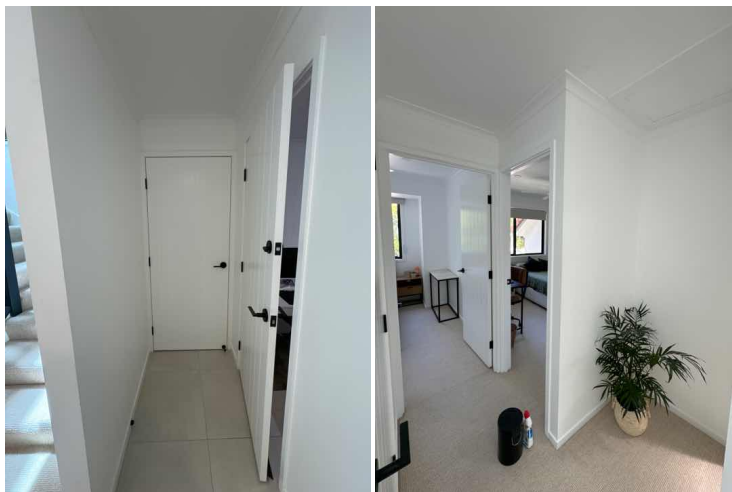
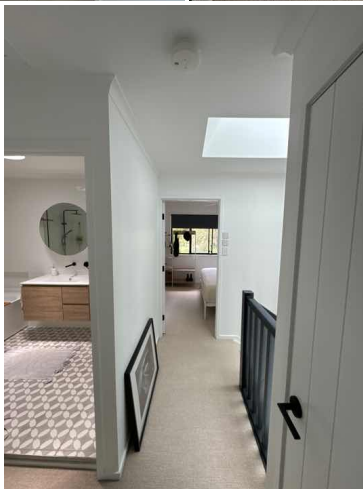
Hallway/s

From the visible and accessible areas, the hallway/ appears to be in a serviceable condition for the age of the property with no notable structural defects sighted.

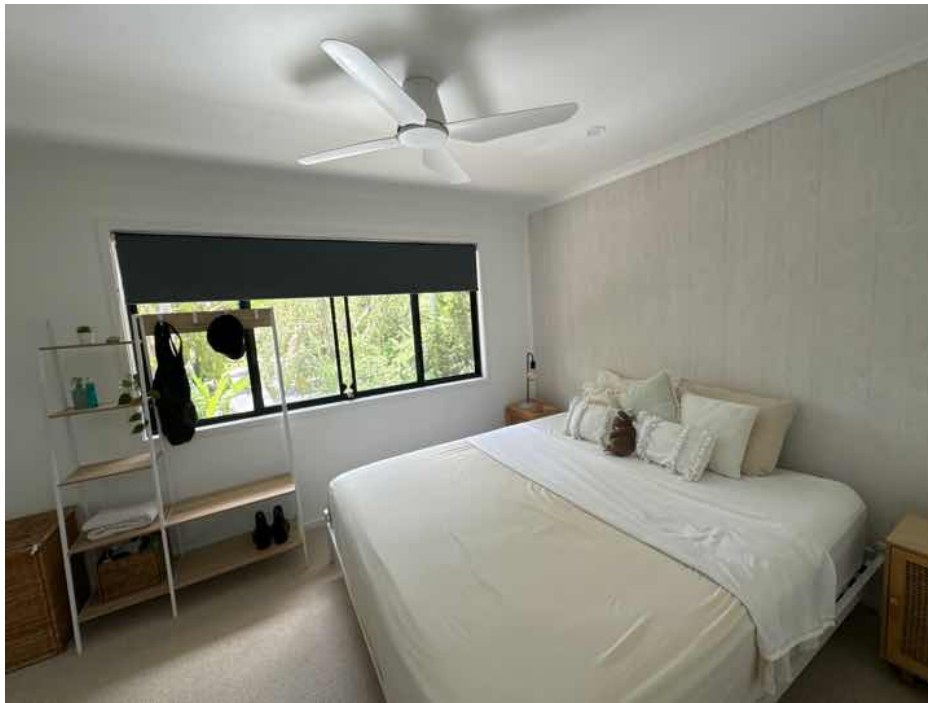
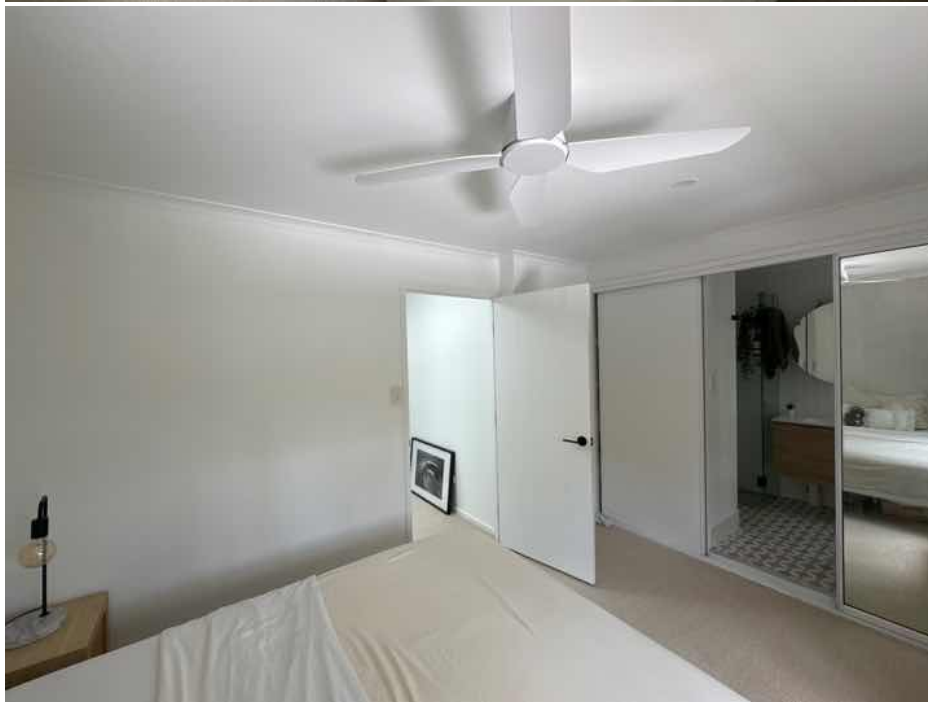
From the visible and accessible areas, this bedroom appears to be in a serviceable condition for the age of the property with no notable structural defects sighted.

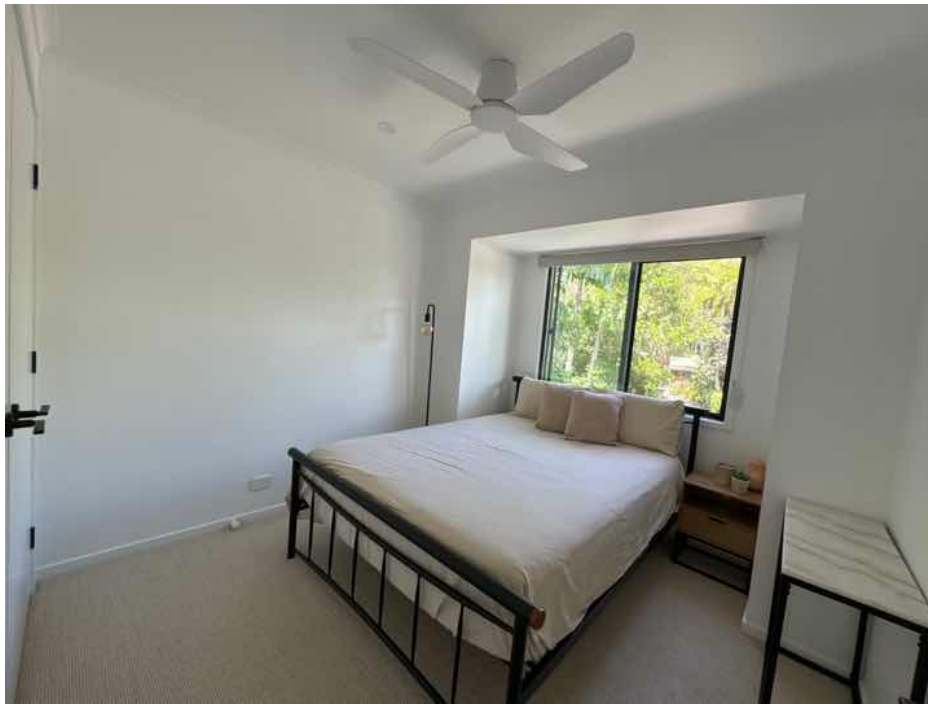
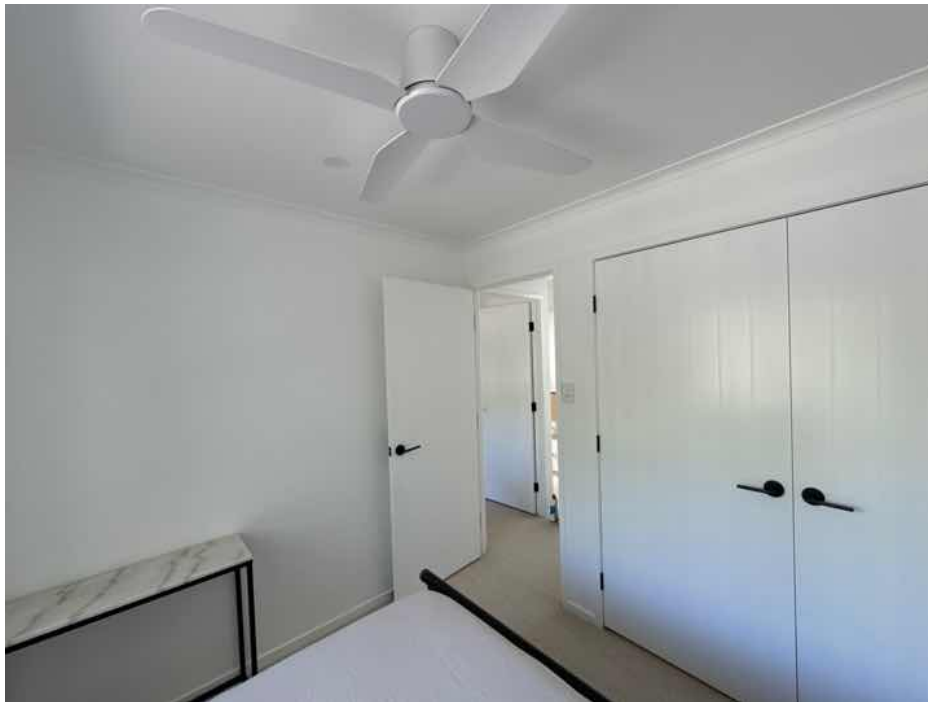
Bedroom 2

From the visible and accessible areas, this bedroom appears to be in a serviceable condition for the age of the property with no notable structural defects sighted.

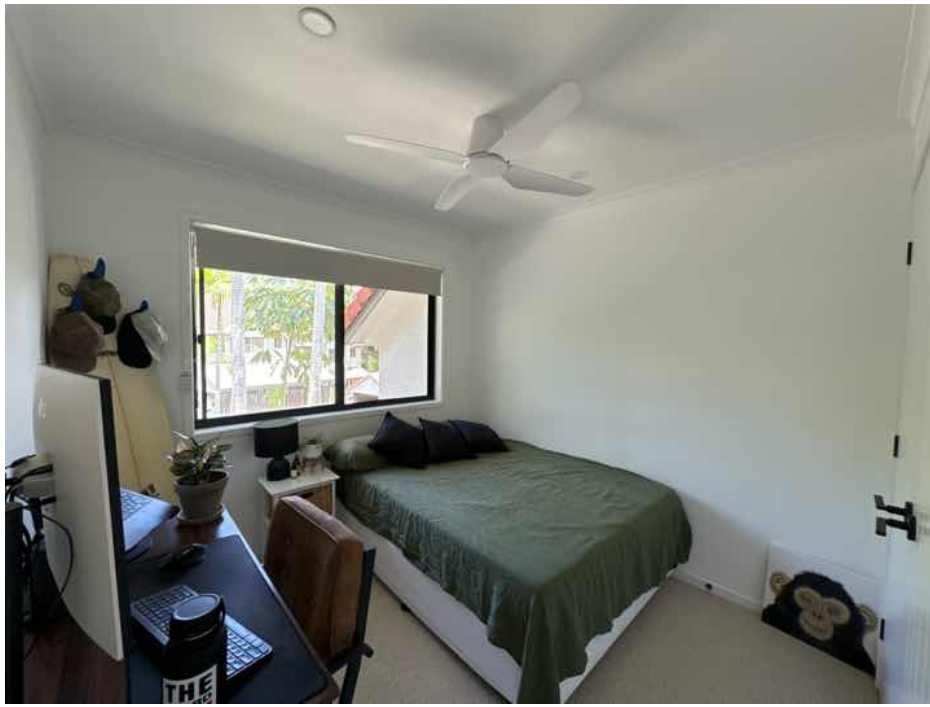
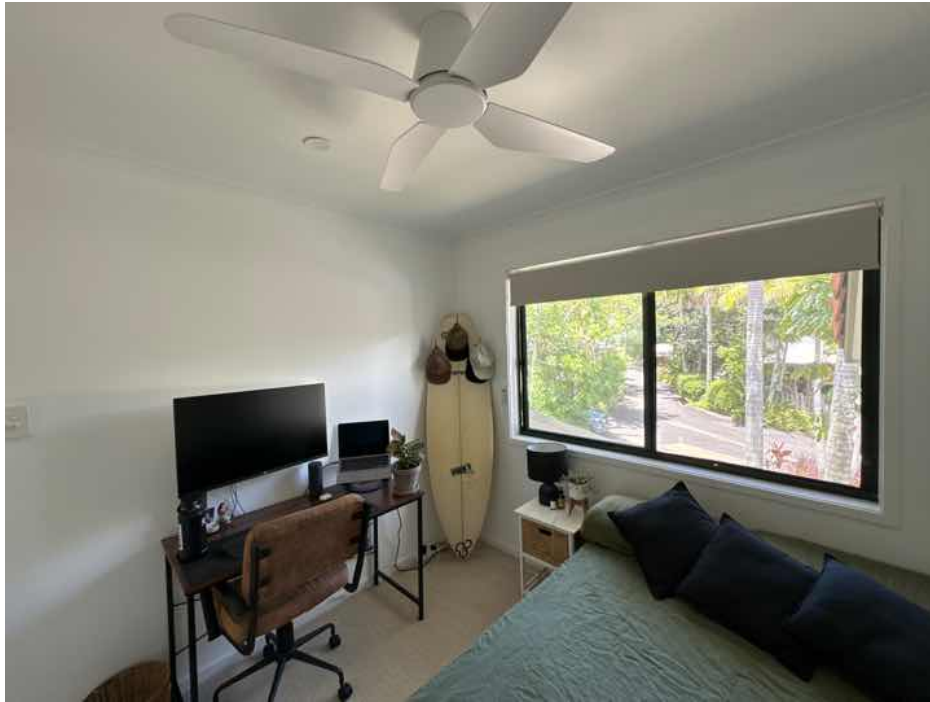
From the visible and accessible areas, this bedroom appears to be in a serviceable condition for the age of the property with no notable structural defects sighted.
