12/17 MAHOGANY DRIVE, BYRON BAY

BUILDING & PEST REPORT

Inspection Report

12/17 Mahogany Drive, Byron Bay, NSW, 2482

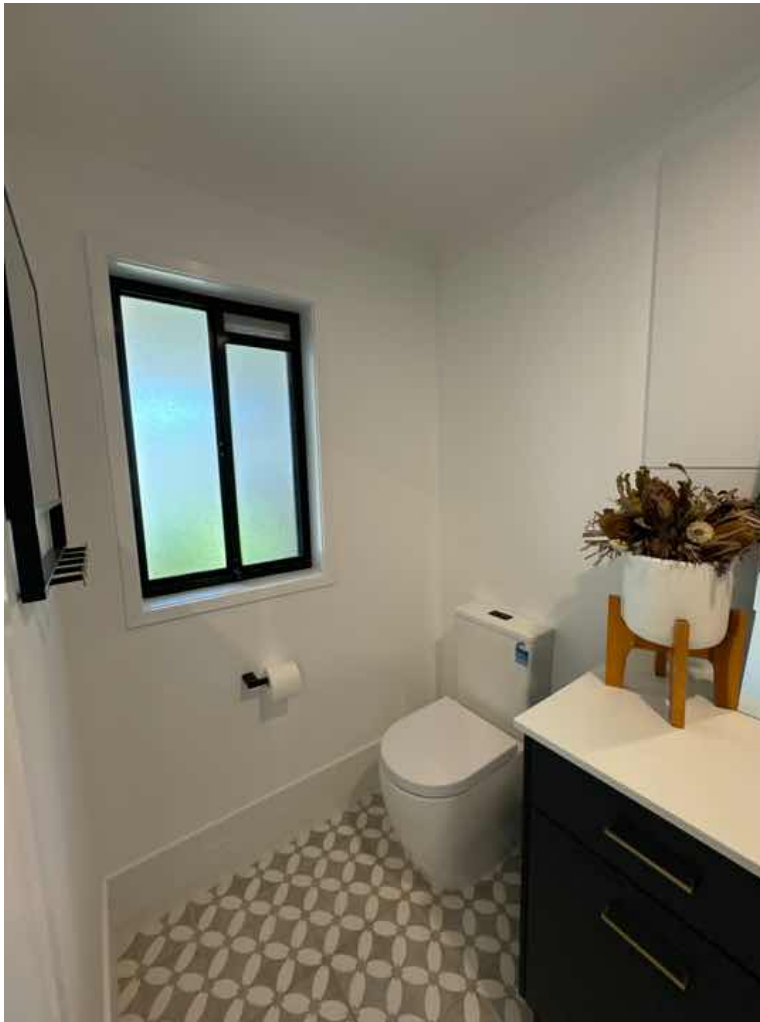
Powder Room

Of the visible areas, the general condition of this bathroom is serviceable or in reasonable condition for age of dwelling.

No exhaust fan is installed - Recommend having one installed.

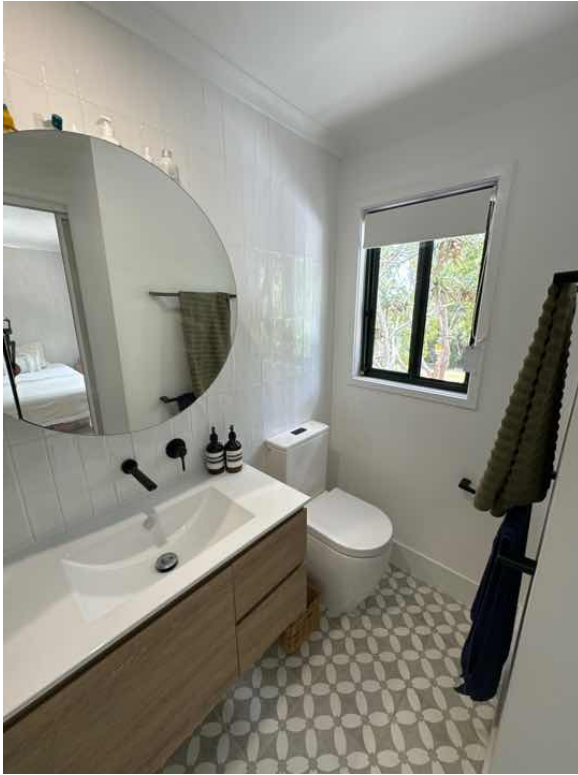
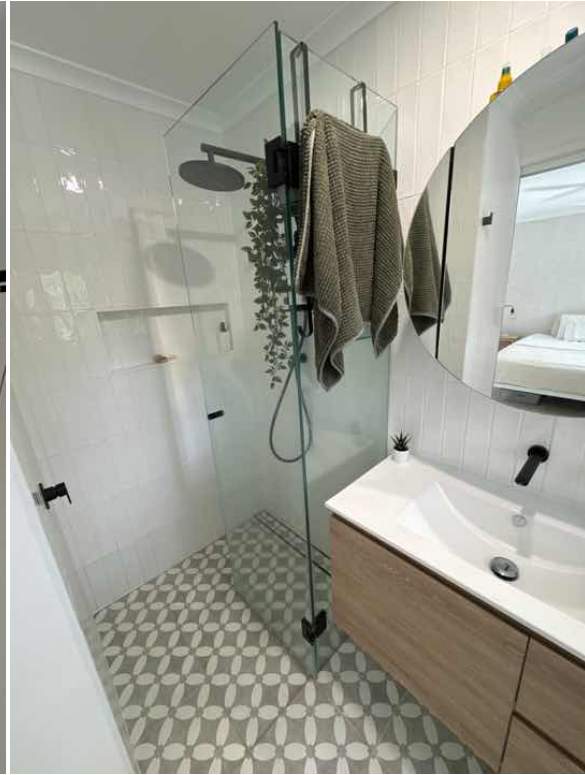
Of the visible areas, the general condition of this bathroom is serviceable or in reasonable condition for age of dwelling.

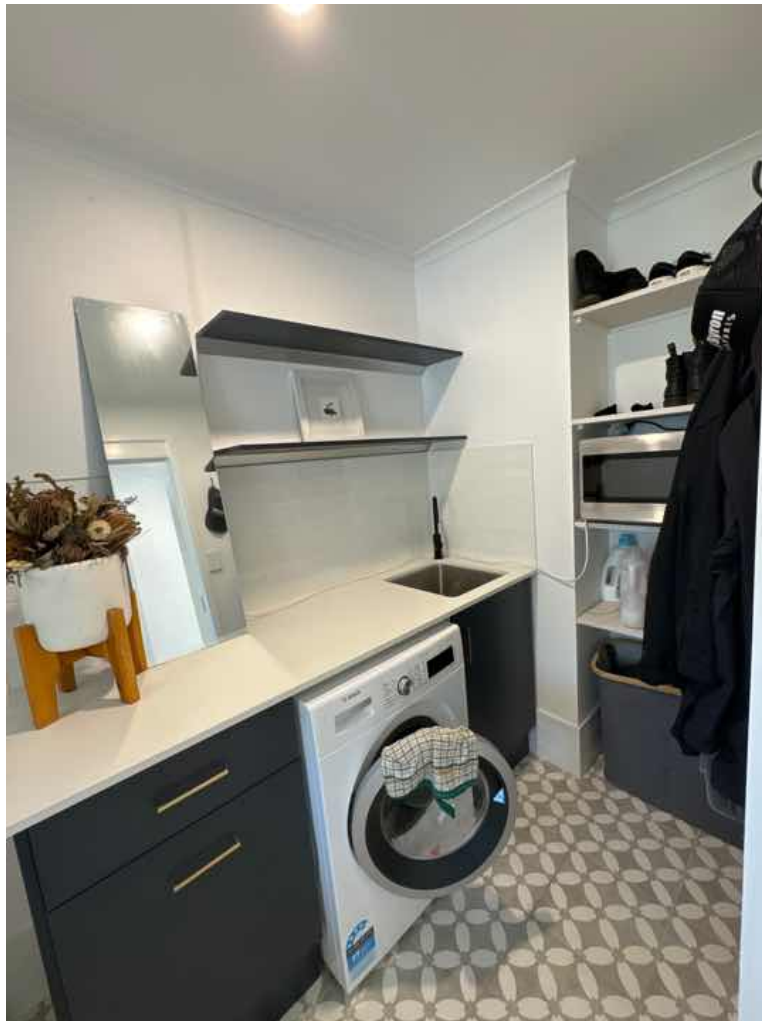
Of the visible areas, the general condition of the laundry is serviceable or in reasonable condition for age of dwelling.

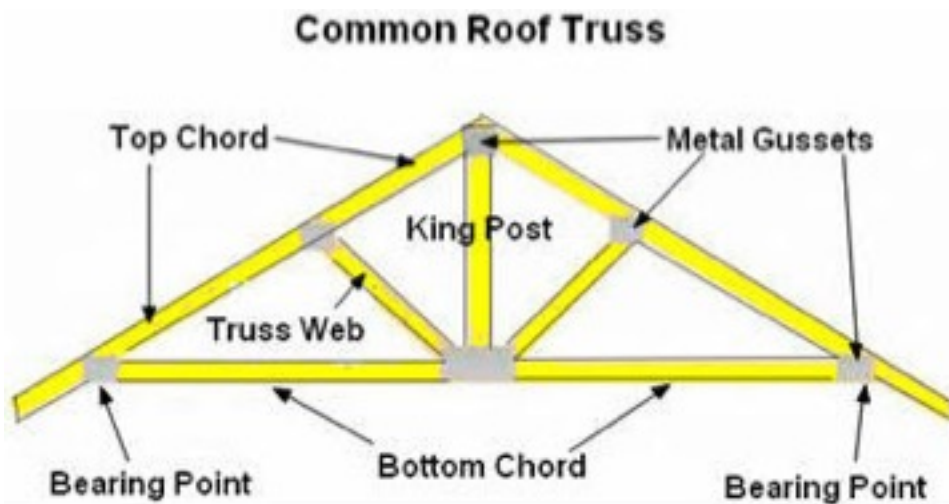
Roof Frame Type

The roof frame is a truss timber frame.
