Building and Pest Report

50A Ruskin Street Byron Bay

Pre-Purchase Building & Timber Pest Inspection Report

7a/21-25 Fletcher Street Byron Bay 2481 New South Wales Australia

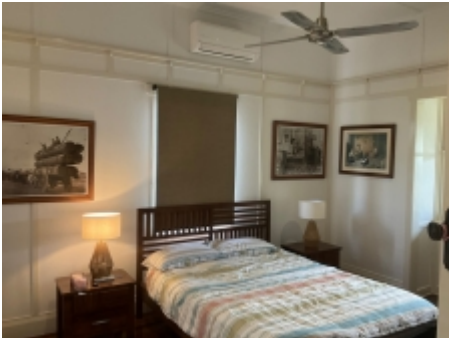
Bed 1

Defect Severity	Minor Defect
Defective Item	Windows
Defect	Painted Shut
Comment	The window sashes have been painted shut. Contact a licensed carpenter for repair.

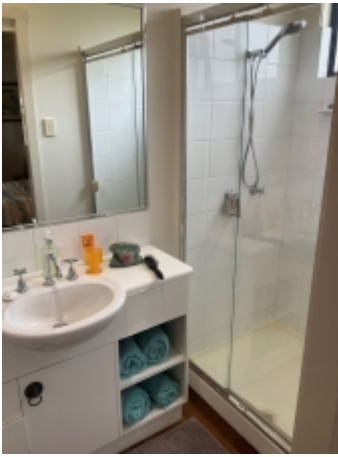
Bath 1

Defect Severity	Minor Defect
Defective Item	Flooring
Defect	Squeaky floor boards
Comment	An area of the floor boards is squeaky underfoot. Contact a licensed carpenter for repair.

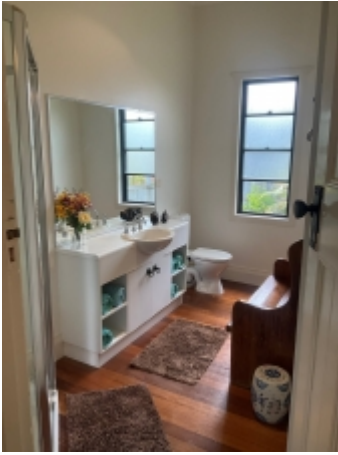
Bath 2

Defect Severity	Minor Defect
Defective Item	Vanity basin/cabinet
Defect	Moisture Damage
Comment	Moisture damage observed to the vanity cabinet. Contact a licensed cabinetmaker for repair or replacement.

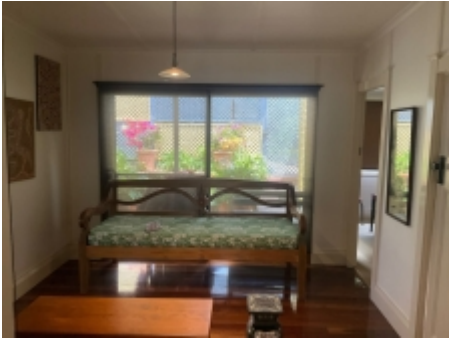
Lounge

Defect Severity	Minor Defect
Defective Item	Flooring
Defect	Loose flooring
Comment	Movement was noted in a section of the floor boards. Contact a licensed carpenter for re-fixing.

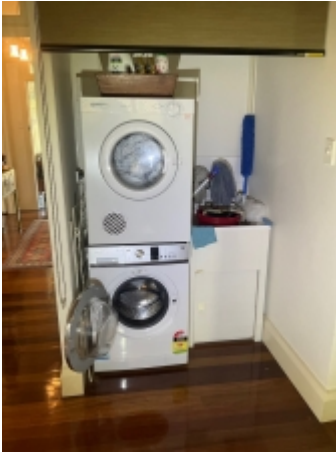
Laundry

Defect Severity	Minor Defect
Defective Item	Flooring
Defect	Timber Fungal Decay
Comment	Timber fungal decay/rot observed in areas of the timber flooring, no high moisture readings were taken at the time of the inspection (likely related to a past leak in this area). Contact a licensed carpenter for repair.

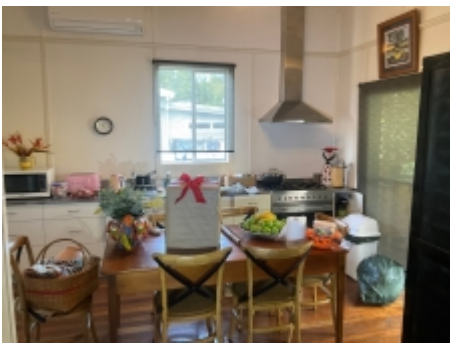
Kitchen

Defect Severity	Minor Defect
Defective Item	Walls
Defect	Cracks Settlement Minor

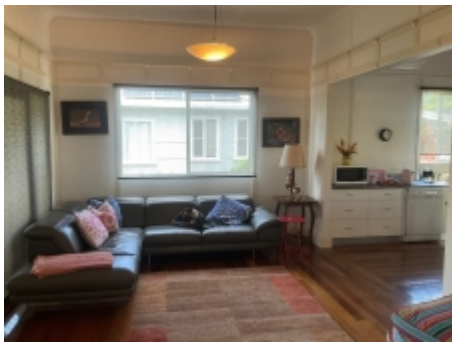
Living

Defect Severity	Minor Defect
Defective Item	Flooring
Defect	Squeaky floor boards
Comment	An area of the floor boards is squeaky underfoot. Contact a licensed carpenter for repair.

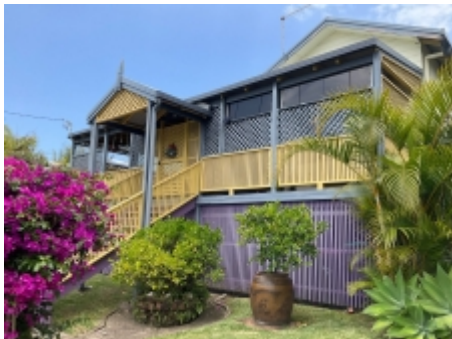
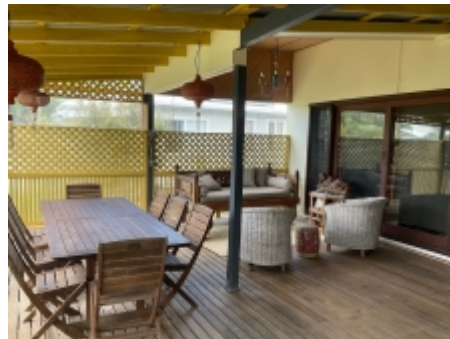
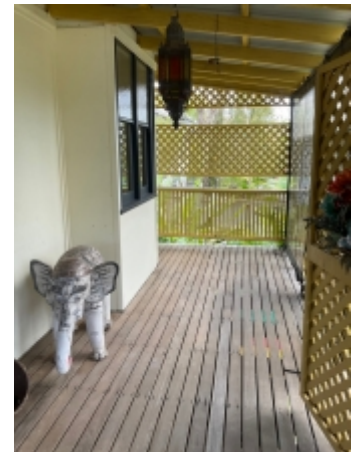
North Elevation

Defect Severity	Minor Defect
Defective Item	Fascia/barge boards
Defect	Timber Fungal Decay
Comment	Timber fungal decay/rot was observed in areas of the fascia/barge boards. Contact a licensed carpenter for repair.

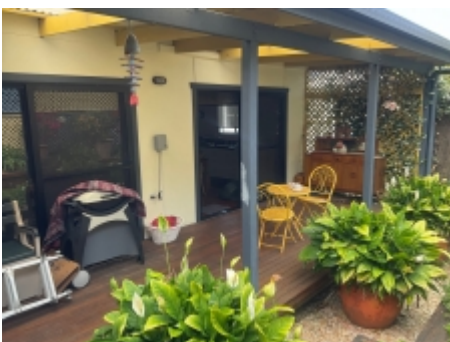
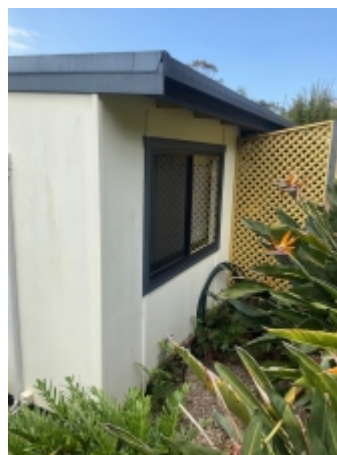
South Elevation

Defect Severity	Minor Defect
Defective Item	Steps
Defect	Dropped/out of level
Comment	The rear garden steps up tp the car park area have dropped and are out of level. Contact a licensed carpenter for further assessment and repair.

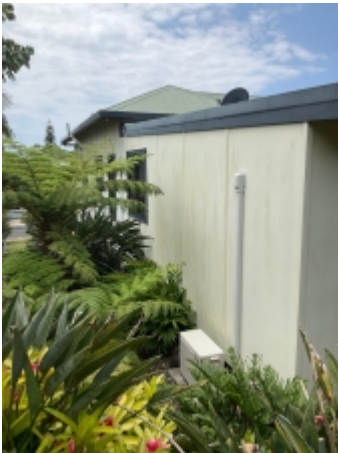
West Elevation

Defect Severity	Minor Defect
Defective Item	External windows
Defect	Rot To Window
Comment	Timber fungal decay/rot was observed in a section of the window architraves. Contact a licensed carpenter for repair.

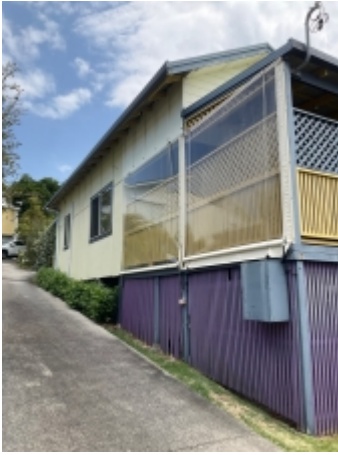
East Elevation

Defect Severity	Minor Defect
Defective Item	External Walls
Defect	Damage to subfloor slats
Comment	The slats enclosing the subfloor area are damaged in areas. Contact a licensed carpenter for repair.

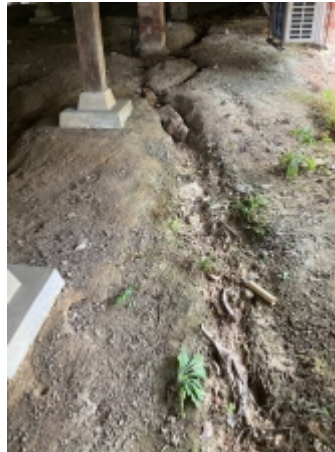
Defect Severity	Minor Defect
Defective Item	Dampness
Defect	Evidence of water entering subfloor
Comment	Although dry at the time of inspection, there is visible evidence of water having entered the subfloor space. This should be monitored during periods of prolonged rainfall and if water is entering the subfloor a licensed plumber must be engaged to assess the site drainage around the home.

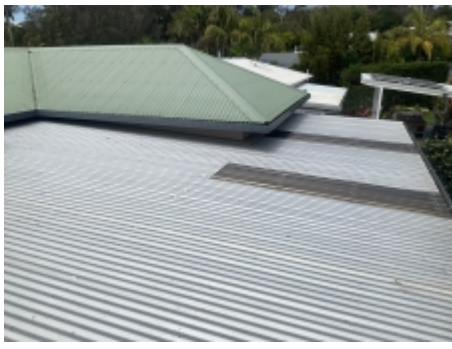
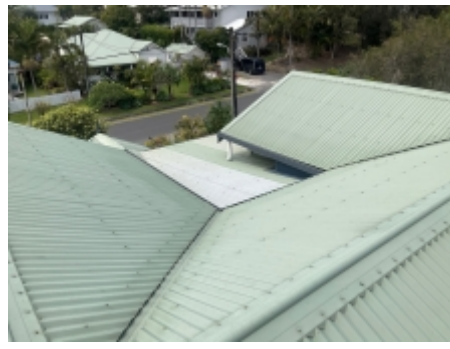
Roof Exterior

Defect Severity	Minor Defect
Defective Item	Roof cladding
Defect	Screw rust
Comment	Rusted roof screws were observed, this can lead to penetrating rust in the roof cladding and leaking. Contact a licensed roof plumber for replacement of affected areas.
