# Inspection Report

## Bloom Inspections

**18 Learmouth Street , Belmont, VIC, 3216**

Inspection Date: 01 Oct 2026

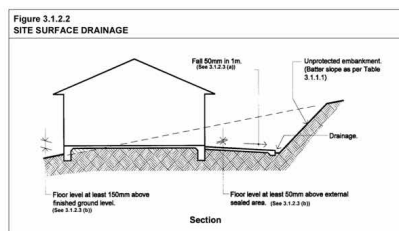
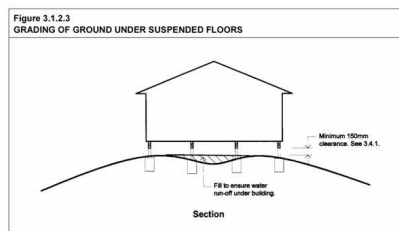
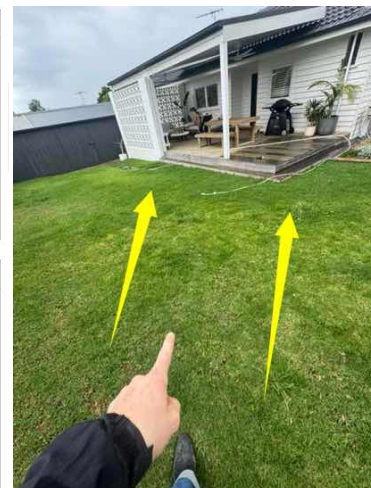
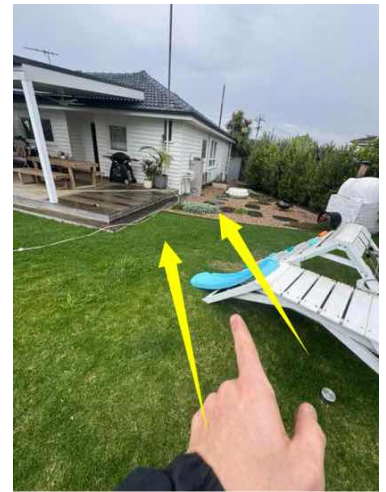
#1. To reduce the risk of moisture related structural stress, improvements to surface water runoff management and site drainage are recommended to the areas described and photographed. Observations indicate that ground levels and surface contours in sections around the dwelling do not provide adequate fall away from the building, which may allow water to accumulate and contribute to footing movement, moisture ingress and potential deterioration of building elements over time. As a general guide, a minimum apron width of approximately 1 metre with 25 mm to 50 mm of fall away from the building is recommended where practicable, and monitoring during periods of heavy rainfall is encouraged to confirm performance. Concealed drainage provisions such as subsurface agricultural lines or covered drains may be present but were not confirmed at the time of inspection. A suitably qualified and licensed plumber and landscaper or drainage contractor should be engaged to undertake a detailed assessment and provide recommendations and quotations for effective surface water management and discharge to an approved stormwater point.

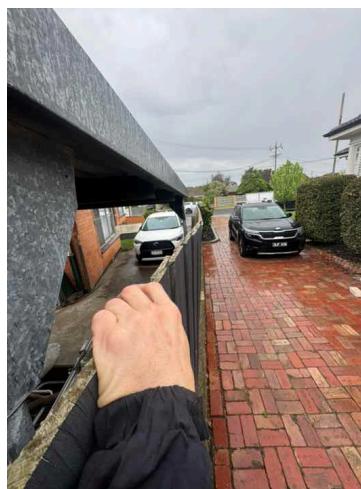
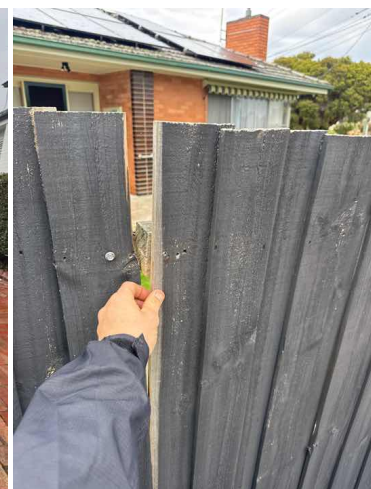
#3. Fencing is ageing and shows deterioration with some sections unstable and leaning out of alignment, likely due to general wear, obstructions, decayed or rotting posts and movement around post foundations which reduces overall stability and serviceability. We recommend a suitably competent and qualified fencing contractor further assess the fencing and provide advice and quotations for any required straightening, reinforcement repair or replacement works to restore stability.

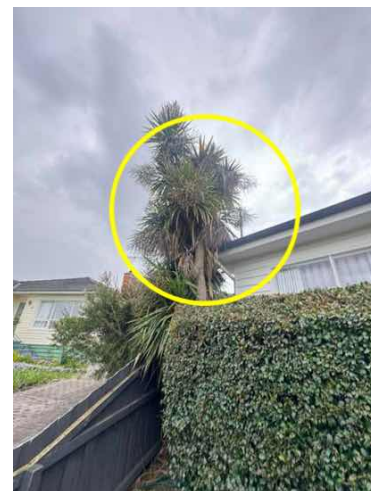
#4. Trees are located in close proximity to the building and overhang sections of the roof, which may contribute to issues including limb impact damage, root related movement to foundations, debris accumulation, corrosive conditions to roofing materials, blocked gutters, ponding water and an increased risk of timber pest activity. Trees positioned too close to structures can impose stresses on footings and underground services, with root influence often extending to an area similar to the canopy spread. If not appropriately managed, ongoing growth may contribute to structural movement and maintenance issues. Pruning, removal or appropriate management should be considered, noting that controlled removal is important to reduce potential ground movement or moisture rebound following removal, and that neighbouring trees may also influence the site. Local council approval may be required for removal of certain trees. A suitably competent and qualified arborist should be engaged to assess the trees, provide management or root barrier recommendations where necessary and supply quotations for appropriate works.

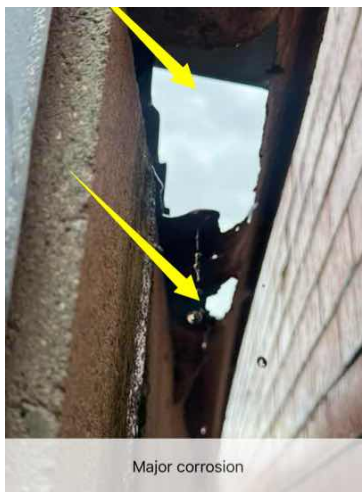
#7. Major corrosion was noted to roof guttering components. Consult a roof plumber to replace affected guttering.

Major corrosion

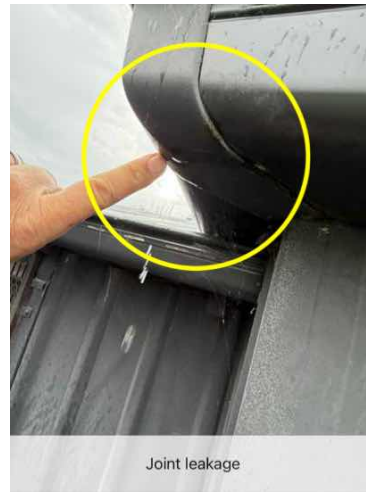
#6. Evidence of gutter joint leakage was observed. We recommend further assessment during rainfall and engaging a plumber for repairs as required.

Joint leakage

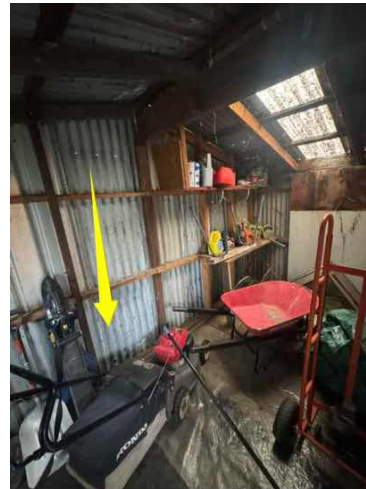
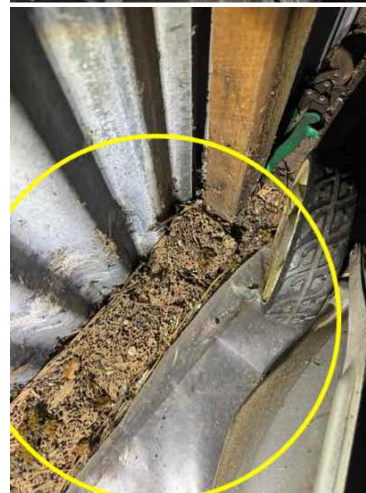
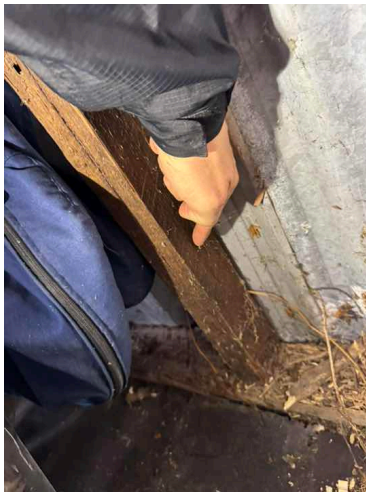
#9. Termite workings/damage were observed to rear of garage/shed to bottom plates and studs. This requires further invasive assessment by a registered builder to remove building components to determine the degree of termite damage present. The damage requires tracing back to the point(s) of entry to the furthest points of termite workings. We also strongly recommend engaging a licensed pest controller immediately to further invasively assess, treat and eradicate if required in accordance with AS3660.2

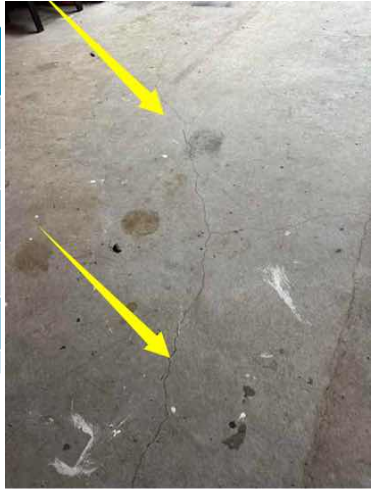
Common concrete curing and settlement cracks were observed to the slab surface. These are generally unavoidable in concrete construction and are described as negligible (less than 1mm). Factors such as excessive water content or rapid drying during concrete curing can increase the likelihood of cracking. If the cracking severity increases significantly, we recommend engaging a registered builder for further assessment and advice.

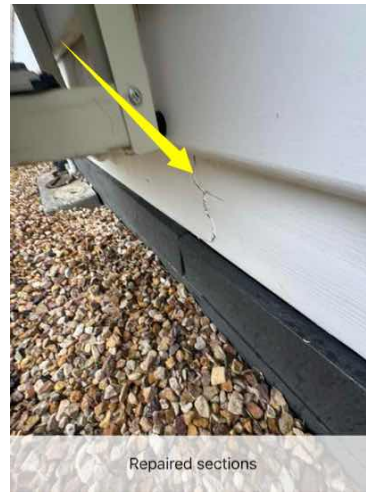
#10. Some wood rot/timber fungal decay was observed to timber components, which if left untreated can weaken the structural integrity of the affected elements and allow further deterioration; appropriate rectification requires removal and replacement of all rotten timber, treatment of remaining affected areas with a suitable fungicide, thorough drying and reinstatement of protective sealing or paint finishes to prevent recurrence. We recommend engaging a suitably qualified registered builder or carpenter and a qualified painter to further assess the extent of decay, provide quotations and carry out the necessary rectification and protective works.

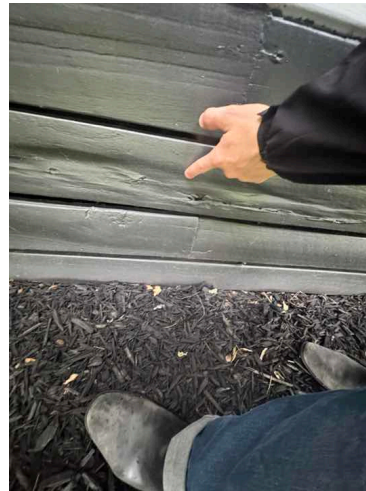
#11. Some base boards are affected with timber fungal decay (wood rot). We recommend to replace any deteriorating boards with a more durable material or treated timber, installed with appropriate gaps to allow for adequate subfloor ventilation.

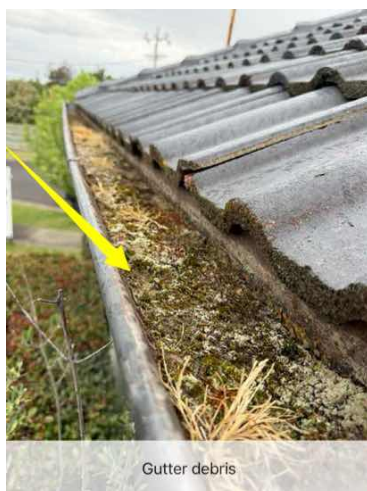
Gutter debris

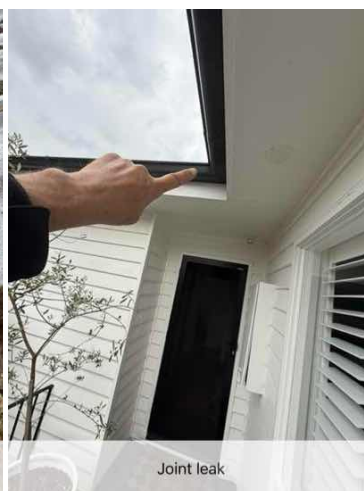
#15. Evidence of leaking gutter joints were observed, which can allow water outflow, moisture damage to fascia and eaves, and deterioration of adjacent building elements if not rectified. It is recommended that a suitably competent and qualified licensed plumber further assess the gutter joints, carry out sealing or repairs as required, and provide quotations for the necessary rectification works.

Joint leak

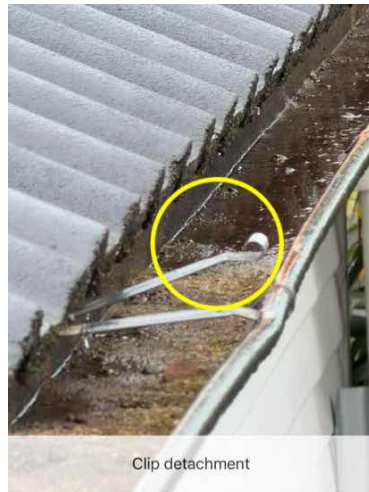
Clip detachment

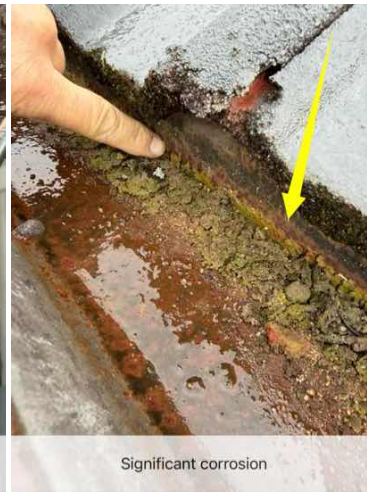
#16. Significant corrosion and rust were observed in sections of guttering. While repairs or treatment may be a temporary fix for surface rust, we recommend replacement for more severely rust-affected components as a safer long-term solution. In the near future, we recommend engaging a qualified roof plumber to further assess, repair or replace any affected guttering components.

Significant corrosion

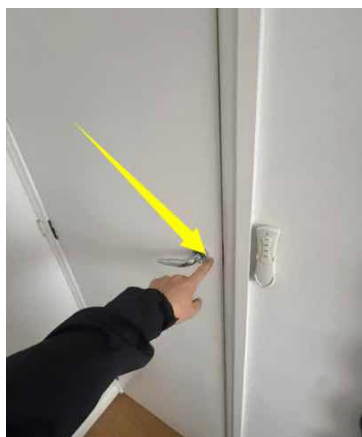
#17. The door was not latching correctly. We recommend engaging a carpenter for hinge, striker or striker plate adjustments.

Latching defect

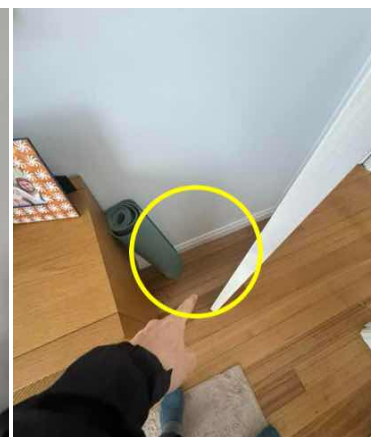
#18. Suitable door stops should to be installed to prevent associated impact damage at doorways. We recommend engaging a carpenter or handy person to install.

Door stops missing

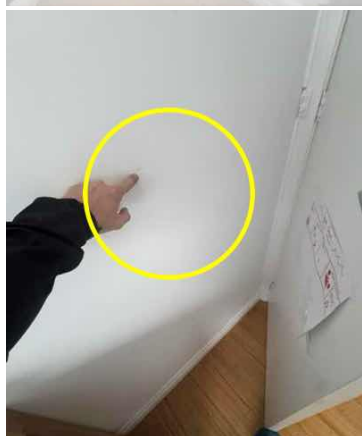
Impact damage

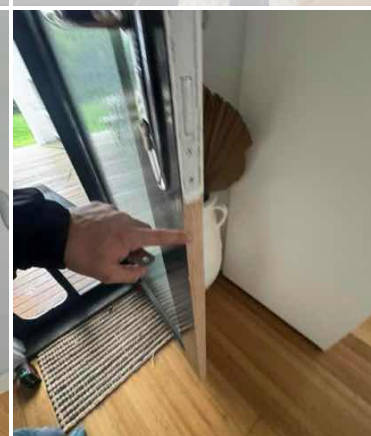
Incomplete paint

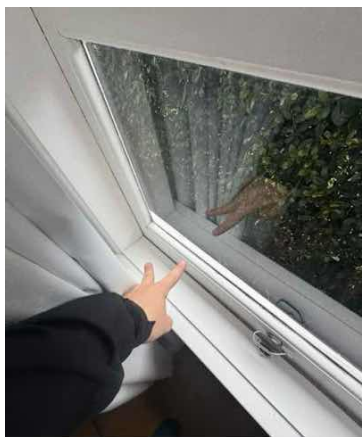
#19. Some windows were binding and difficult to operate. This can relate to; general wear and tear, excessive paint cover or home foundation movement. Seasonal effects can also cause intermittent binding. If binding persists contact a carpenter or window specialist to make required adjustments or repairs.

Some windows binding

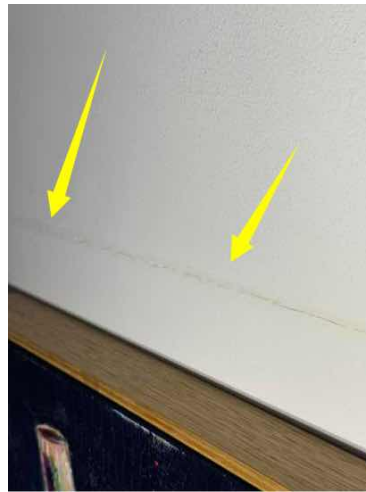
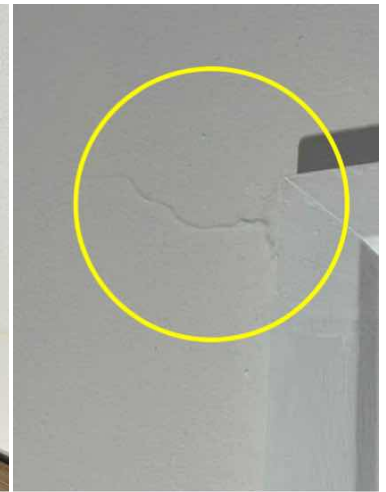
#20. Some minor settlement cracking and plastering and painting imperfections were observed to wall and ceiling linings. These conditions are generally consistent with normal ageing and typical building movement and appear within an expected range for a structure of this type and age. Minor cracking to internal linings is common where buildings experience movement, as plaster is a rigid material with limited flexibility and can crack when stresses from normal structural movement are released. In most cases, localised patching and repainting is sufficient to maintain appearance. Monitoring of crack locations is recommended and if cracking becomes wider, more pronounced or progressive over time, a suitably qualified building professional should be engaged to further assess and provide advice on any necessary repairs.

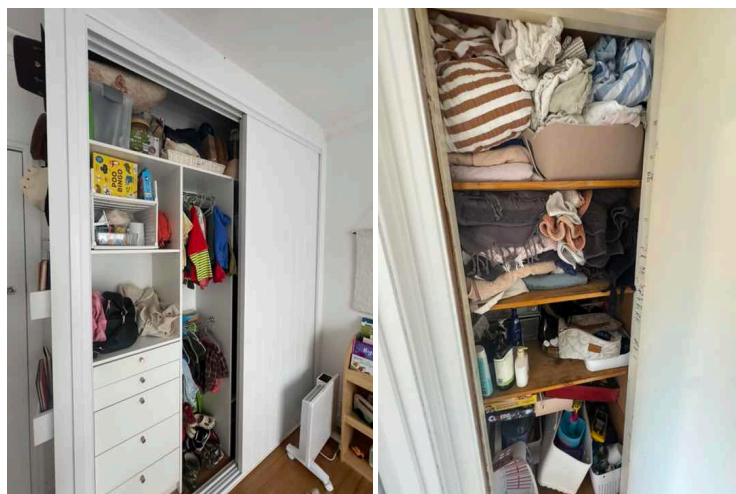
Loose handle

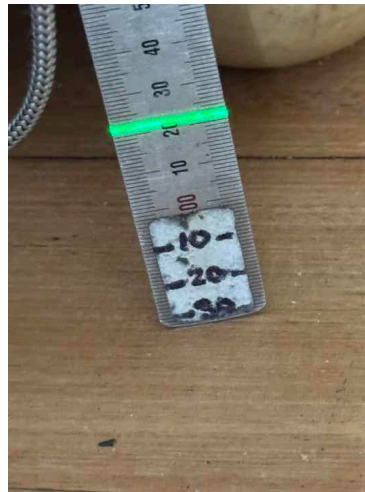
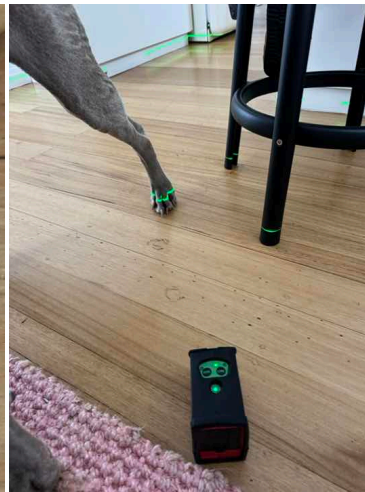
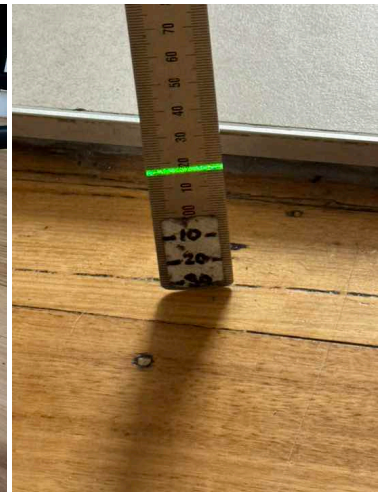
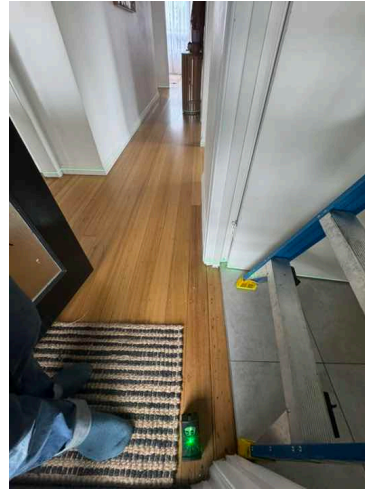
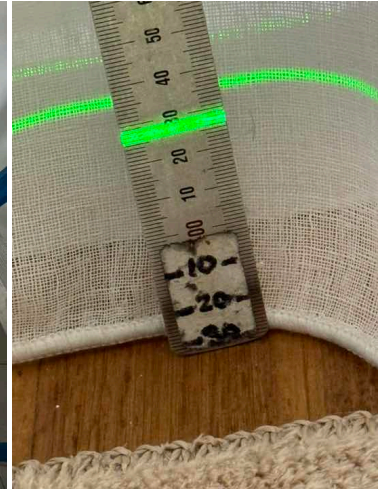
#21. Floor levels were measured to accessible areas and recorded a variance of approximately 40-45mm high to the fireplace area at the time of inspection. Variance of this magnitude is typically indicative of moderate building movement and should be regarded as a cautionary finding as it may reflect past or ongoing foundation movement, noting that observations are limited to conditions present at the time of inspection only. Contributing factors may include site drainage issues, moisture variation within foundation soils or leaking plumbing services, and if movement continues this may result in further distortion, cracking and reduced serviceability of the structure. It is recommended that site drainage is improved where required, all gutters and downpipes are checked to ensure adequate fall and discharge, and a licensed plumber is engaged to inspect for leaks including underground or subsoil services. Ongoing annual monitoring of floor levels is recommended and if increased variance, additional cracking or further movement becomes evident a suitably qualified structural engineer should be engaged to carry out further assessment and provide advice.

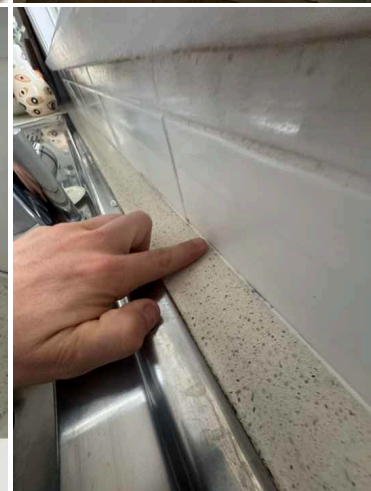
Sealant ageing

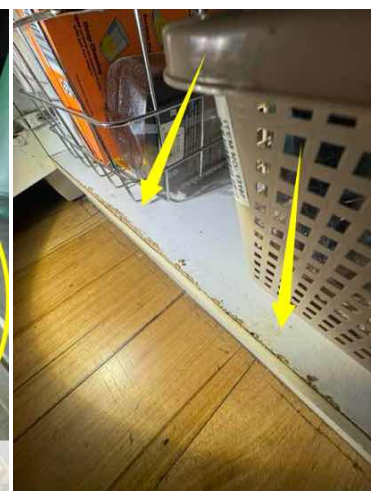
Evidence of previous water leakage was observed to cabinetry; while the area was dry at the time of inspection, ongoing moisture exposure may lead to deterioration, swelling, or mould growth if the source has not been fully resolved. It is recommended that the area be monitored and that a suitably qualified plumber and/or cabinet maker be engaged if further moisture is detected to confirm rectification and carry out any necessary repairs.

Evidence of previous leak

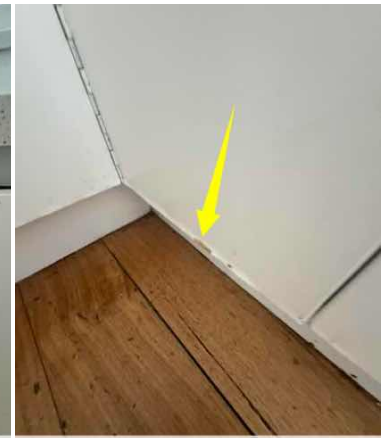
Cupboard doors would benefit from hinges alignment adjustments.

Doors binding and need adjustments

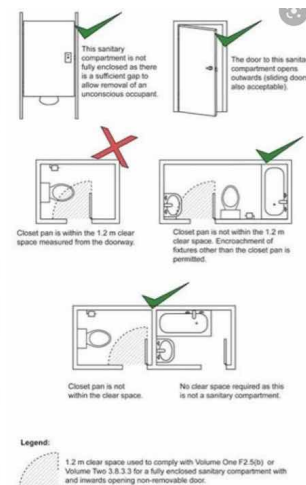
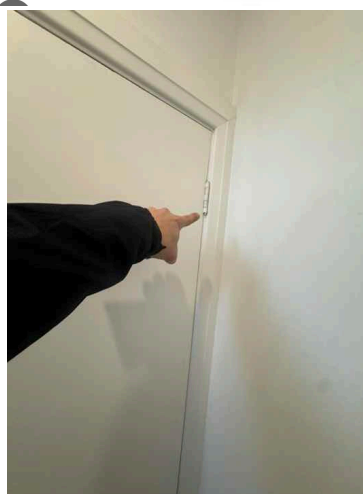
#23. SAFETY HAZARD. Safety hinges should be installed for safety reasons. The toilet is too close to the in-swinging door for regular hinges to be used. In rectifying, the top of the door may need to be trimmed to accommodate lift-off hinge operation. We recommend engaging a carpenter to rectify.

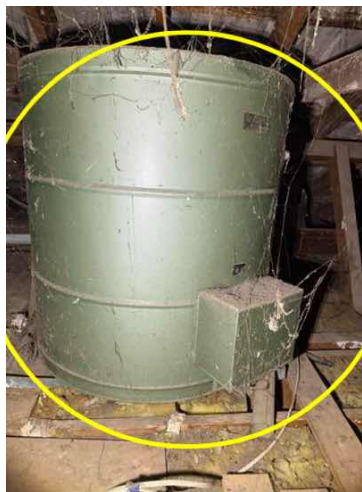
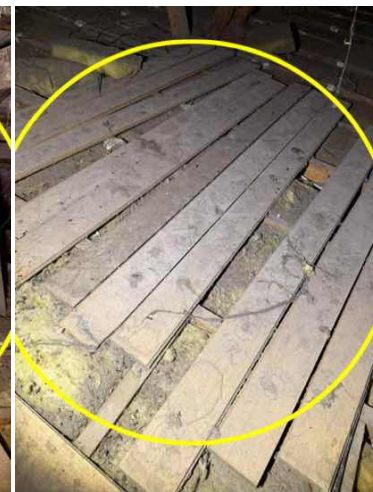
#24. Debris within the roof void obstructs the visual inspection and can harbour vermin. We recommend safely removing all debris.

The decommissioned hot water unit is an obstruction.

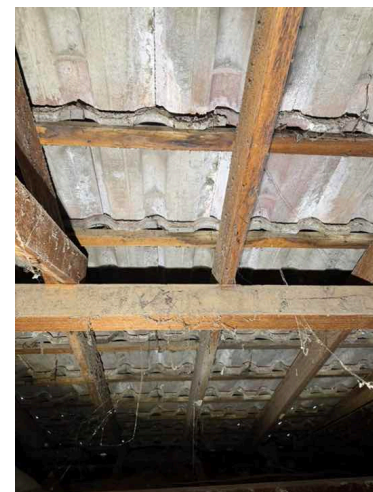
No sarking, sisilation or foil-wrap was observed under the roof cladding. Roof sarking is a pliable membrane that is positioned under the roof cladding during construction that is overlapped and rolled out parallel or perpendicular to the eaves. The over-lap must ensure that any storm-driven rain or condensation accumulation is directed down to guttering. Sarking is generally not mandatory however, it is considered beneficial for a few reasons. Sarking provides a vapour barrier that improves thermal performance while restricting wind and dust ingress into the roof void. A bushfire ember attack is also reduced if sarking has been installed. Retrospectively installing sarking is not practical as the roof covering needs to be removed to do so.

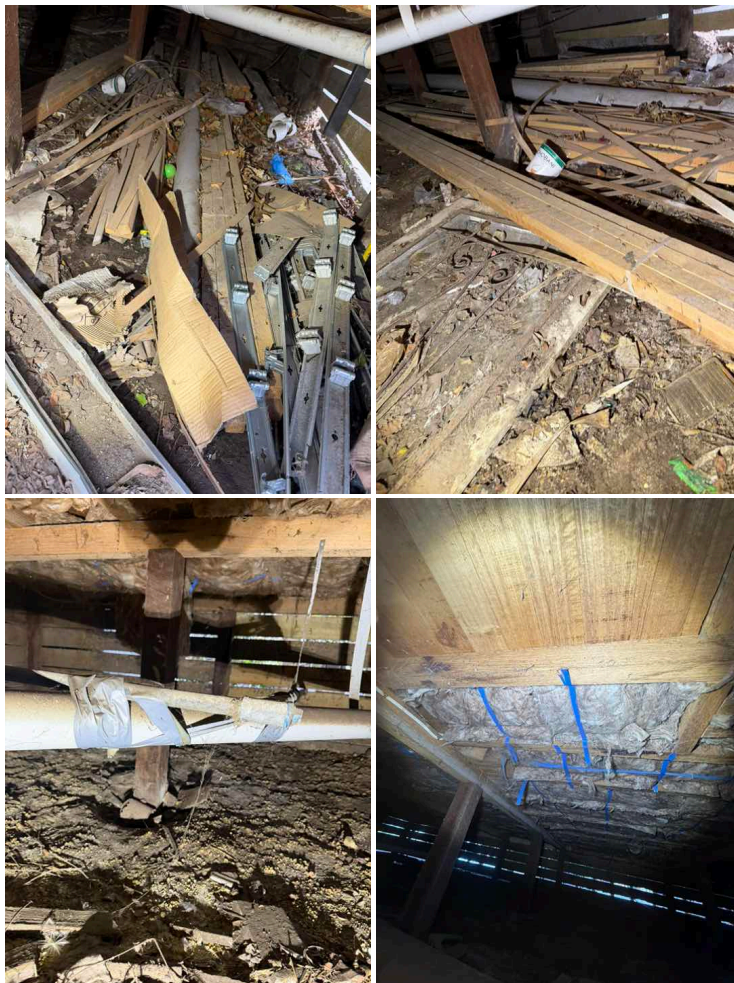
Plumbing pipes restricted access to some areas. Under floor insulation obstructed full visual inspection to the underside of flooring and sections of the adjacent framing.

There was physically restricted access to areas obstructed by debris.

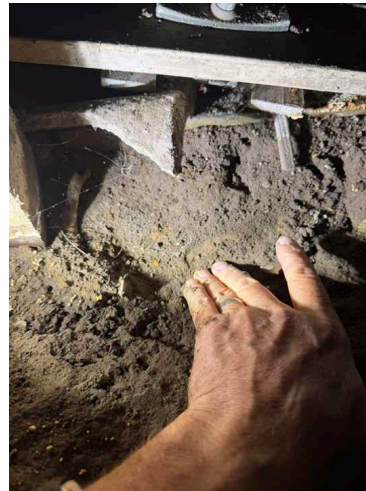
#29. Dampness was observed in the subfloor soil, which if not minimised can negatively impact the structural integrity of the building by weakening masonry components, footings and foundations, and by creating conditions conducive to timber pest activity and fungal timber decay (wood rot) in timber elements. It is recommended that a suitably competent and qualified builder, drainage contractor, or licensed plumber further assess contributing factors such as surface water drainage, plumbing leaks, and subfloor ventilation, implement appropriate moisture management measures, and provide quotations for the required rectification works.

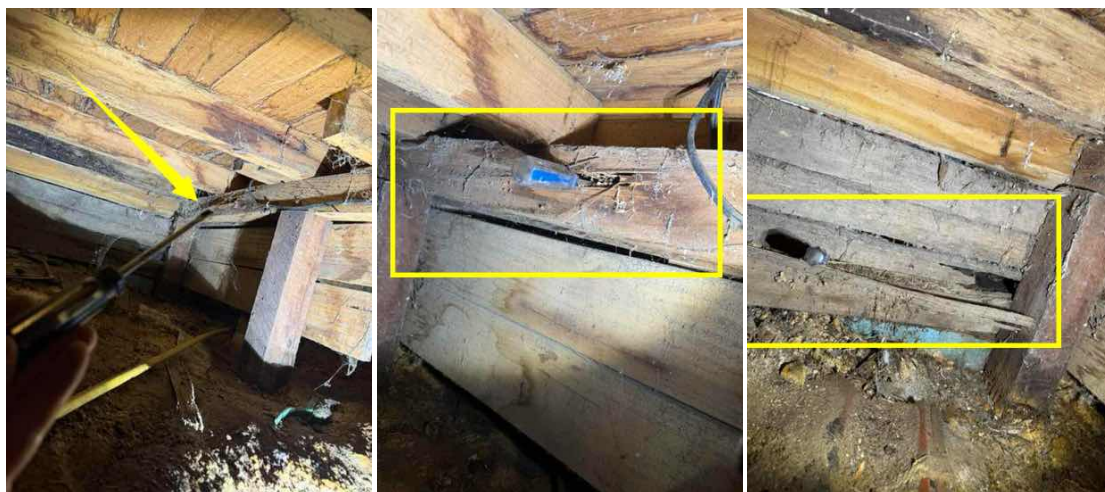
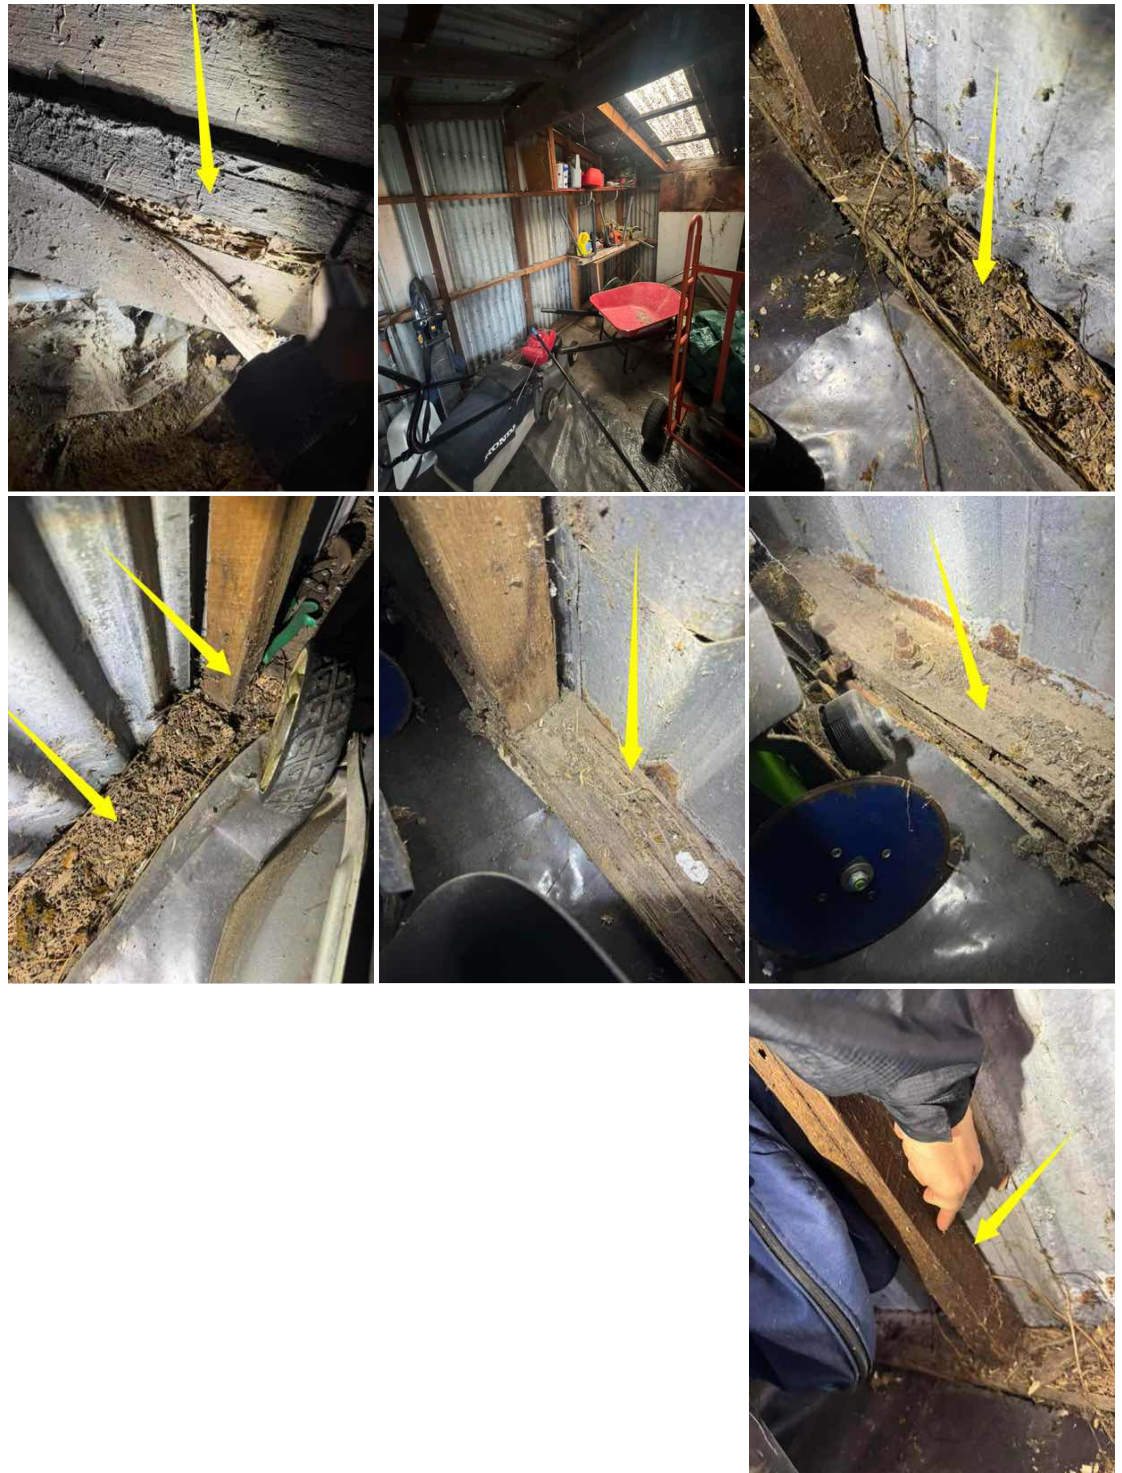
- Subfloor bearers
- Shed bottom plate and studs

No the visible detected damage does not currently present as a safety hazard however further investigation is recommended.

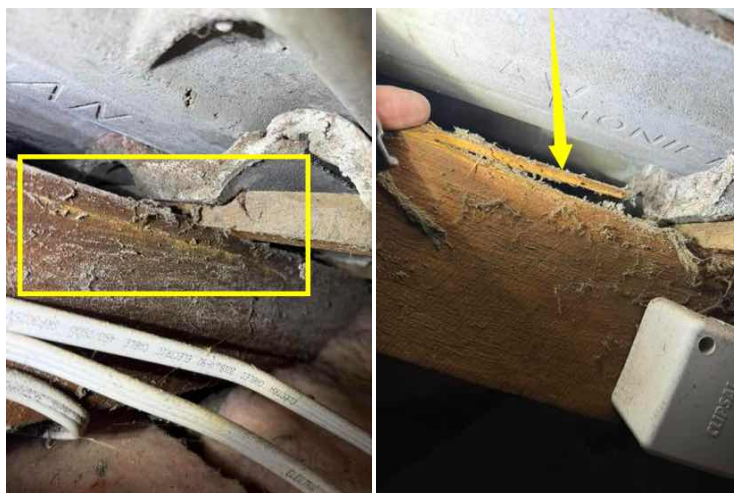
- Roof framing timbers

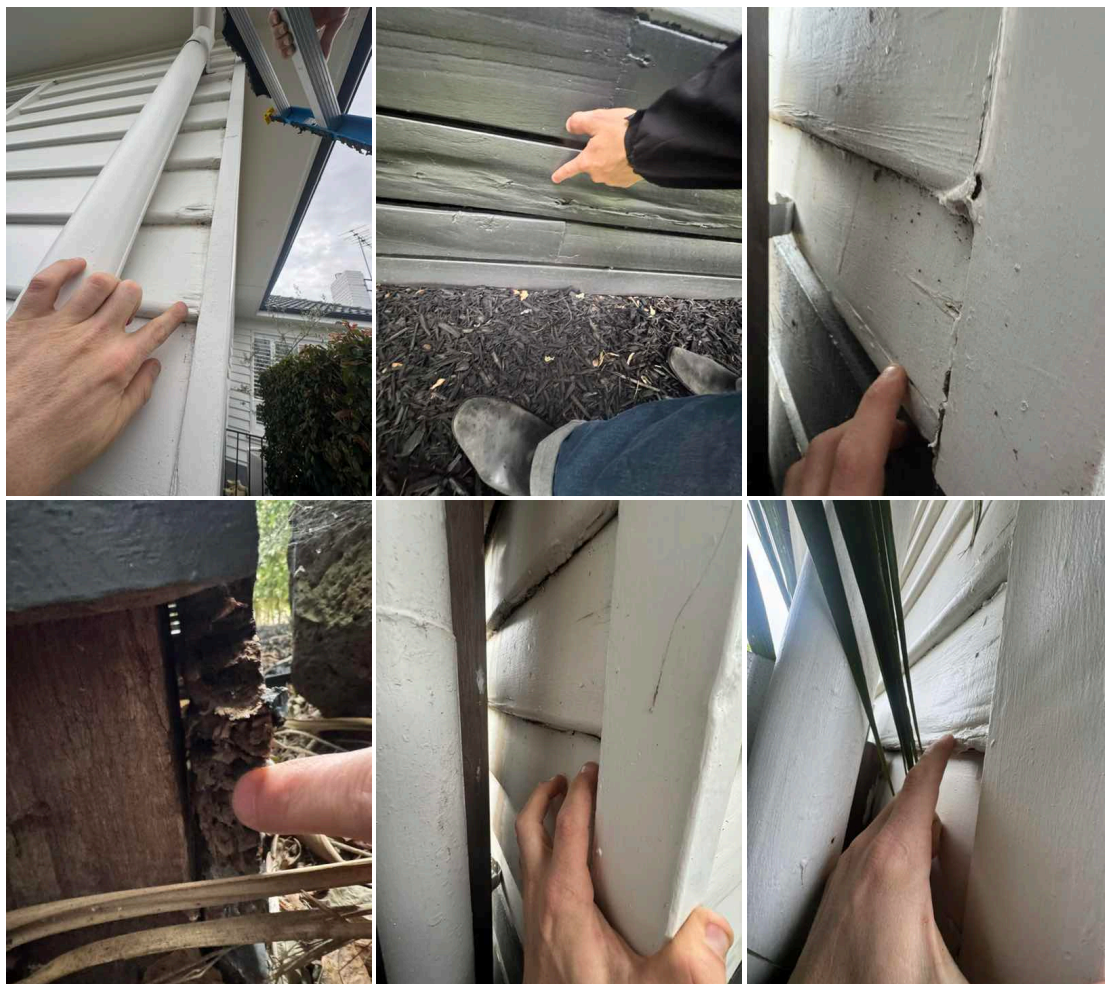
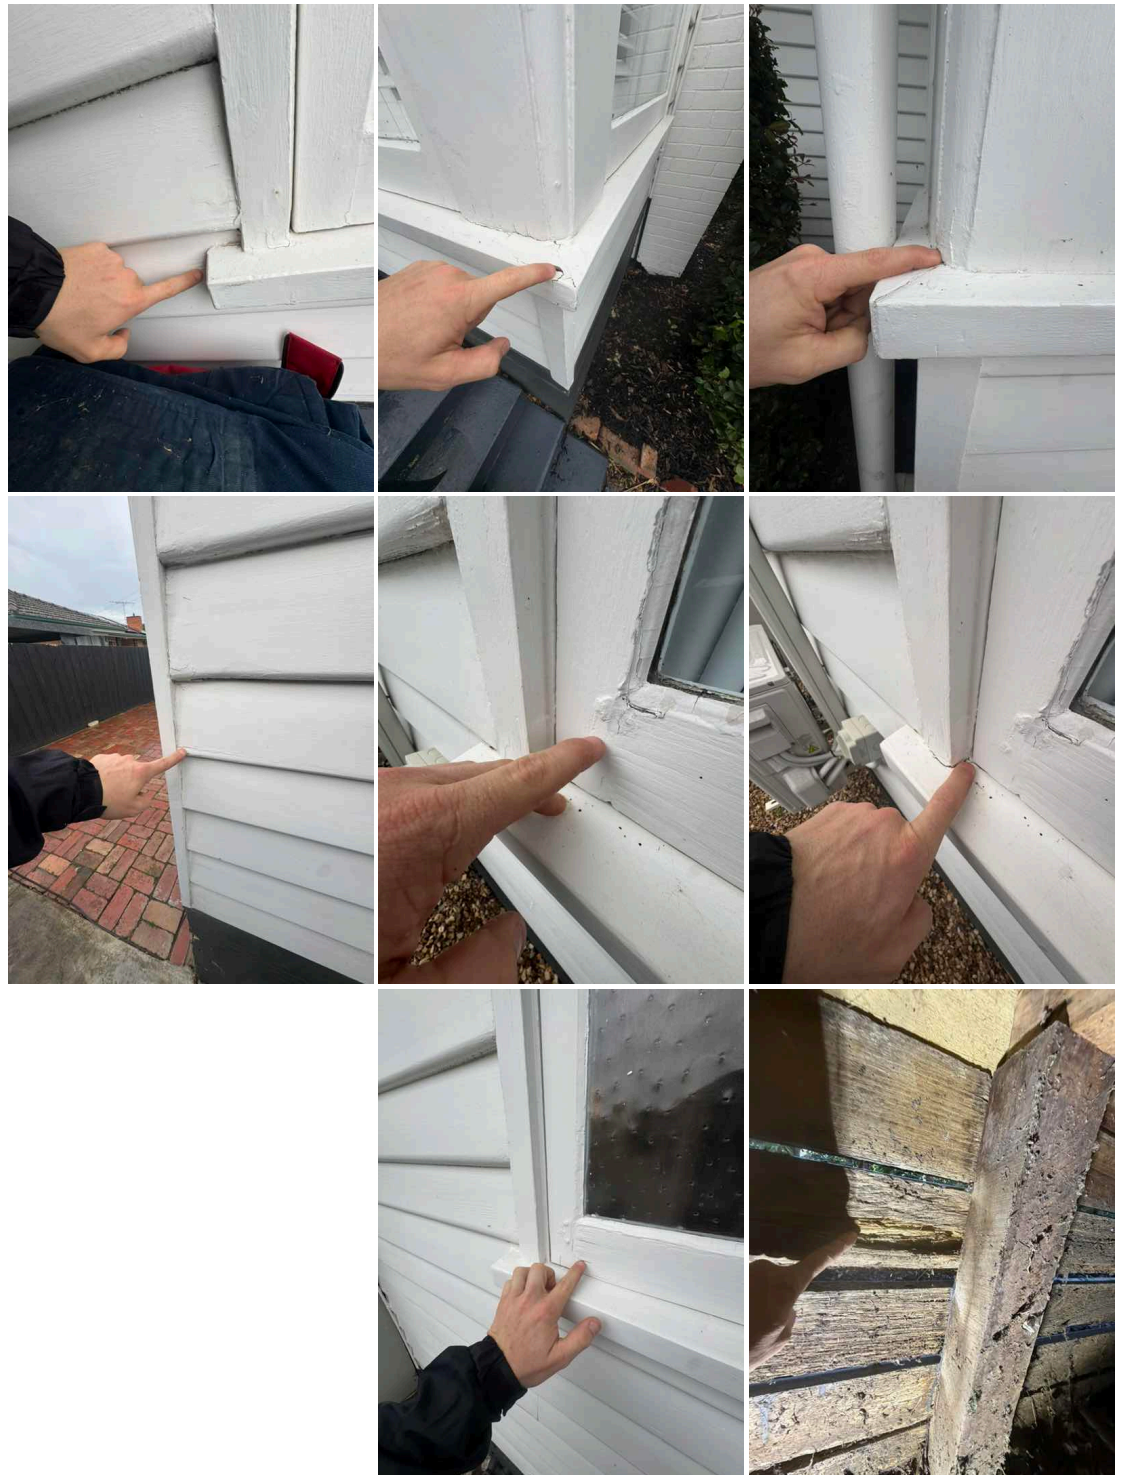
- Baseboards
- External wall cladding
- Windows

**Worst extent of damage caused by Wood Rot:**  
Minor non-structural damage.

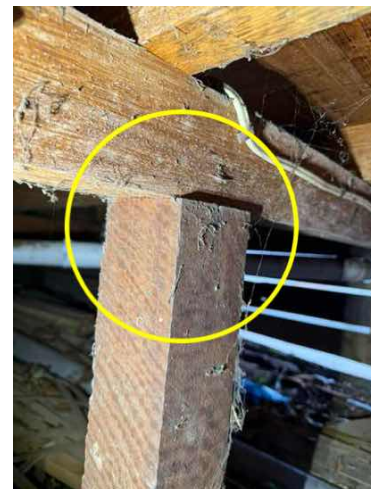
Inadequate due to missing stump caps.

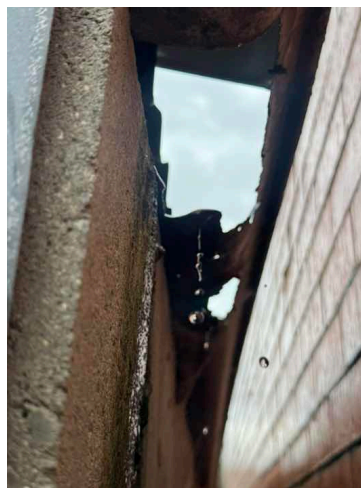
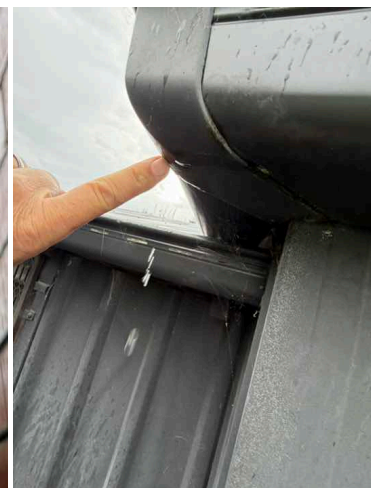
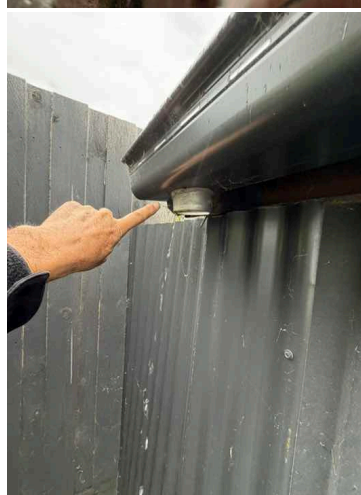
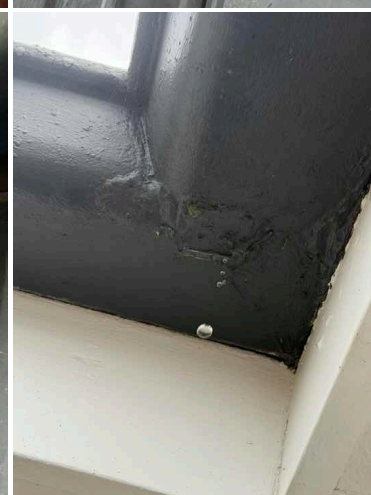
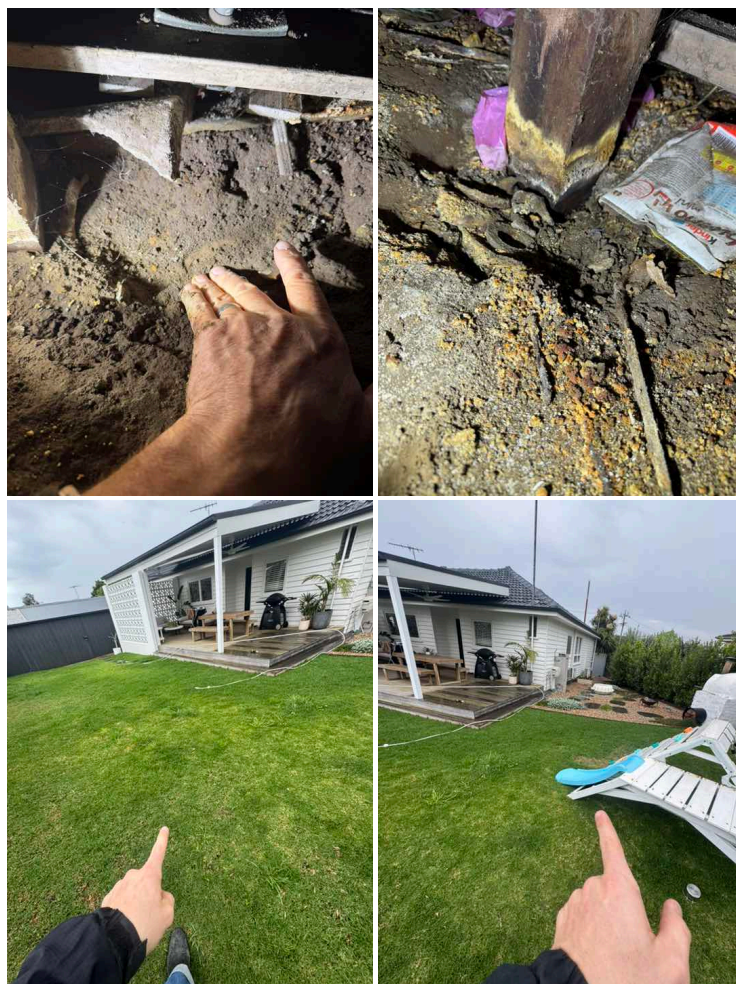
- Guttering defect(s)
- Downpipe defect(s)
- Site surface water management and drainage issues
- Subfloor soil dampness

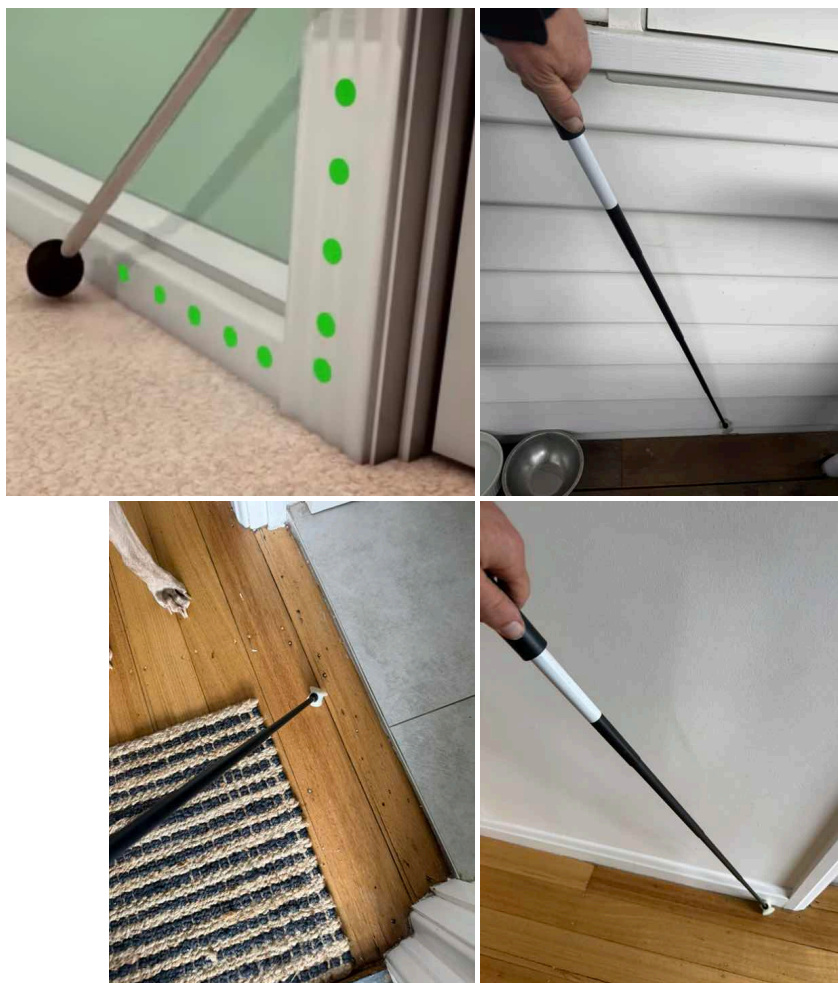
**HIGH:** Having regard to access limitations, inspection obstructions and the observed conducive conditions at the property, the assessed level of potential undetected timber pest activity is considered to be high at the time of inspection. The non-invasive visual inspection was supplemented by non-marking percussion (sounding) testing of timber components and digital moisture meter readings to typical and areas of concern. These detection methods are limited in nature and are inferior to invasive or destructive inspection techniques. It should also be noted that in some localities, properties may inherently be subject to a high relative timber pest risk irrespective of visible evidence at the time of inspection. Extensive non-invasive percussion (sounding) testing of accessible timber components was undertaken to assist in identifying potential concealed termite damage within inspected building structures and components, within the defined property inspection boundaries

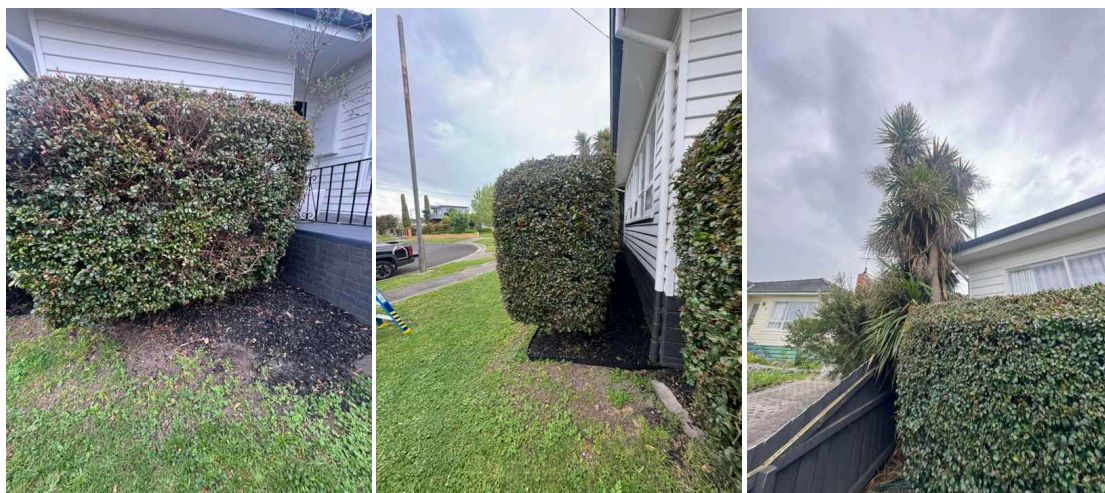
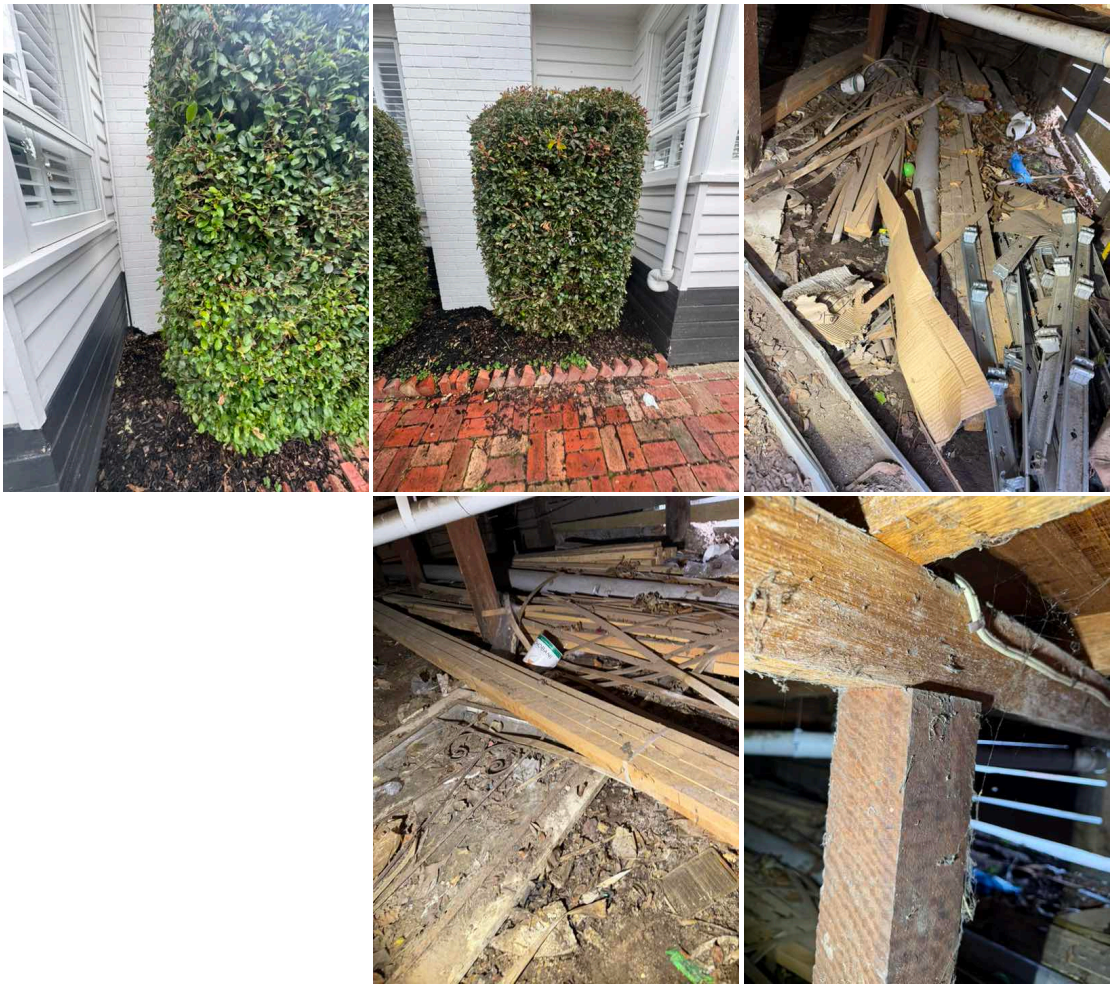
## Issues Found Conducive To Timber Pest Activity

- Employ methods to decrease dampness observed to the subfloor soil such as improving site drainage and increasing subfloor ventilation.
- Timber stumps are recommended to be upgraded to concrete stumps with termite repelling ant caps.

- Replace damaged or missing termite shields and ant capping to allow easier detection of termite activity and increase protection of subfloor timbers. Ant capping aims to prevent concealed termite entry by forcing the termites to build mud tunnels around the visible sections of the ant capping enabling visual detection. Ant Capping will not prevent the entry of termites into a structure however, correctly fitted ant caps will assist in early detection.
