**THE  
BUILDING  
AGENCY NSW**

# **Pre Inspection Building And Timber Pest Report**

**Inspection Date: 17 Jun 2026**

Property Address: 8 Coringle Place Woodcroft 2767

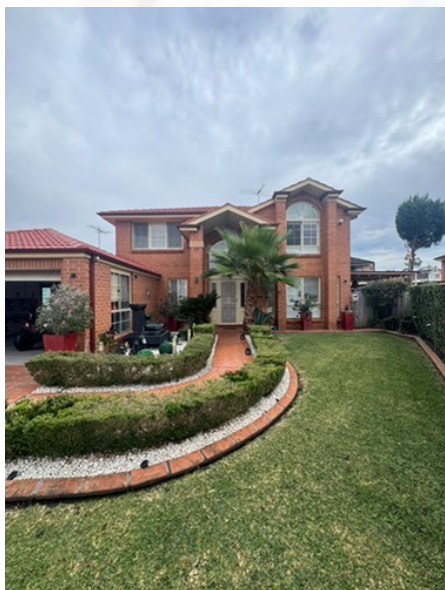
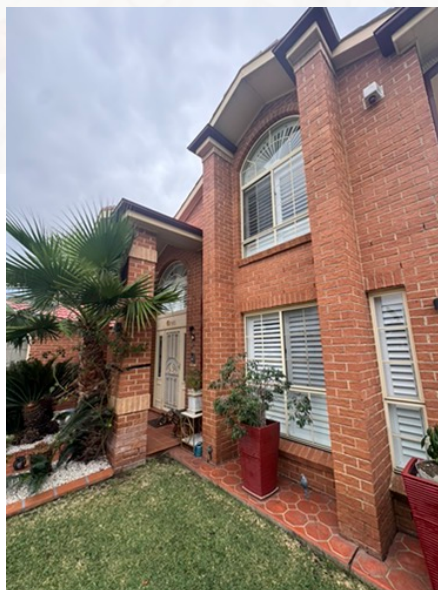
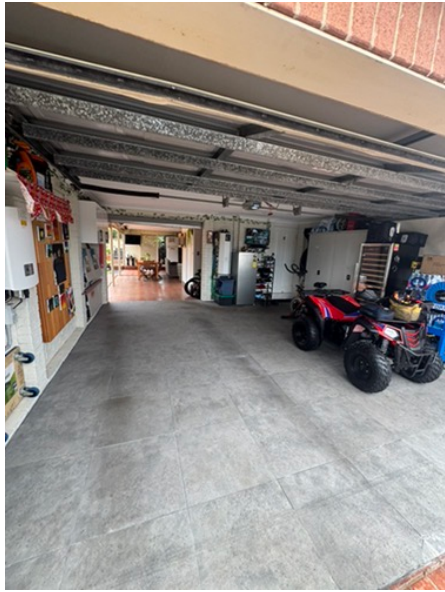
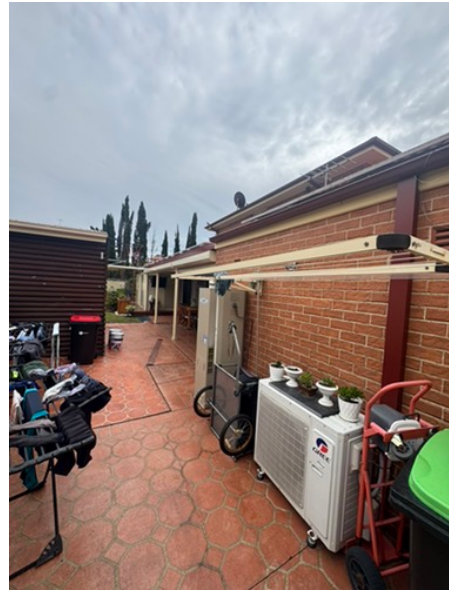
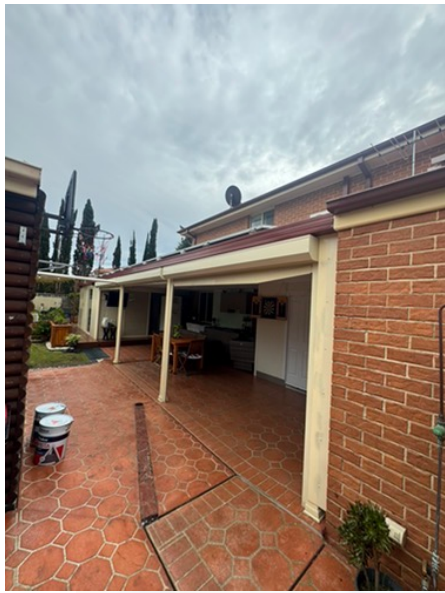
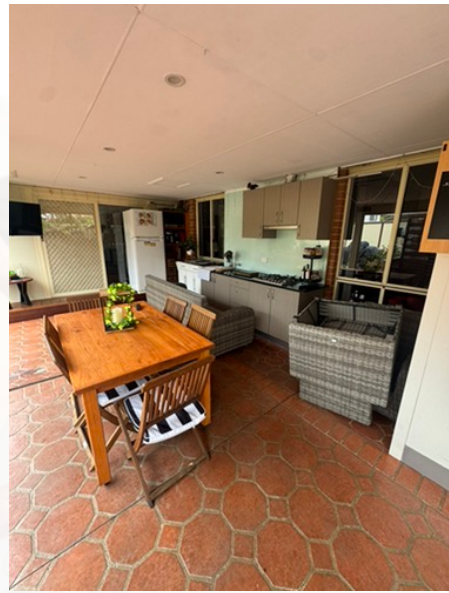
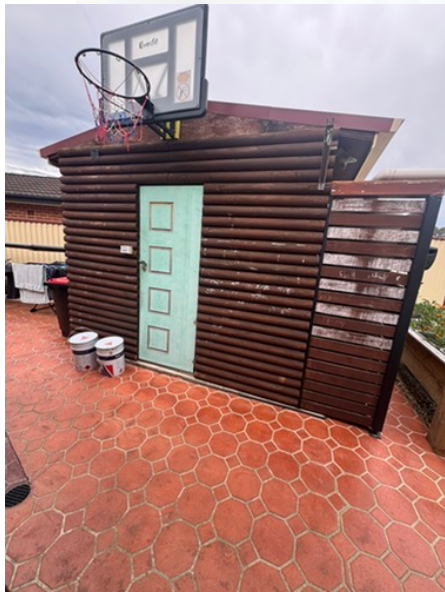
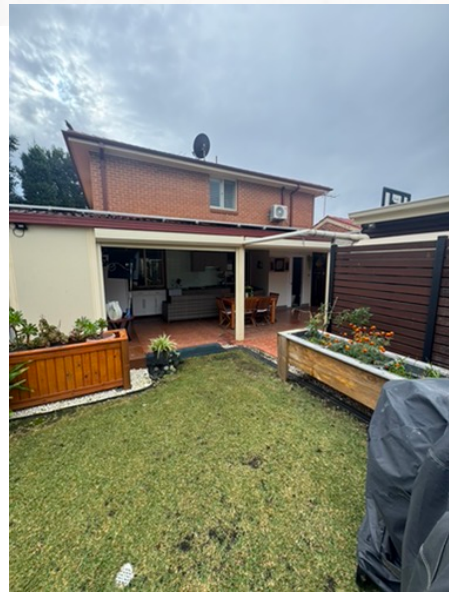
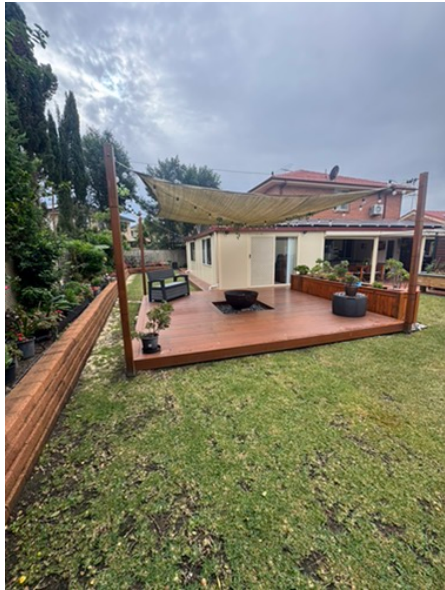
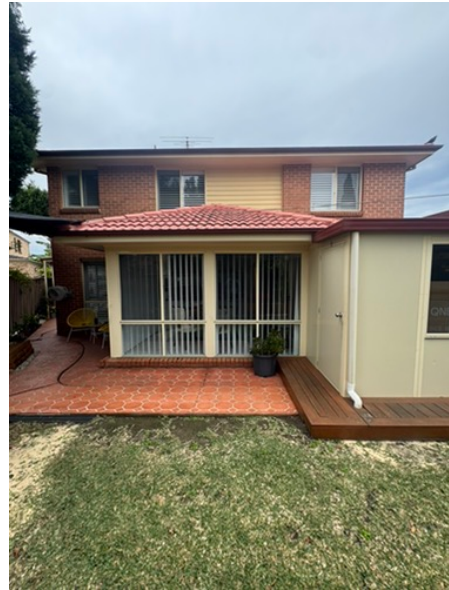
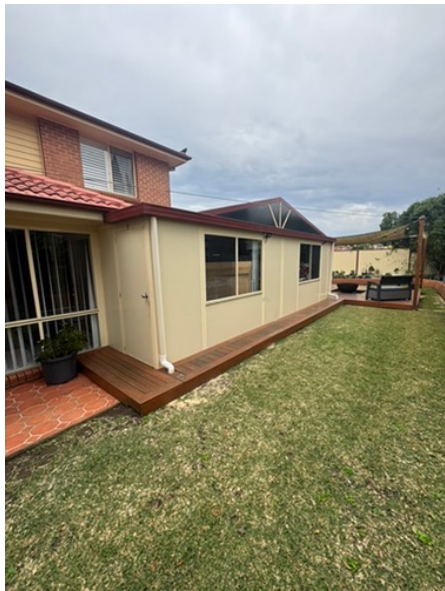
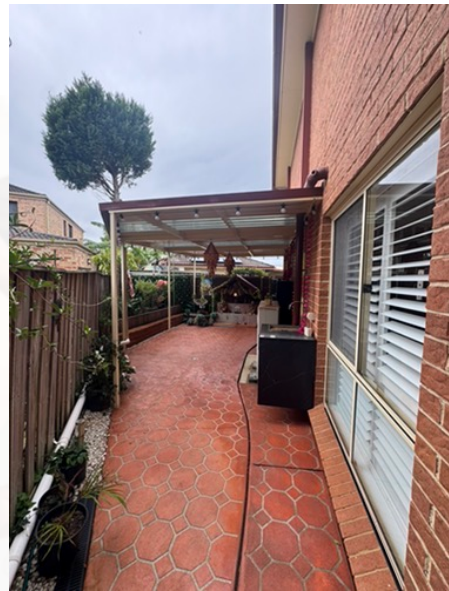
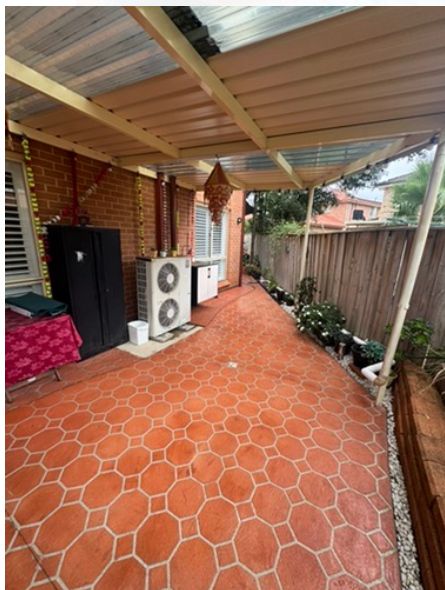
During a comprehensive inspection of the property's external areas conducted at ground level, a thorough assessment of all visible exterior components was performed. The evaluation included the exterior walls, gutters, downpipes, windows, doors, driveway, pathways, fencing, gates, landscaping, and exterior paint finishes. Additionally, whatever could be observed of the roof from the ground level was also examined.

The inspection aimed to identify any apparent minor and major defects affecting the integrity and aesthetic appeal of the property's exterior. As this was a visual inspection, the identification of issues was limited to those areas that were clearly observable and accessible. Any anomalies or imperfections detected during this process will be comprehensively outlined in the subsequent report, thereby equipping prospective buyers with the necessary information to make an informed decision regarding the property's condition and potential need for repairs or maintenance. It is paramount for potential purchasers to carefully review this report to understand all current and potential issues, thereby safeguarding their investment in the property.

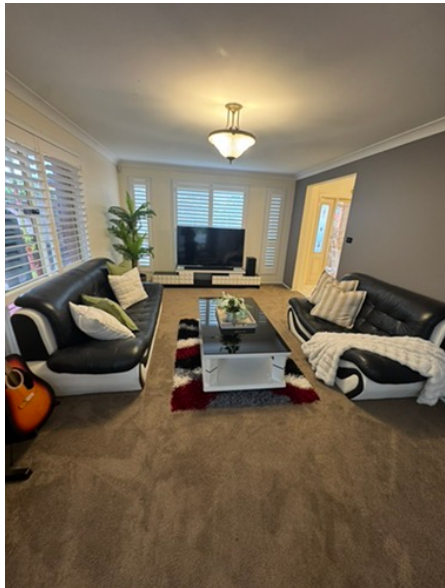
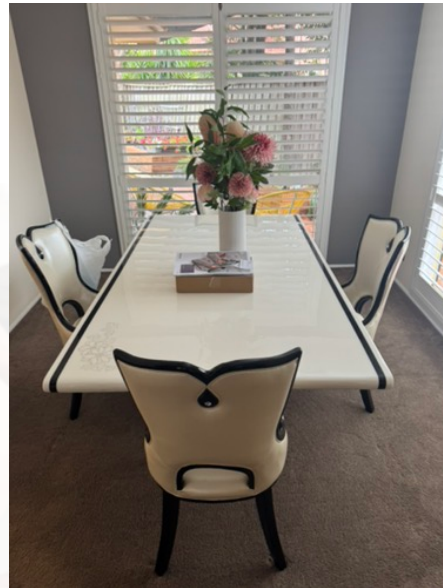
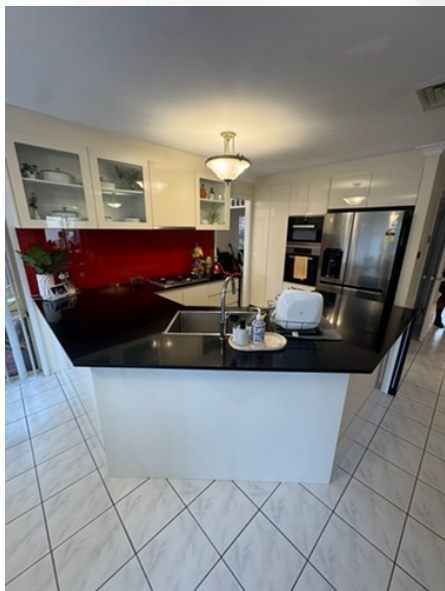
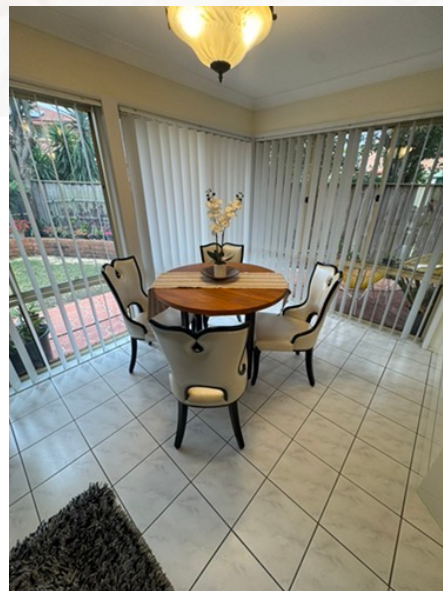
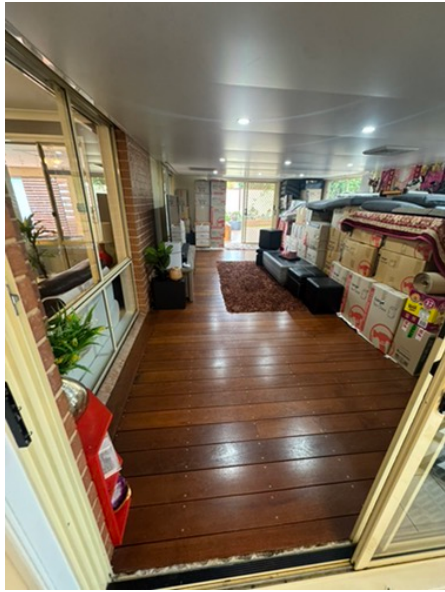
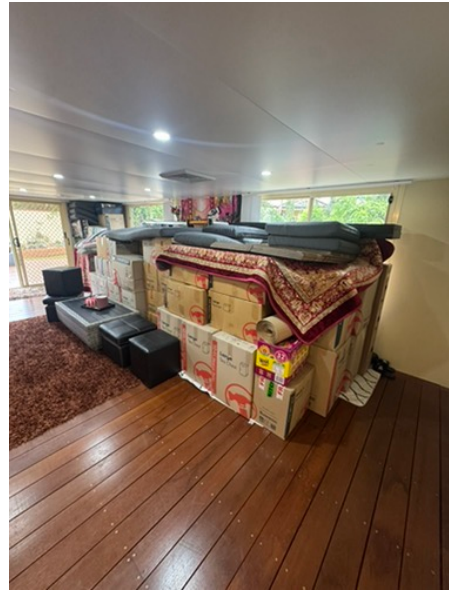
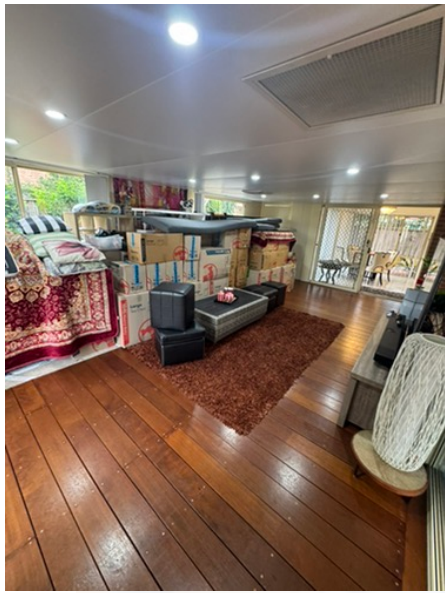
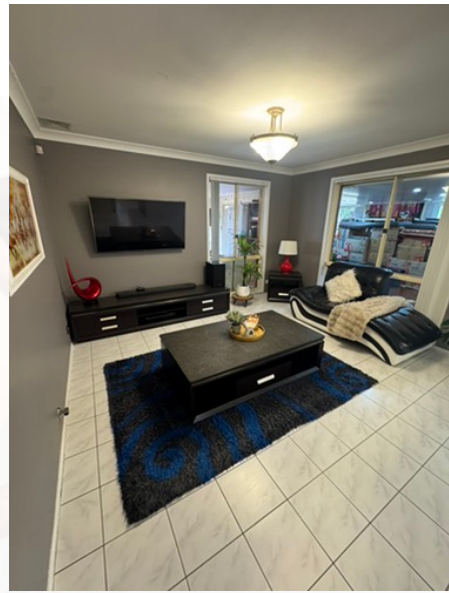
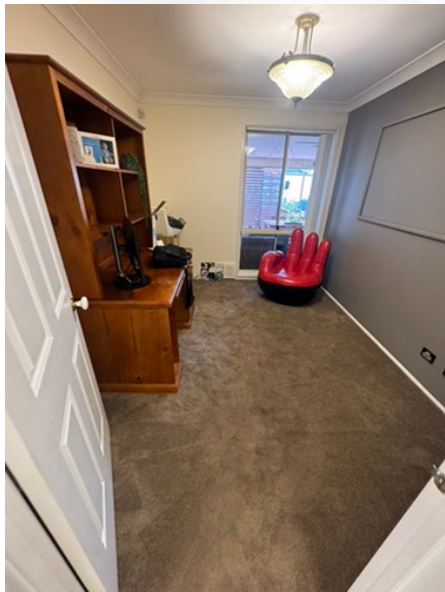
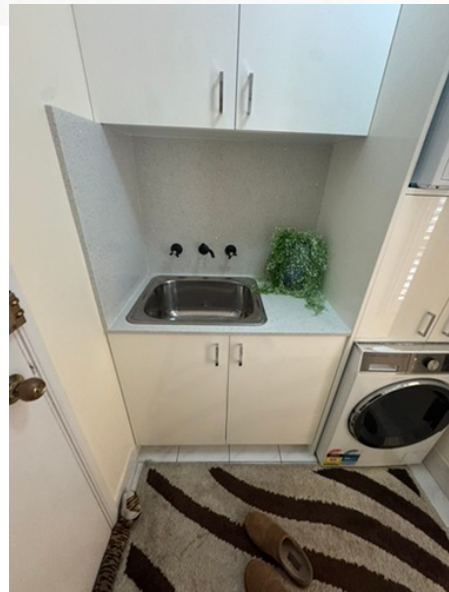
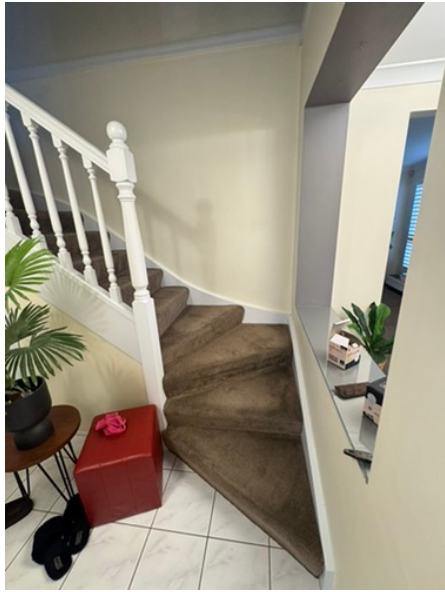
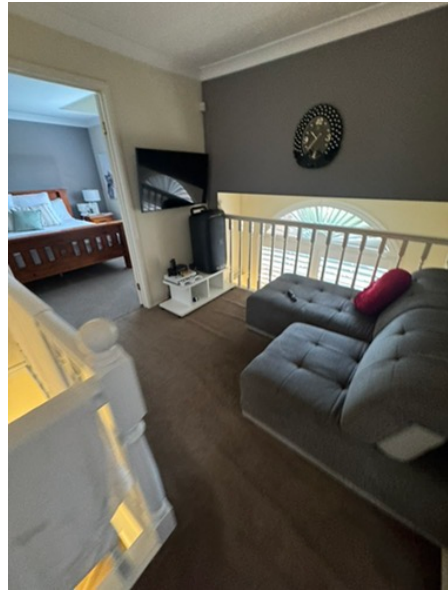
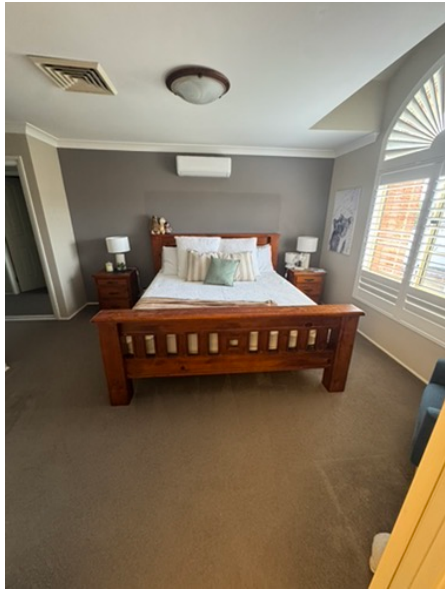
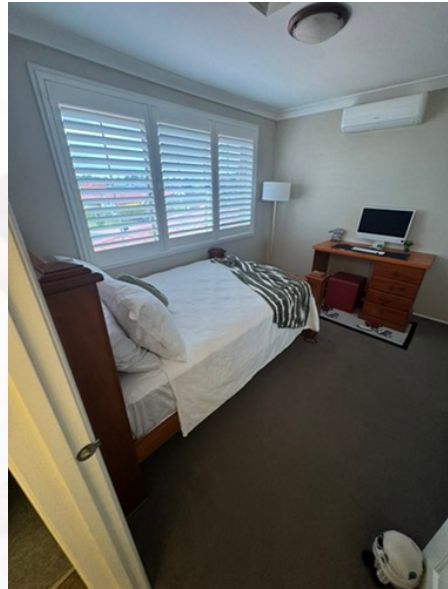
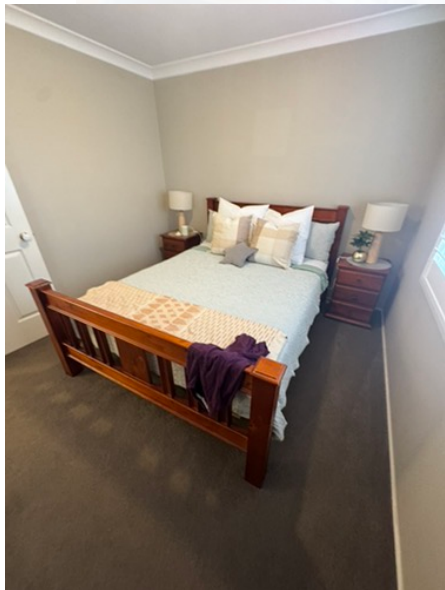
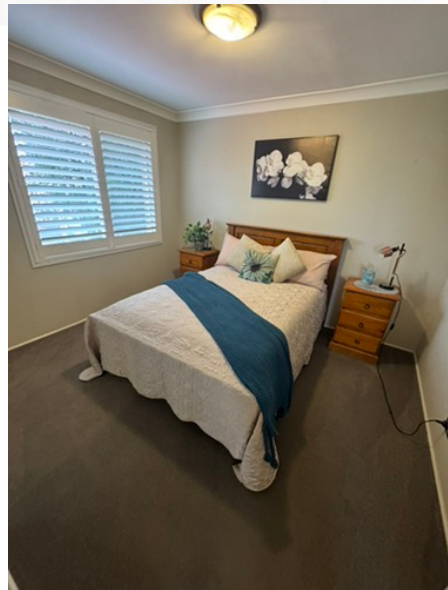
**Location:** All Internal Areas

Upon inspection of the internal areas of the residence, a comprehensive assessment was conducted to identify any visible defects or issues that may impact the dwelling. The inspection encompassed all internal areas, with a meticulous evaluation of potential defects such as visible cracks, water damage, and overall structural integrity. Specific attention was given to the condition of walls and floors, as well as the presence of water hammer or any other safety concerns that might compromise the inhabitants' well-being.

It is important to note that if no significant defects are identified during the inspection, regular maintenance and periodic checks are recommended to ensure the continued condition and safety of the property.
