RESIDENTIAL BUILDING REPORT

Complies with Australian Standard AS 4349.1-2007- Inspection of Buildings
Part 1: Pre-Purchase Inspections - Residential Buildings

Property Address: 12 TANTANGARA PL - WOODCROFT

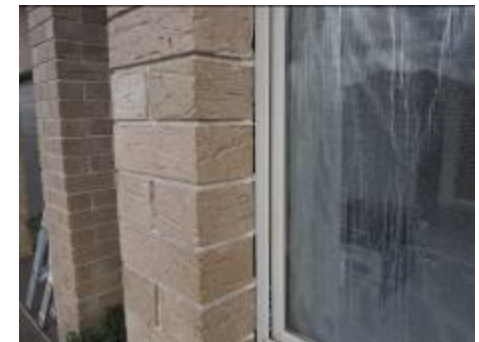
Fig 11

2.6 Steps		Tolerable.	* Handrails are required were a person has the potential to fall one meter or more.
2.7 Balconies, Verandah, Patios, Decks, suspended concrete floors, balustrades.	Verandah Alfresco	Repatch the damaged ceiling hole most likely due to the relocated camera. No significant defects were noted at the time of the inspection.	Fig 11. Fig 29

<u>Where is the Cracked Area?</u>	<u>Detailed Photo of Crack</u>	<u>Width and Length of Crack</u>
Concrete Slab		
Suspended Concrete		
Masonry/rendered wall/Column		
Timber - Building Elements	Fig 11, 37-40,45,64,65,73.	< 1 mm
Paths/Driveway/Paving/Step	Fig 19-21,	> 1 mm
Fences/flower bed/Retaining Walls	Fig 23-28
