RES - Mould Remediation Report - 52 Ure St Hendra QLD 4011

Laundry Leak (Now Repaired)

Room Notes: Work Completed**Work Complete Mould Remediation 11/2/26**

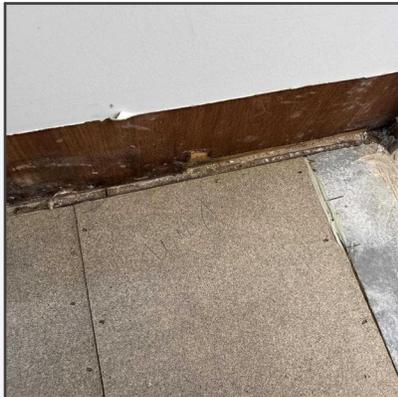
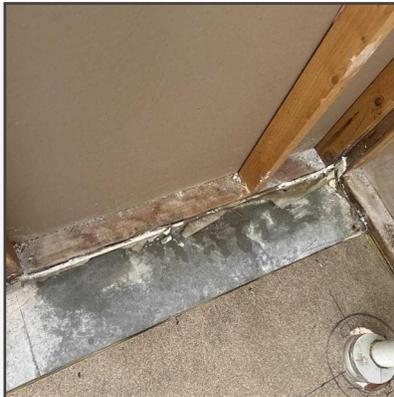
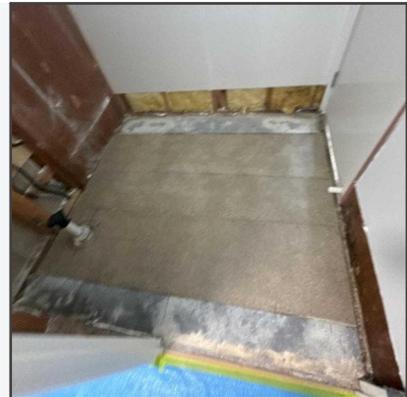
A previous leak from the laundry pipe caused moisture build-up and mould development underneath the house. The area is currently undergoing renovation, and the leak has been repaired.

Given that it's the subfloor, we used abrasive cleaning, and followed up by encapsulation using IAQ 6000 fibrelock mould resistant paint to encapsulate any residues.

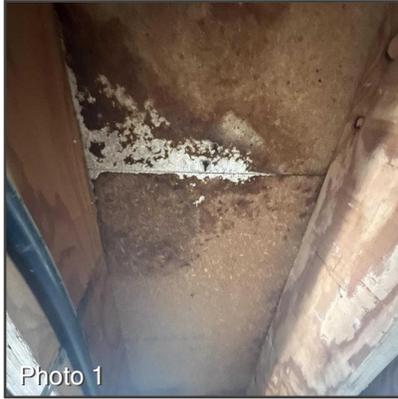
Photo 1

We conducted an inspection regarding mould remediation. The client explained that the water leak caused mould growth on the subfloor. The top area will be sealed with water proofing however under the house requires cleaning.
