# Pre-Sale Building & Timber Pest Inspection Report

37 Webster Ave, Hendra QLD, Australia

09 Jan 2026

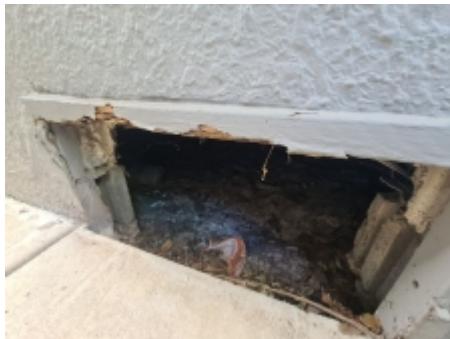
### Obstruction Photos

It is important to note that as an inspection of the above areas was not possible at the time of the inspection, defects, timber pest activity or damage may therefore exist in these areas.

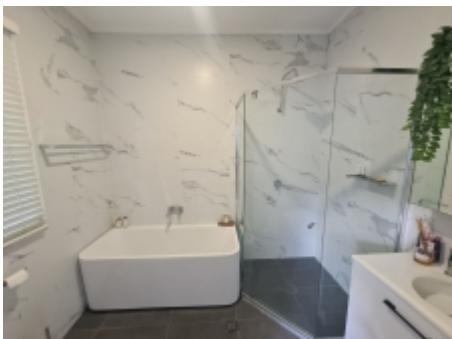
**Bathroom**

Minor Defect

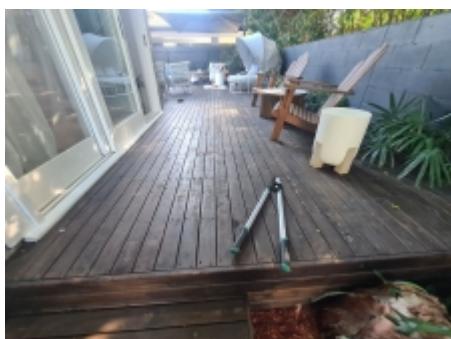
## Right side Deck

No access point found for subfloor to deck

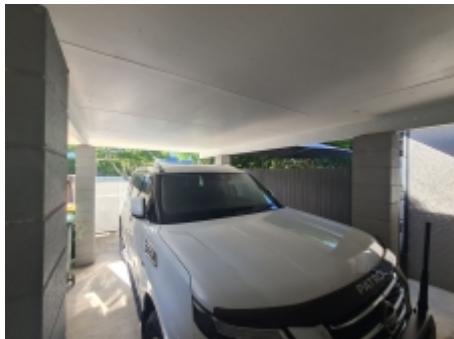
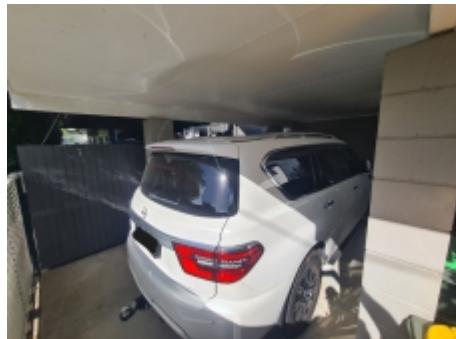
## Carport

4WD parked in carport at time of inspection

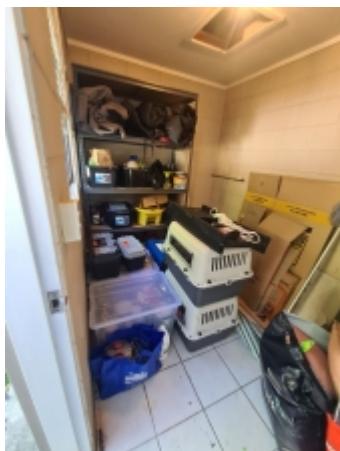
## Outside Laundry

Laundry attached to carport  
Laundry was heavily stored at time of inspection

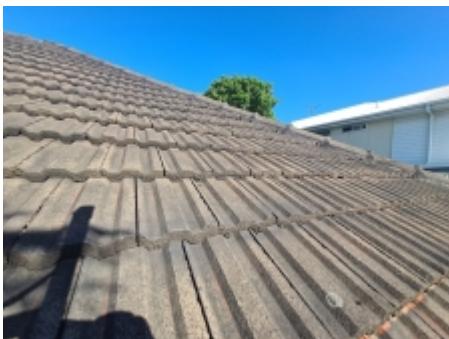
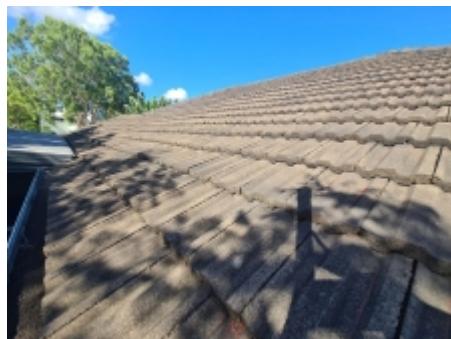
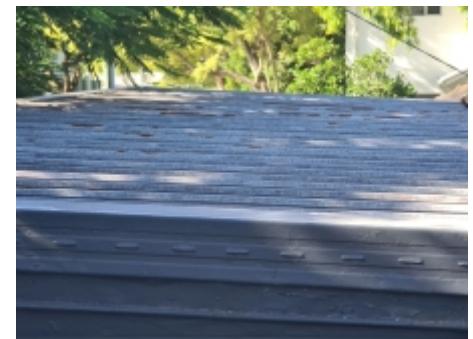
### Pitch too steep to allow safe access

Due height restrictions and the steep pitch of the roof a full inspection could not be conducted  
Recommend to have roof looked over by a licensed roofer

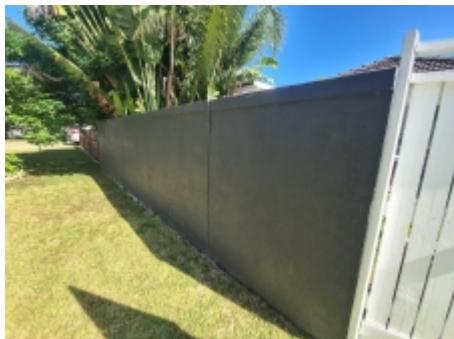
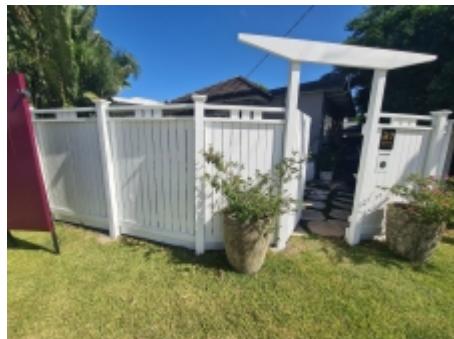
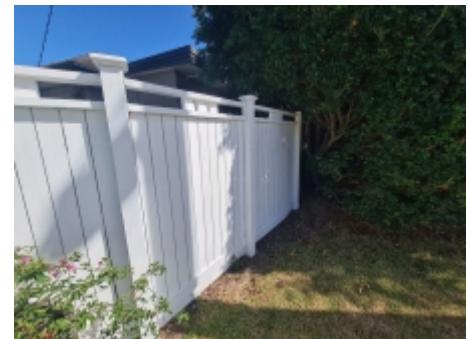
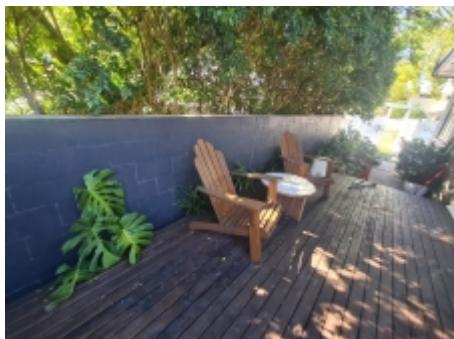
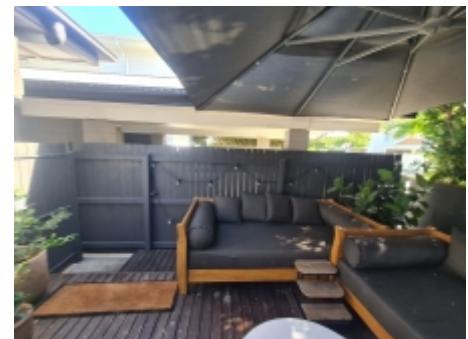
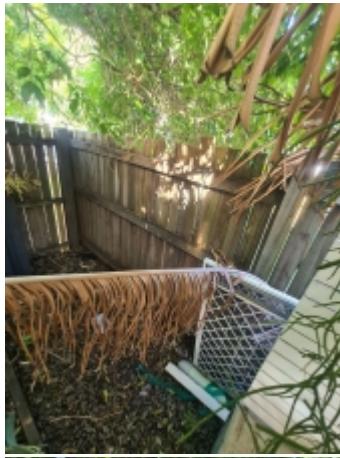
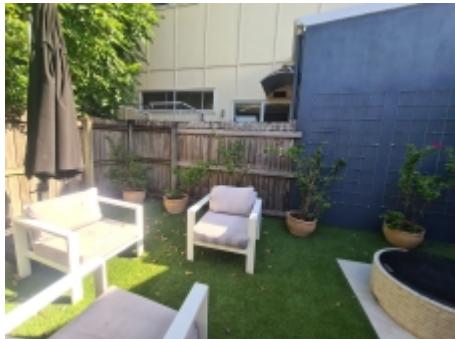
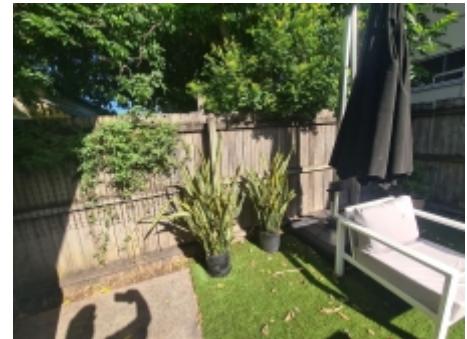
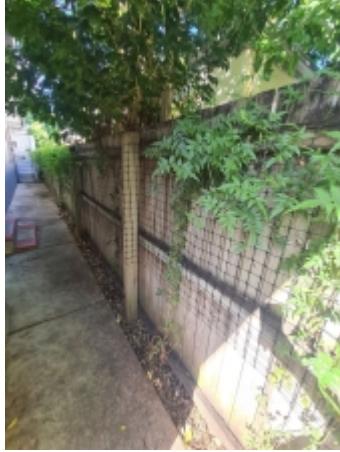
Site Area Photo

Defect Severity	<span style="background-color: green; width: 10px; height: 10px; display: inline-block;"></span> Minor Defect
Comment	Cracking to masonry block fence. Front

Defect Severity	<span style="background-color: green; width: 10px; height: 10px; display: inline-block;"></span> Minor Defect
Comment	Dislodged render from movement at control join. Front

Cracking to masonry block fence. Right side
