Pre-Sale Building & Timber Pest Inspection Report

2 Mikado Street Hamilton 4007 Queensland Australia

19 Dec 2025

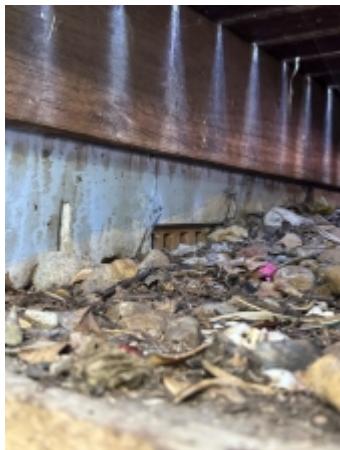
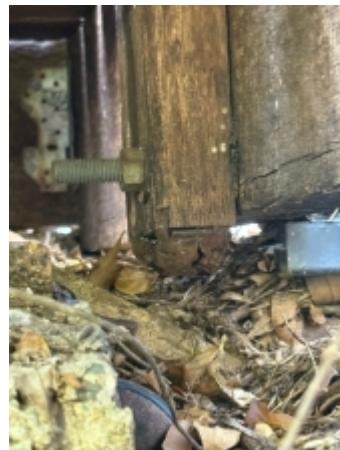
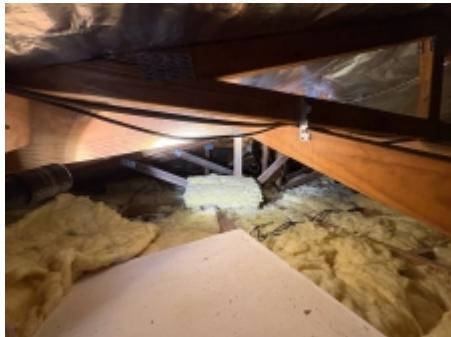
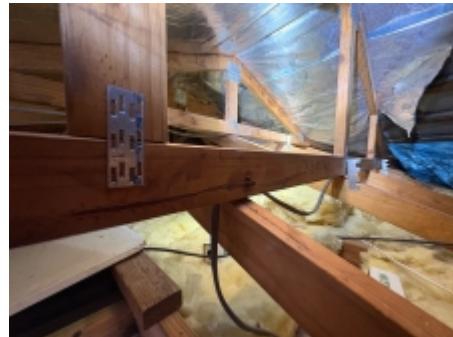
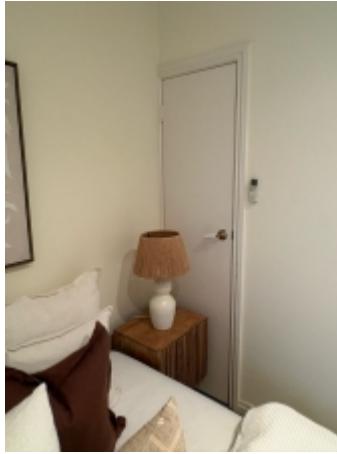
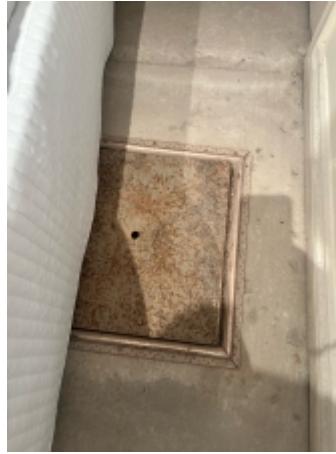
Obstruction Photos

It is important to note that as an inspection of the above areas was not possible at the time of the inspection, defects, timber pest activity or damage may therefore exist in these areas.

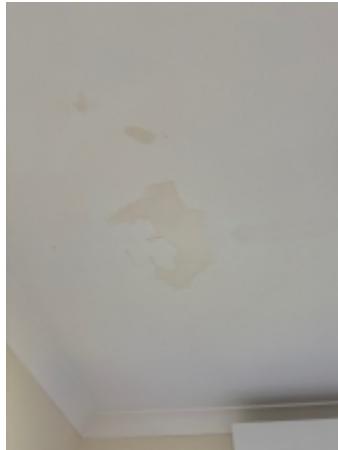
Defect Severity	 Minor Defect
Comment	Water stain on ceiling. The cause of this should be further investigated and rectified if necessary.
Defect Images

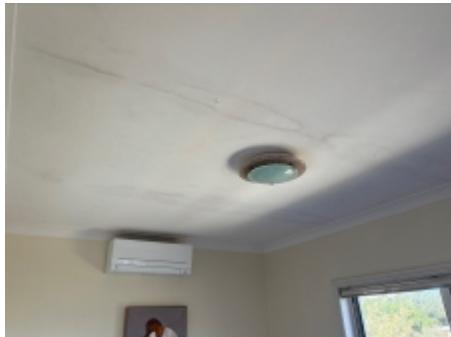
Defect Severity	 Minor Defect
Comment	Water stain on ceiling. The cause of this should be further investigated and rectified if necessary.
Defect Images

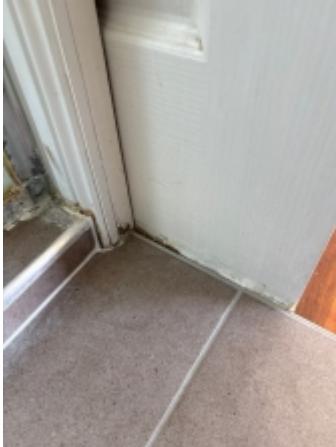
Water damage noted to door frame and door. Door does not function because of this

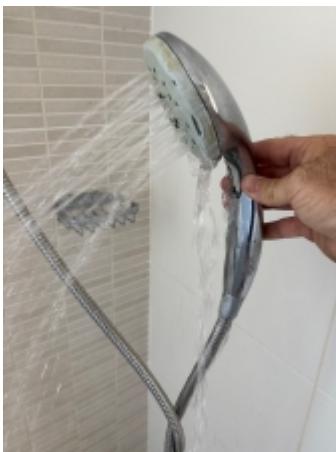
Shower head leaks and will require maintenance

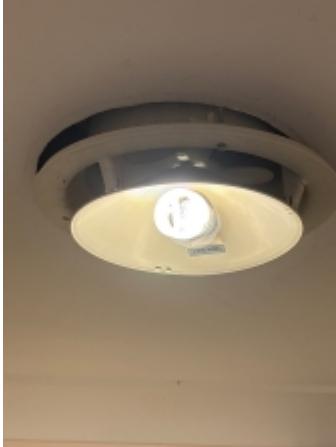
Fan light is detached from the ceiling

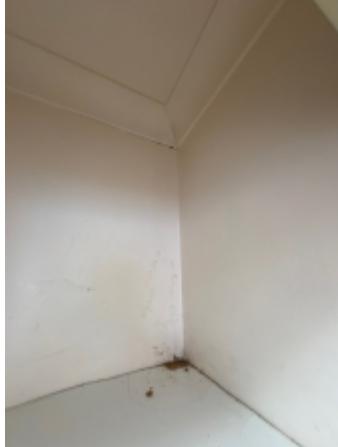
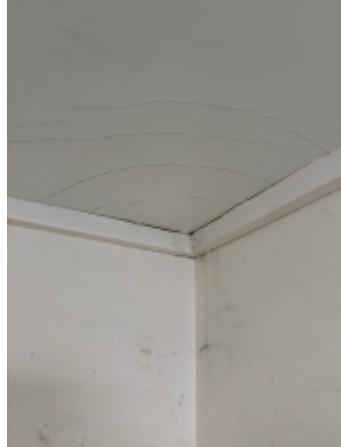
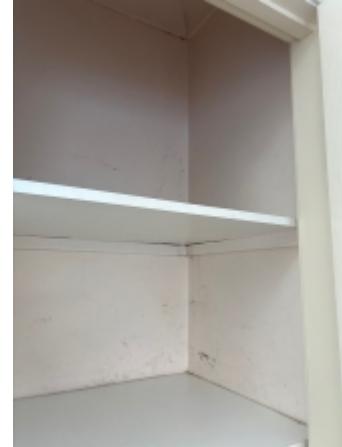
Defect Severity	Minor Defect
Comment	Water damage noted to wardrobe shelf and wall

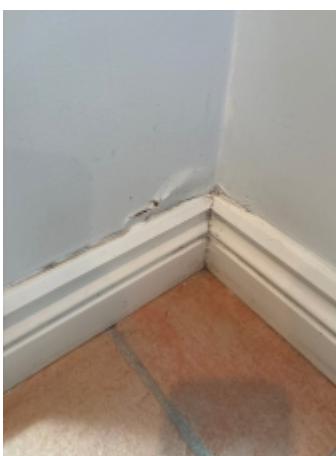
Plaster and paint has bubbled

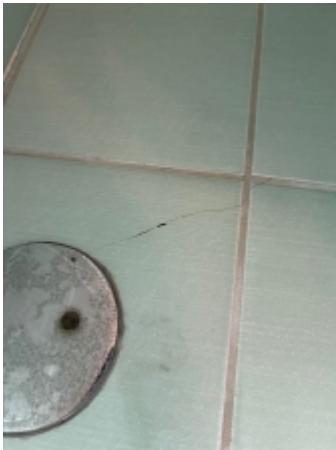
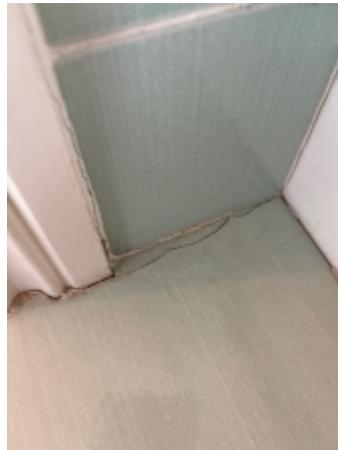
Some cracked tiles were noted to the floor area

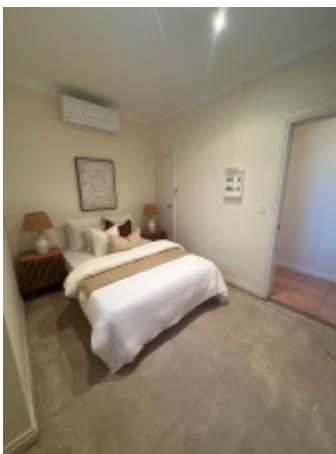
Bedroom 5

Defect Severity	 Minor Defect
Comment	Mould and water damage noted
Defect Images	
A close-up photograph of a white baseboard showing mould and water damage.	A close-up photograph of a white baseboard showing mould and water damage.

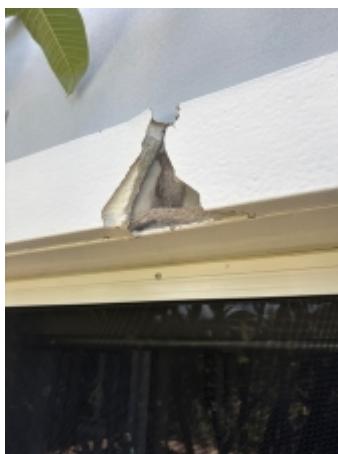
Broken window/door trims

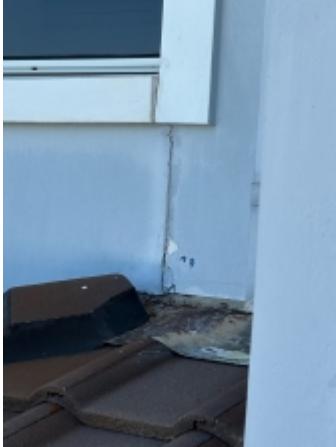
Cracking noted to cladding

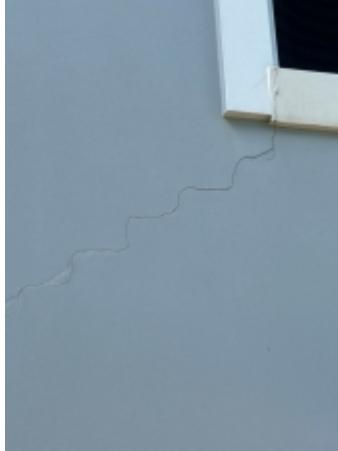
Defect Severity	 Minor Defect
Comment	Damage noted to trims around doors and windows
Defect Images	
Defect Severity	 Minor Defect
Comment	Cracking noted to brickwork and render

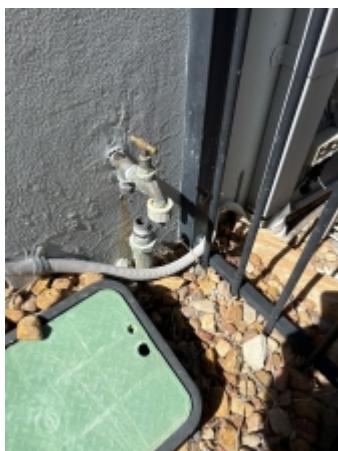
Recommend tap overflow be directed to a drain

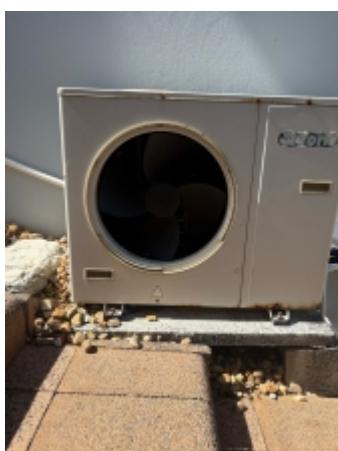
A/C unit is missing a fan cover

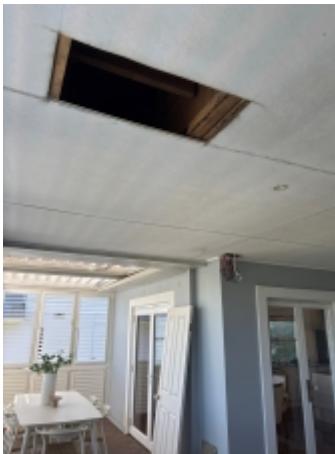
Water leaks noted to ceiling. Repairs required to ceiling. The cause of this should be further investigated and rectified.

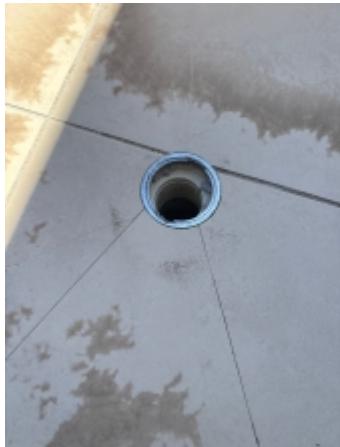
Missing drain cover this has potential for debris to enter drain and block plumbing

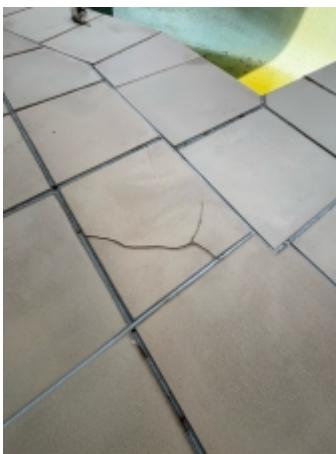
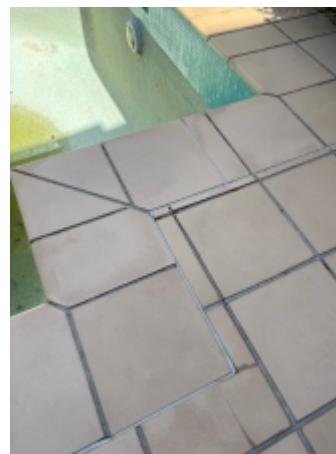
Minor Defect

Cracked floor tiles

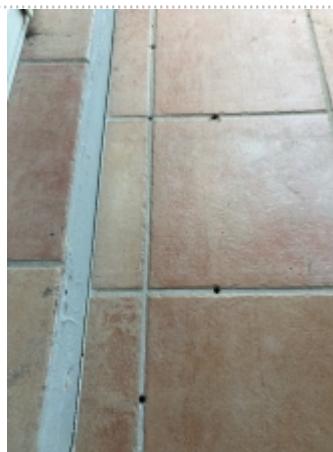
Treatment sticker in meter box

Evidence of drilled holes in ground

It is also recommended that the Purchaser make further inquiries with the Vendor regarding the history of Timber Pests at the Property and in particular, if any Termite Activity has ever occurred at the Property, including but not limited to, any trees on the Property.

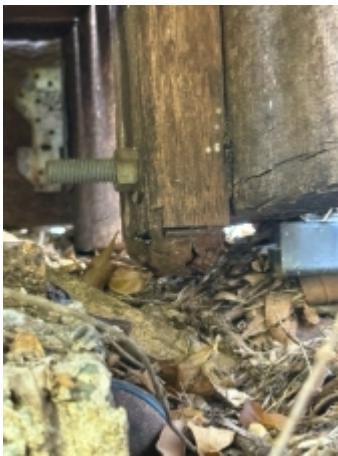
Was evidence of Fungal Decay found at the time of the inspection? Yes

Visible damage appears to be located in the following areas: Landscaping Timbers

If any evidence of fungi is reported, it is strongly recommended that the full extent of any such activity and damage be fully understood through the engagement of a Licensed Builder, Structural Engineer or appropriately qualified expert.

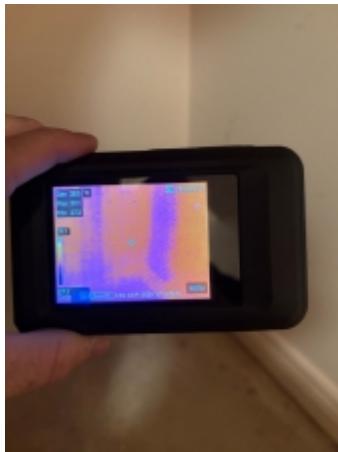
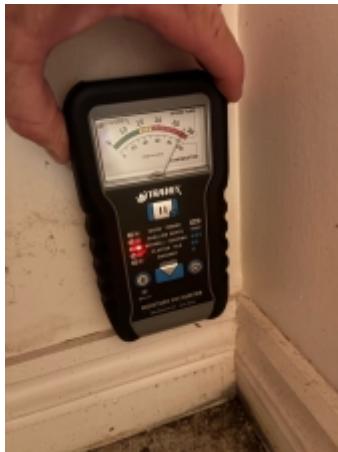
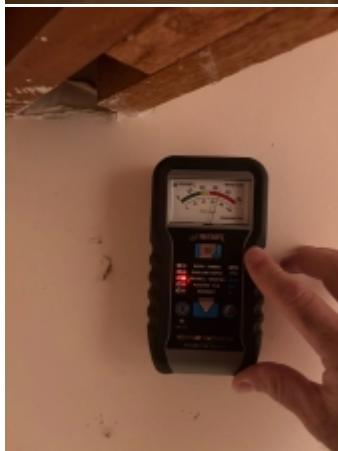
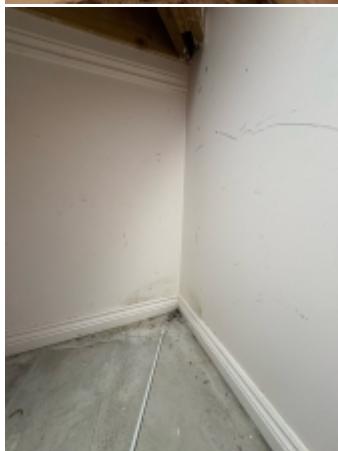
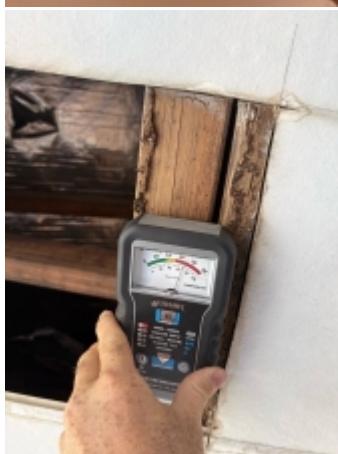
Outdoor area ceiling has had a leak and repairs are on going. Timber moisture levels are high

If high moisture or thermal levels have been reported, it is important to ensure further expert advice is obtained in order to determine the reason, extent of any damage caused and estimated cost of rectification as areas with high moisture are more prone to Timber Pest attack.

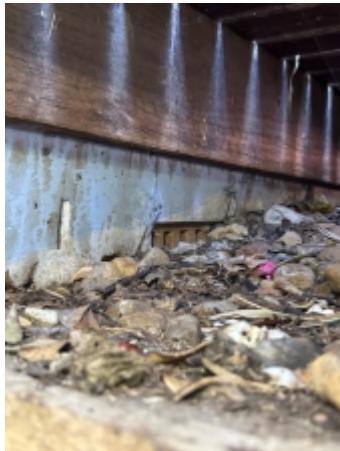
Does the slab edge inspection zone fully comply?

No

The concrete edge should not be concealed but rather, a visible inspection zone of at least 75 mm should be maintained to allow visible detection of possible termite activity with regular Inspections undertaken in accordance with AS 3660.3.

If the edge is concealed, it is possible that termite entry may already have occurred but could not be detected at the time of Inspection. A Licensed Builder may also be contacted to find alternative solutions to the problem if visibility is not readily available.
