Pre-Purchase Building & Timber Pest Inspection Report

In accordance with Australian Standard AS 4349.1 - 2007 and AS 4349.3-2010

14 Kerenjon Ave Buderim Queensland, 4556

16 Jan 2026

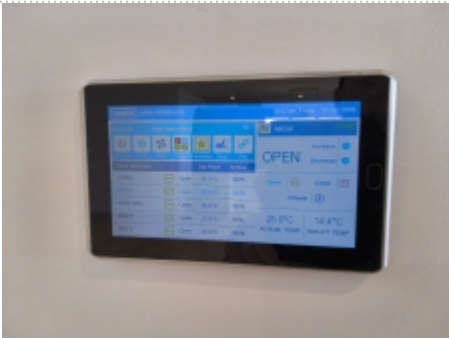
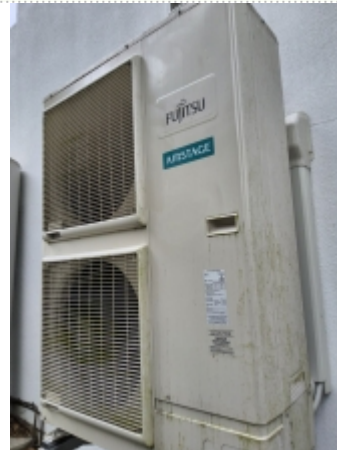
P.3 Air Conditioning No evidence of air conditioning defects was found

Below are the images from the Premium Airconditioning Inspection where no defects were identified.

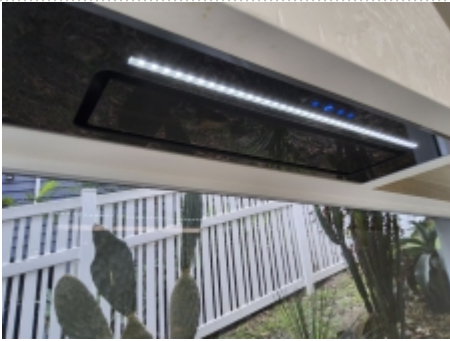
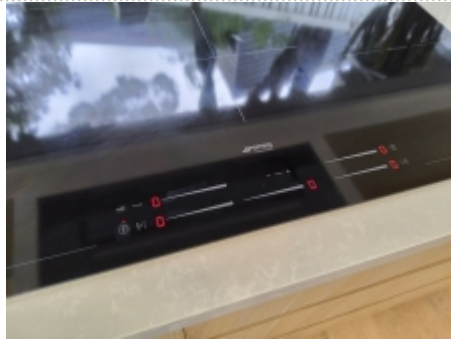
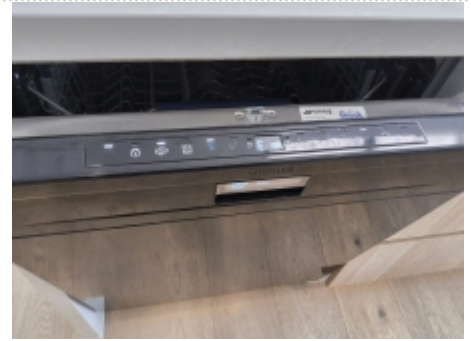
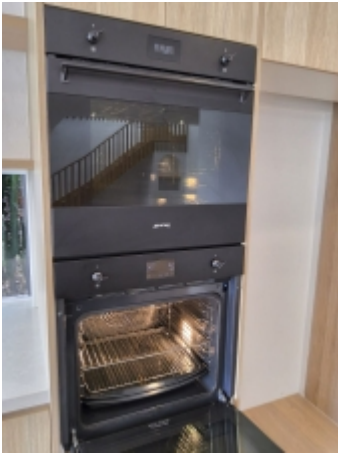
P.5 Appliances No evidence of appliance/s defects was found

Below are the images from the Premium Appliances Inspection where no defects were identified.

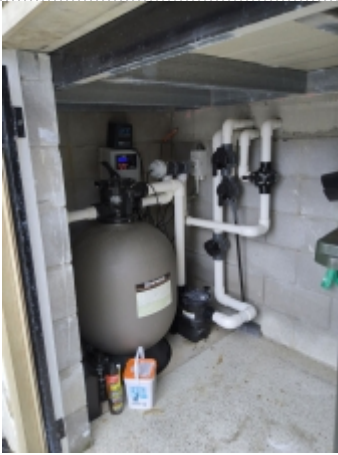
Was there any evidence of any other defects? No

Below are the images from the Premium Other Inspection where no defects were identified.

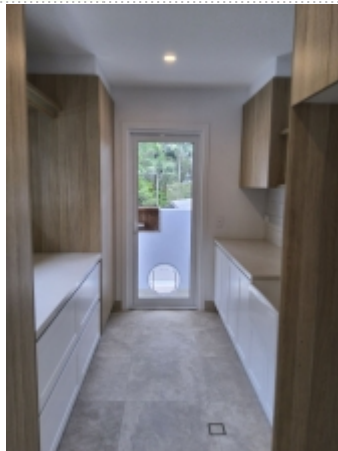
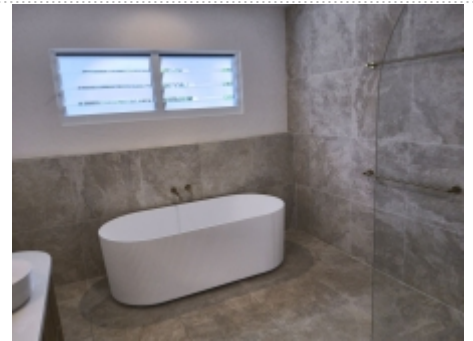
Additional obstruction and general photos taken at the time of inspection.

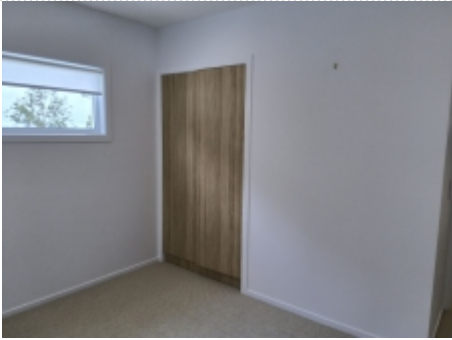
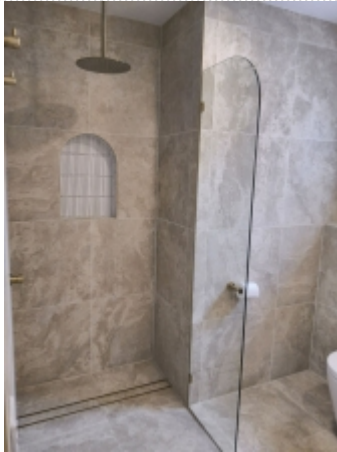
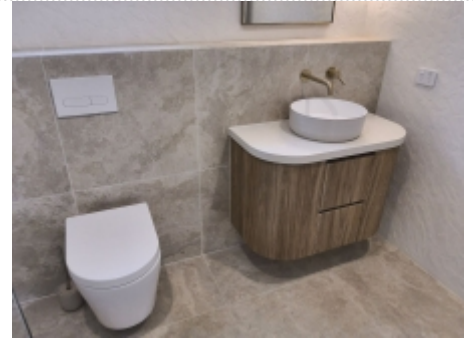
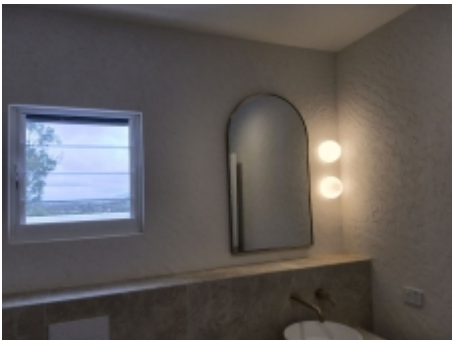
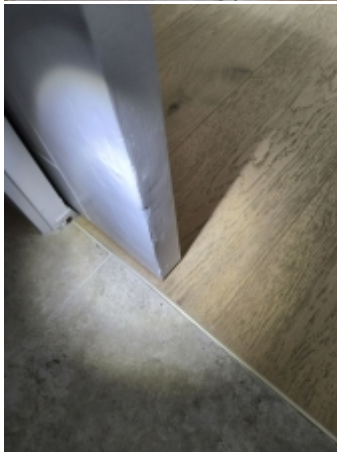
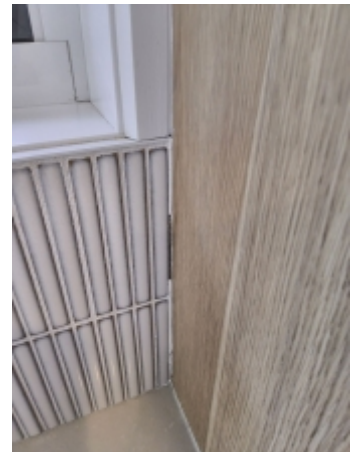
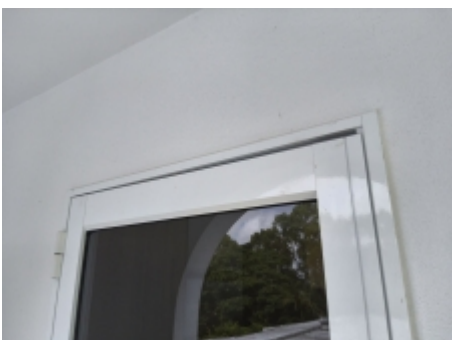
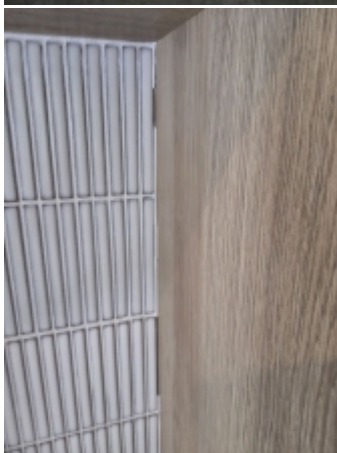
Additional obstruction and general photos taken at the time of inspection.

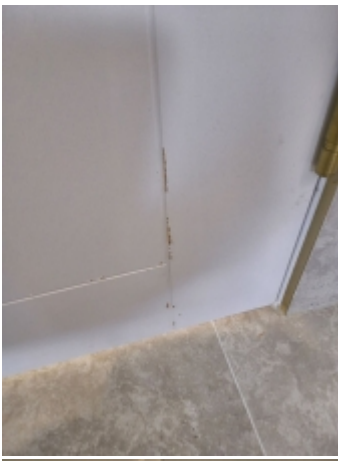
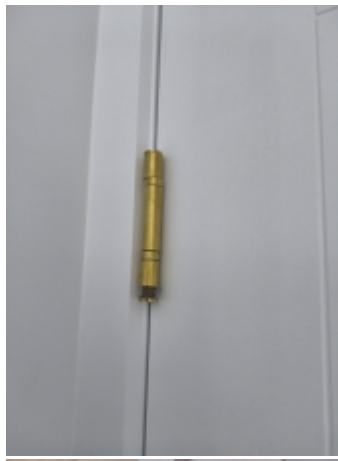
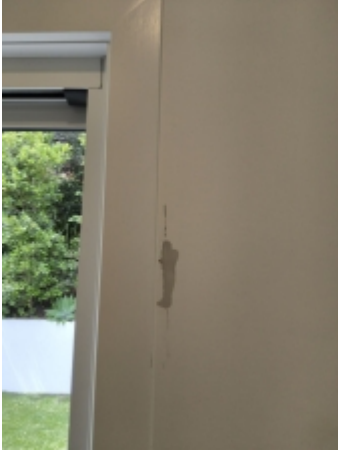
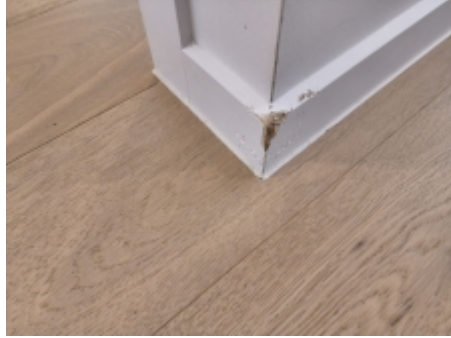
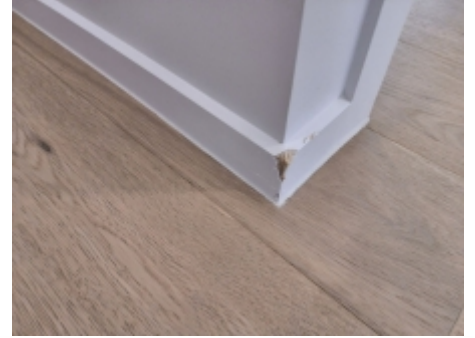
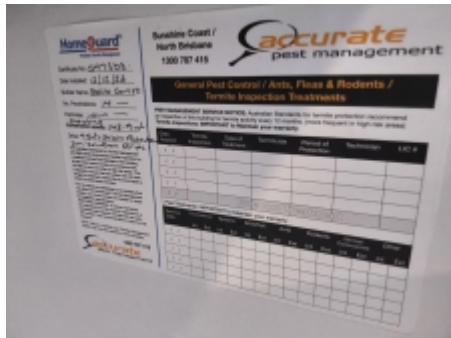
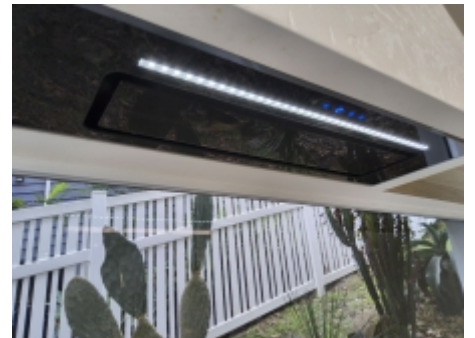
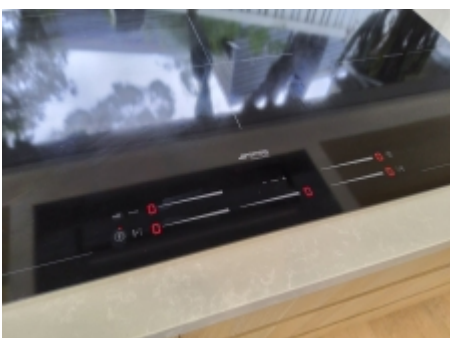
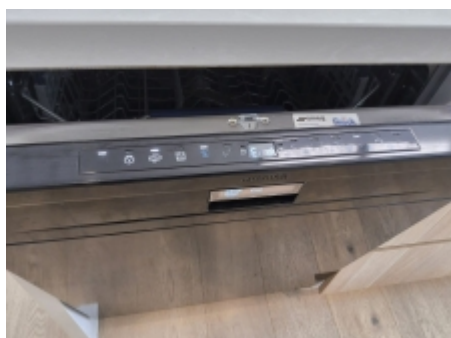
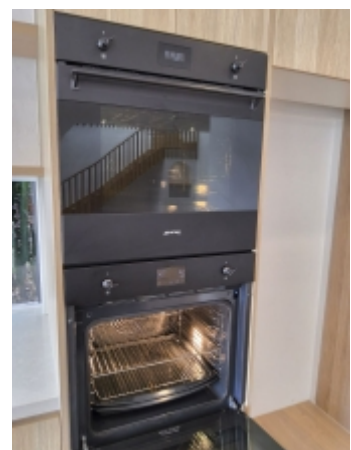
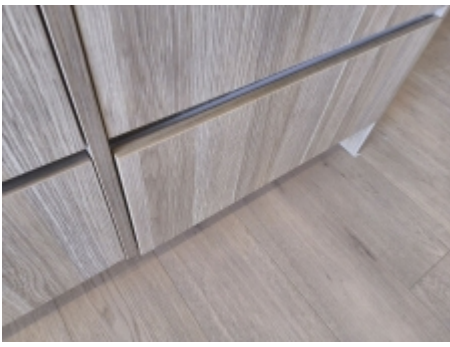
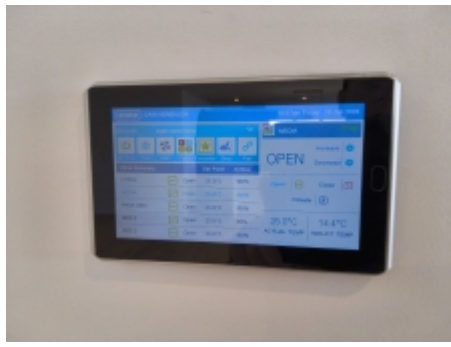
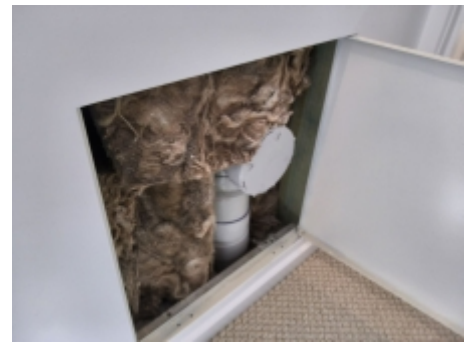
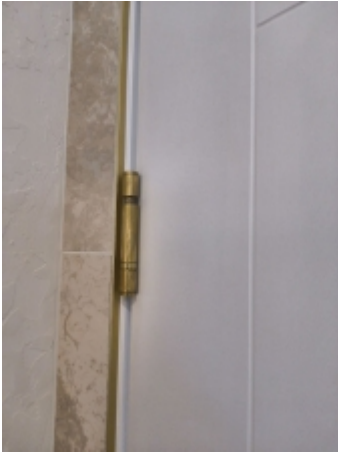
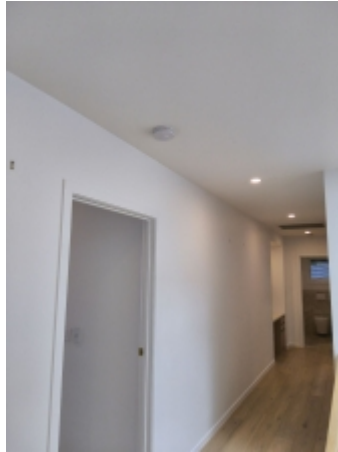
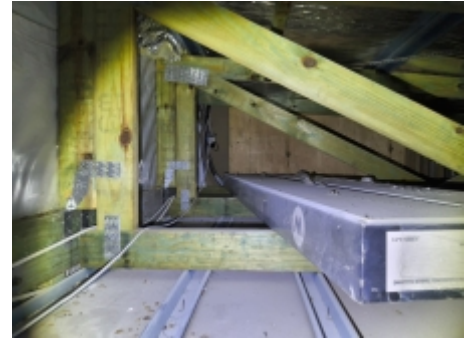
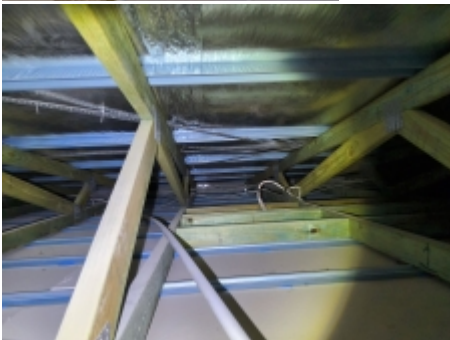
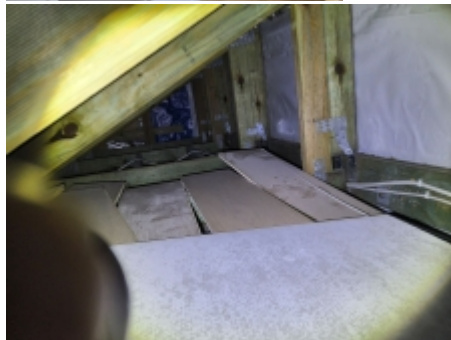
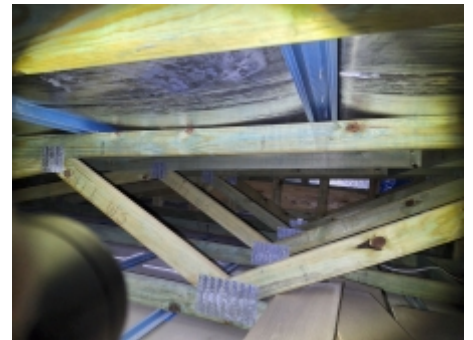
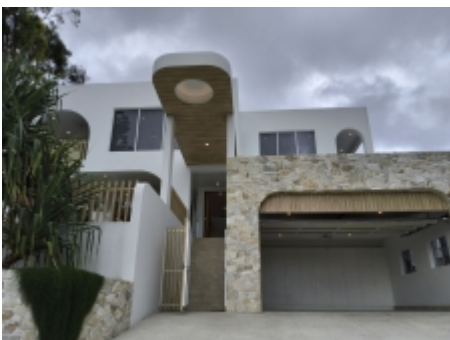
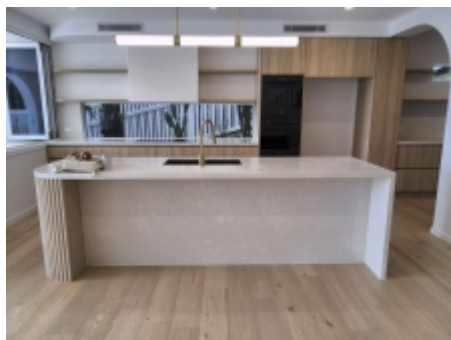
Shown example of moisture readings taken around wet areas that did not indicate elevated moisture.
