# Building and Pest Report

## 1/14 The Terrace, East Ballina

### Pest And Building Inspection

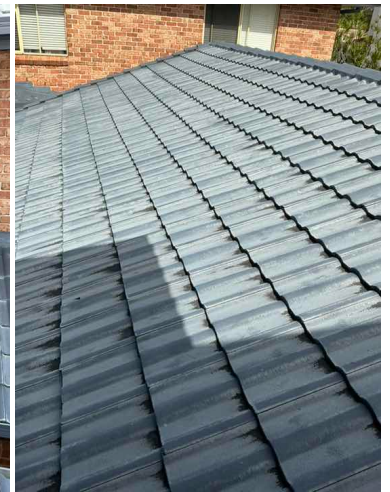
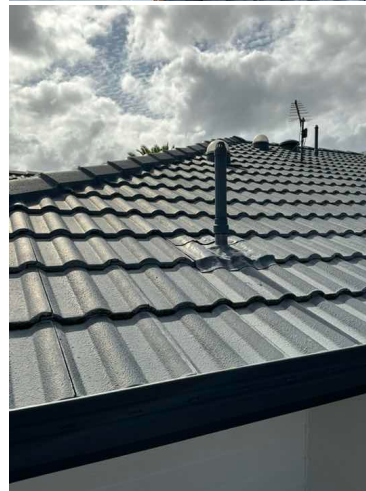
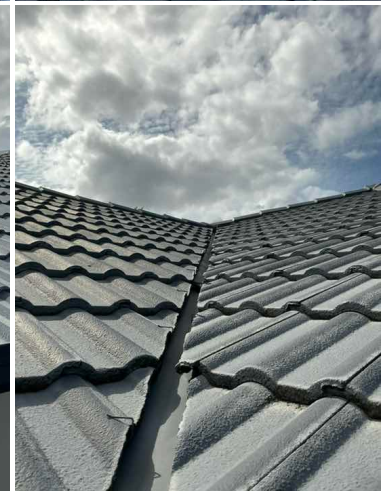
Of the visible areas, the general condition of the roof is in serviceable condition for the age.

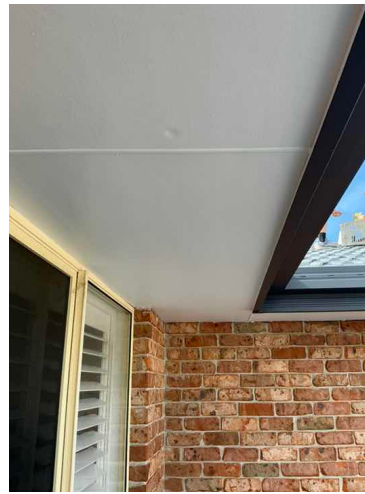
The entry porch serviceable or in reasonable or condition for the age of this dwelling.

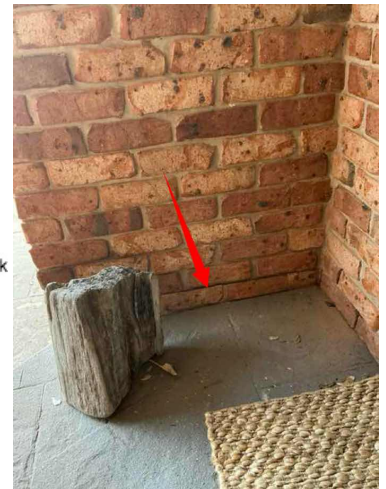
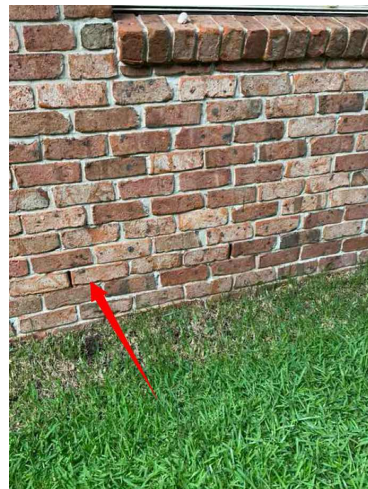
On visual inspection, the general condition of the exterior walls is serviceable for the age.

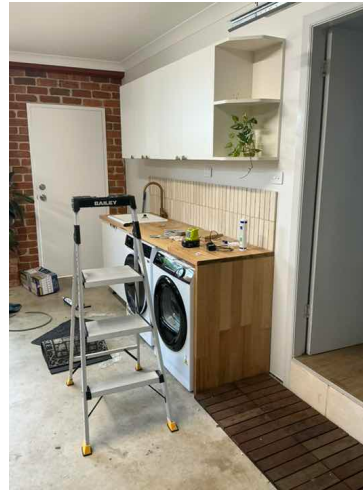
Of the visible areas, the general condition of the laundry is serviceable or in reasonable condition for age of dwelling.
