# Building and Pest Report

## 37 Rainforest Wy, Lennox Head

Report/Agreement #	0403261049588
Inspection Date:	04 Mar 2026
Inspection Time:	10:00 am

**The Scope of the Inspection:** This report Complies with Australian Standards AS 4349.1-2007. Inspection of Buildings Part 1: Pre- Purchase Inspections-Residential Buildings- Appendix "C"

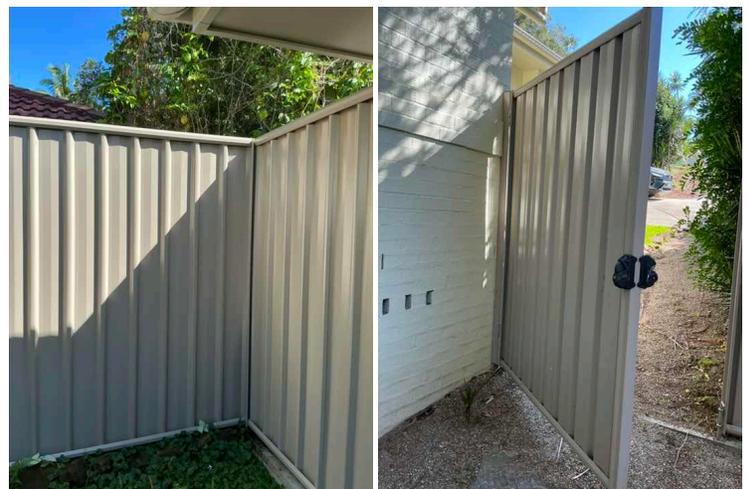
Of the visible areas, the general condition of the fences and gates is serviceable for the age of dwelling.

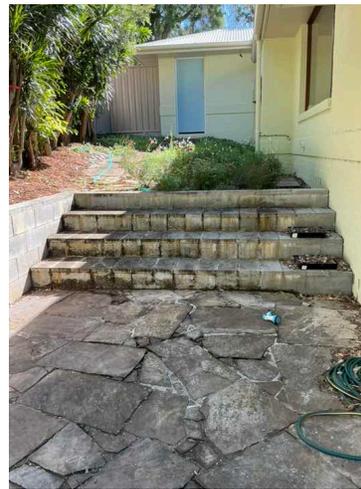
Of the visible areas, the general condition is serviceable or in reasonable condition for age of dwelling.

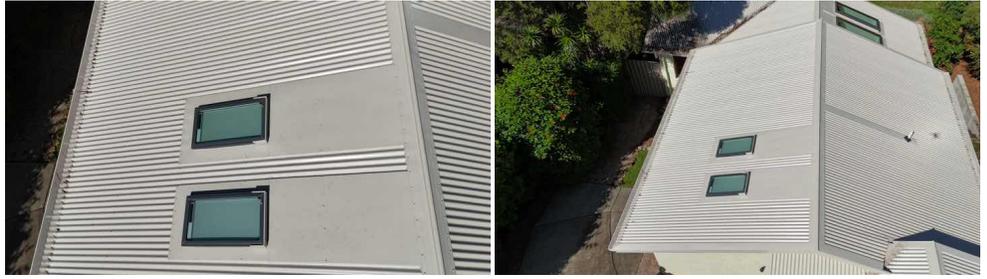
Of the visible areas, the general condition of the roof is in serviceable condition for the age.

Note: In the absence of rainfall there is no guarantee that the roof won't leak.

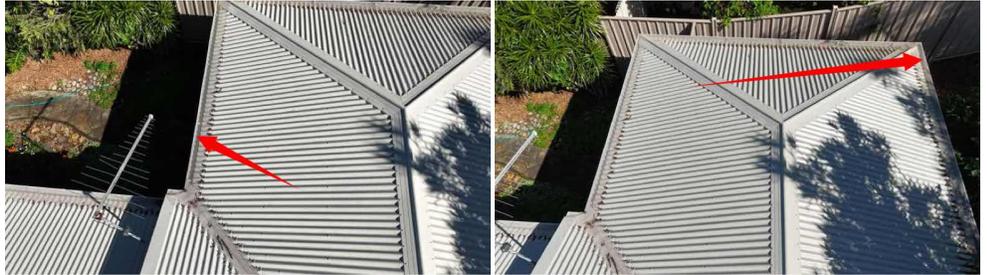
Visible section of The roof cladding appeared in a serviceable condition for the age of this dwelling. Annual maintenance inspection recommended.

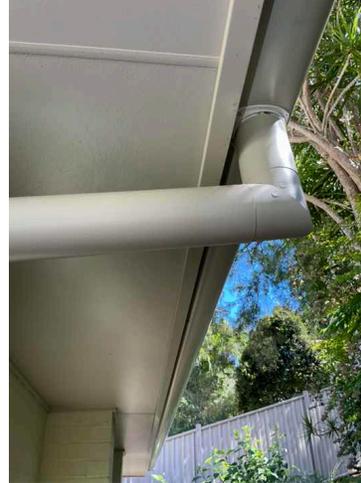
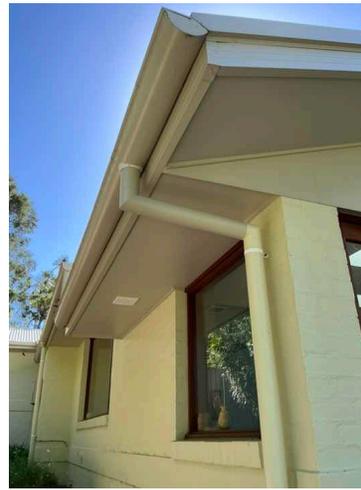
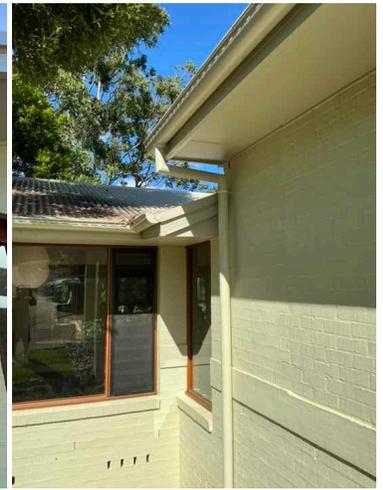
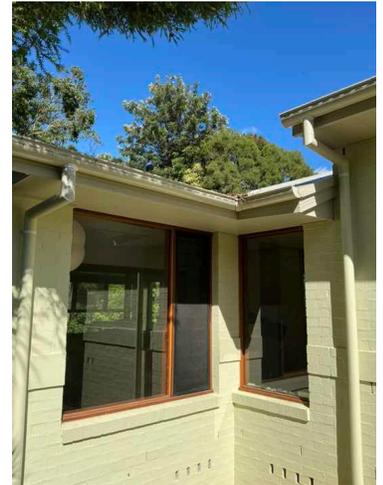
On visual inspection no apparent defects were noted to the down pipes and are considered serviceable, however no comment can be made with regard to blockages or connections to stormwater or functionality in the absence of rain. Note: Periodic maintenance checks should be carried out for rust penetrations and leaks.

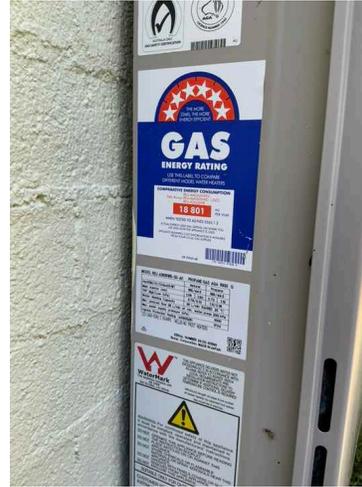
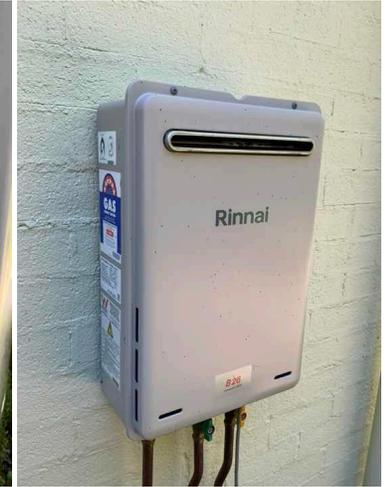
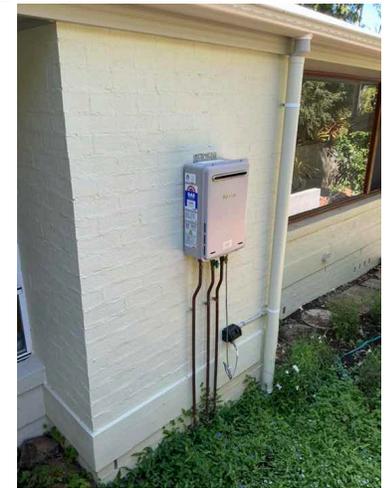
The hot water system appears to be in a serviceable condition. No specific tests other than running the hot water from a tap was carried out. No determination has been made as to the suitability or adequacy of the hot water system in relation to capacity or otherwise.

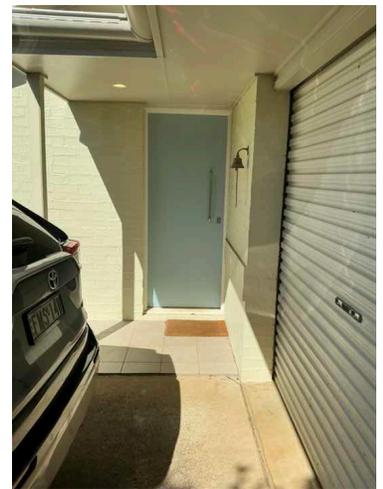
The entry porch serviceable or in reasonable or condition for the age of this dwelling.

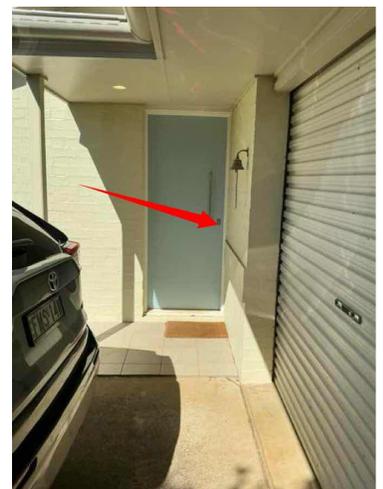
On Visual Inspection the external condition of the doors is serviceable.

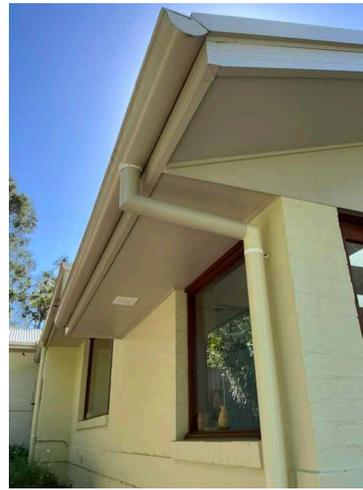
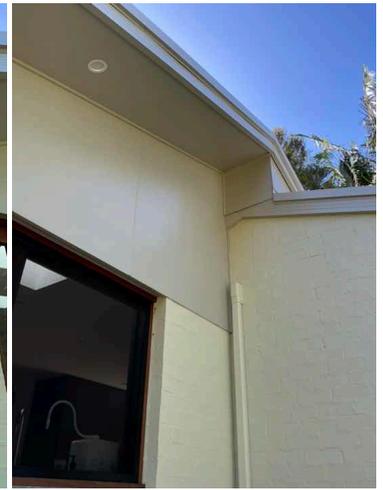
On visual inspection, the general condition of the fascia/barge boards is serviceable.

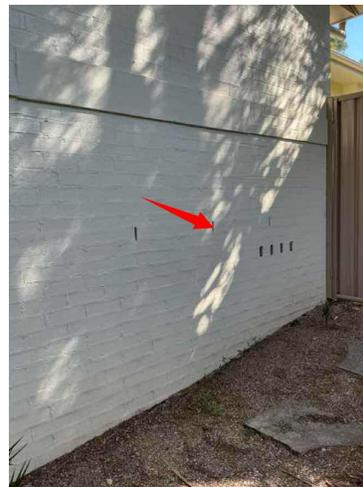
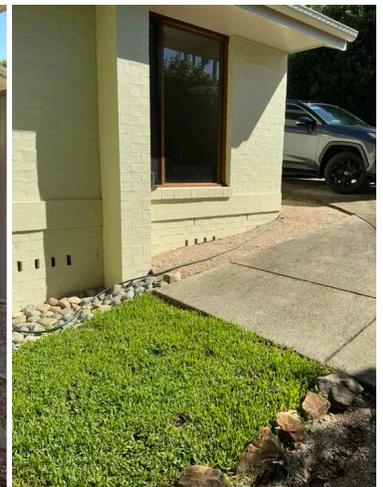
Of the visible and accessible areas, there was no visible evidence of excessive rising damp on the external walls at time of inspection.

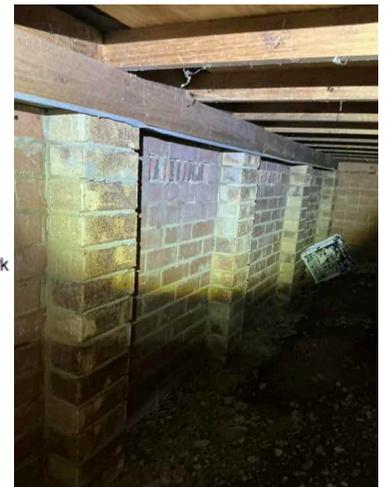
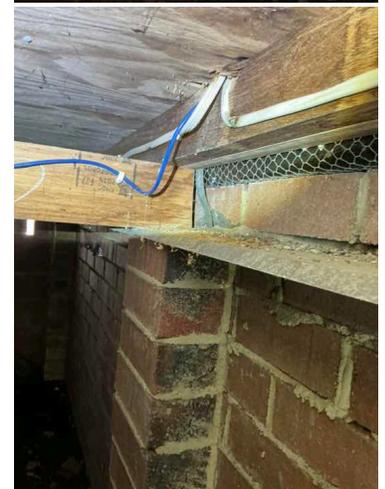
A damp proof course (DPC) was noted.

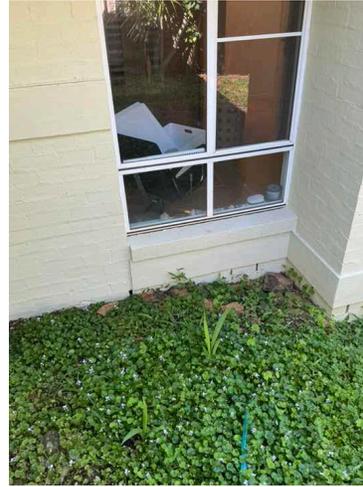
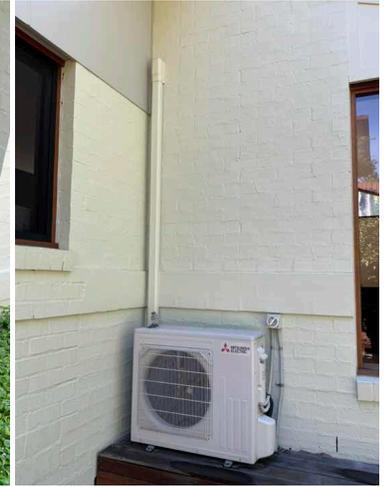
On visual inspection, the general condition of the exterior walls is serviceable for the age.

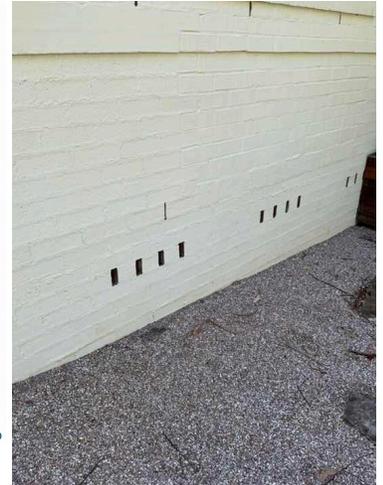
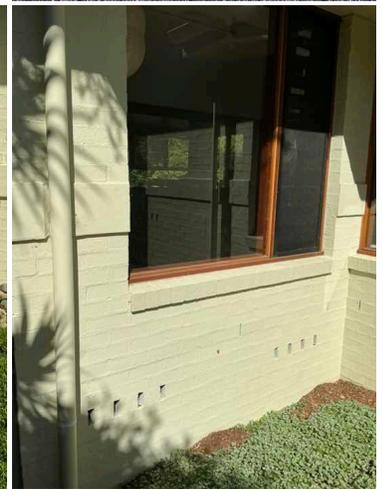
The weep holes are unobstructed .

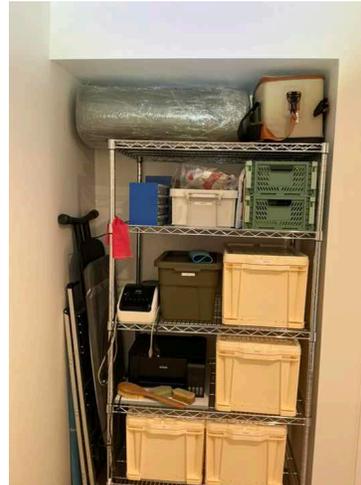
Stored items restricted a full and thorough inspection of this area. Defects may exist in the obstructed and inaccessible areas. It is strongly recommended that full access be granted to enable a thorough inspection as there may be timber pest activity, damage or defects. Note: Where vehicles and storage has restricted a full inspection it is advised that this area be cleared so a full and unobstructed inspection can be carried out.

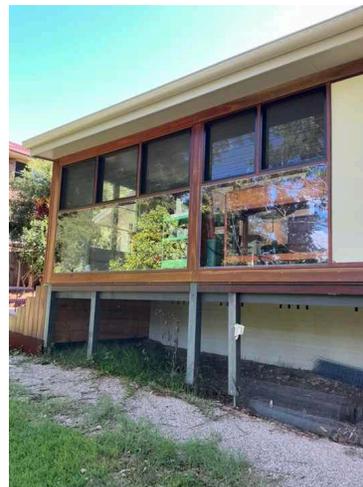
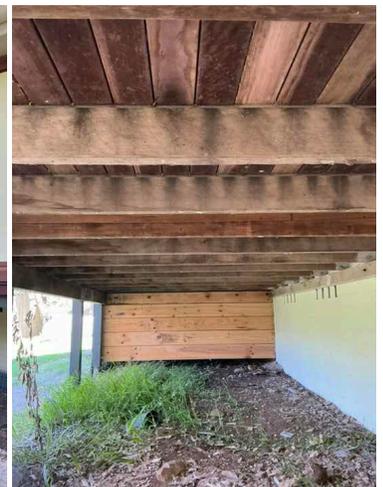
Of areas visible, the decking appears to be in a serviceable condition.

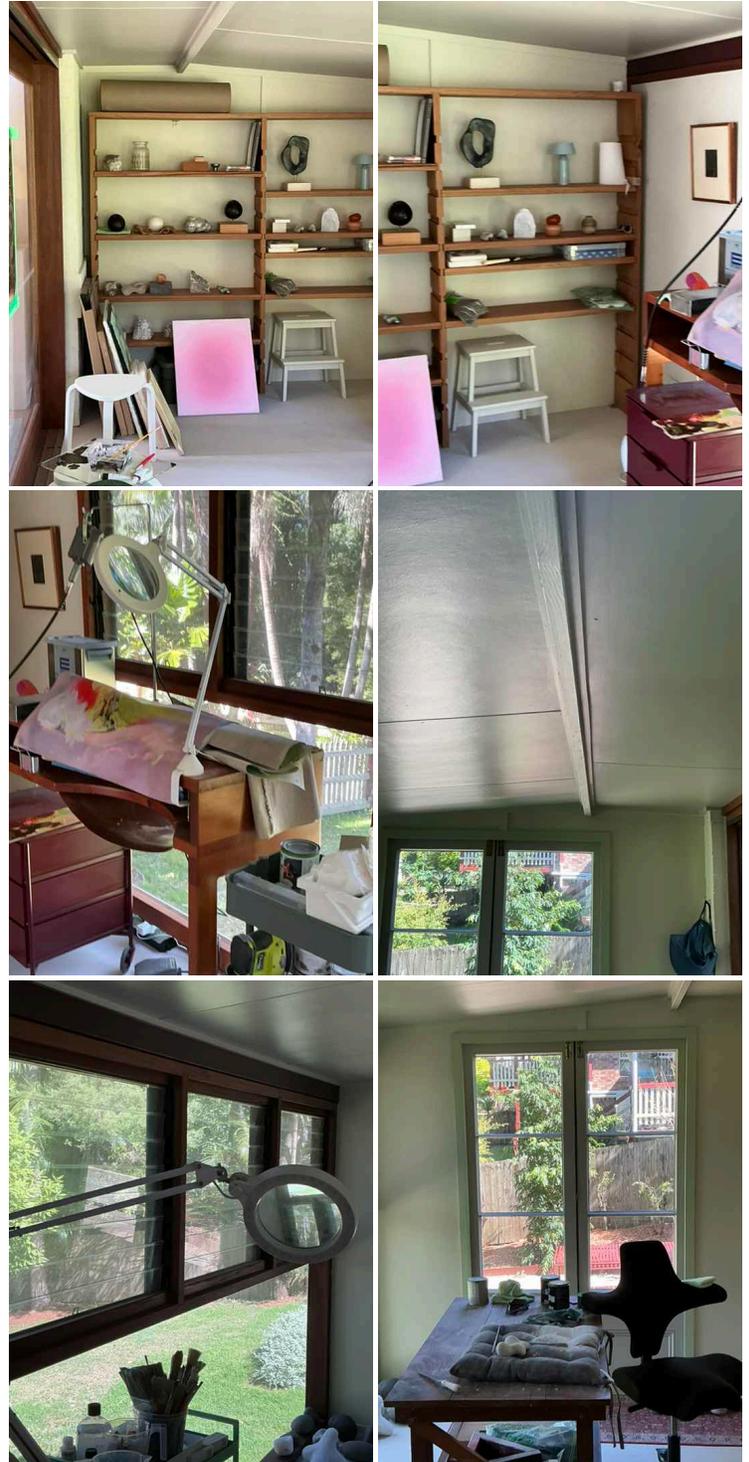
## Verandah Findings

Though we are not structural engineers the veranda/s appear to be in a serviceable condition.

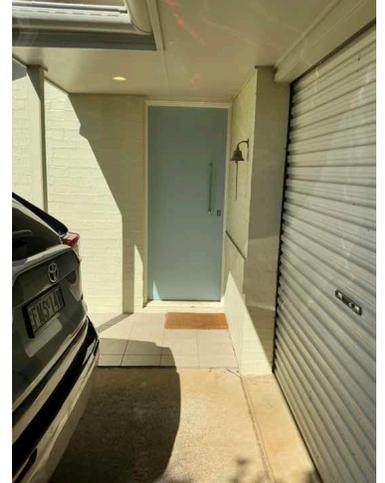
### **Front Entry Doors**

The doors are in serviceable condition with no notable defects observed.

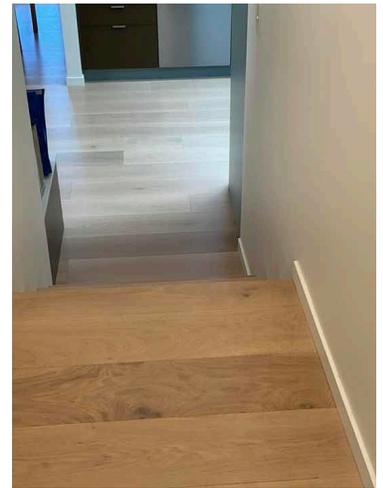
The internal staircase and components appear to be in a serviceable condition for the age with no notable defects sighted.

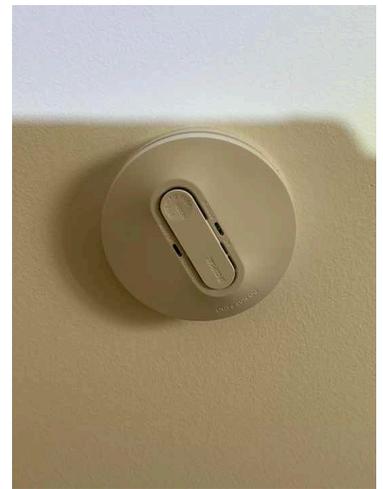
## Smoke Alarm

Yes a smoke alarm was sighted but not tested.

Legislation requires smoke Alarms to be installed. Check with your local council regarding type, locations and other related requirements.

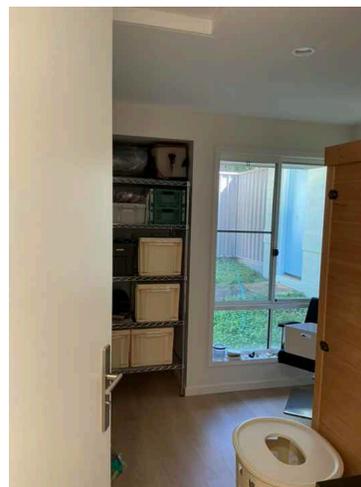
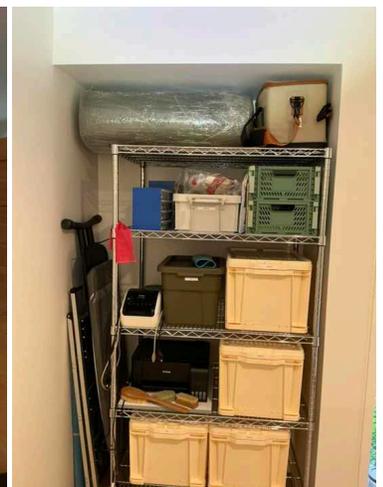
## Bedroom 1

From the visible and accessible areas, this bedroom appears to be in a serviceable condition for the age of the property with no notable structural defects sighted.

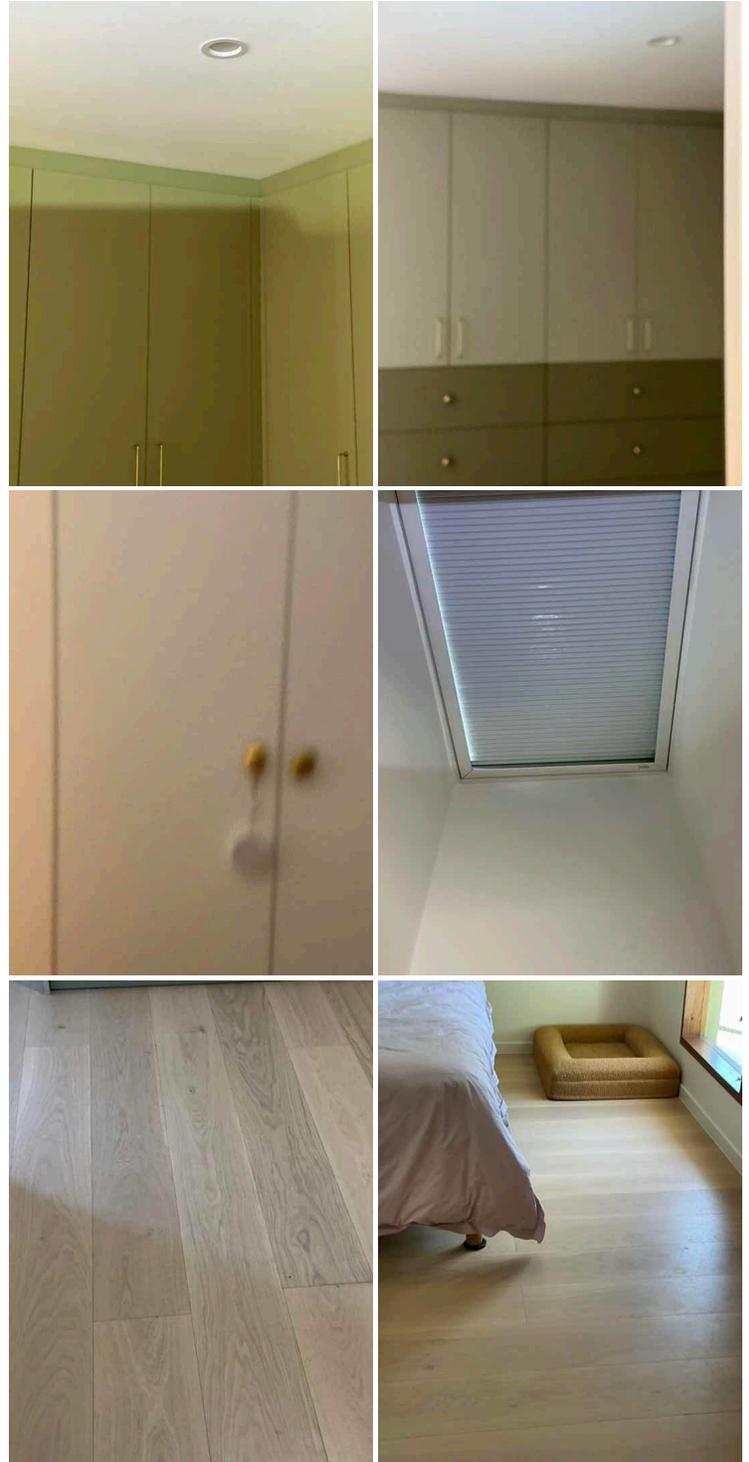
## **Bedroom 2**

From the visible and accessible areas, this bedroom appears to be in a serviceable condition for the age of the property with no notable structural defects sighted.

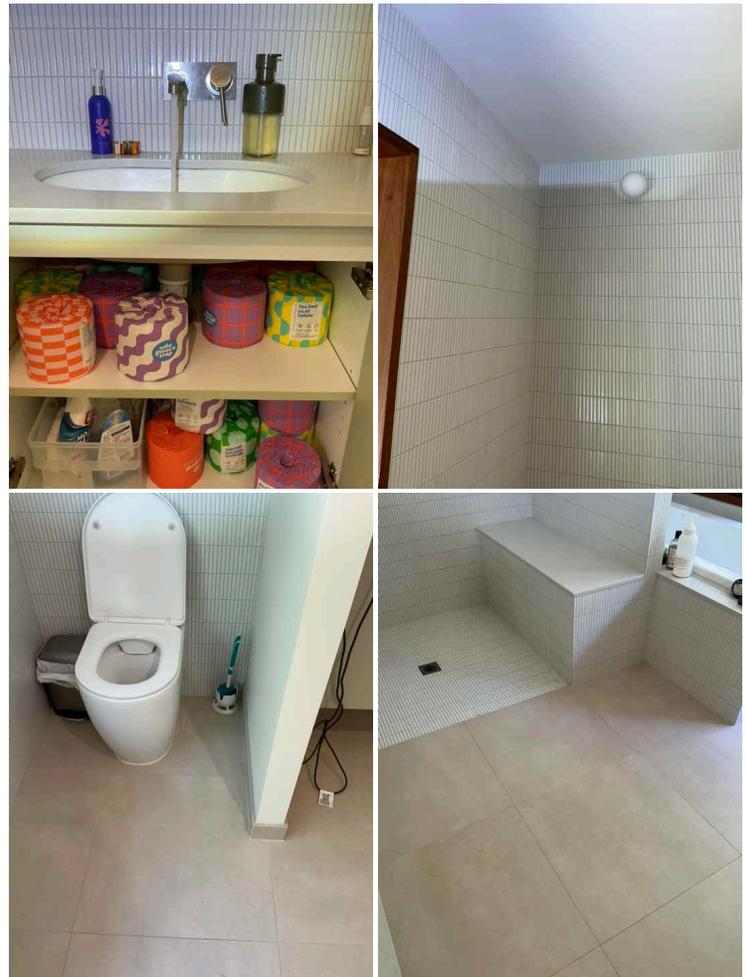
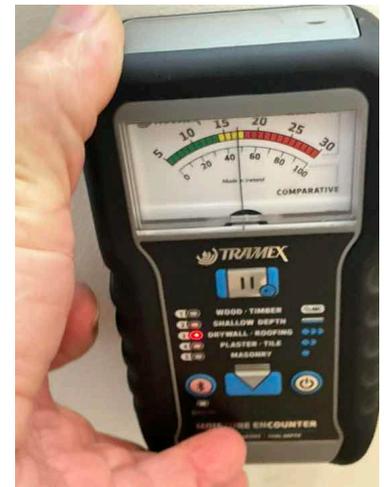
Of the visible areas, the general condition of this bathroom is serviceable or in reasonable condition for age of dwelling.

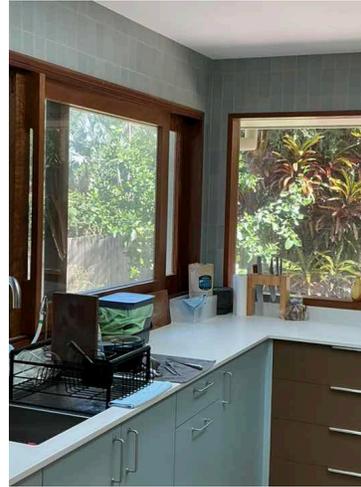
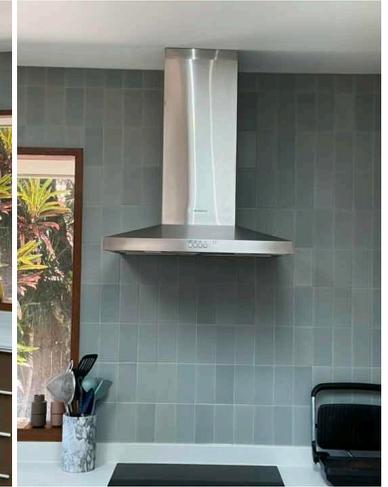
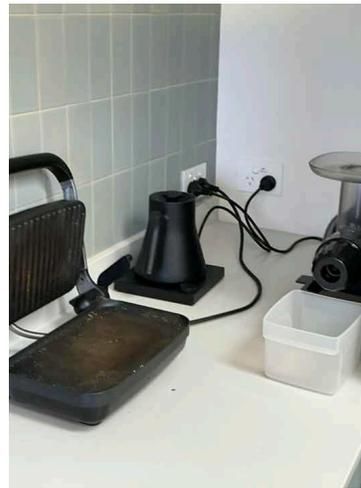
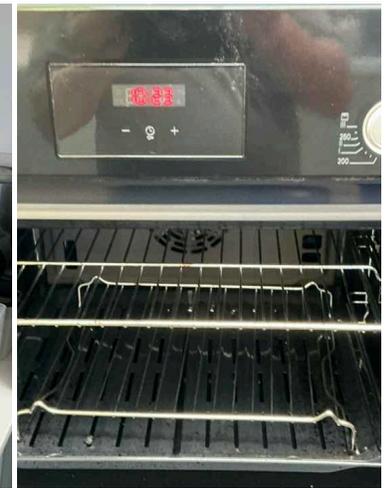
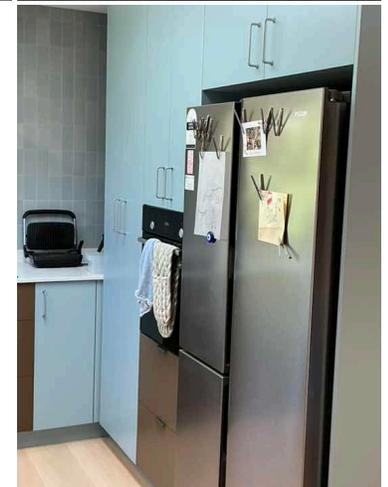
Of the visible areas, the general condition of the kitchen and pantry is serviceable or in reasonable condition for age of dwelling.

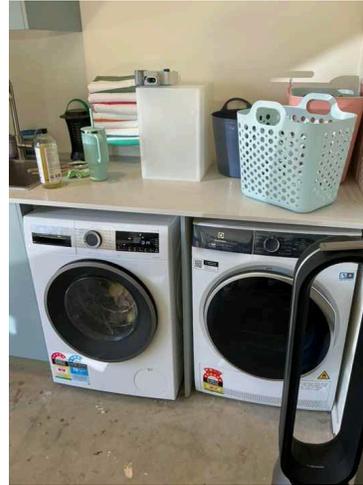
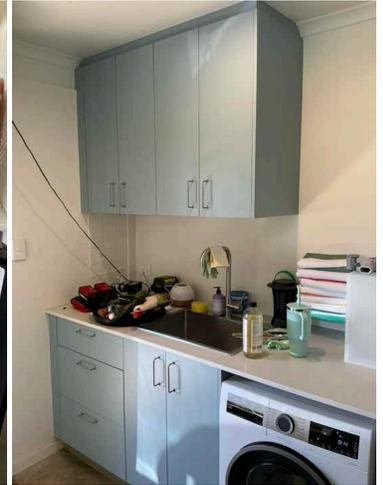
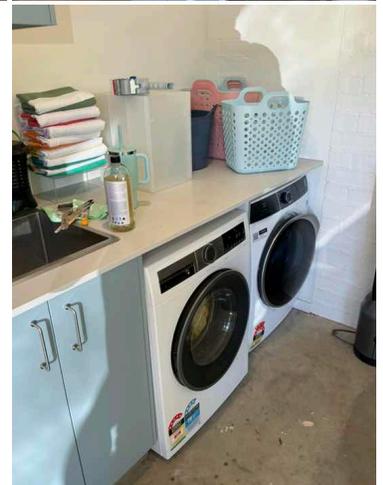
Of the visible areas, the general condition of the laundry is serviceable or in reasonable condition for age of dwelling.

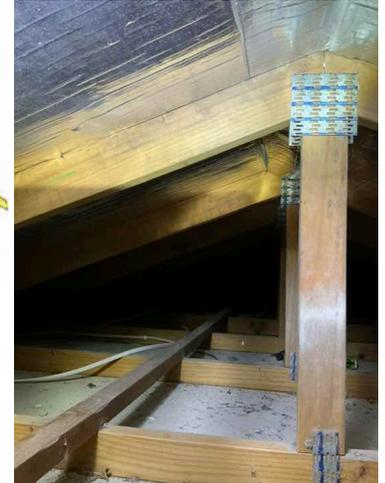
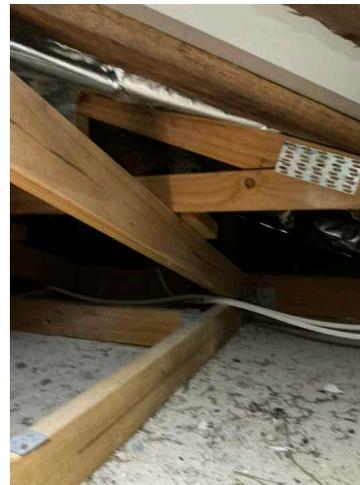
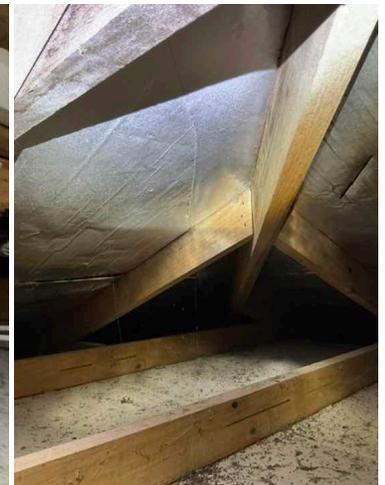
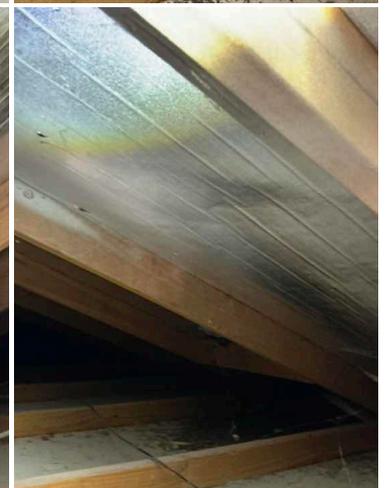
# ROOF VOID

The roof frame is a truss timber frame.

Visible sections of the roof void is in a serviceable condition for age of this dwelling.

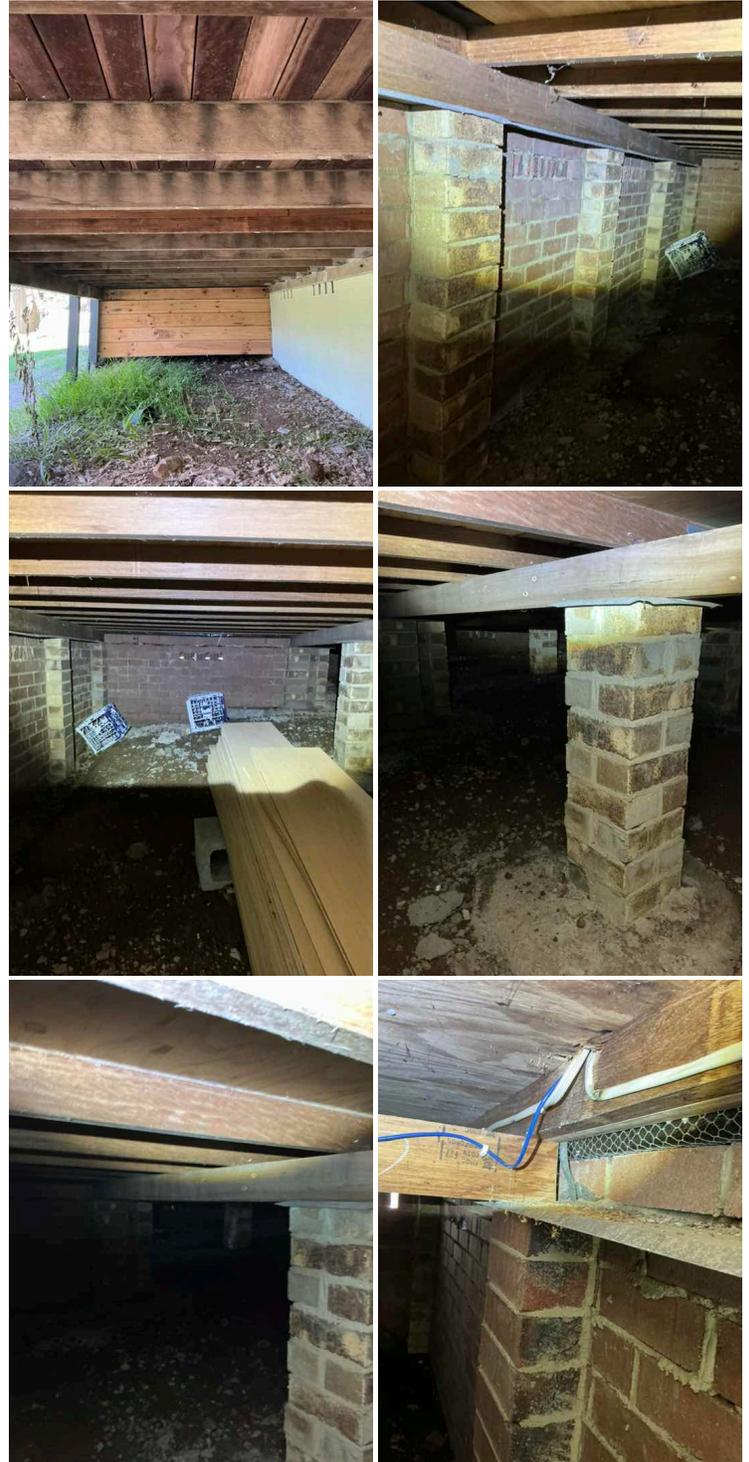
Of areas accessible and visible, the subfloor and components appeared to be in a serviceable condition.

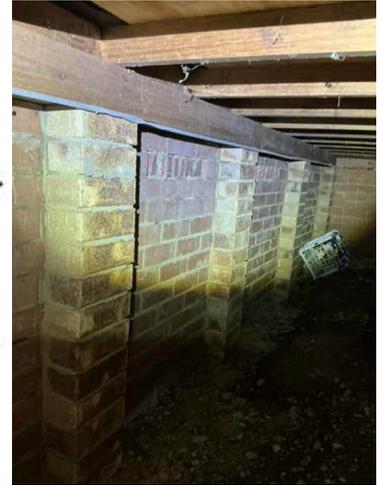
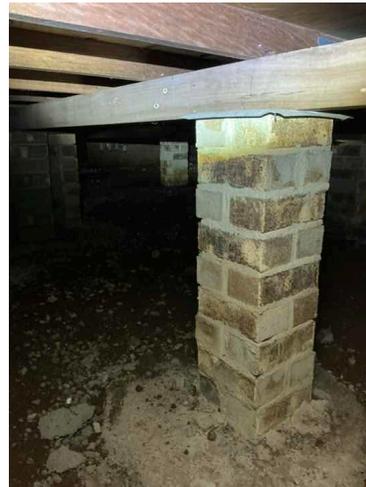
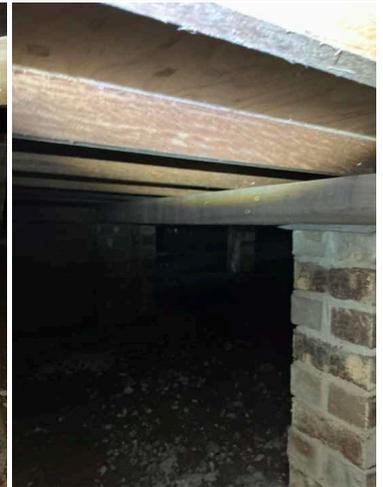
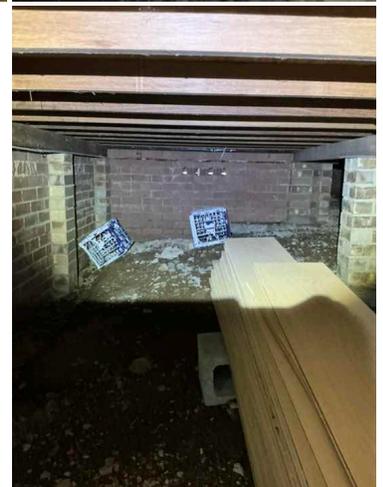
## Footings Type

Footings are brick piers with timber bearers and joists.
