PEST AND BUILDING PRE-PURCHASE REPORTS

Inspection Report

37 Montwood Dr, Lennox Head, NSW, 2478

Pest And Building Inspection

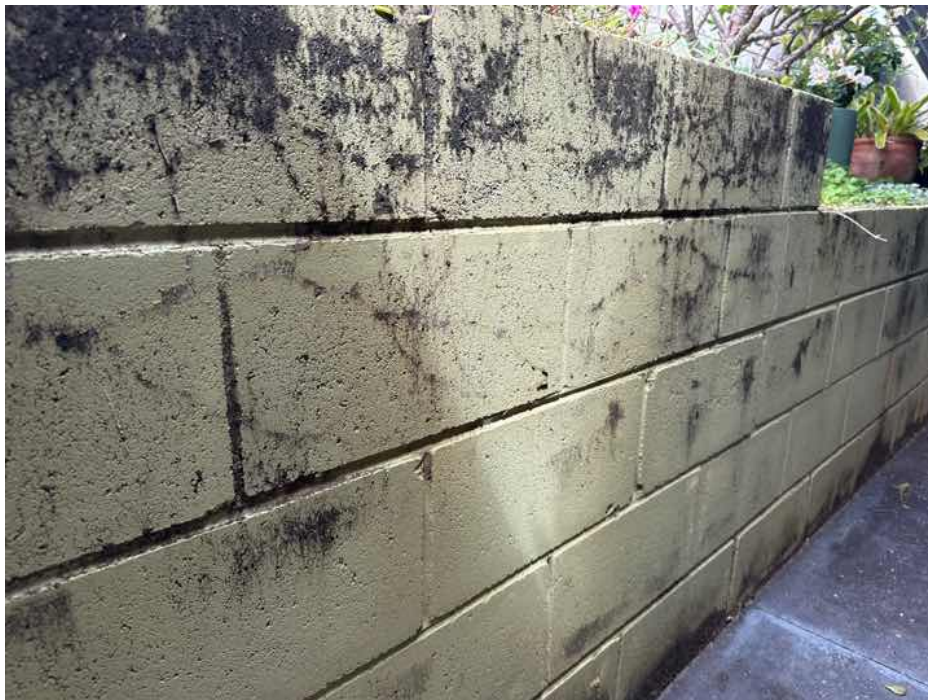
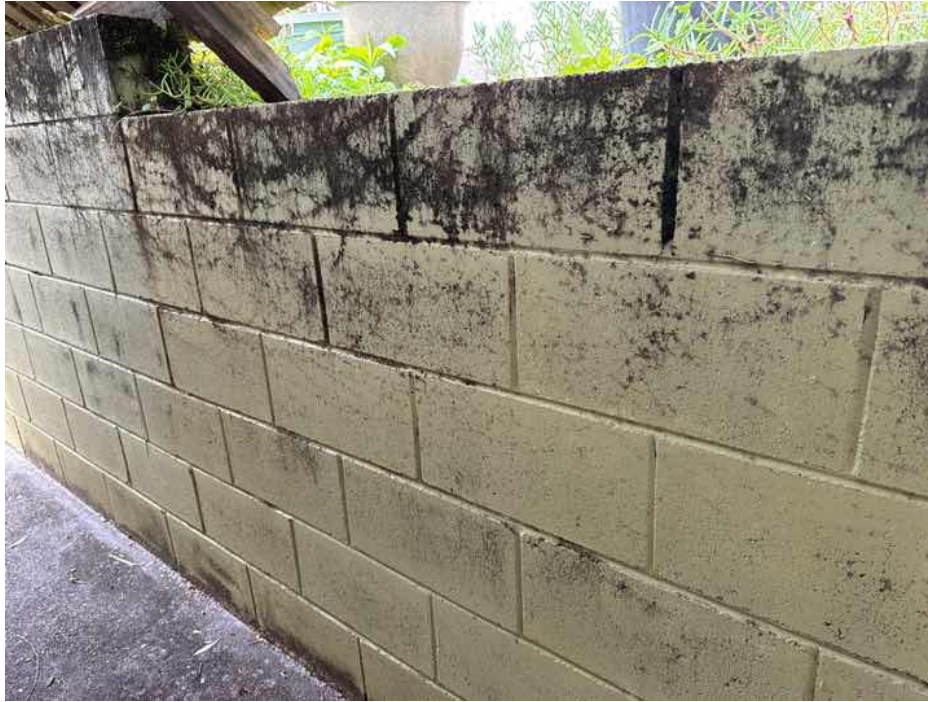
Of the visible areas, the general condition is serviceable or in reasonable condition for age of dwelling.

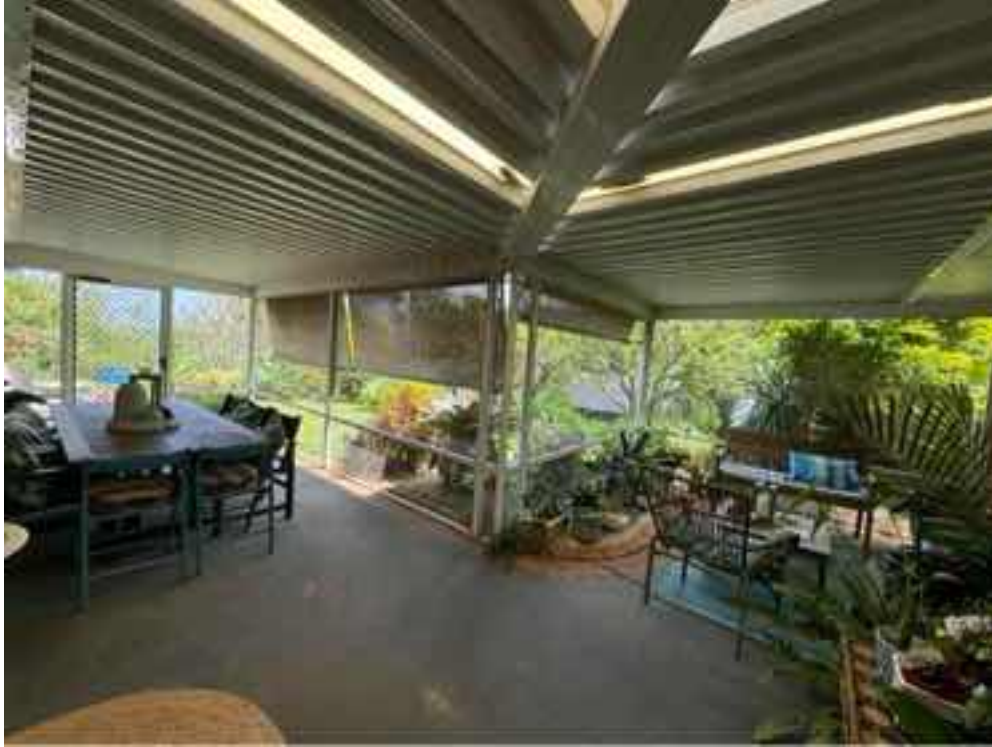
Visible sections of the Alfresco area are serviceable or in reasonable or condition for the age of this dwelling.

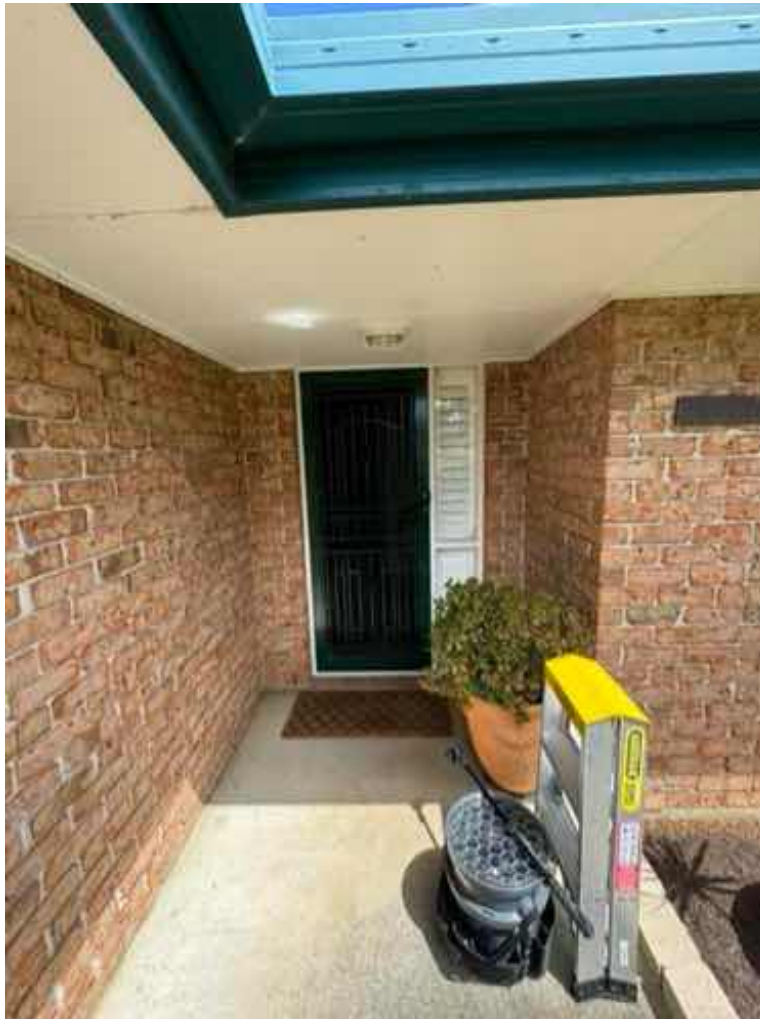
Entry Porch Area

The entry porch serviceable or in reasonable or condition for the age of this dwelling.

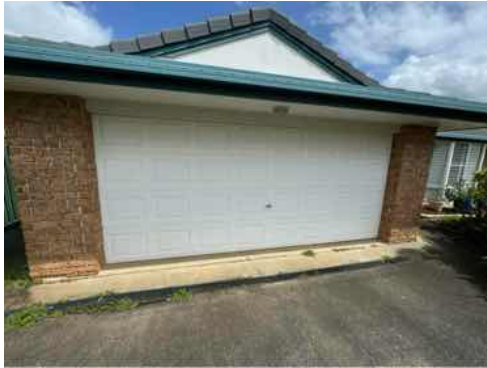
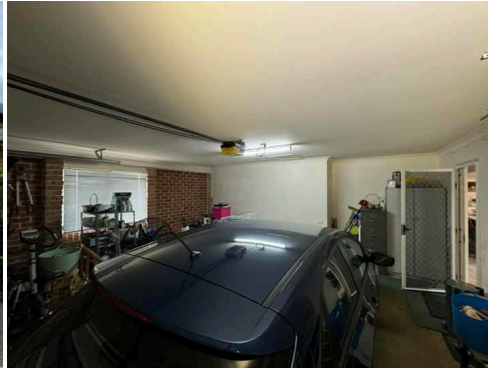
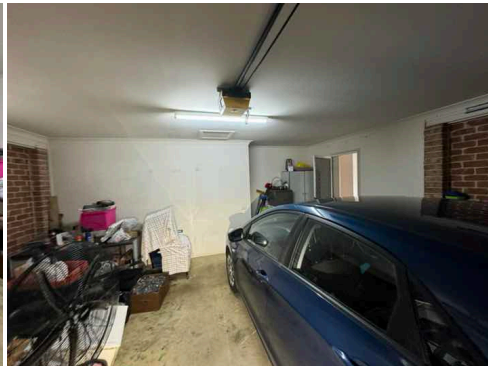
From the visible and accessible areas, the garage appears to be in a serviceable condition for the age of the property with no notable structural defects sighted.

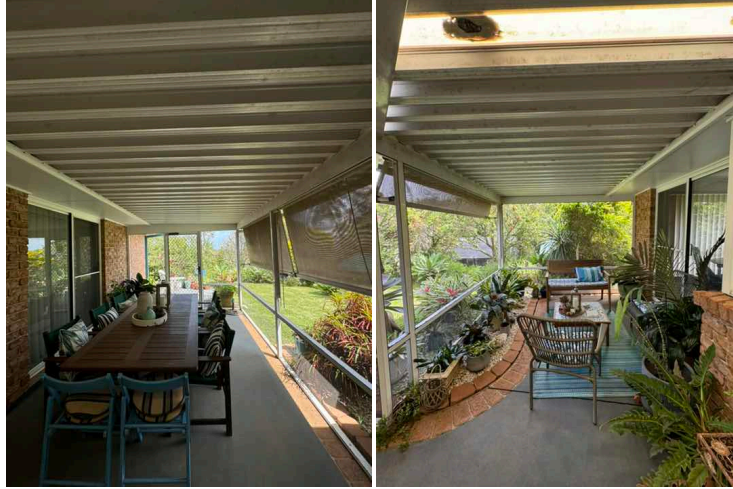
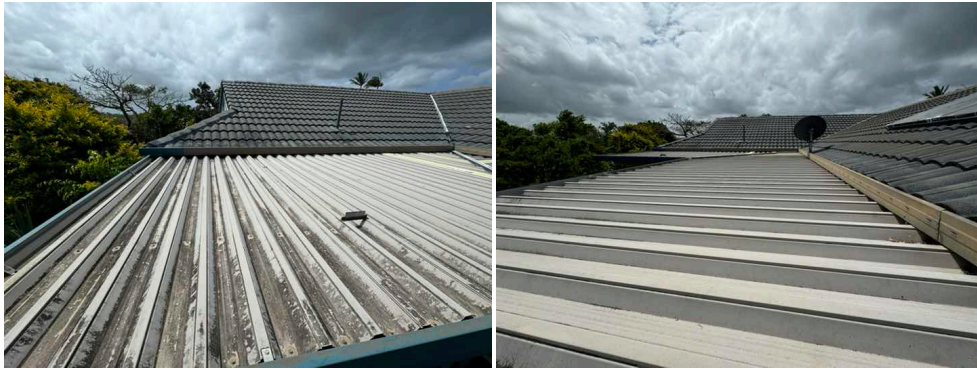
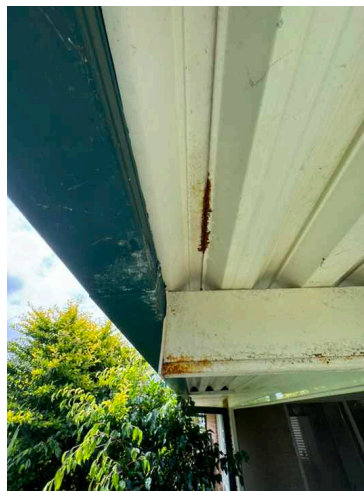
The Pergola is in a serviceable condition with no notable defects sighted.

Some rust beginning to attack the metal members. Have checked by a suitably qualified tradesman.

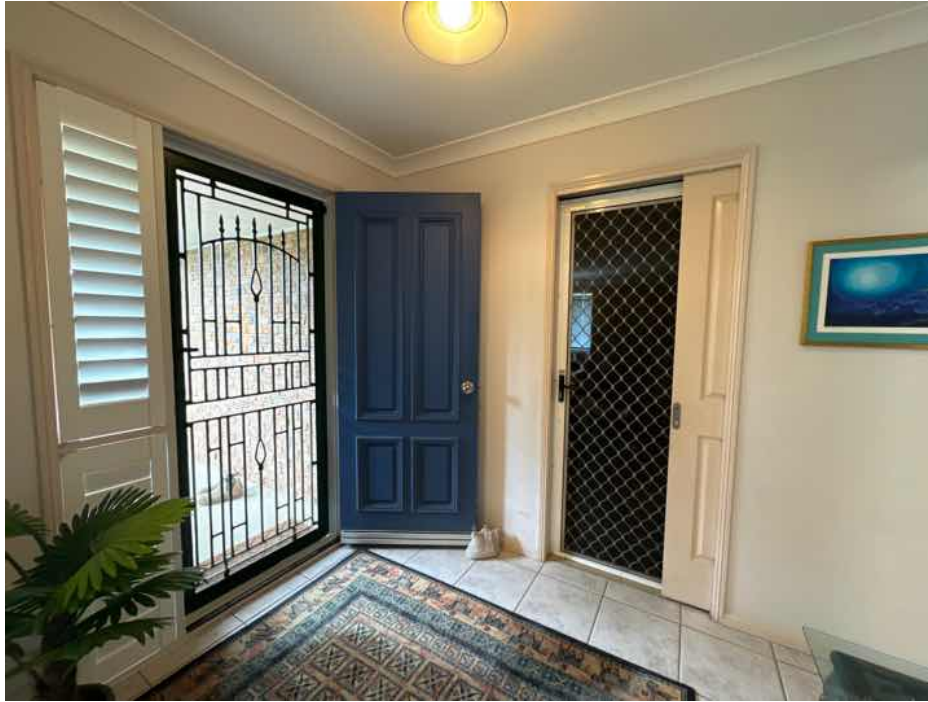
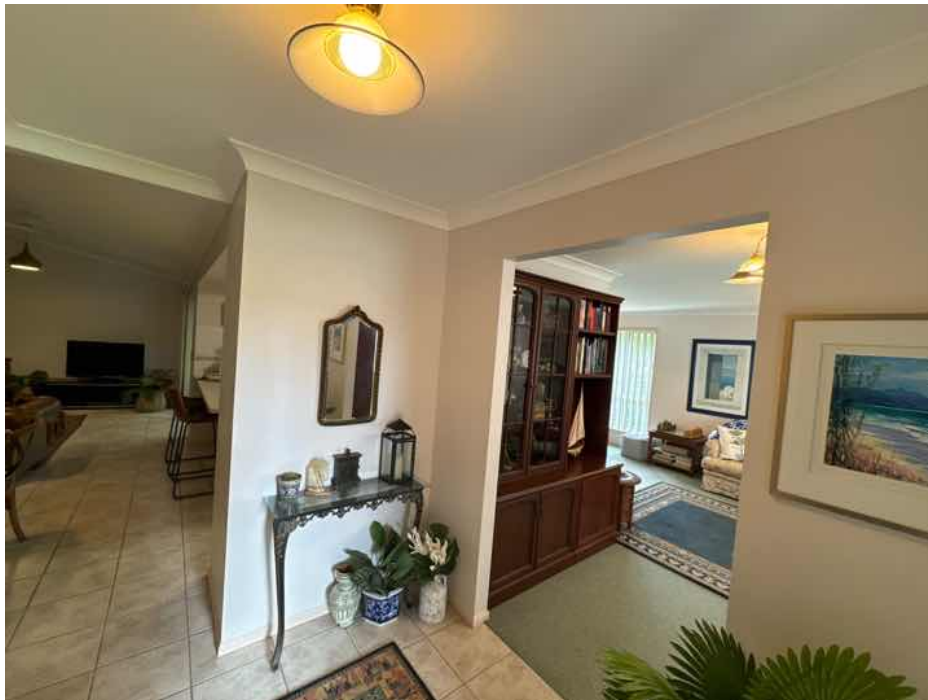
From the visible and accessible areas, this area appears to be in a serviceable condition for the age of the property with no notable structural defects sighted.

Typical cornice separation/detachment observed. I recommend you contact a qualified painter for repairs.

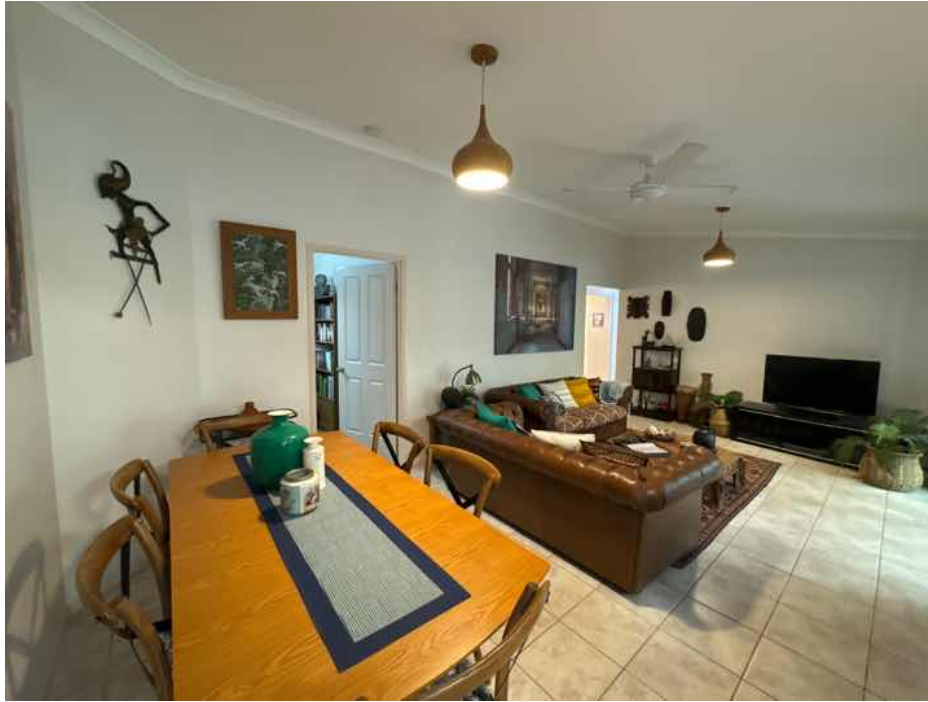
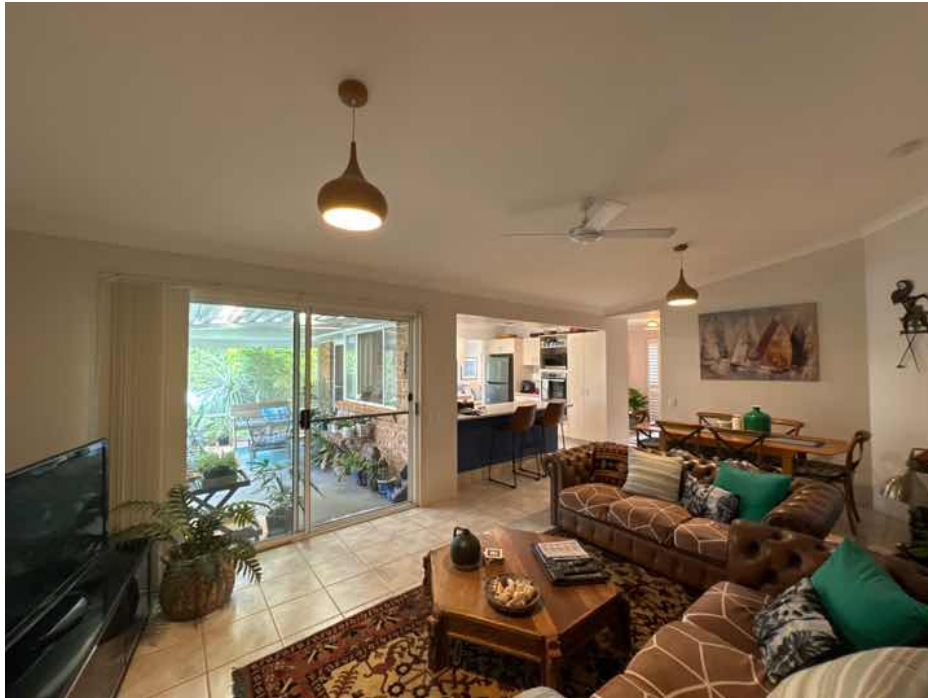
Family Room

From the visible and accessible areas, this room appears to be in a serviceable condition for the age of the property with no notable structural defects sighted.

Typical cornice separation/detachment observed. I recommend you contact a qualified painter for repairs.

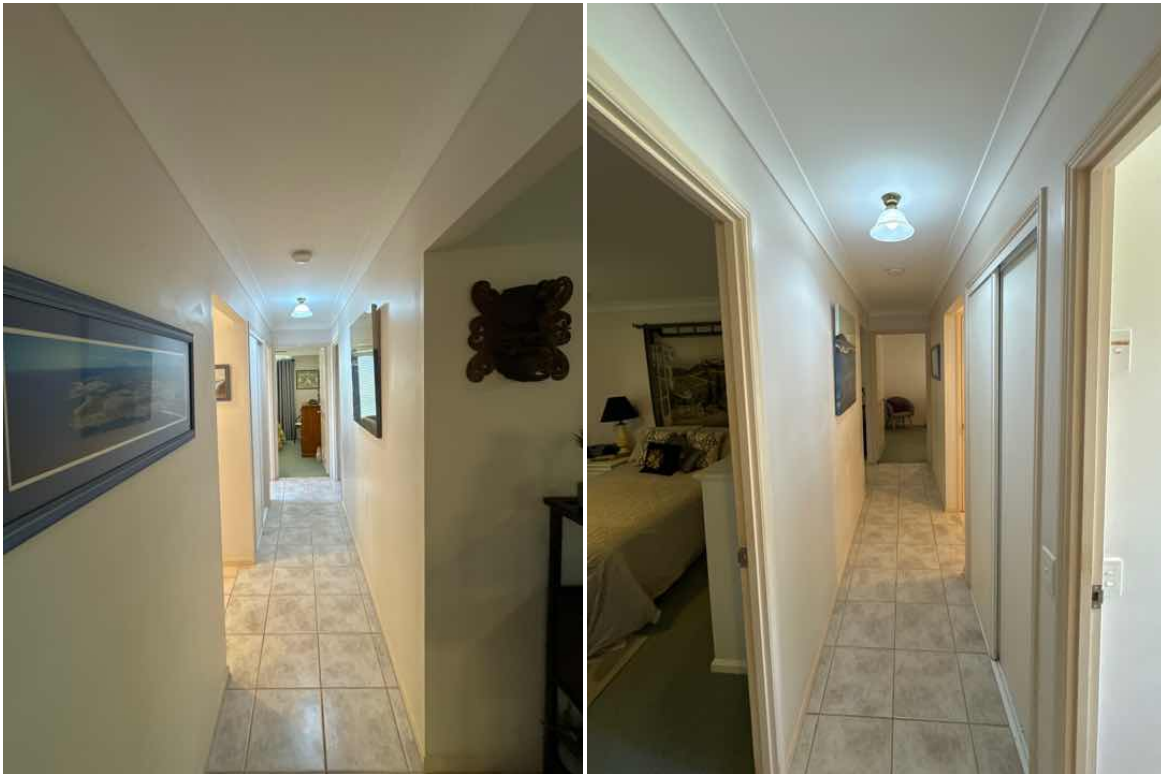
From the visible and accessible areas, the hallways/ appears to be in a serviceable condition for the age of the property with no notable structural defects sighted.

Typical cornice separation/detachment observed. I recommend you contact a qualified painter for repairs.

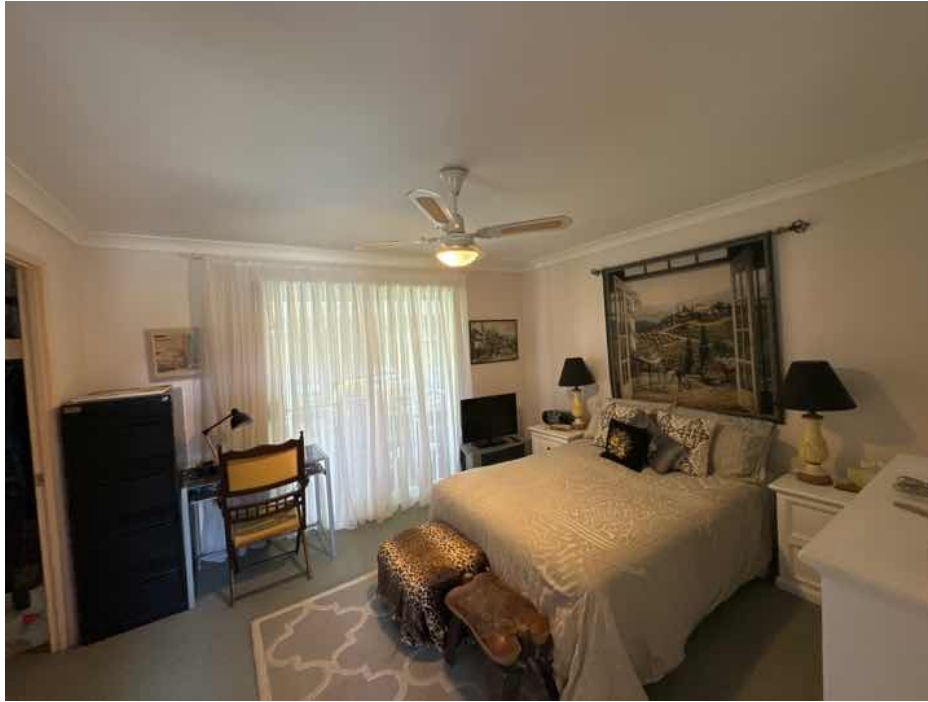
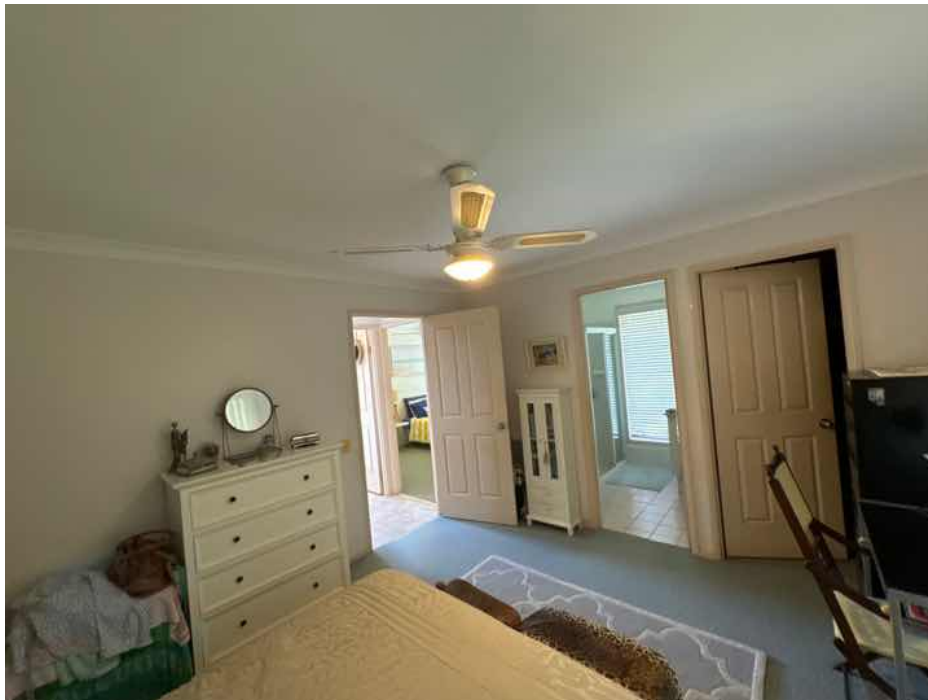
From the visible and accessible areas, this bedroom appears to be in a serviceable condition for the age of the property with no notable structural defects sighted.

Typical cornice separation/detachment observed. I recommend you contact a qualified painter for repairs.

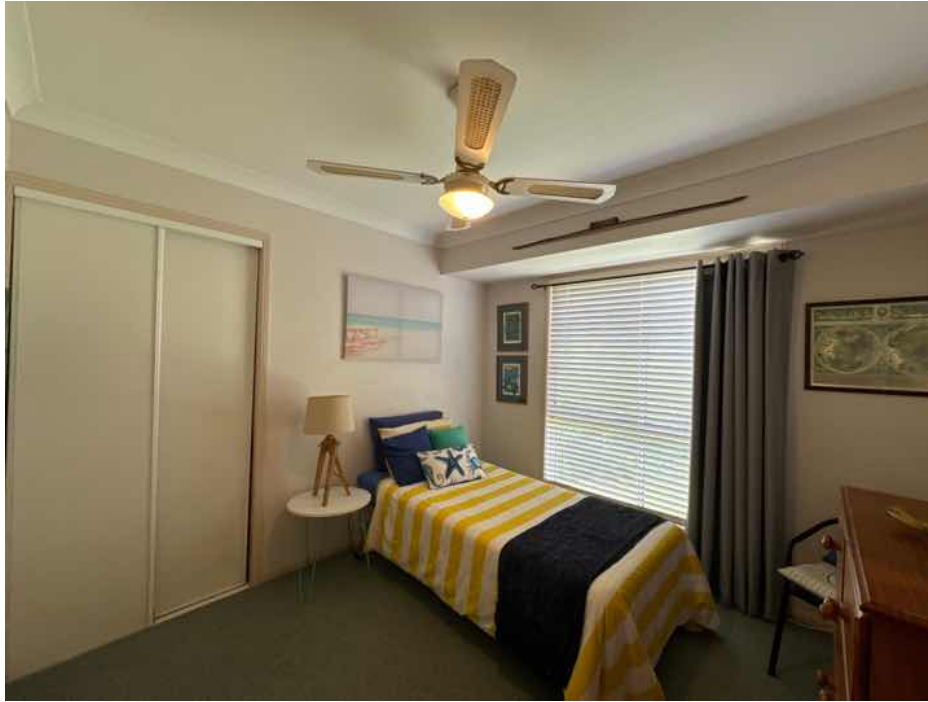
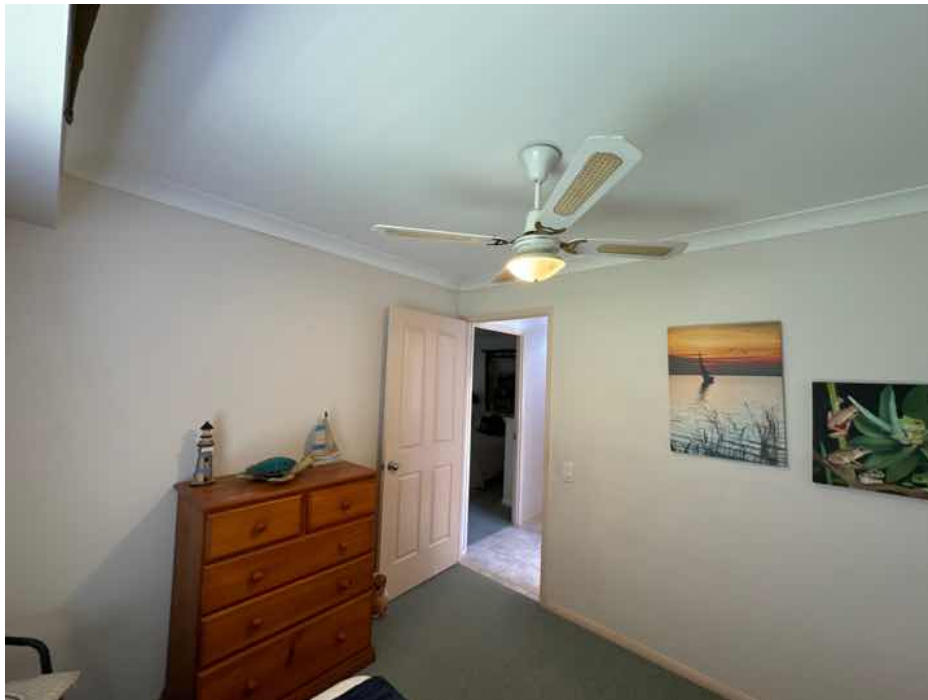
From the visible and accessible areas, this bedroom appears to be in a serviceable condition for the age of the property with no notable structural defects sighted.

Typical cornice separation/detachment observed. I recommend you contact a qualified painter for repairs.

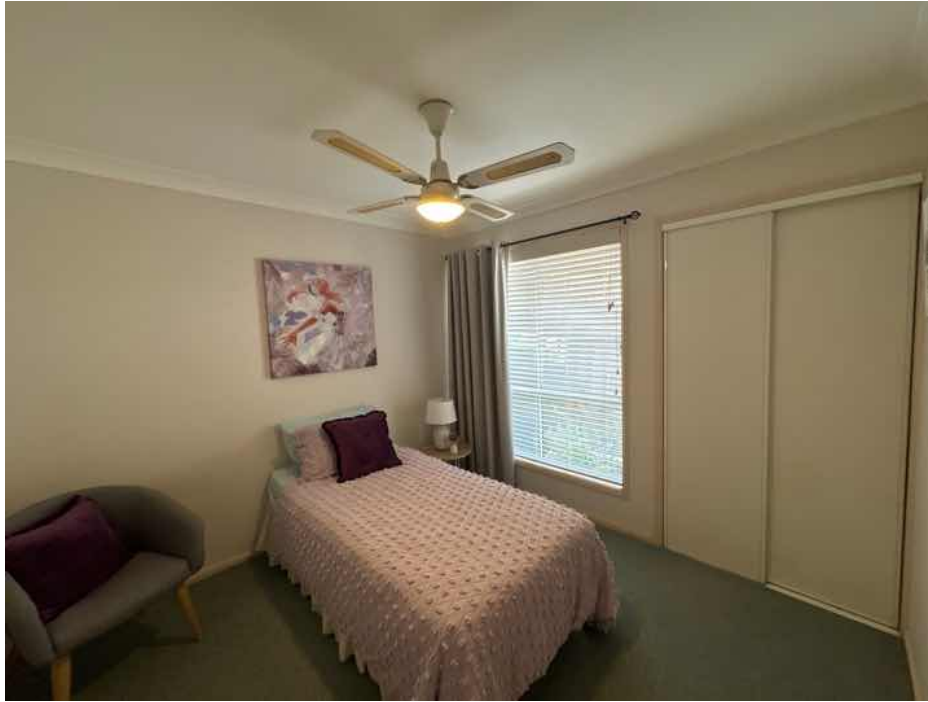
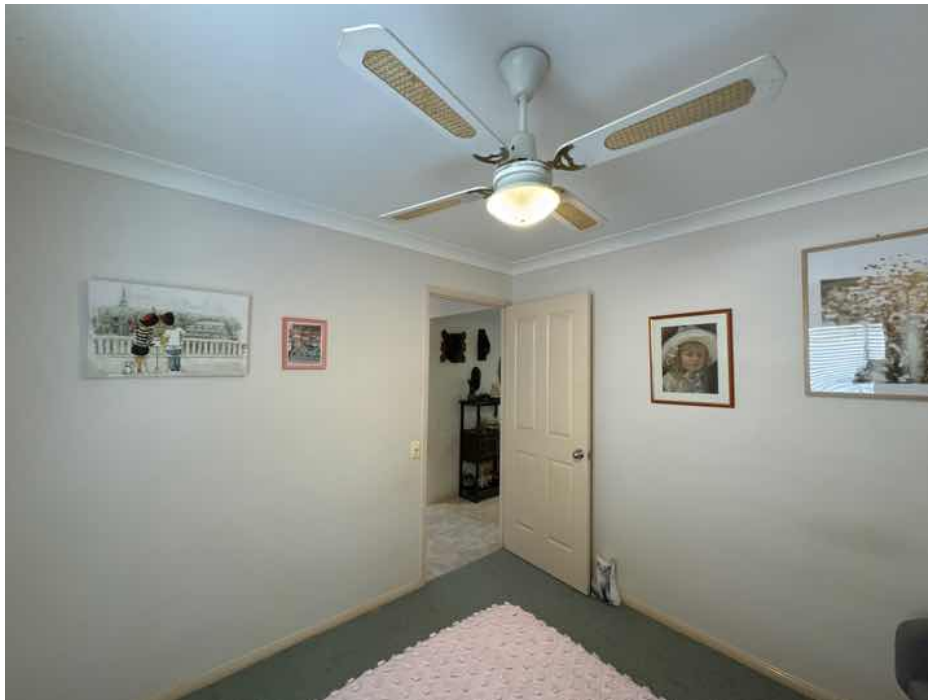
From the visible and accessible areas, this bedroom appears to be in a serviceable condition for the age of the property with no notable structural defects sighted.

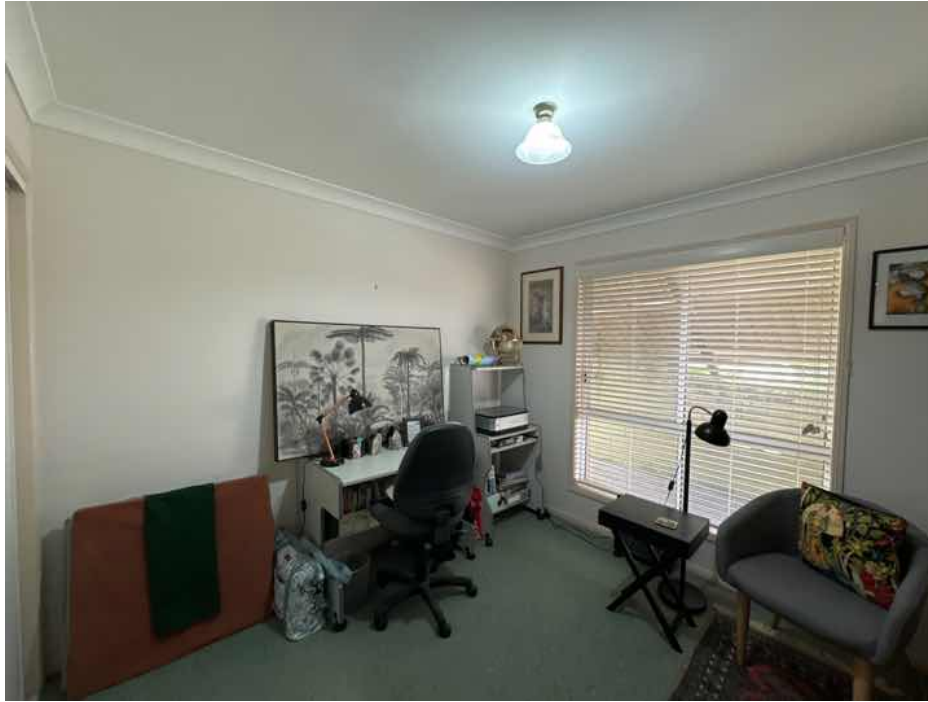
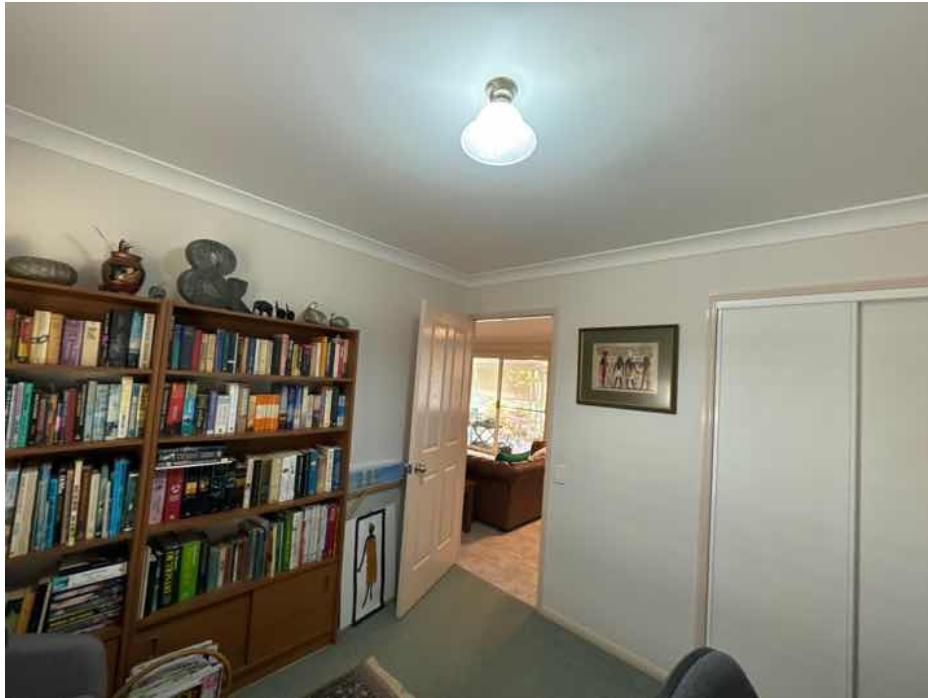
Bedroom 4

From the visible and accessible areas, this bedroom appears to be in a serviceable condition for the age of the property with no notable structural defects sighted.

Typical cornice separation/detachment observed. I recommend you contact a qualified painter for repairs.

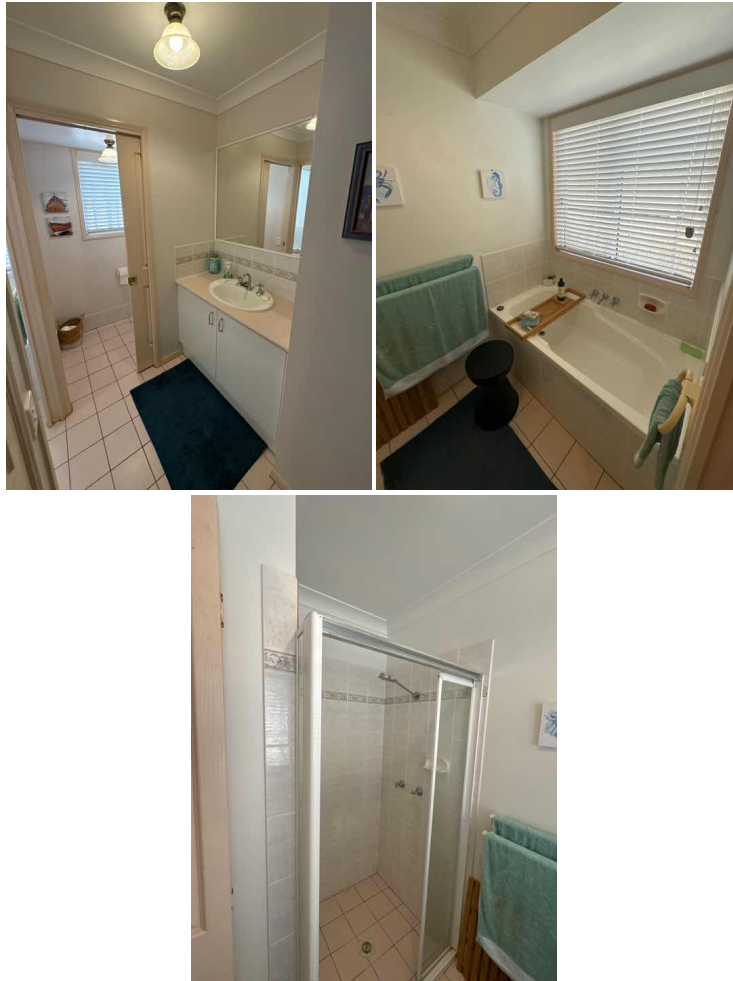
Of the visible areas, the general condition of this bathroom is serviceable or in reasonable condition for age of dwelling.

Cornice separation. I recommend you contact a licensed plasterer for repairs.

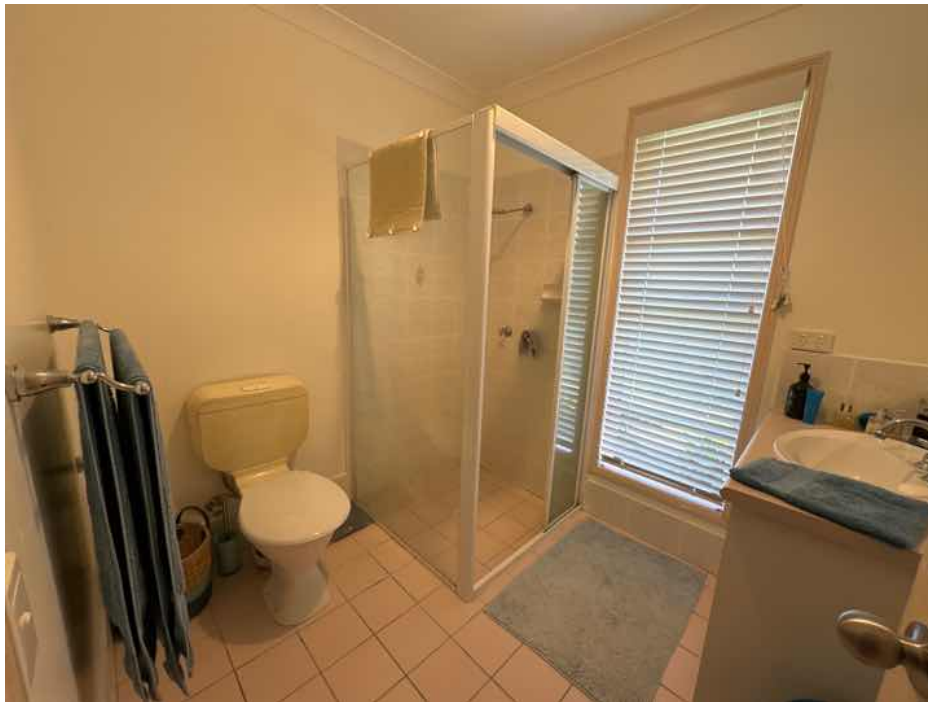
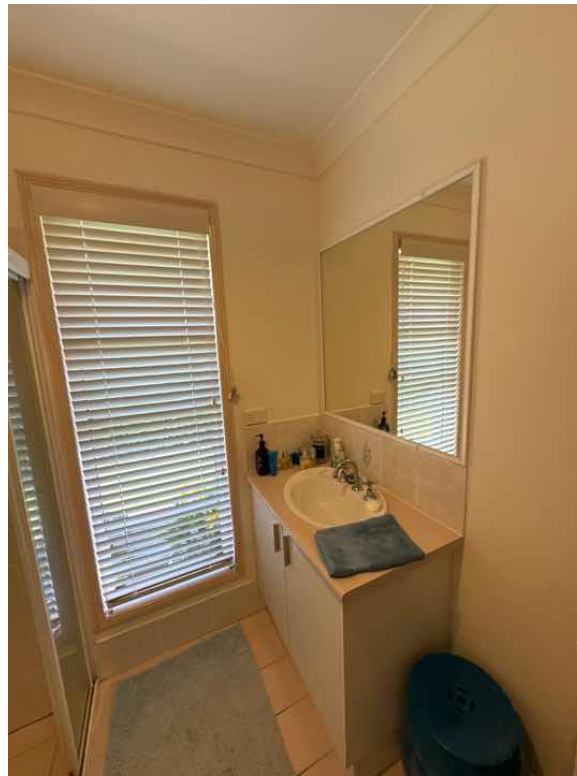
Of the visible areas, the general condition of this bathroom is serviceable or in reasonable condition for age of dwelling.

Cornice separation. I recommend you contact a licensed plasterer for repairs.

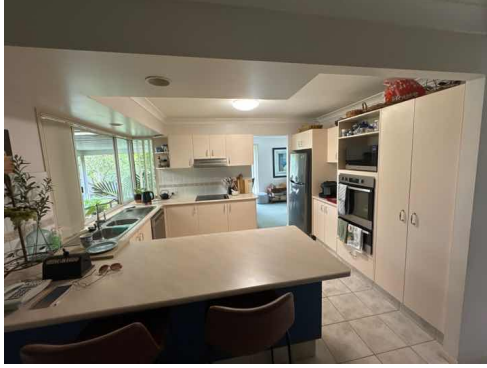
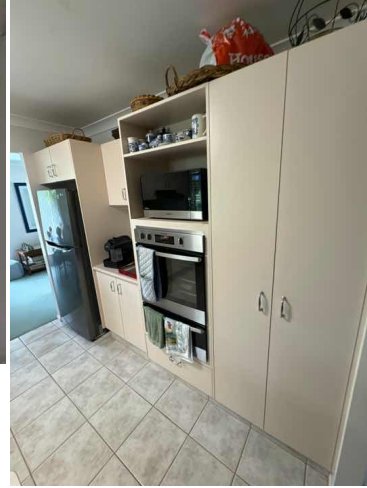
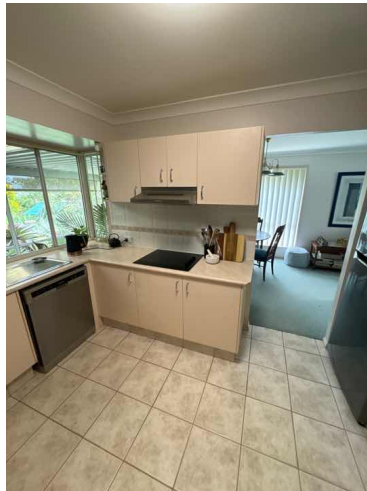
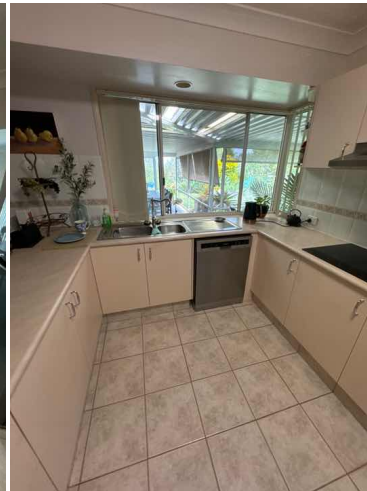
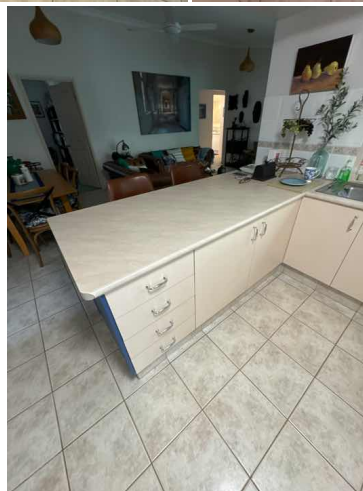
Cornice separation. I recommend you contact a licensed painter for repairs.

Some chipped and damaged tiled were noted. Replacement recommended by a qualified tiler

Drummy tiles noted. This needs to be repaired at the earliest as this has the potential to lead to many related issues such as damp, water ingress to other areas and cracked tiles. Contact a qualified tiler for repairs and recommendation.

Adjustment to cabinet doors required, in some instance hinges may need to be replaced.

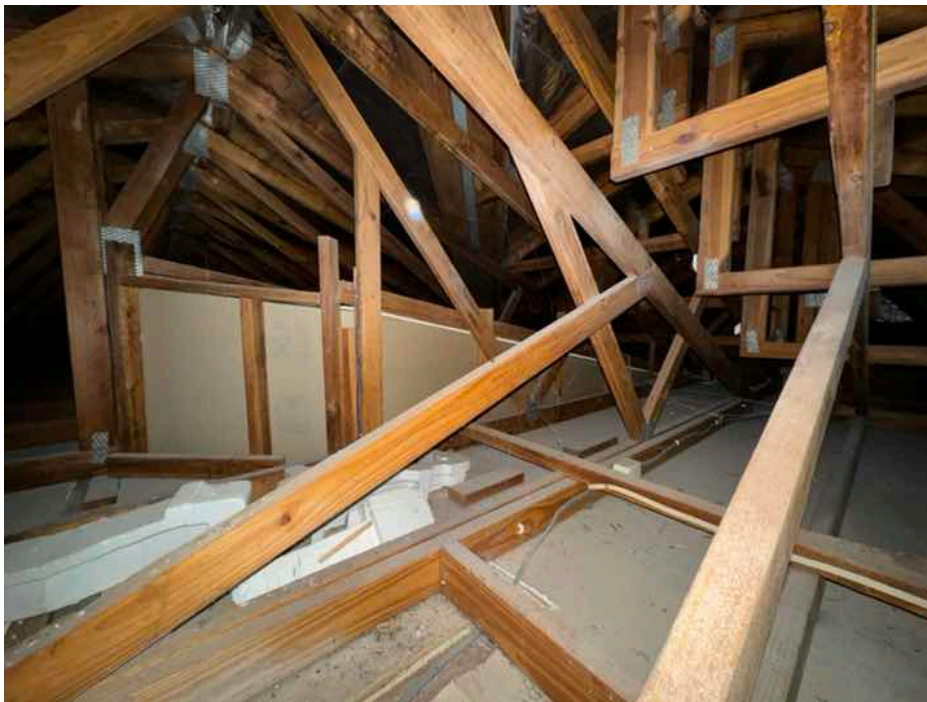
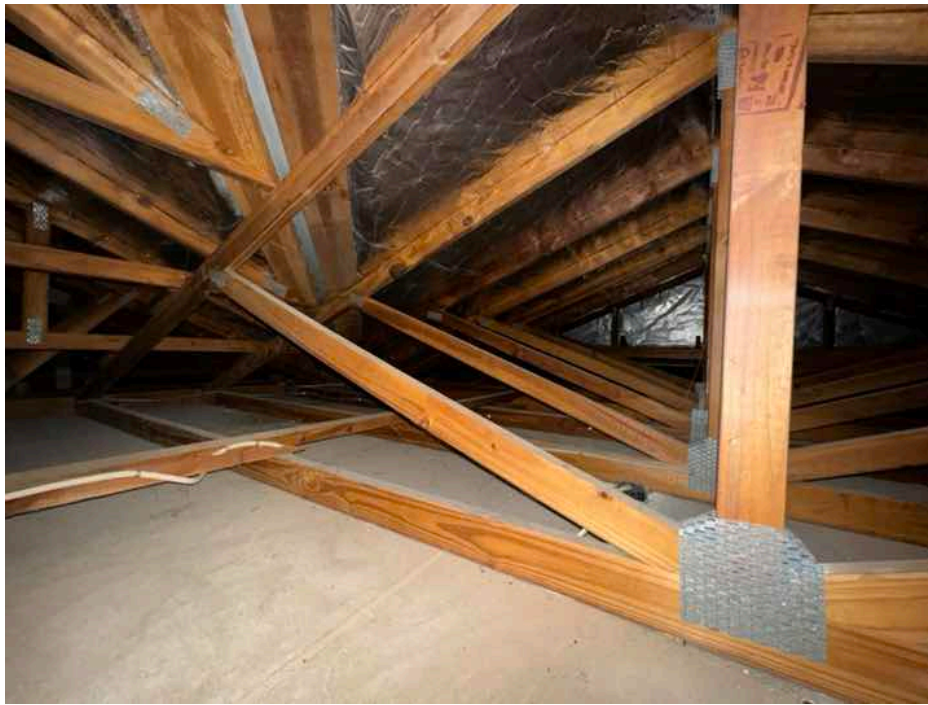
Visible sections of the roof void is in a serviceable condition for age of this dwelling.

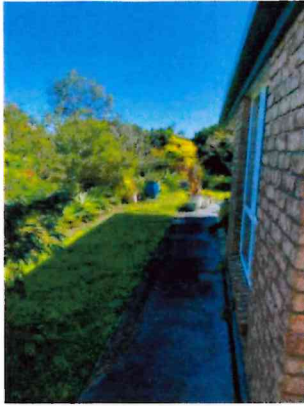
Showing rear of dwelling.

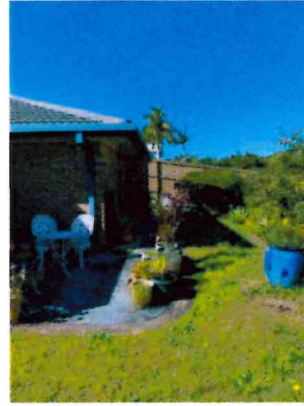
Showing rear of dwelling.

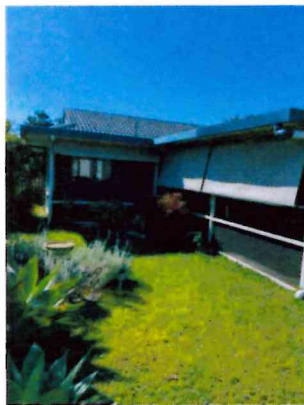
Showing rear of dwelling.

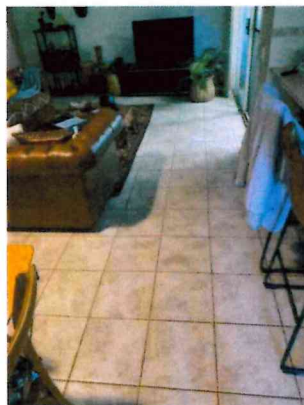
Showing internal flooring.
