# Building and Pest Report

## 58B Stoneyhurst Dr, Lennox Head

### Pest And Building Inspection

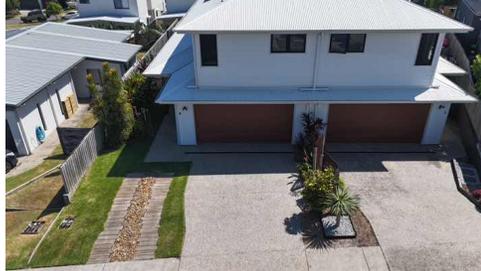
On visual inspection, the general condition of the driveway is serviceable.

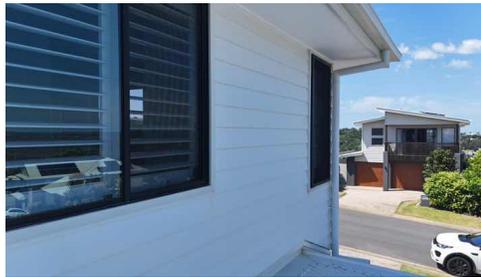
The downpipe/s wall clips is detached or missing. Although minor and easily rectifiable, we recommend a licensed roof plumber be engaged for repairs.

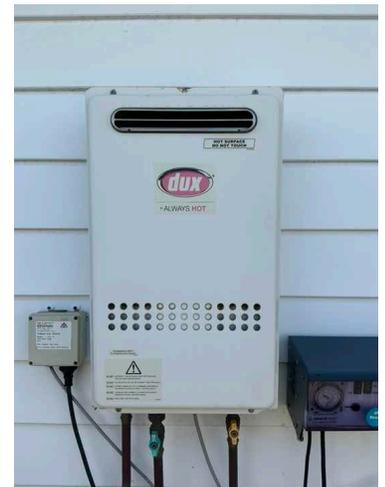
The make of the hot water unit is dux.
