Building and Pest Report

127a Montwood Dr, Lennox Head

Pest And Building Inspection

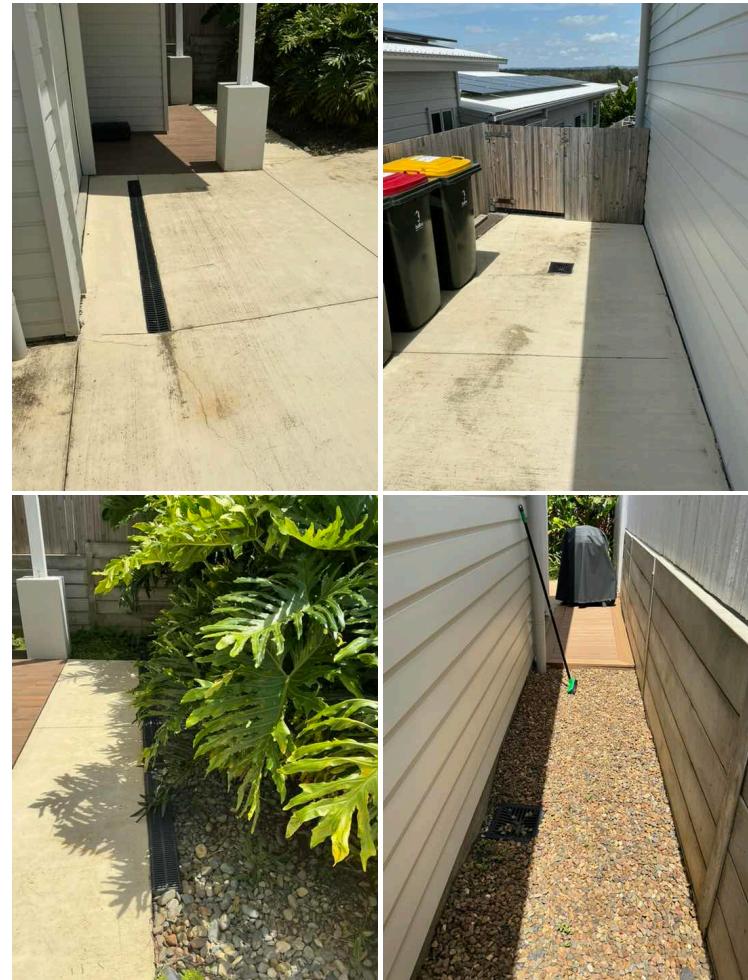
Drainage Findings

There was no visible evidence of excess ponding or fall towards the property walls at the time of the inspection. Regardless, it is difficult to ascertain in dry conditions and it is therefore recommended that you assess same after a rainfall period to be able to sufficiently ascertain if any problems exist in this regard. If water is ponding around perimeter walls and paths or appears to be flowing into the footings/foundations you must have assessed by a qualified plumber or landscaper.

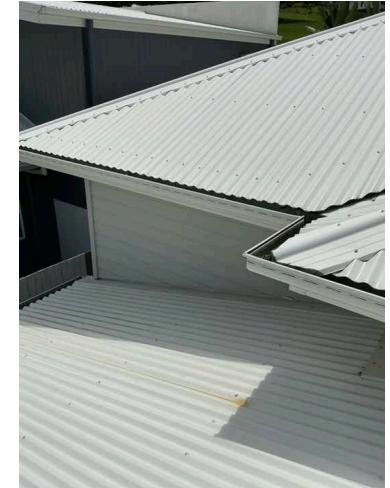
Of the visible areas, the general condition of the roof is in serviceable condition for the age.

Note: In the absence of rainfall there is no guarantee that the roof won't leak.

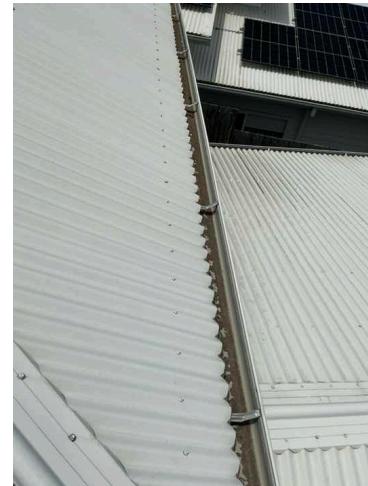
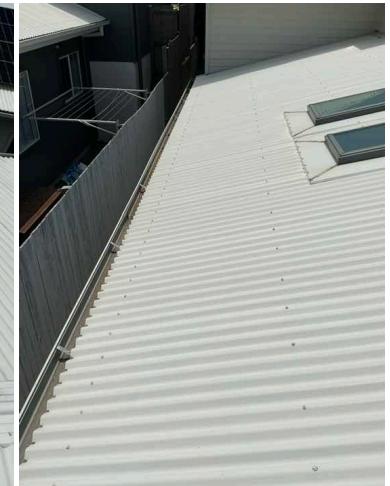
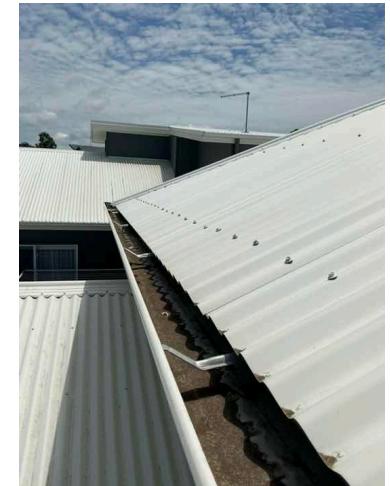
Gutter Findings

All visible and accessible of the physical nature of the guttering system appears to be in a serviceable condition with no apparent defects at the time of inspection. In the absence of prolonged rain fall efficiency of the guttering can not be assessed and you may find that further investigation or repairs maybe required. Note: Periodic maintenance checks should be carried out for rust penetrations and leaks.

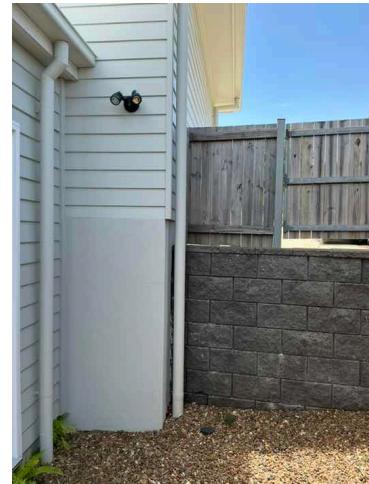
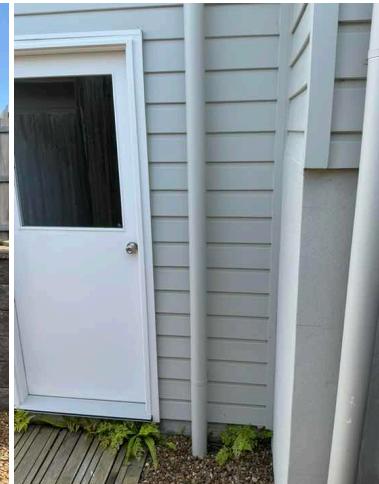
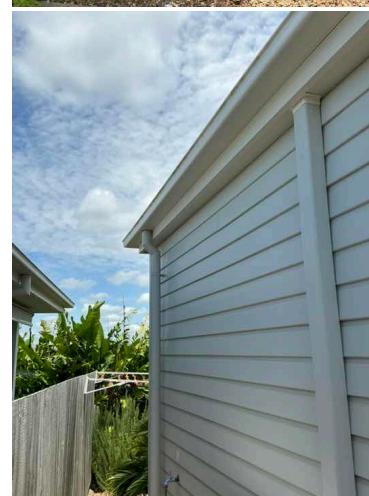
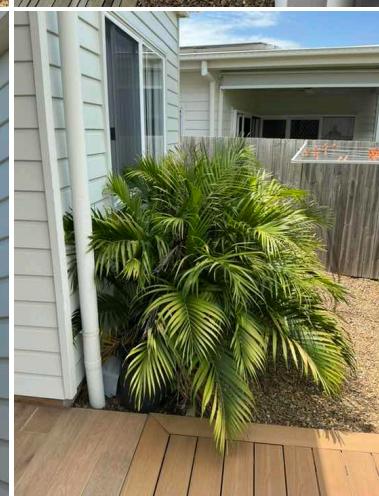
Downpipe Findings

On visual inspection no apparent defects were noted to the down pipes and are considered serviceable, however no comment can be made with regard to blockages or connections to stormwater or functionality in the absence of rain. Note: Periodic maintenance checks should be carried out for rust penetrations and leaks.

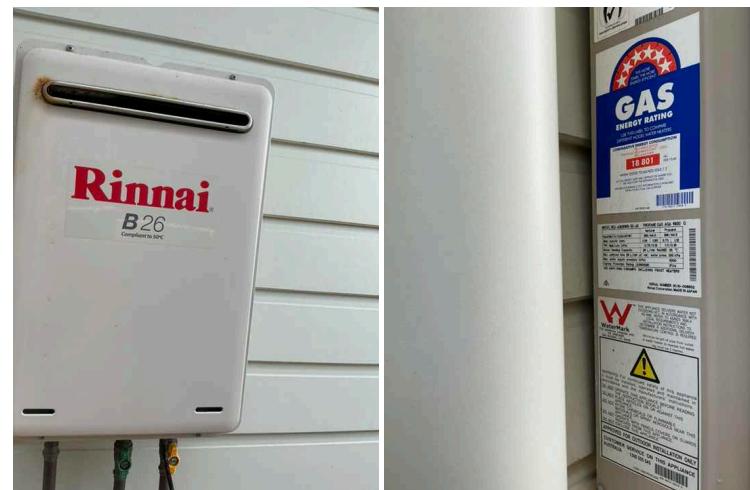
System Make

The make of the hot water unit is rinnai.

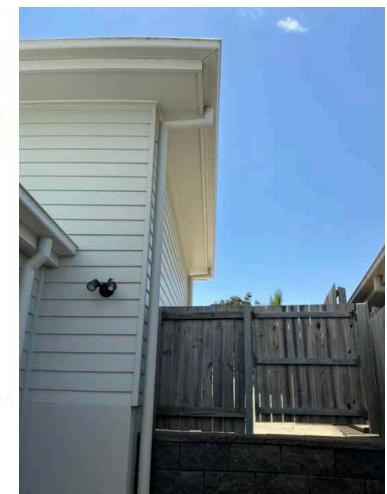
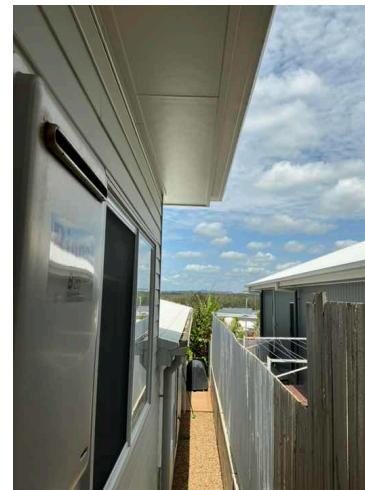
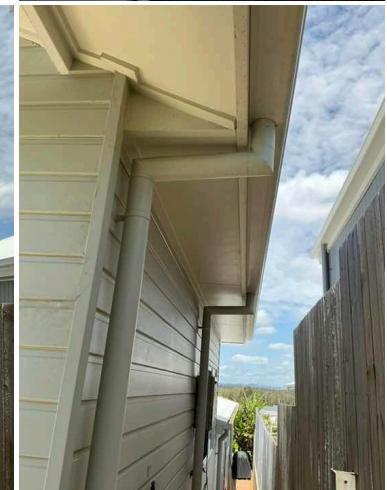
Eave Condition

The soffit lining (eaves) are in a serviceable condition with no notable defects.

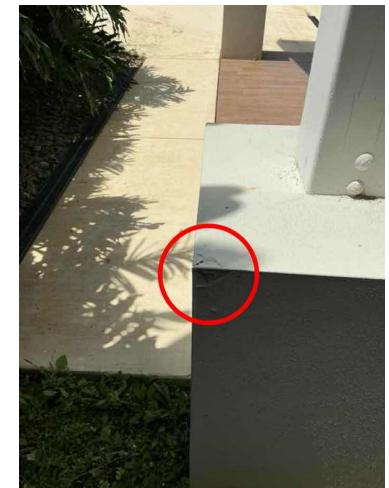
Overall Condition

The entry porch serviceable or in reasonable or condition for the age of this dwelling.

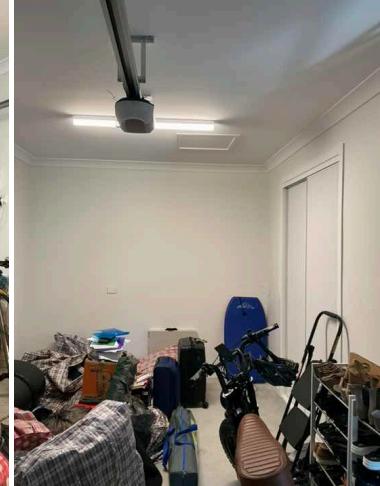
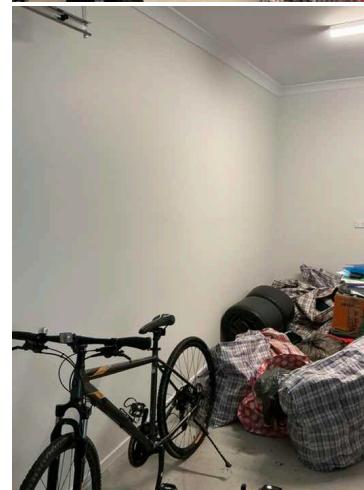
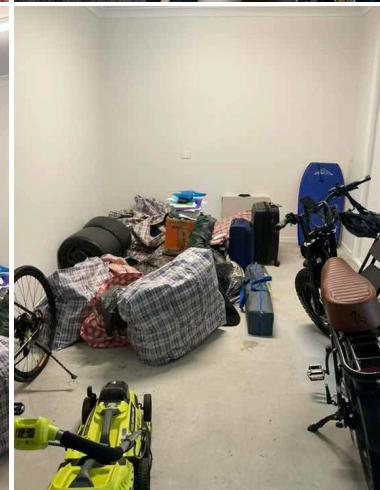
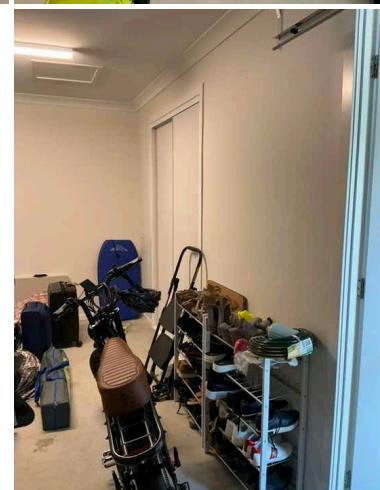
Stored items restricted a full and thorough inspection of this area. Defects may exist in the obstructed and inaccessible areas. It is strongly recommended that full access be granted to enable a thorough inspection as there may be timber pest activity, damage or defects. Note: Where vehicles and storage has restricted a full inspection it is advised that this area be cleared so a full and unobstructed inspection can be carried out.

From the visible and accessible areas, the garage appears to be in a serviceable condition for the age of the property with no notable structural defects sighted.

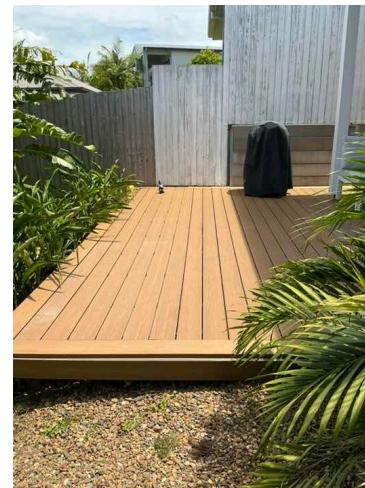
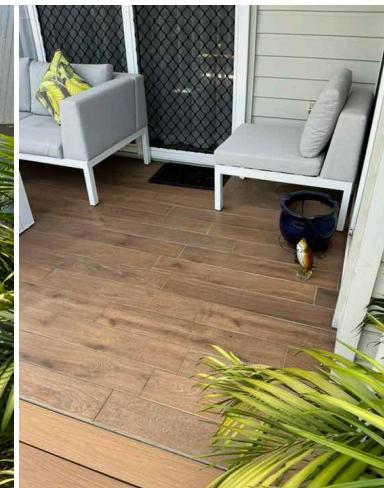
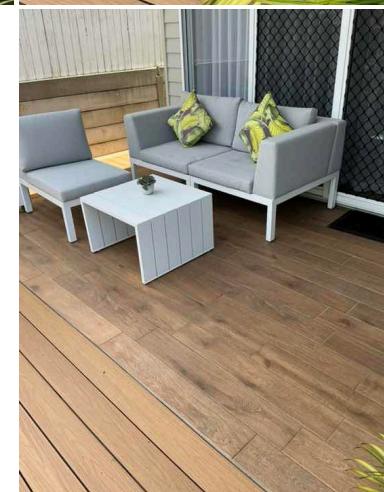
Decking Findings

Of areas visible, the decking appears to be in a serviceable condition.

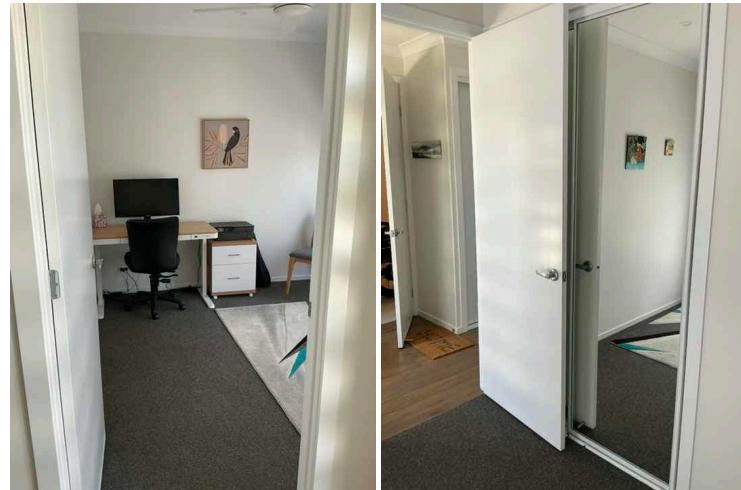
Study

From the visible and accessible areas, this room appears to be in a serviceable condition for the age of the property with no notable structural defects sighted.

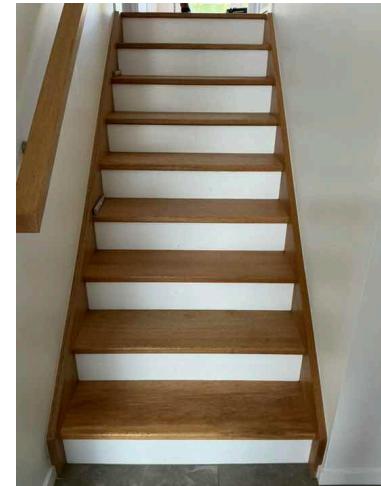
Internal Stair Case

The internal staircase and components appear to be in a serviceable condition for the age with no notable defects sighted.

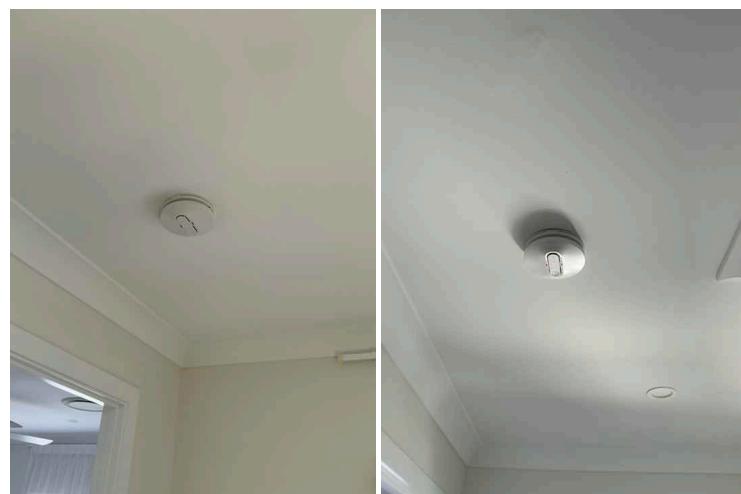
Yes 2 smoke alarms were sighted but not tested.

Legislation requires smoke Alarms to be installed. Check with your local council regarding type, locations and other related requirements.

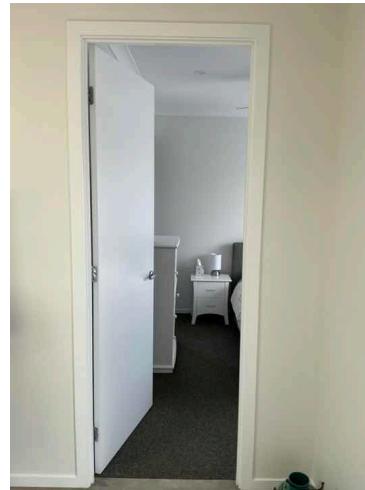
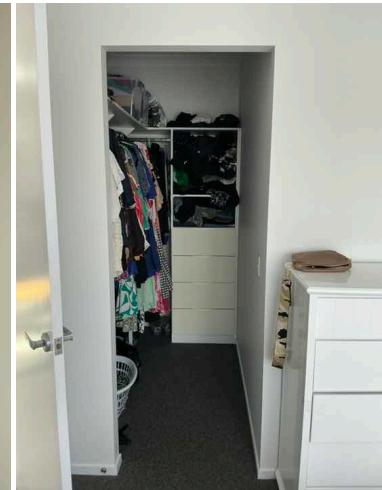
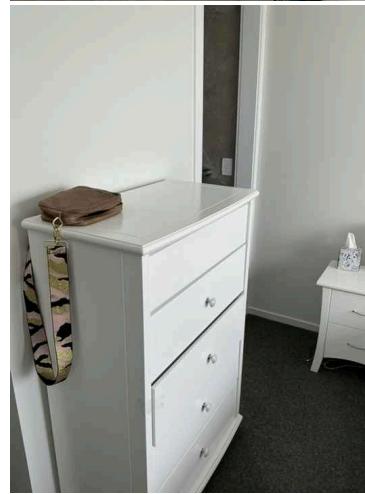
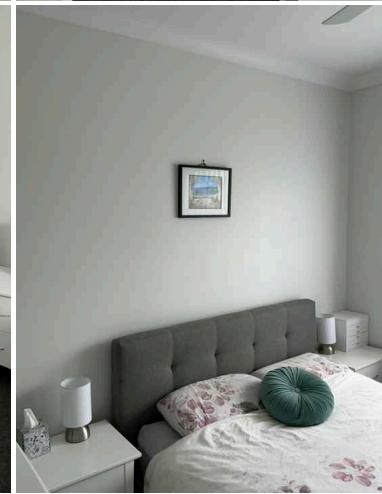
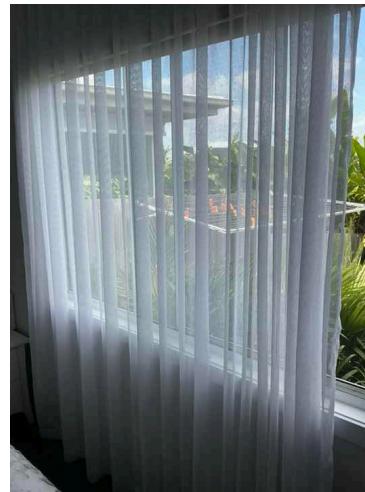
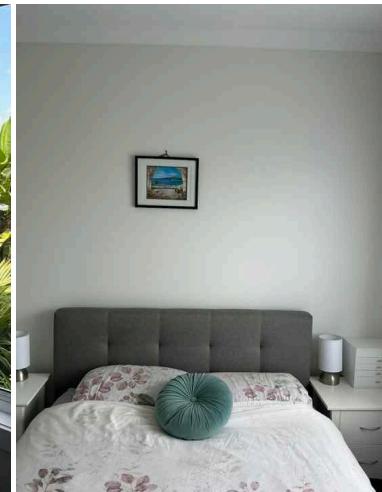
Bedroom 1

From the visible and accessible areas, this bedroom appears to be in a serviceable condition for the age of the property with no notable structural defects sighted.

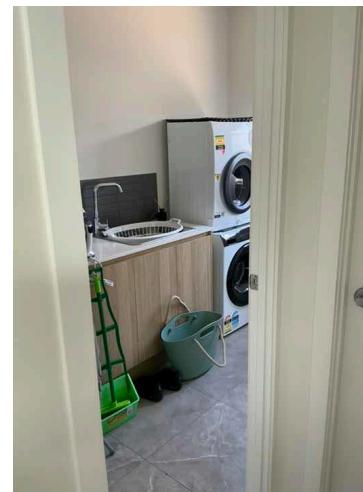
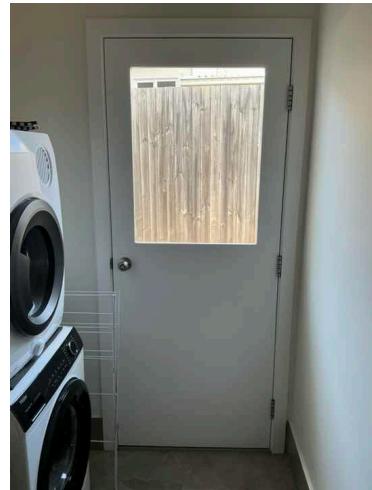
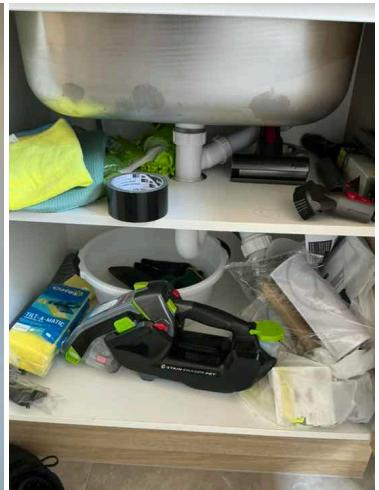
Of the visible areas, the general condition of the laundry is serviceable or in reasonable condition for age of dwelling.

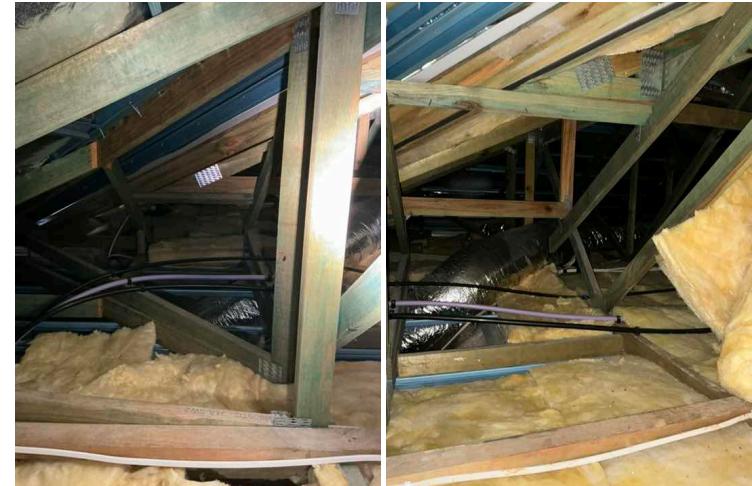
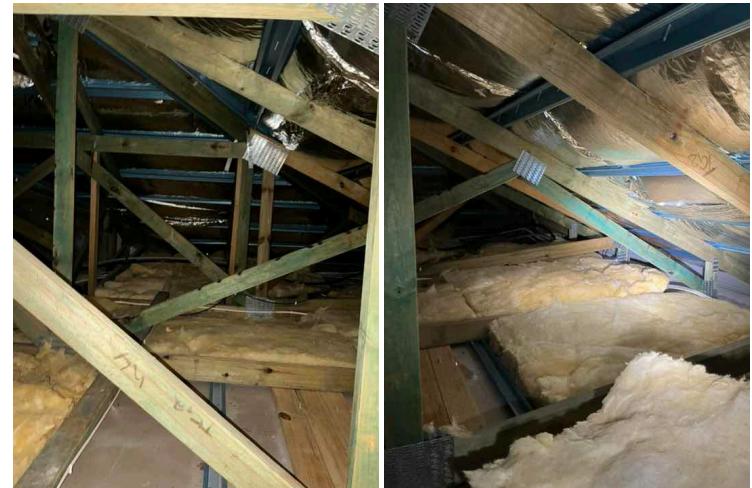
Visible sections of the roof void is in a serviceable condition for age of this dwelling.

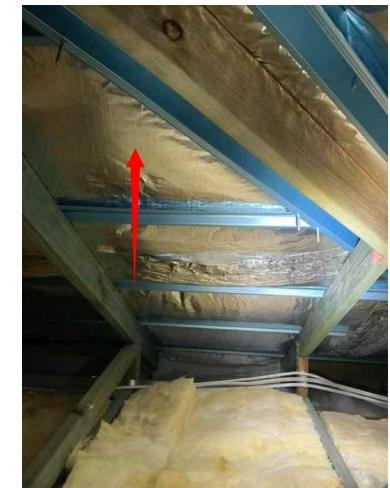
The sarking generally is in a serviceable condition.

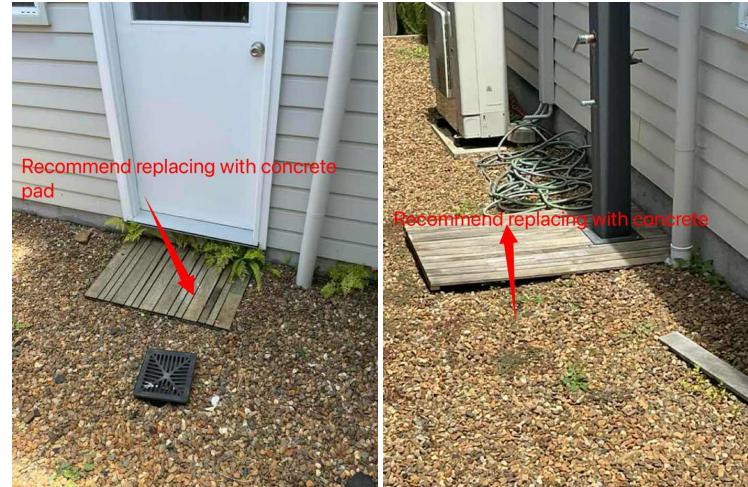
No visible pipe leaking found at time of inspection.

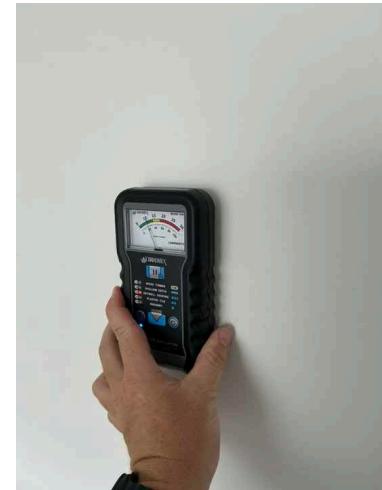
At the time of the inspection, our electronic moisture meter readings were normal.
