# Inspection Report

## East Coast Building Solutions

**24 Antrim Street, East Ballina, NSW, 2478**

### Pest And Building Inspection

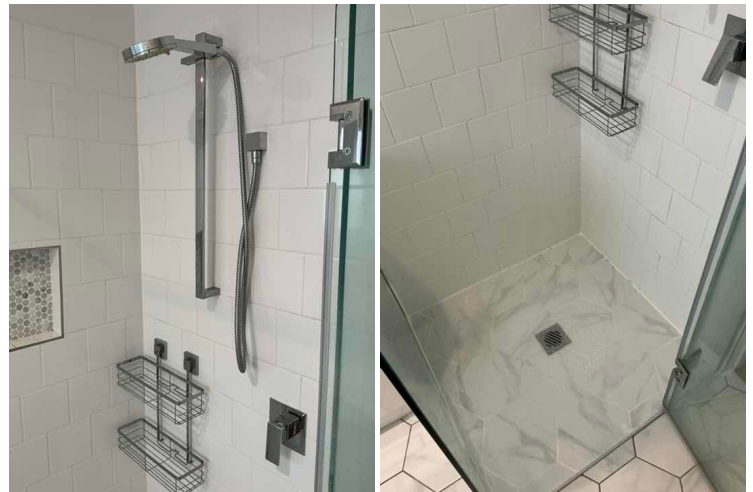
Of the visible areas, the general condition of this bathroom is serviceable or in reasonable condition for age of dwelling.

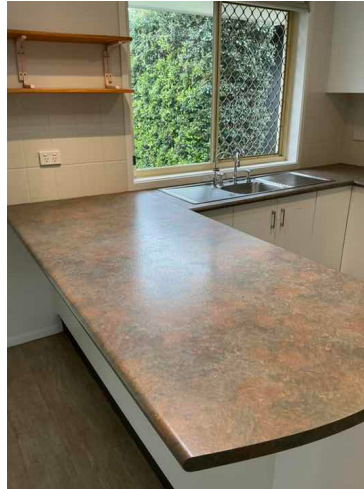
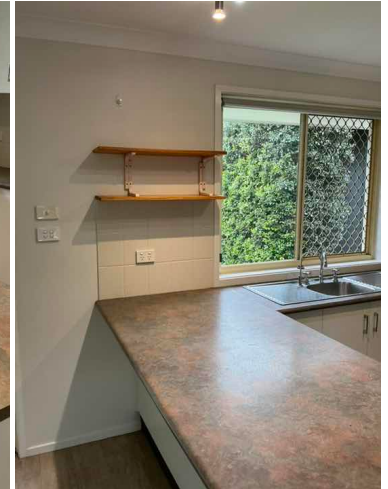
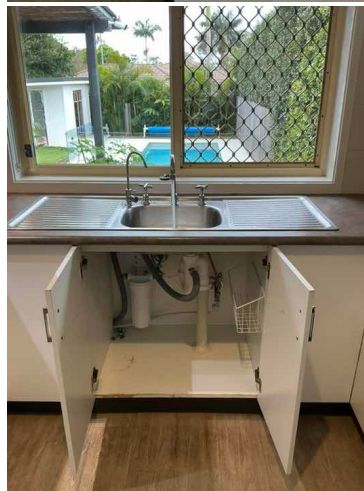
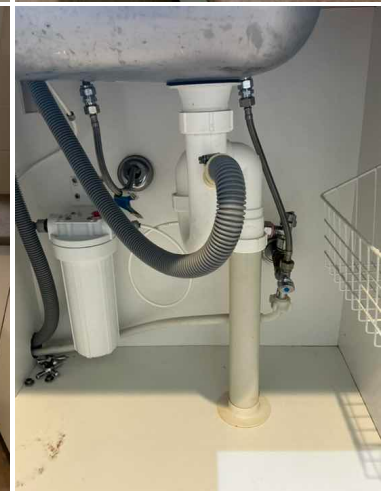
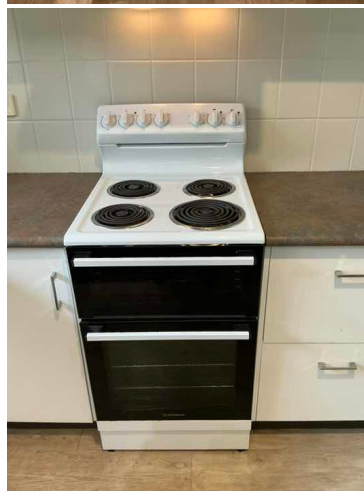
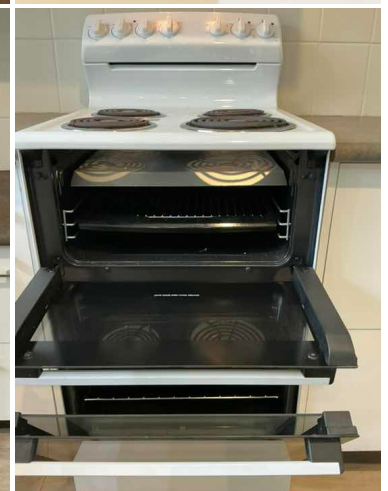
Of the visible areas, the general condition of the kitchen and pantry is serviceable or in reasonable condition for age of dwelling.

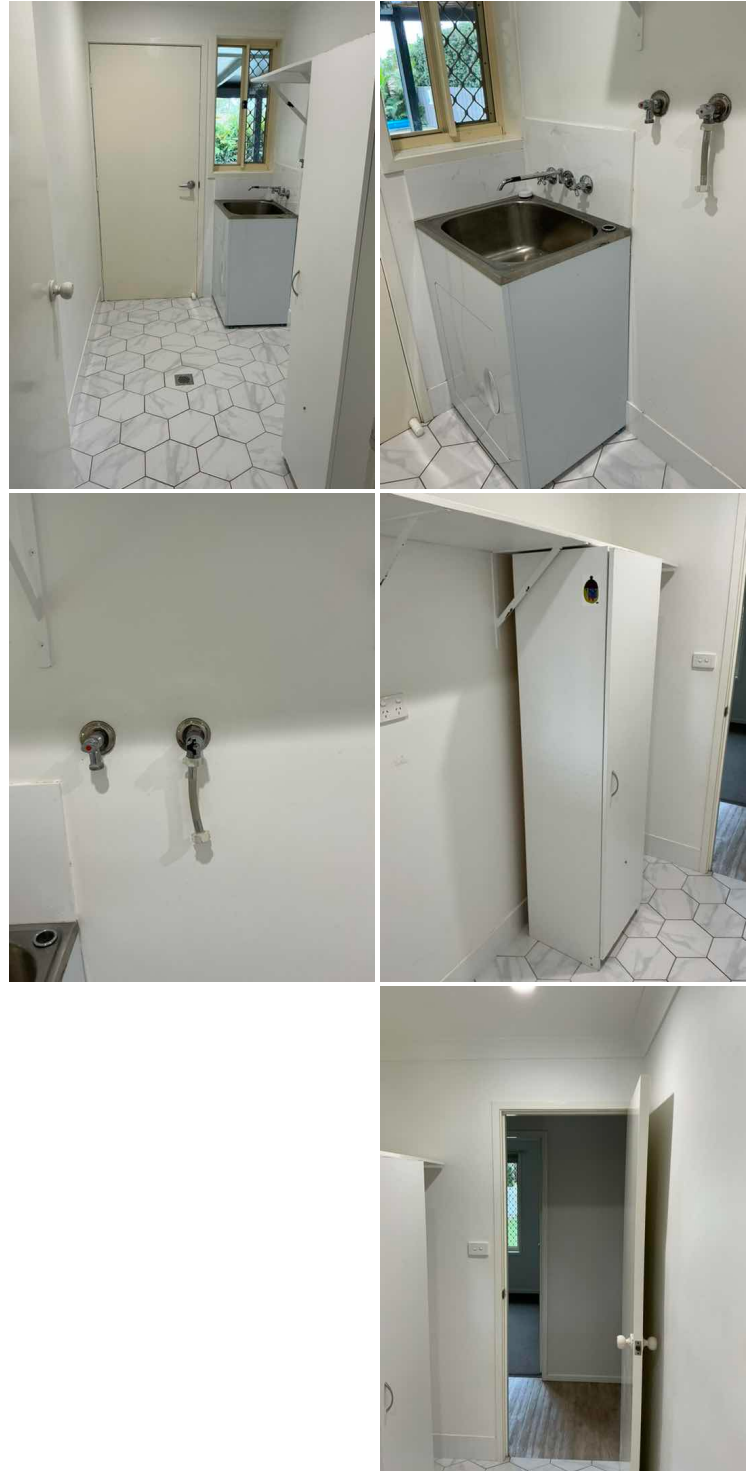
Of the visible areas, the general condition of the laundry is serviceable or in reasonable condition for age of dwelling.

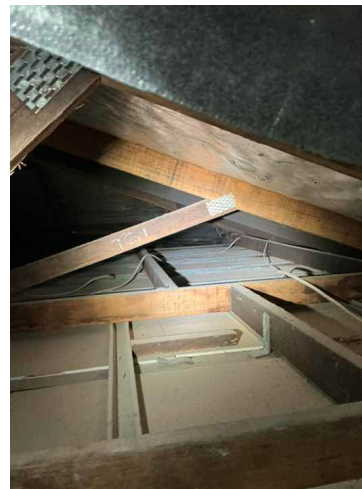
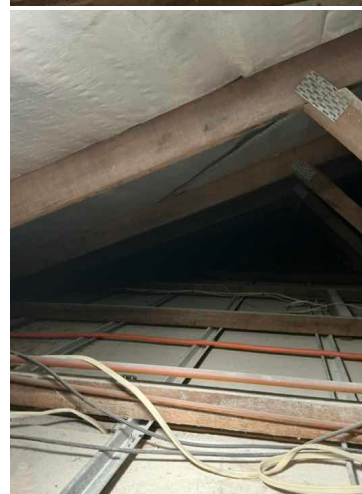
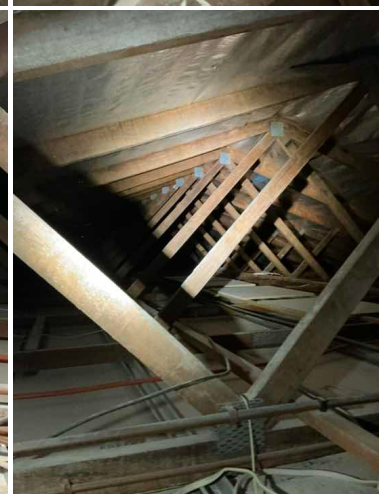
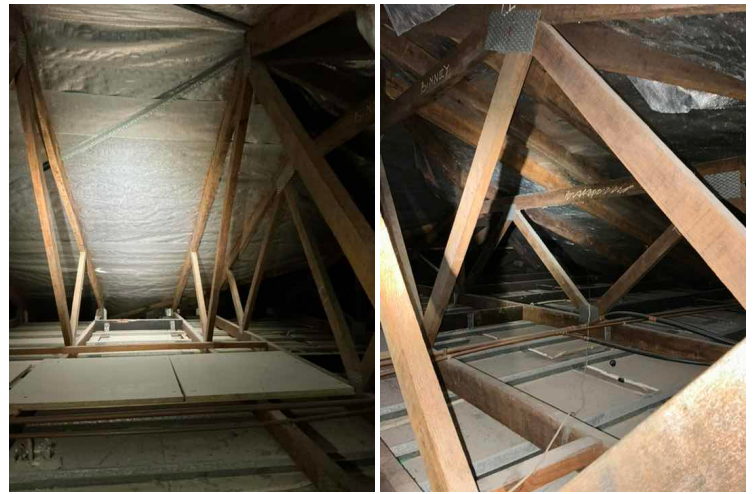
Visible sections of the roof void is in a serviceable condition for age of this dwelling.

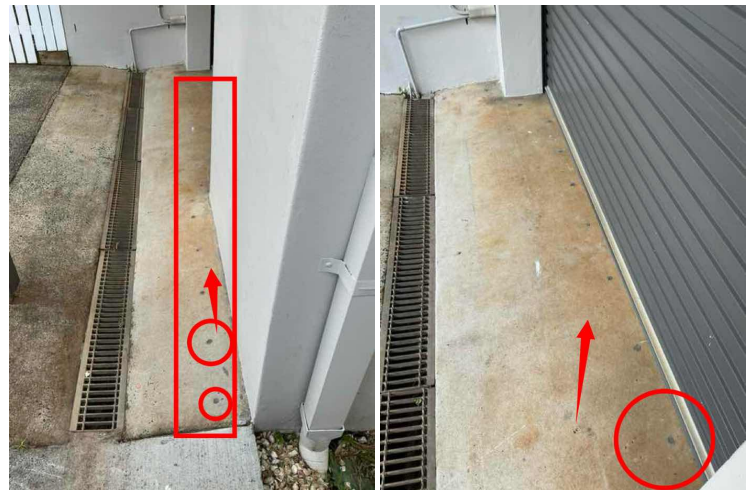
Yes, a reticulated pipe system was located at the dwelling.

Yes, Drill Holes (Chemical Treatment) were located at the property.

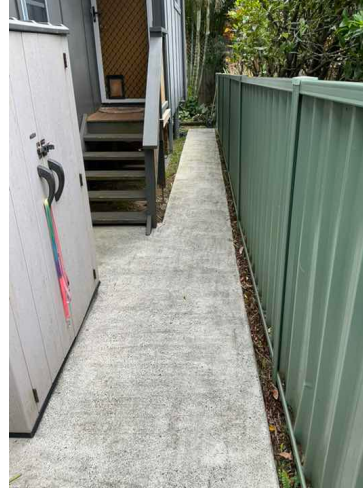
The paths around the home are in a serviceable condition for the age of this dwelling with no major defects visible.

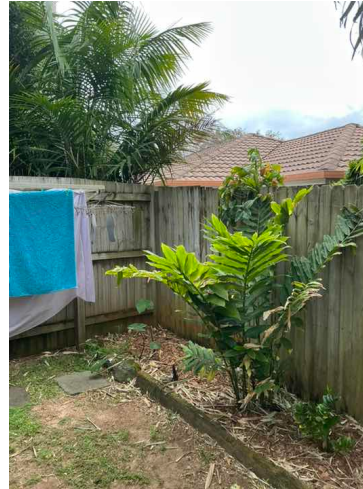
Of the visible areas, the general condition of the fences and gates is serviceable for the age of dwelling.

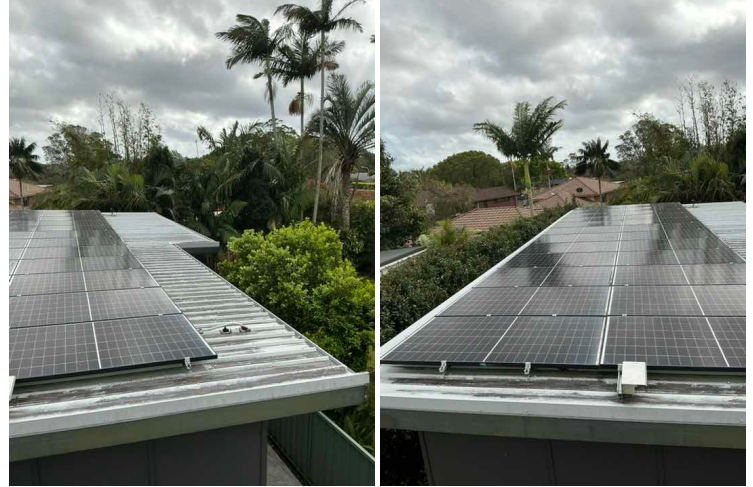
Of the visible areas, the general condition of the roof is in serviceable condition for the age.

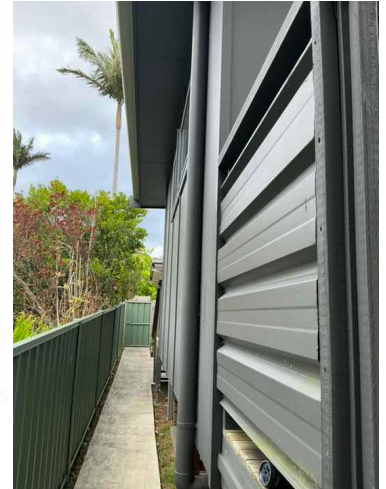
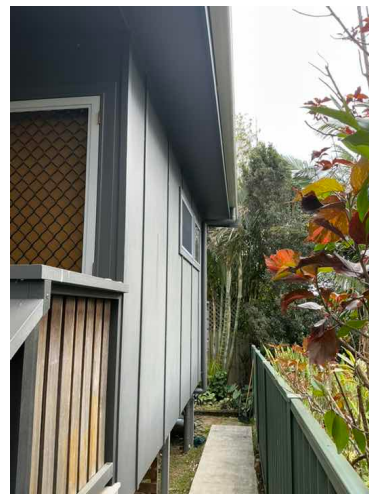
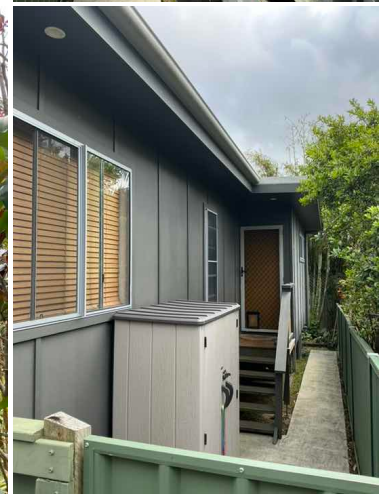
The soffit lining (eaves) are in a serviceable condition with no notable defects.

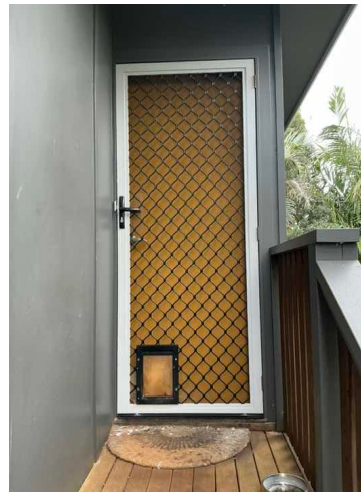
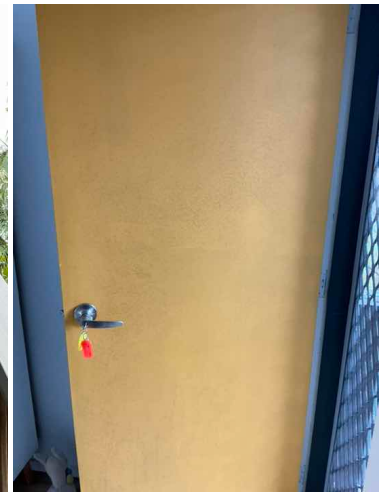
On Visual Inspection the external condition of the doors is serviceable.

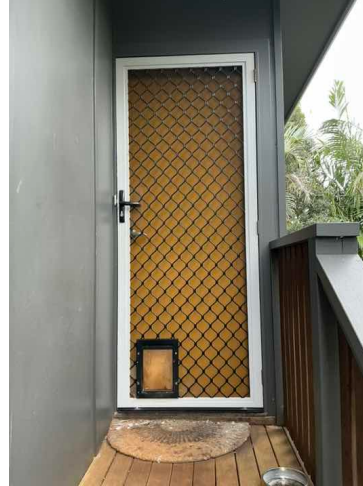
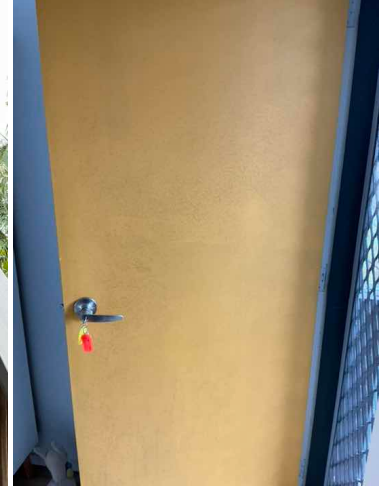
#### **Front Entry Doors**

The doors are in serviceable condition with no notable defects observed.

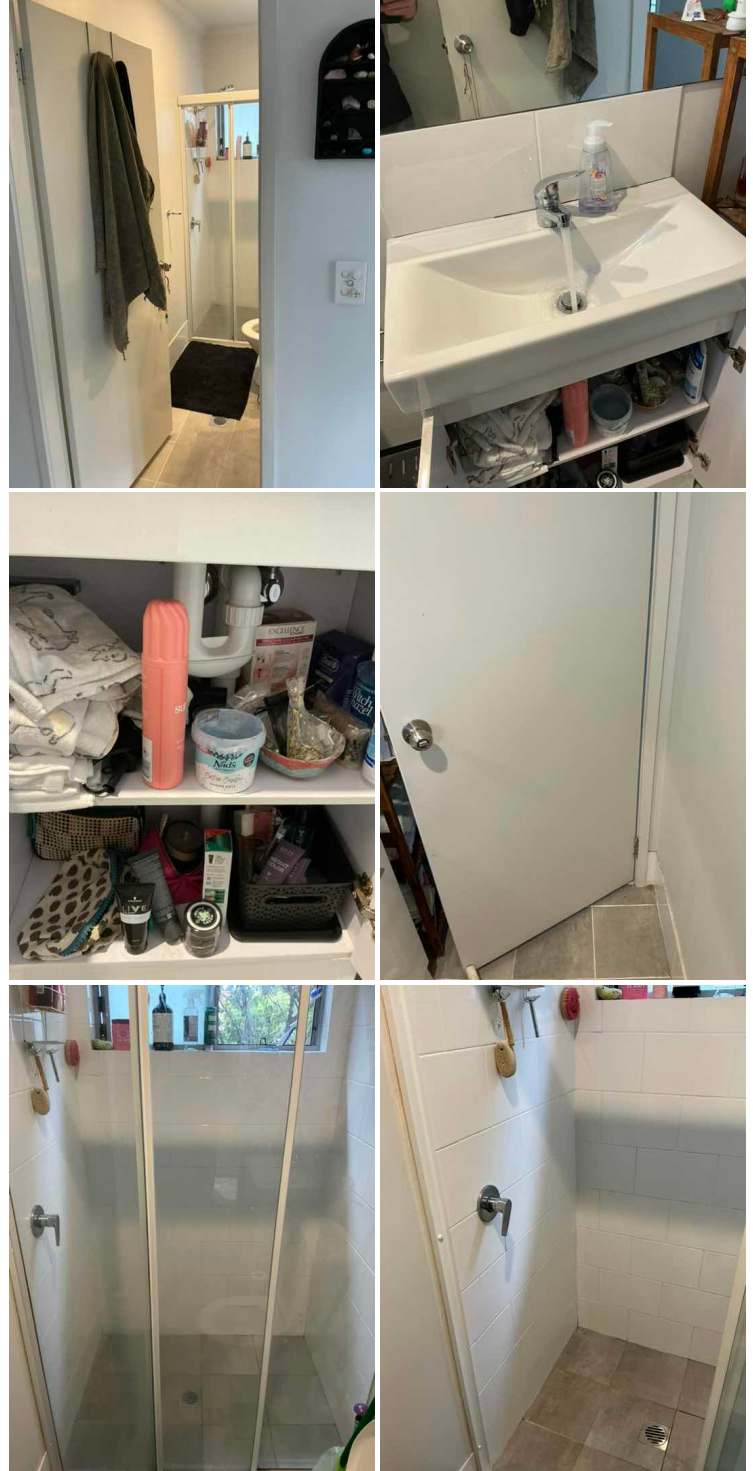
Of the visible areas, the general condition of this bathroom is serviceable or in reasonable condition for age of dwelling.

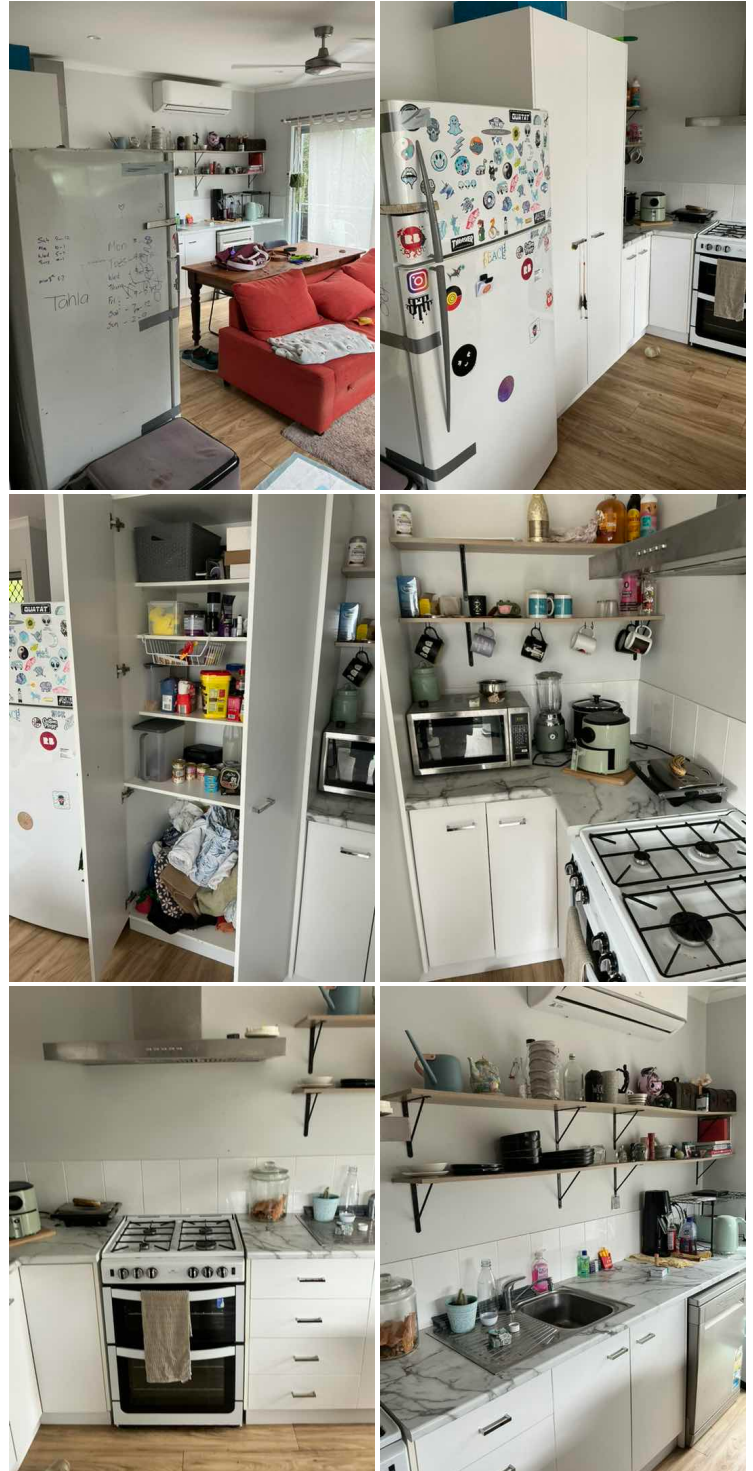
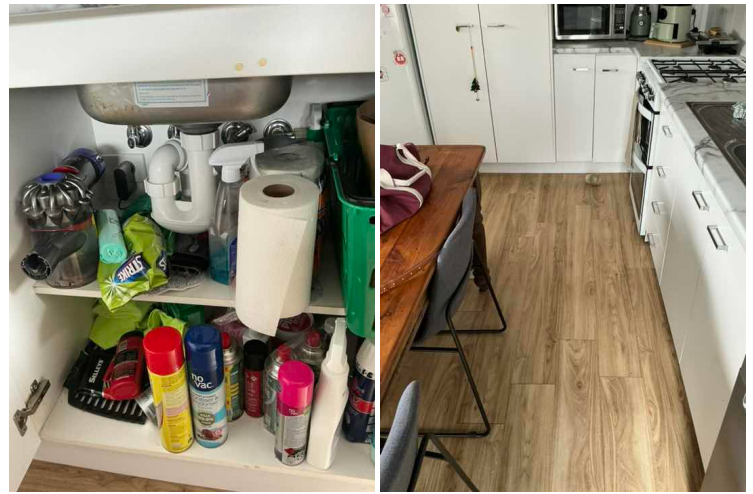
Of the visible areas, the general condition of the kitchen is serviceable or in reasonable condition for age of dwelling.
