# Building and Pest Report

## 32 Montwood Dr, Lennox Head

# Inspection Report

**32 Montwood Drive , Lennox Head , NSW , 2478**

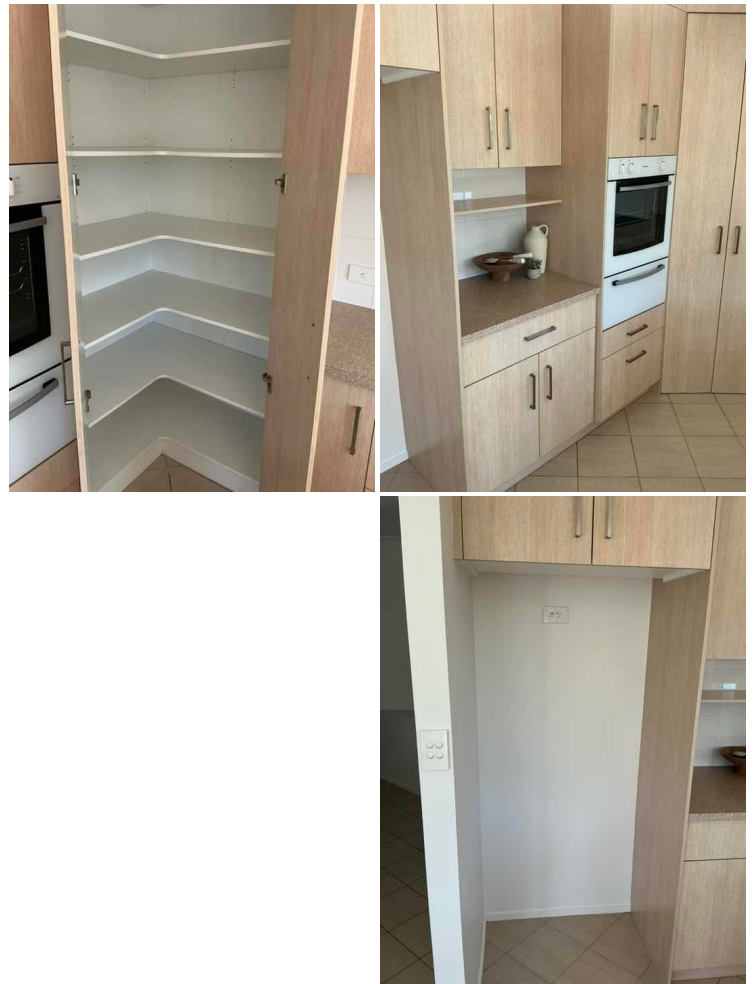
### **Cupboards And Bench Tops**

These components appear to be in a serviceable condition

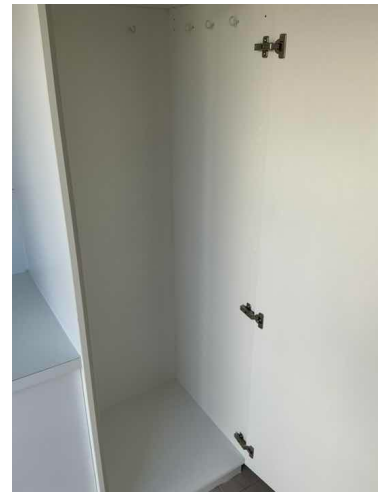
Of the visible areas, the general condition of the laundry is serviceable or in reasonable condition for age of dwelling.

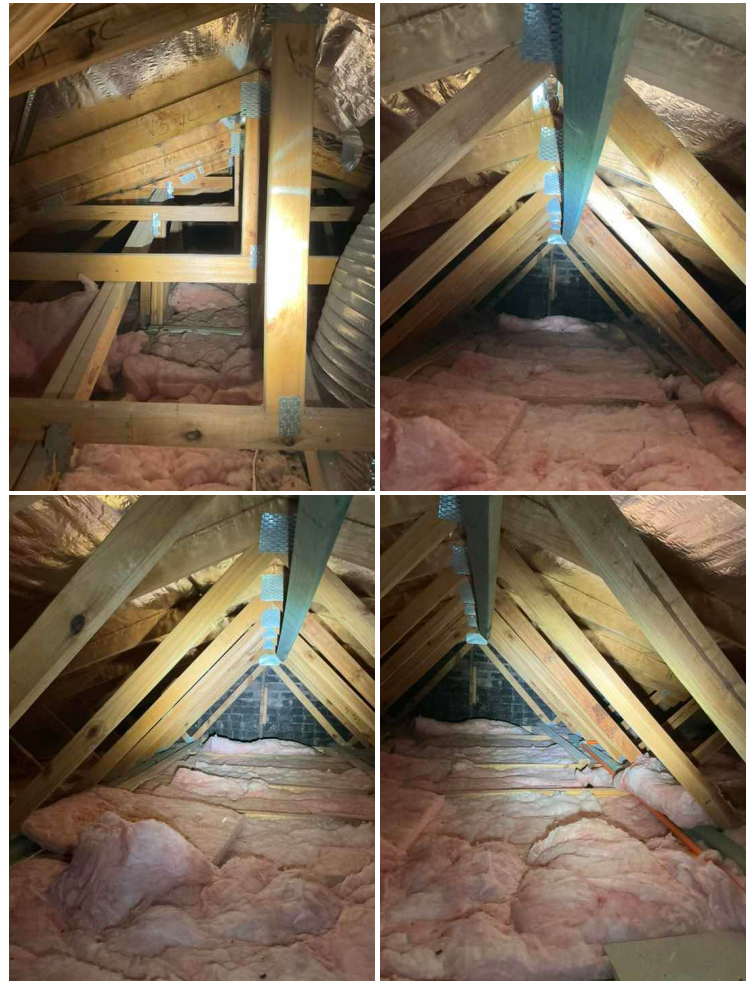
Visible sections of the roof void is in a serviceable condition for age of this dwelling.

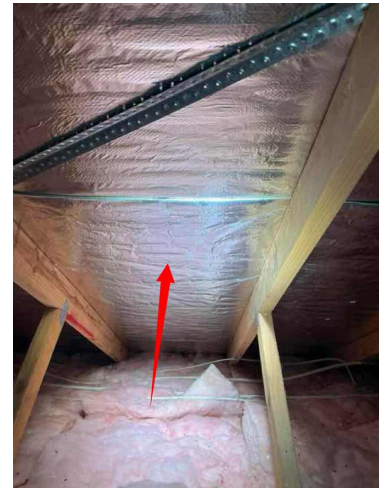
Sarking is installed.

The sarking generally is in a serviceable condition.

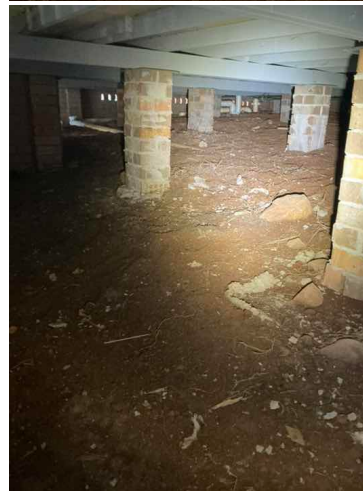
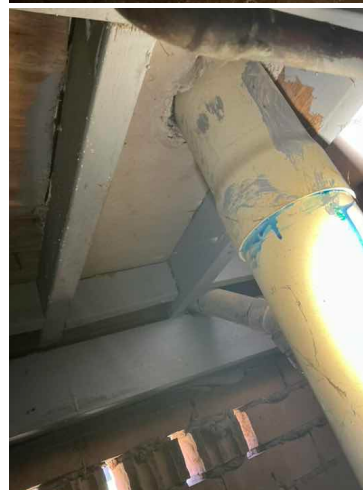
## SUBFLOOR

Of areas accessible and visible, the subfloor and components appeared to be in a serviceable condition.

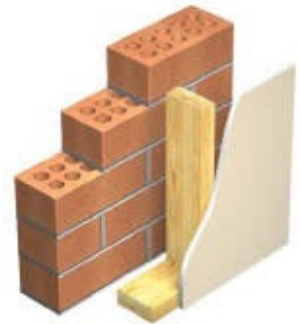
#### BRICK VENEER WALL

The structure is of brick veneer construction.

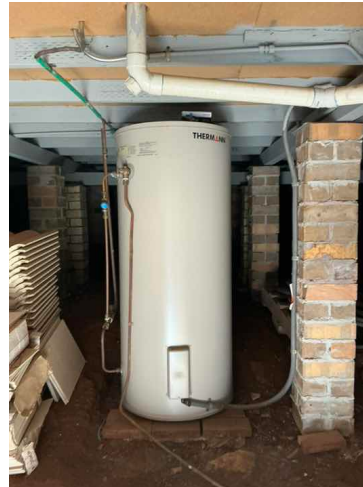
#### **Was the overflow sufficiently drained**

Yes. The hot water overflow does not drain to the perimeter of the building.
