# Building and Pest Report

## 5 Susan Place Skennars Head

| Report/Agreement # | 17112511273777 |
| Inspection Date: | 17 Nov 2025 |

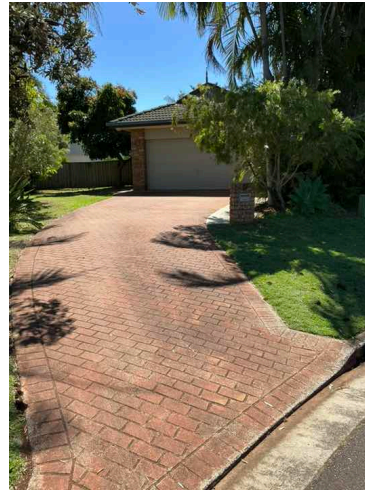
On visual inspection, the general condition of the driveway is serviceable.

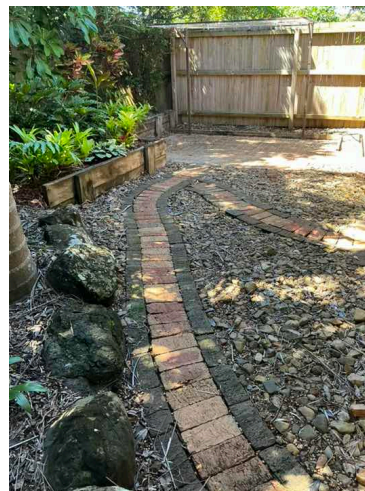
The paths around the home are in a serviceable condition for the age of this dwelling with no major defects visible.

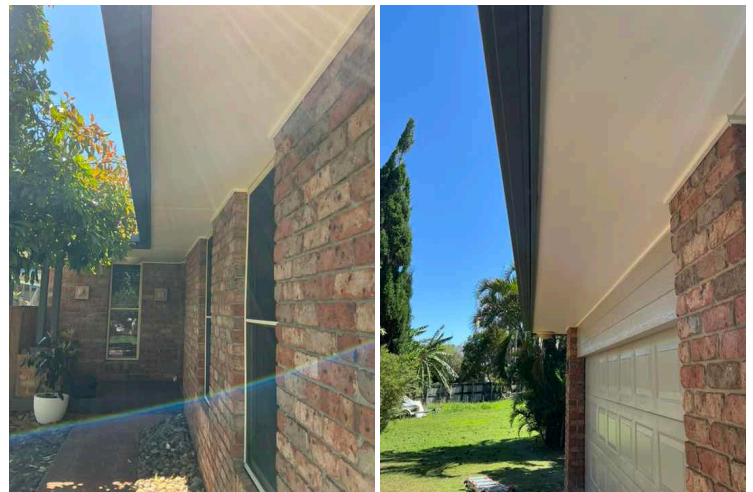
All visible and accessible of the physical nature of the guttering system appears to be in a serviceable condition with no apparent defects at the time of inspection. In the absence of prolonged rain fall efficiency of the guttering can not be assessed and you may find that further investigation or repairs maybe required. Note: Periodic maintenance checks should be carried out for rust penetrations and leaks.

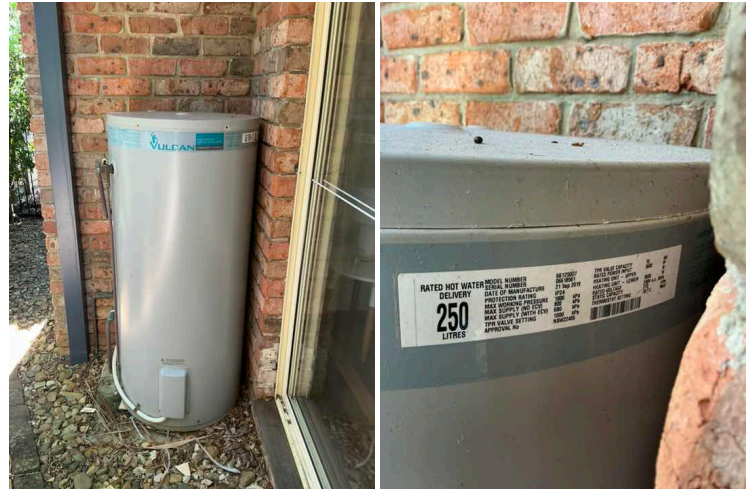
The hot water system appears to be in a serviceable condition. No specific tests other than running the hot water from a tap was carried out. No determination has been made as to the suitability or adequacy of the hot water system in relation to capacity or otherwise.

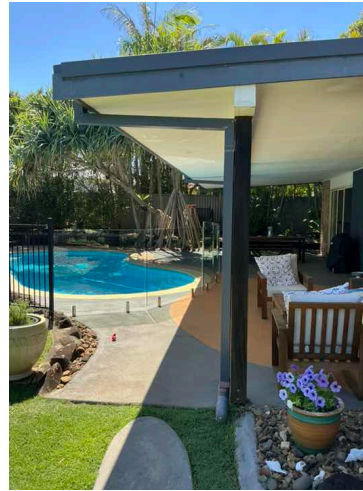
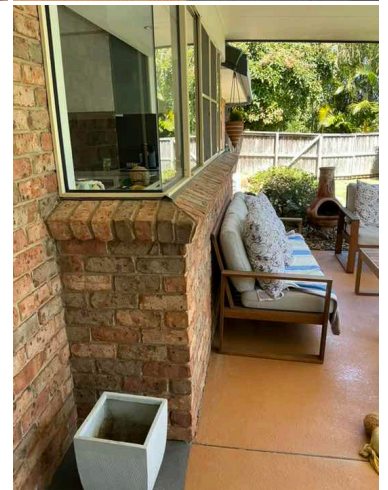
Visible sections of the Alfresco area are serviceable or in reasonable or condition for the age of this dwelling.

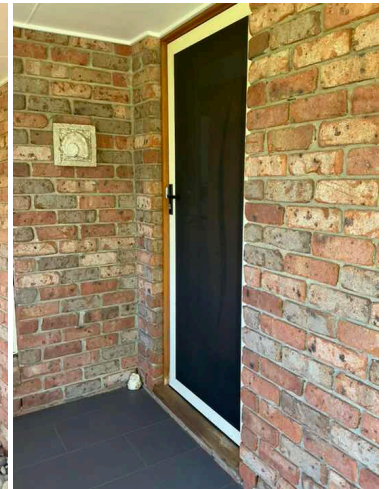
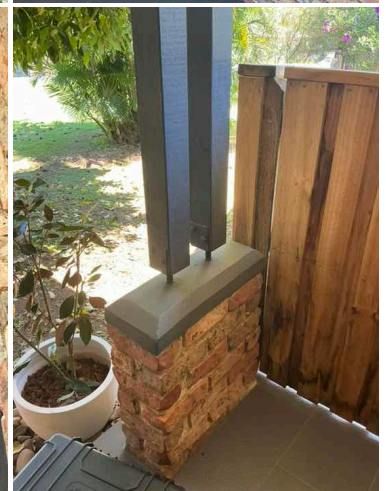
The entry porch serviceable or in reasonable or condition for the age of this dwelling.

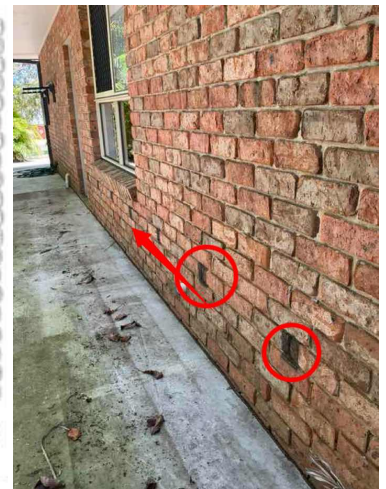
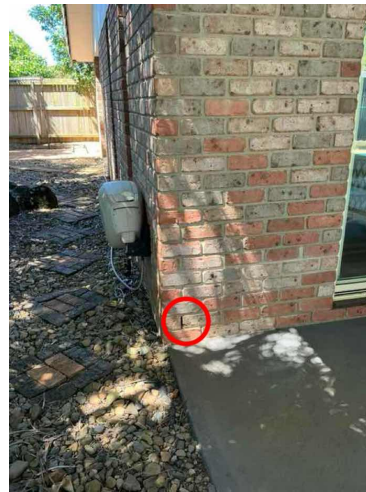
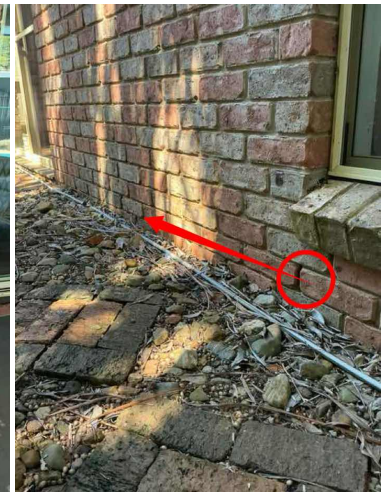
### **Findings**

The weep holes are unobstructed .

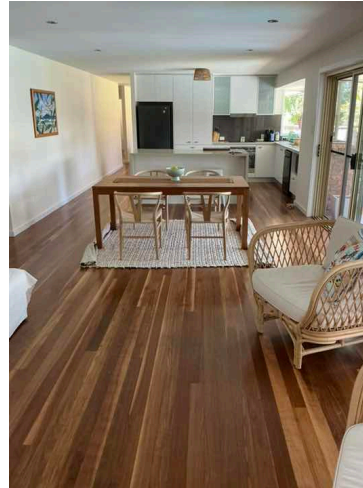
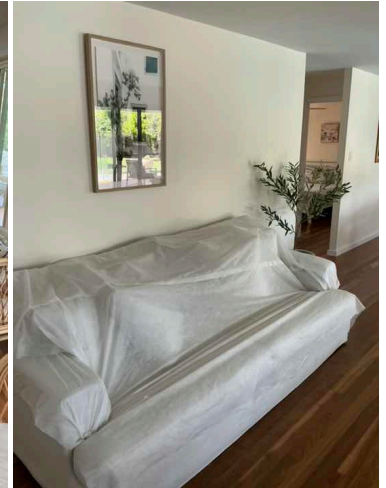
## **Combined Living & Dining**

From the visible and accessible areas, this room appears to be in a serviceable condition for the age of the property with no notable structural defects sighted.

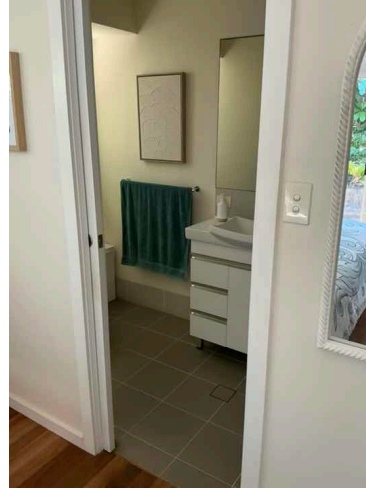
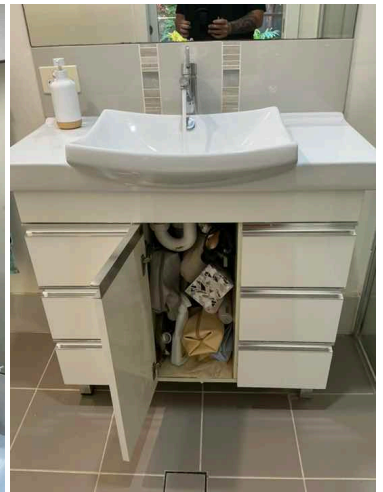
This bathroom is located in the master bedroom.

Of the visible areas, the general condition of this bathroom is serviceable or in reasonable condition for age of dwelling.

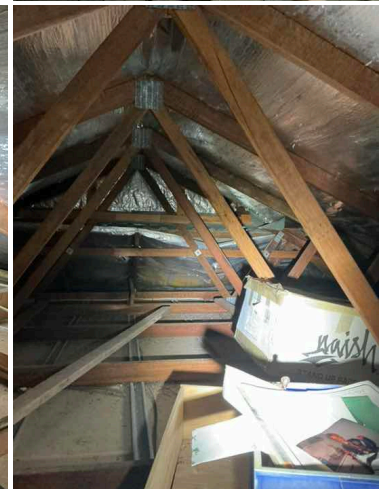
Visible sections of the roof void is in a serviceable condition for age of this dwelling.
